Ref BEK-23071-22

### **Land at 21 Thomas Street, Lindley – Biodiversity Net Gain - Justification of Baseline Habitats Used.**

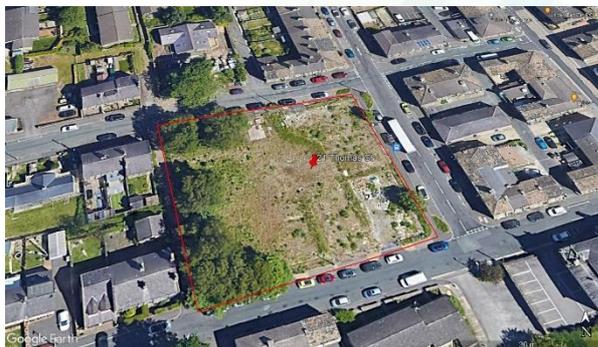
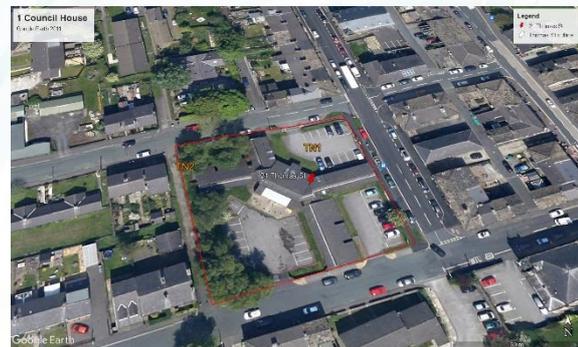
Google Earth 2021 compared with Google Earth 2011, showing substrates prior to demolition of buildings.

This site consists of the majority rubble and remnants of demolition materials. The substrate is concrete patches, rubble from building demolition and gravel, with two small (35m<sup>2</sup>) patches of grassy vegetation where previous planted borders have existed (see Google Earth Images below). The non-native bushes are regeneration across the site, with some native ruderal species.
