Bat Survey to
31 Chapel Hill
Linthwaite
West Yorkshire
HD7 5NJ

13th March 2023

Updated on 22nd August 2023 to include activity survey results

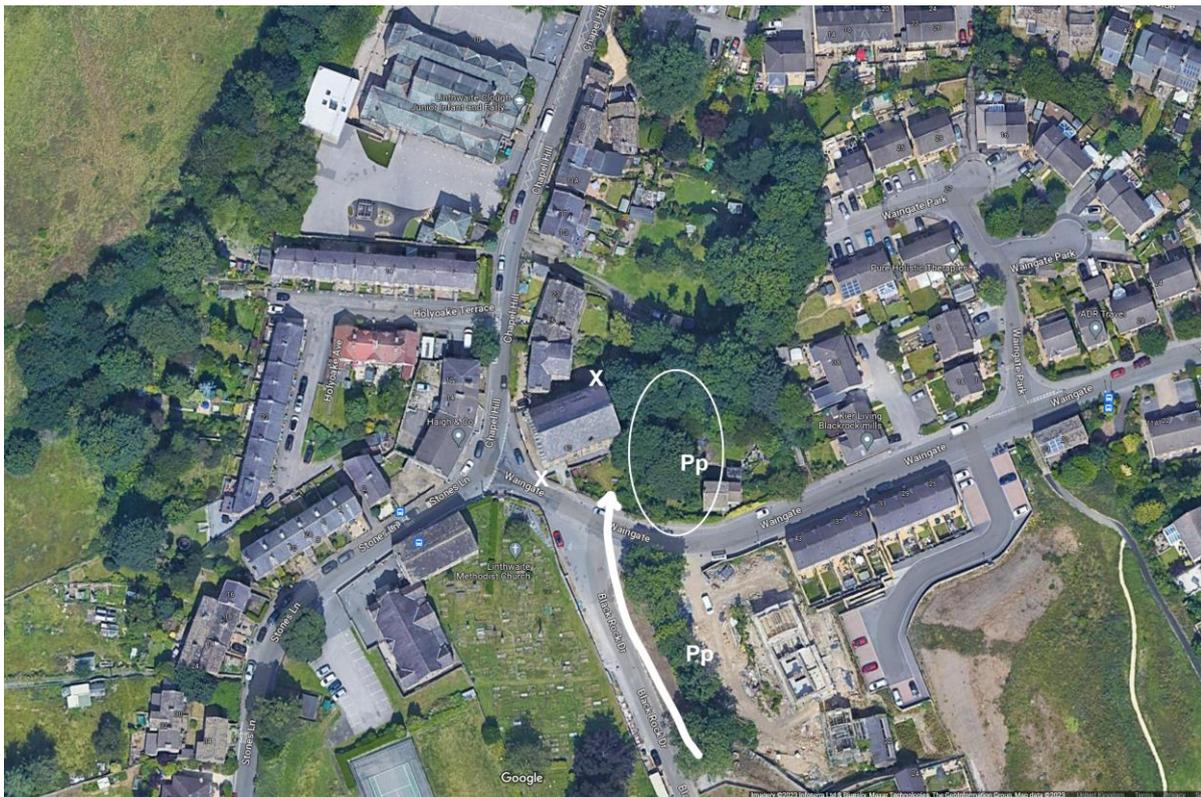
Figure 3 Bat activity and flight patterns

No bats were observed emerging from the chapel, but bats were on the wing just 20 minutes after sunset indicating local emergence. Common pipistrelle bats were observed flying into the survey site from a southerly direction along Black Rock Drive. At least four pipistrelles flew in from this direction over a period of 10 minutes indicating the roost is in that direction. The bats

proceeded to forage around the garden on the south and east of the chapel and small numbers of bats were recorded here throughout the survey.
