**Linthwaite Methodist
Church, Chapel Hill
Heritage Statement**

AB Heritage Project No: 62353

Date: 02/05/2023

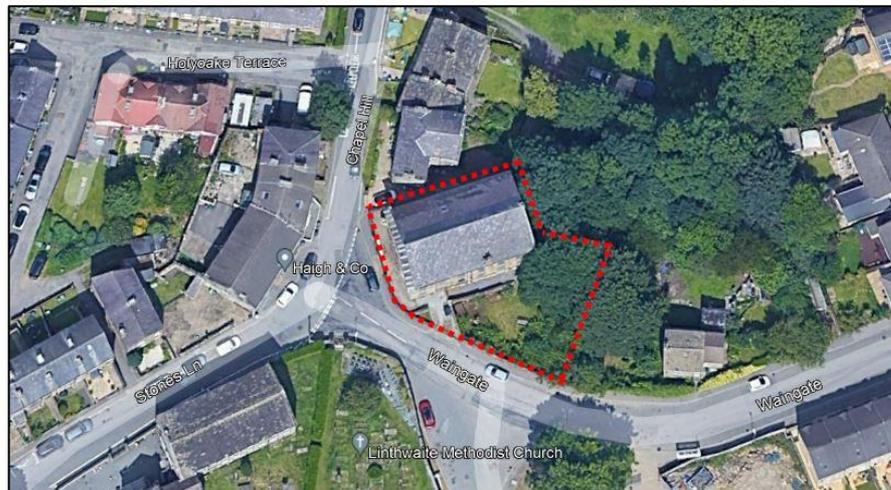
Plate 1. Site Location (Google earth 2023)

1.2.2 The site includes a fairly large garden that is significantly lower than the street. This garden is presently quite overgrown and bounded by mature trees. To the north of the former chapel are residences and their own rear gardens (Plate 1). The site is covered by the Linthwaite Conservation Area.

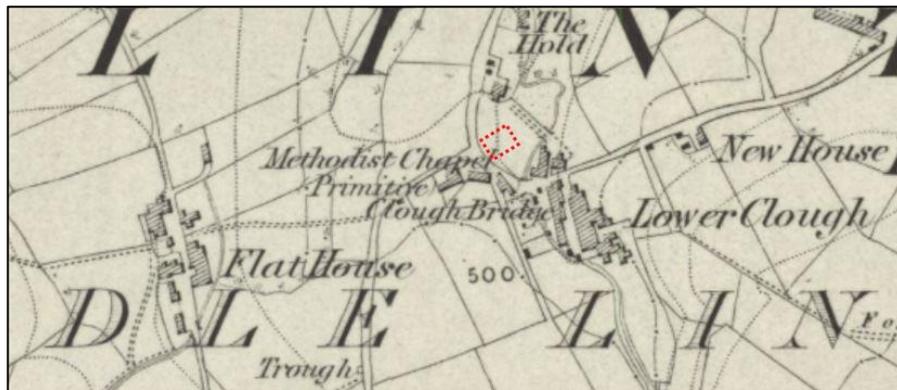
Plate 2. Location of application site in 1854 (NLS, 2023)

- 4.1.1 Linthwaite is considered to be a village with origins in the Norse period (Kirklees Council, 2010). Originally a series of small hamlets or farmsteads, these eventually amalgamated by the mid-19th century, to form the village that is largely recognisable today.
- 4.1.2 Plate 2 shows the area of Low Clough, including Chapel Hill in 1854 prior to the construction of the application building. The Plate shows that across the street on Stones Lane, a Primitive Methodist Chapel was already in place.

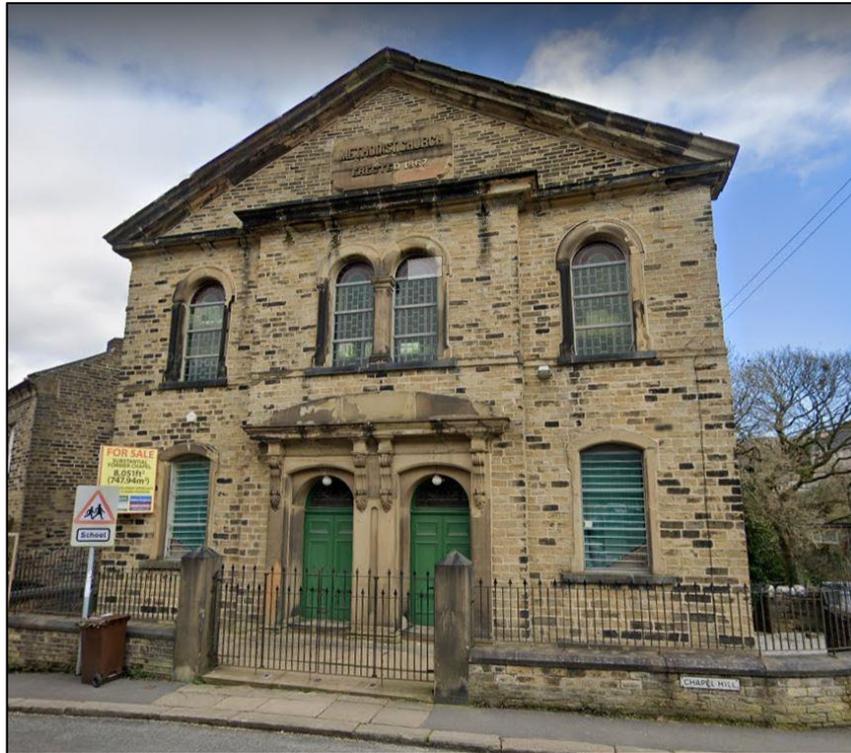
Photo 1. Principal west elevation and entrance

Hammer dressed stone with ashlar dressings. Pitched stone slate roof. Stone brackets to gutter. Two storeys and lower ground floor. Continuous first floor still band. Six-bays long by four-bay pedimented front. Ground floor windows are segment headed. First floor windows are round arched, those to side elevations with impost band. The central front bay breaks forward slightly and has two round arched, six-panelled doors within cambered heads. Cornice area is supported on 4 console brackets with foliated base. At first floor level is paired round arched window. Single lights to each side, both floors. Large tablet in tympanum reads in raised capitals: 'Methodist Church Erected 1867'. Stained glass to north elevation window basement level contains flat.

4.2.4 Exceptions to the List Entry are the windows, some of which are modern or at least not original, these include three sash windows with one either side of the domestic entrance on the south elevation and two modern casements on the north elevation. The rest of the windows are metal framed and very likely to be original. The roof now includes a Velux-style skylight. The domestic type of door on the south elevation is plain with a Yale lock and a number plate '31' (Photo 2).

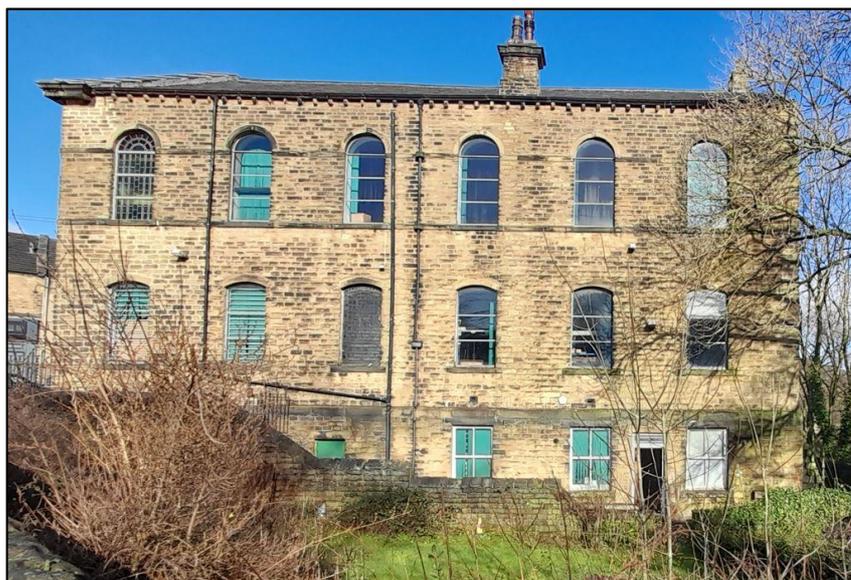
Photo 2. South elevation

- 4.2.5 The chimneys shown on Photo 2 include one at the rear of the building that would have served the boiler. That shown extending at the eaves on the south elevation has no associated chimney stack or fireplaces and must have been fed by pipework or a cavity behind the interior wall, most probably for the central heating system and / or heated floors. The south elevation is the easiest way to appreciate the verticality of the building, with the differing designs of the windows at each storey, from flat headed, through segmental and finally round headed.

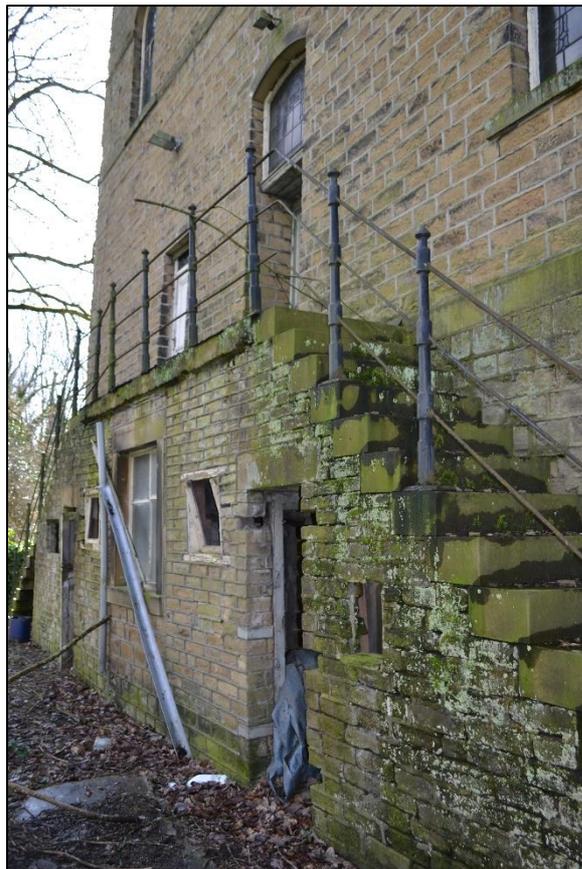
Photo 3. Stair structure on east elevation

- 4.2.6 To the rear the lower ground floor is at its fullest extent. There is a door (potentially original) in the middle of the east elevation at ground floor. This is accessed from outside by a twin set of stone steps with wrought iron railings, built over a very badly damaged brick outbuilding (Photo 3). It was noted during the site visit that this structure had completely sheared off the east rear elevation. A structural report (Marsh Design, 2023) suggests this may have been caused by inadequate foundations, and that the structure will need to be completely removed during the development works. Unless this was replaced, the rear ground floor access door would be isolated.

- 4.2.29 In a large part, the Methodist Church retains a great deal of the original character and many original fixtures and fittings, such as the floors, much of the doors and joinery and the windows. Stand out features include the first-floor geometric stop rail, the large windows and the first-floor ceiling.
- 4.2.30 Other features, such as the columns, could be easily retained but the condition of much of the wall panelling is beyond saving. As well as the panelling on the walls, the ceiling and many of the windows have sustained damage, but these could be repaired. The exterior of the building is largely unchanged, but the east end stair structure is beyond repair and would probably need to be rebuilt entirely.

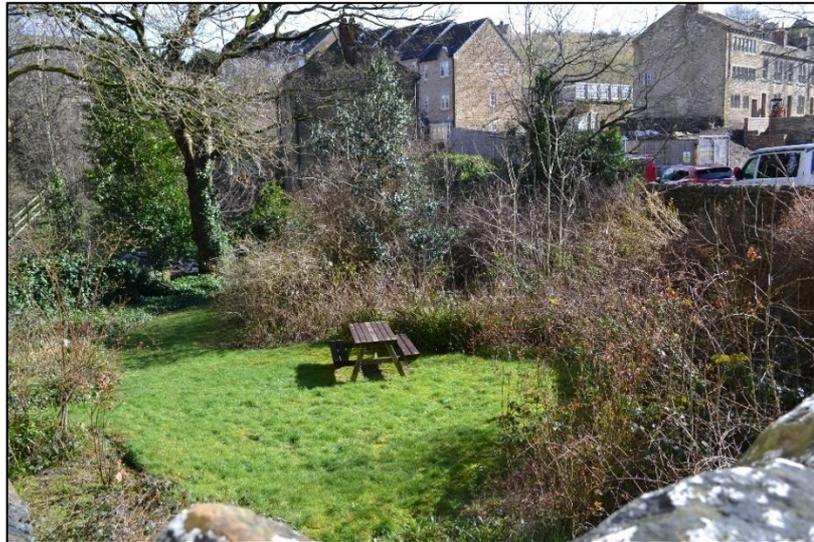
Photo 4. The garden

- 4.2.8 Adjacent to the south elevation but separated by a stone wall is the garden. As described above, the garden is at an appreciably lower elevation than the building. Photo 4 below, shows the present condition of the garden. It is proposed that the garden be redeveloped to provide residents parking, by way of a ramp from Waingate.

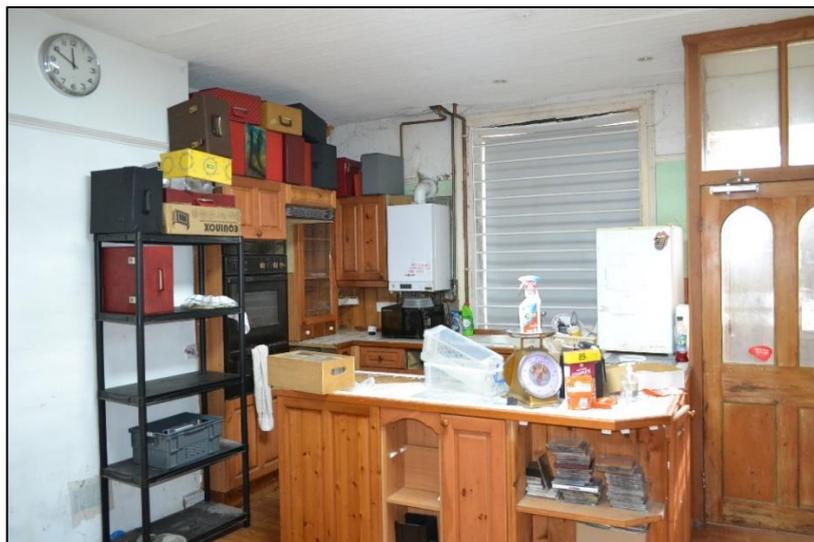
Photo 5. Kitchen on lower ground floor

- 4.2.9 The lower ground floor is accessed by the domestic door on the south elevation. As expected by the rising landform, the lower ground floor does not extend under the whole building but only the eastern half. This floor comprises a kitchen, WC, an office and 3 store rooms.
- 4.2.10 This floor of the Methodist Chapel has perhaps been modified to the greatest extent. On entering the building one walks into a kitchen with domestic water boiler, sink etc.

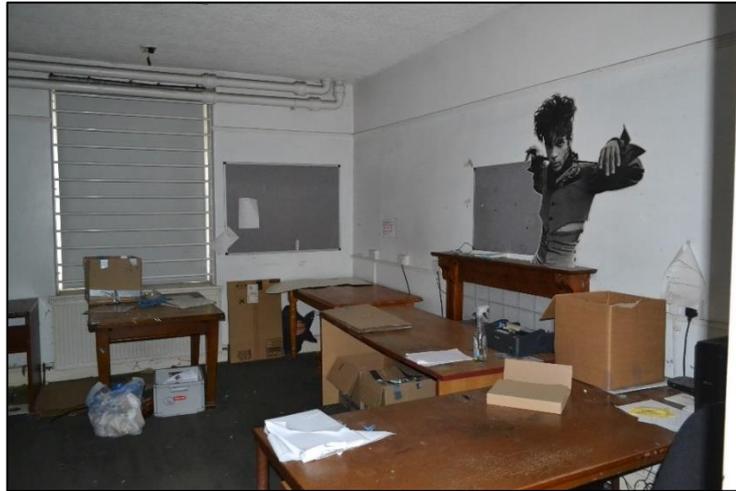
Photo 6. Office on lower ground floor

4.2.11 Passing through the kitchen are the small offices a WC and stores. All appear to have been 'institutionalised' (Photo 6). Modern radiators and electrics were evident.

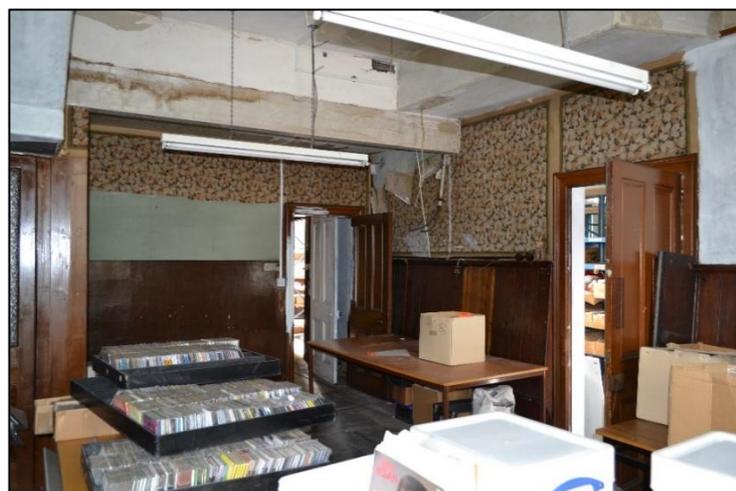
Photo 7. South range office, ground floor

4.2.13 Much of the decoration on this floor is intact from the 19th / early 20th century, including the panels on the walls, wallpaper and many fixtures such as cupboards and pigeon-holes. All floors appear to be original and in places very old vinyl covers the floorboards. Photo 7 below is typical of the appearance and condition of these rooms. Of interest is the original joinery and doors which are mainly well preserved, but the half panelled walls have suffered from wear and tear and there is much damage from new services and fixing for cables etc.

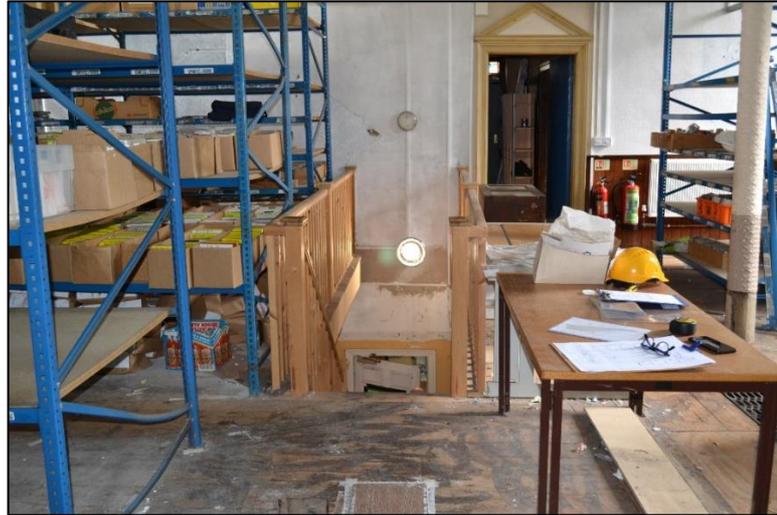
Photo 8. The ground floor auditorium showing storage racks. Looking south

- 4.2.14 The main congregation auditorium offers the most impressive space in the building. This would have originally included rows of pews, but now this area is utilised with stacking shelves and storage racks (Photo 8).

- 4.2.15 Despite the clutter, this space still makes an impressively large room, and the acoustics still ring. It is clear from Photo 8, that the access stair down to the lower ground floor is not original. The floors on the ground floor are, however, original and still include the cast iron grilles that trace the underfloor heating. The cast iron columns that would once have been integrated with the pews, and which hold up the first floor raking gallery are present (Photo 9).

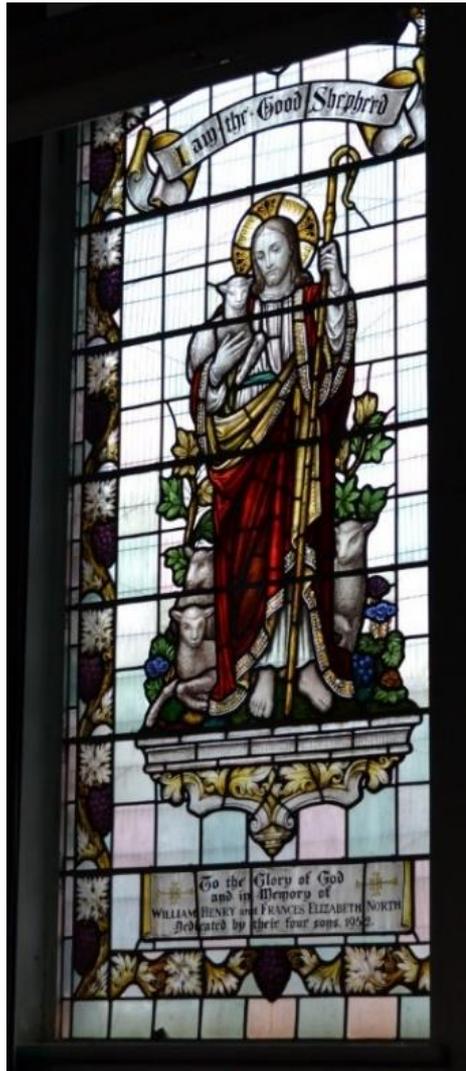
Photo 10. Stained glass window

- 4.2.16 From the interior it is easier to appreciate the form and condition of the windows. On the ground floor south elevation all the windows are metal framed comprising three horizontally divided sections. The metal window frames on this elevation are largely sound, but work is required to secure them in place, as the existing putty and paintwork has degraded.
- 4.2.17 There is a single stained-glass window (Photo 10) on this elevation, depicting Jesus Christ as the shepherd. It is dated 1952 and is dedicated to William Henry and Francis Elizabeth North. This is a colourful and poignant feature on an otherwise plain and functional elevation.

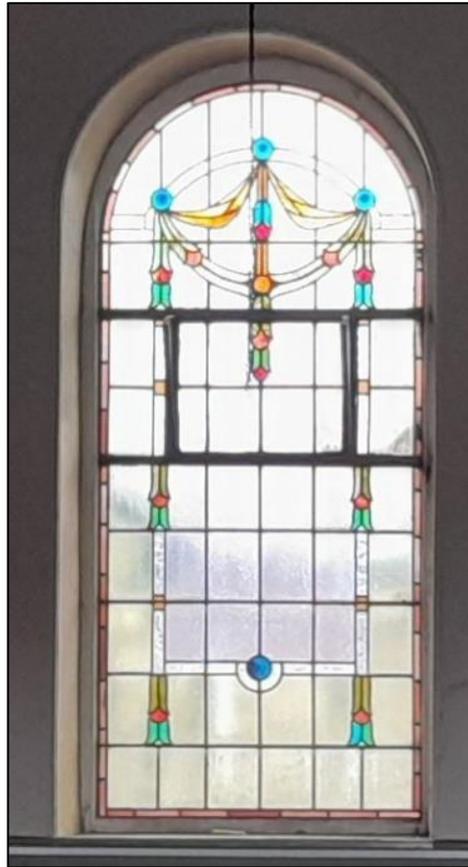
Photo 11. North elevation window

- 4.2.18 On the north elevation the ground floor windows are different to those on the south elevation, by featuring a stained glass design of coloured swags (Photo 11). The coloured design continues through to the first floor (but here the windows are round headed). All windows the north elevation above lower ground floor have this design, but almost all are damaged to a degree.

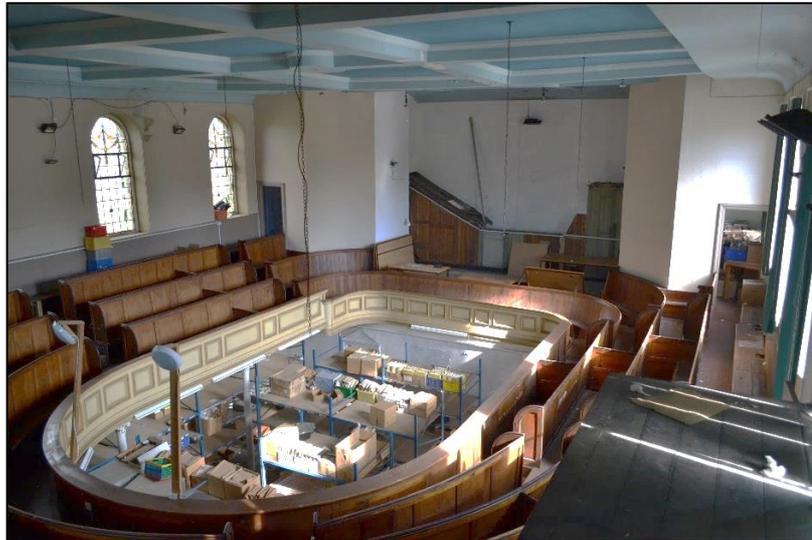
Photo 12. The first floor auditorium

- 4.2.21 The first floor comprises the large upper auditorium, a staircase to the attic at the west end and at the east end a set of rear rooms, presumably for the minister to prepare and which provides access to either side of the auditorium.
- 4.2.22 The first floor is largely unaltered since it ceased in use as a Methodist Church. The key features are the large, raking gallery replete with banks of wooden pews; a large, decorated band picked out in simple geometric design that forms the stop rail for the congregation, preventing persons falling to the ground floor; the pulpit end of the auditorium, and the decorated coffered ceiling (Photo 12).

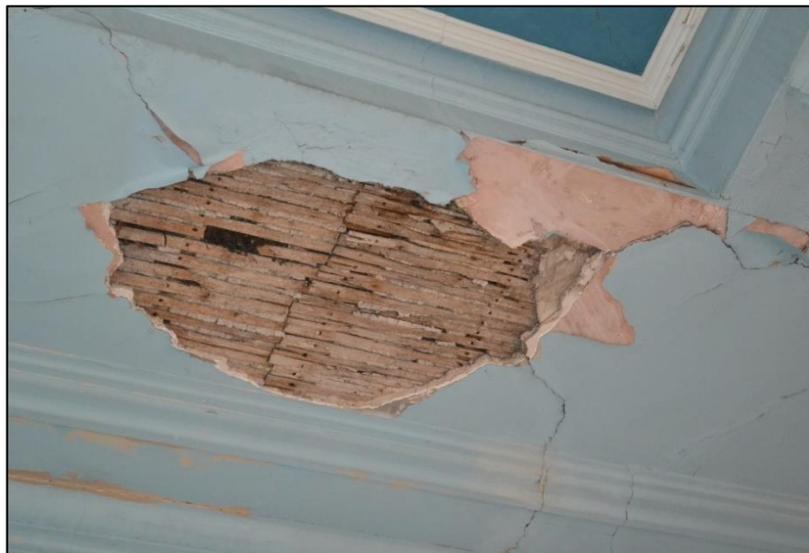
Photo 13. Damaged ceiling

- 4.2.23 The pews and the associated stop rail are *in situ* and are in good condition. Three banks of pews line three sides of the auditorium providing the congregation with unhindered views of the pulpit end. The floors are original.
- 4.2.24 The coffered ceiling has suffered a degree of damage, mainly from what appears to be water ingress and damp. Above the pulpit plaster has fallen away from the ceiling revealing the lath work beneath (Photo 13). Overall, though, the damage is repairable, and the ceiling would make an attractive feature in the proposed apartments.

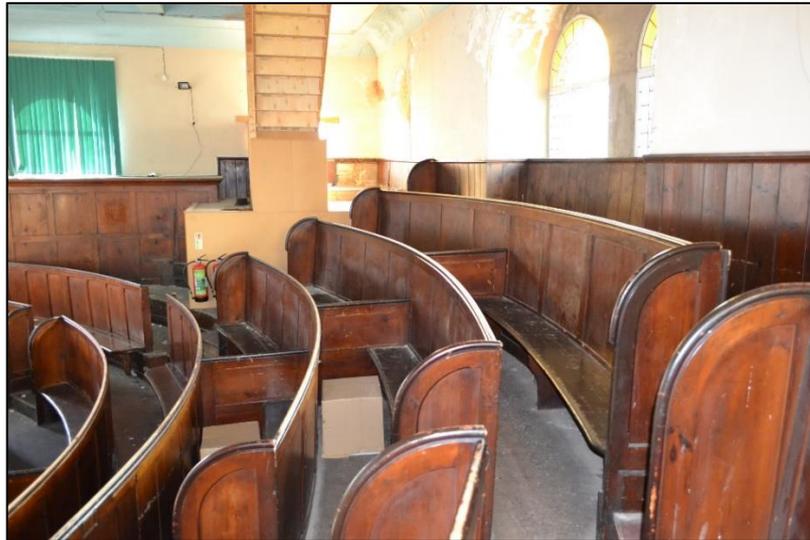
Photo 14. West end of upper auditorium. Note the makeshift stair

- 4.2.25 At the west end is a very modern, makeshift stair access to the attic (Photo 14). This is of no heritage value at all, and it is unclear, though doubtful, that it has replaced a previous stair here. There is a large attic access panel in the northeast rear room behind the pulpit, and this was probably the traditional way to get into the roof space.

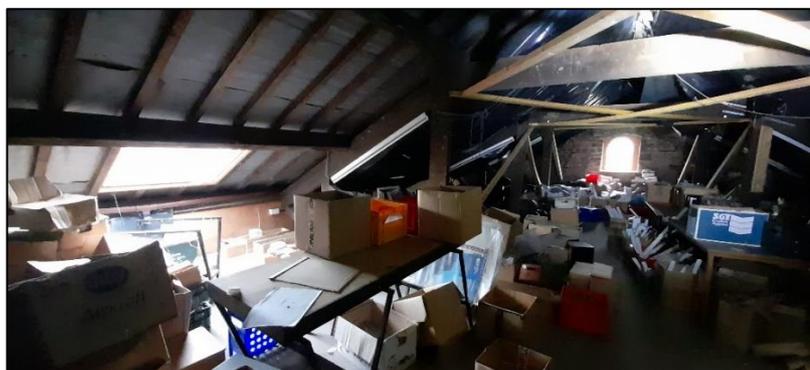
Photo 15. The attic

- 4.2.28 Access was via the makeshift stair. Inspection of the attic was hindered by the lack of electric light and the profusion of stored goods. The impression was that the roof timbers in places had been damaged and there was evidence of temporary reinforcement on some timber members. The roof included a single skylight of the Velux variety on the north pitch of the roof. A single round headed window, smaller than the elevation windows is present at the east end, but this looks like a later insertion. Photo 15 below is a general shot of the attic in 2023. Note: The structural survey includes a more thorough account of the attic (Marsh Design, 2023).
