# Bat Survey to Helm Farm

Helm Lane  
Colne Bridge  
HD5 0PU

24<sup>th</sup> August 2022

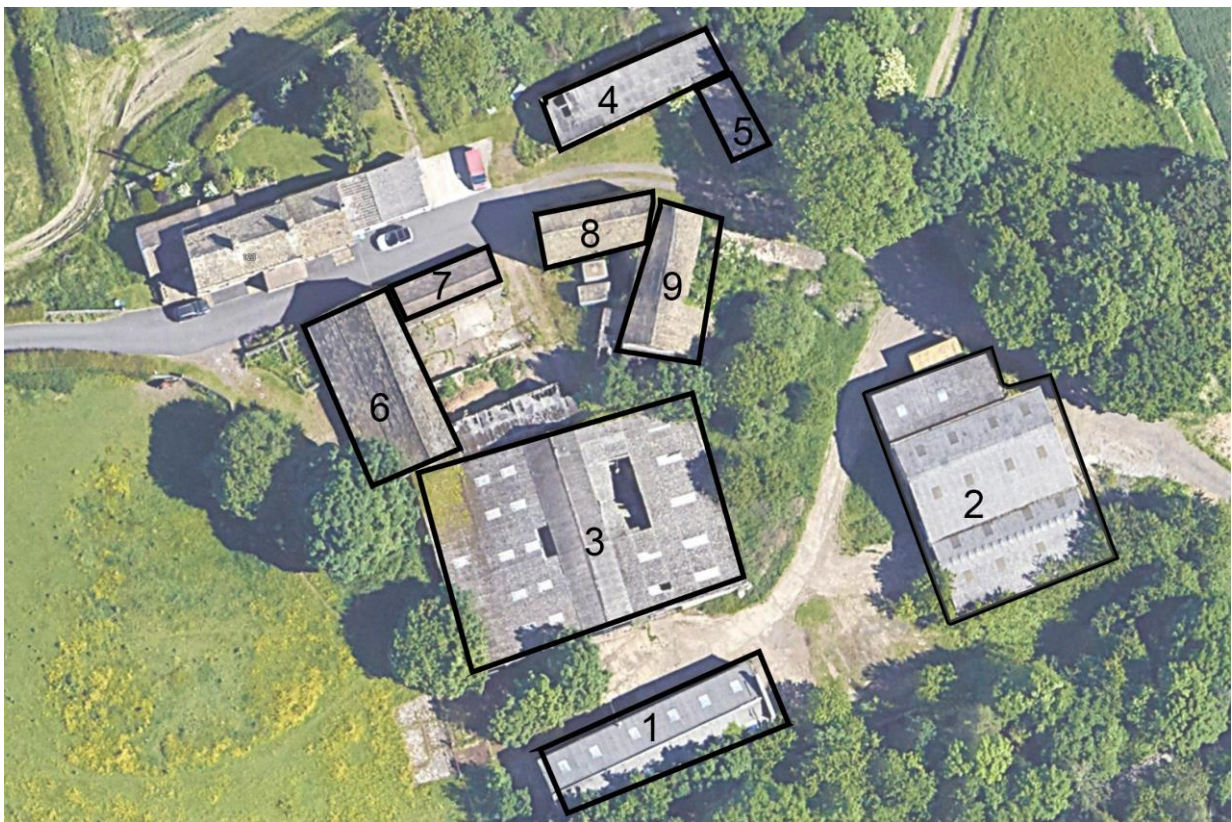
Figure 3 Plan of buildings surveyed.

The site consists of a several agricultural buildings, many of which have fallen into disrepair, and all are no longer used. For ease of reporting, the buildings have been numbered 1-9 shown below.

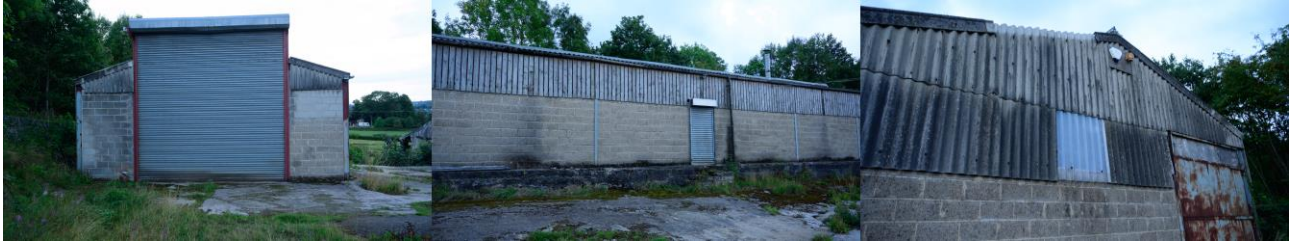
### Building 1

A modern agricultural unit with blockwork lower walls, corrugated asbestos upper walls and roof and large, roller shutter door to the front. Very few PRFs and considered unlikely to be used by bats. This building is assessed as being of 'negligible' importance to bats. No further survey work is required.

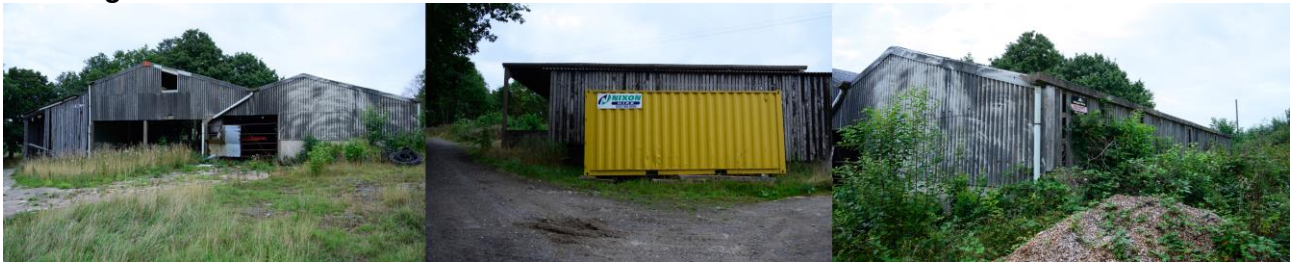
### Building 2

Large dilapidated agricultural unit built from corrugated asbestos sheeting. Wide ridge sections, single thickness sheets to walls and roof and lack of external features suggest this would not be used by bats. The building is considered to have 'negligible' roost potential. No further survey work is required.

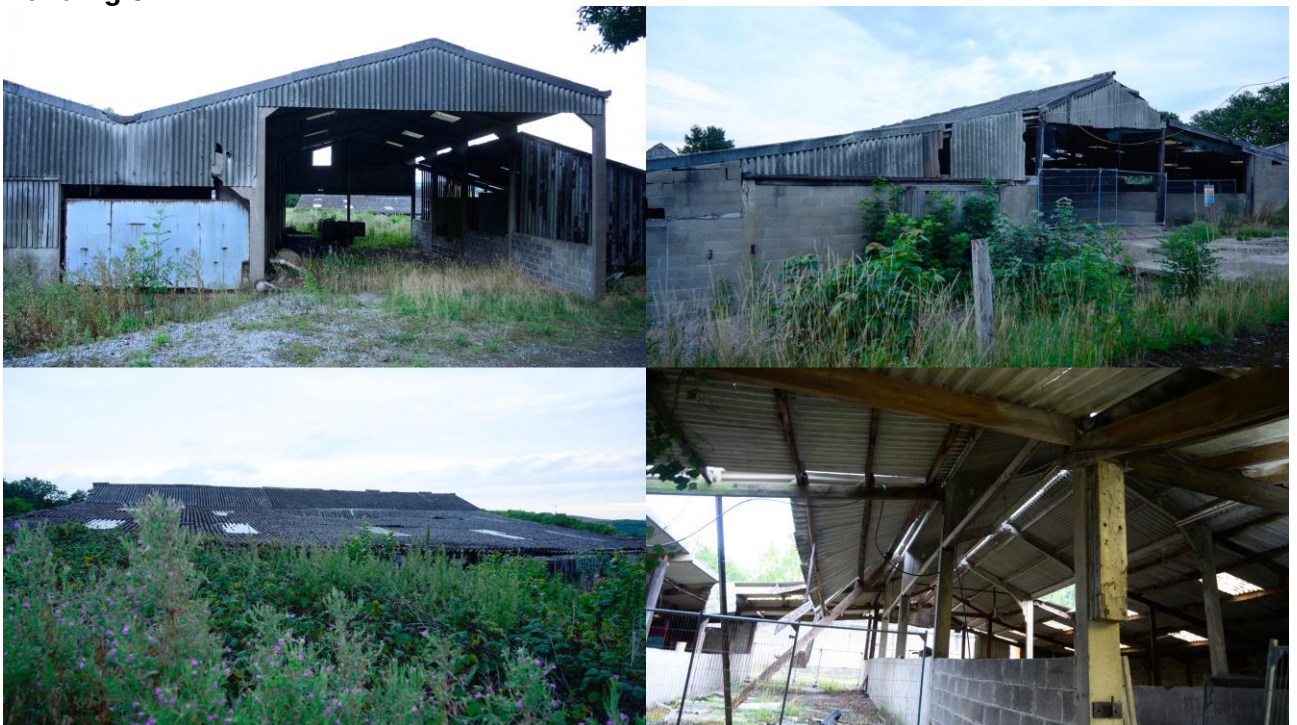
### Building 3

A very large and dilapidated agricultural unit with blockwork lower walls and corrugated upper walls and roof. The unit is held up by a wooden frame but has no PRFs and is considered to be of negligible interest to bats. No further survey work is required.

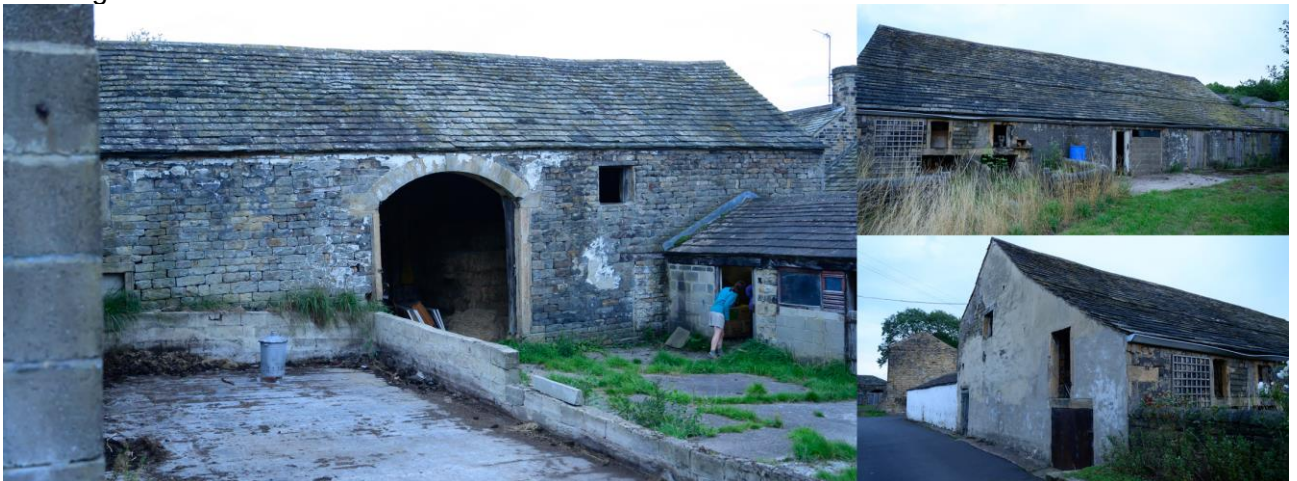
#### Building 6

A period stone barn with stone roof tiles in very good condition. The roof is sound and has no missing or slipped tiles and the ridge tiles are in situ. The north elevation is cement rendered and has a sound dry verge. There is a lean-to extension to the west elevation which has been incorporated into the main roof creating a long, sloping pitch to that side of the roof. The roof has been stripped and turned and lined with a polyethylene liner. The timbers are original with large A-frame beams and associated mortice joints. The barn is open having a large coach house entrance to the front with no doors allowing bats to freely access the interior. An internal

search revealed a scattering of droppings on stored goods, most likely associated with bats flying through the barn rather than roosting. However, there was a small cluster of droppings at the base of one of the large A-frame timbers which indicated a possible night roost or feeding perch of brown long-eared bat.

Although no bats were seen to emerge from this building and no brown long-eared bats were seen in pre-emergence flight, the barn is likely to be being used by bats in some capacity and will require further survey work and possibly an EPSM licence. The barn is assessed as being of 'high' roost potential.

The proposed works to convert the buildings to residential is likely to harm or destroy bat roosts and will require further work to establish the extent of use of the buildings by bats. A detailed method statement will be required and a EPSM licence will be required before any work can commence on buildings 6, 8 and 9. Buildings 1-4 have negligible interest to bats and do not require to be part of any licencing and can be demolished at any time without impact to bats.

Mitigation and compensation will be created as part of the method statement required to obtain the European Protected Species Mitigation Licence that will be required before any works commence. The mitigation is likely to cover, but is not limited to, stripping all roof tiles by hand,

outside the period for bat occupancy, avoid using breathable membranes, ensuring contractors are made aware of the possible presence of bats via a tool talk, advising vigilance and careful observation before pointing holes to avoid entombing bats. A sympathetic lighting scheme will also be required.

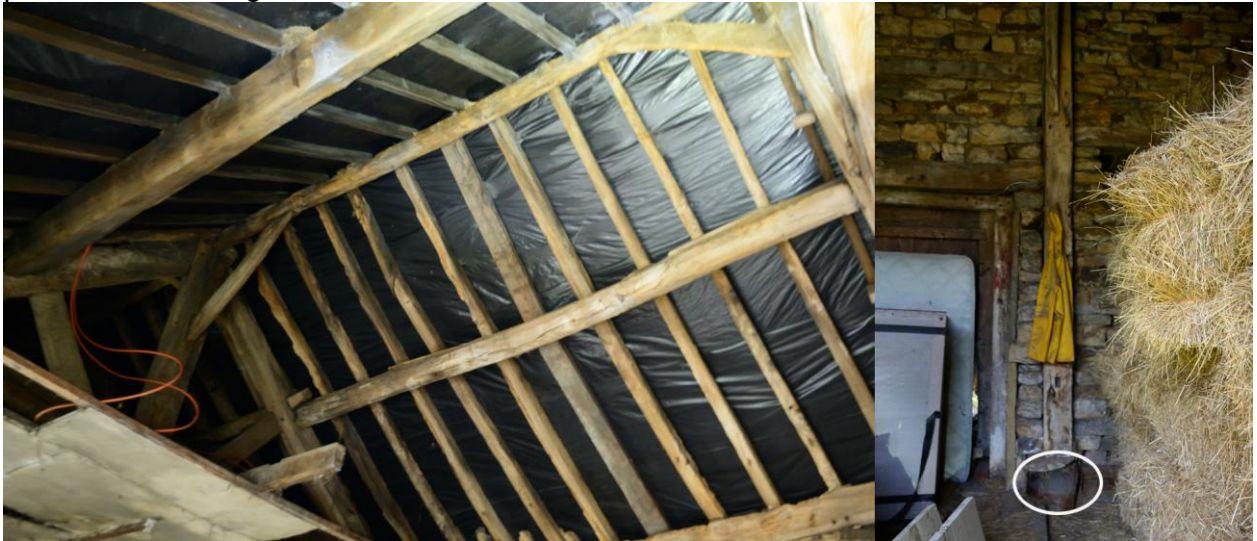
The plate above shows the internal roof of building 6 and the location of the droppings associated with brown long-eared bats which is directly opposite the large coach doors.

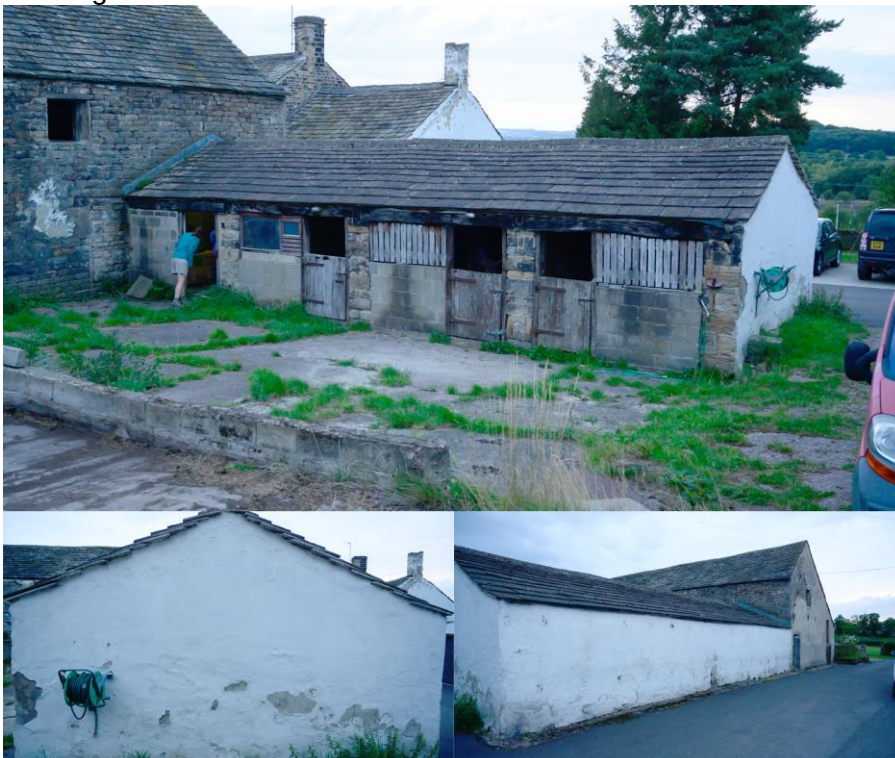
#### Building 7

This is a single storey stable block built from brick with a cement render. The building was originally open-fronted with brick peers supporting the roof but these have been walled in between with blockwork to create the stable. The roof is lined and is covered with a composite roof tile to look like stone. The building assessed as 'negligible' roost potential as the walls are

rendered and the composite tiles sit flat. All ridge tiles are present, and the dry verge is sound. Several active swallow nests were located in this building but no evidence of bats.

Works to mitigate and compensate for nesting swallows and barn owls will also be required.

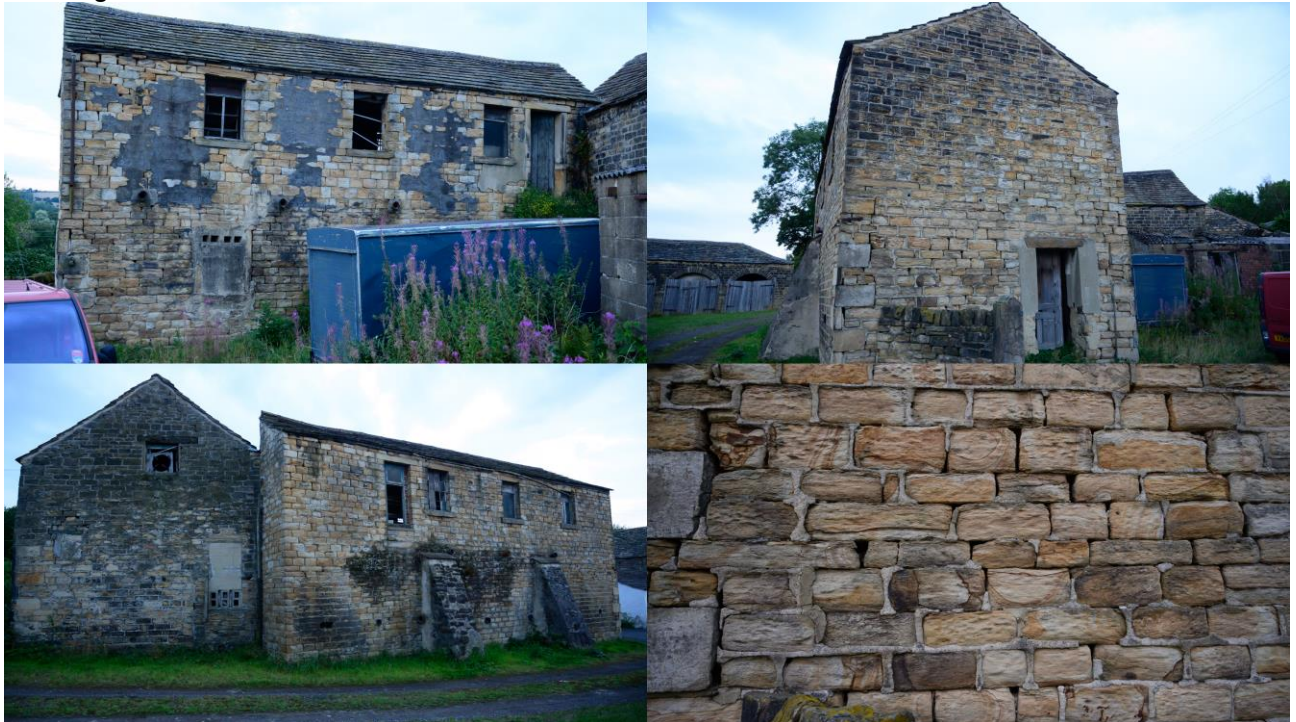
#### Building 8

This is a double height period stone barn with stone roof. The walls are rubble-filled and have had some remedial works undertaken but there are many holes which appear to go deep into the stonework. The roof has a stone tile and is sound and without slipped or missing tiles and the ridge tiles are present. The dry verges have been pointed and appear sound. It was not possible to gain access to the upper floor to inspect the roof interior as the only access is from external stone steps which were obscured by very dense brambles which will need clearing in order to gain access. It is possible to view the interior through the missing upper floor windows using a high-powered lamp and binoculars. Inspection revealed that there has been some attempt at insulating the roof by attaching insulating material to the rafters. This appears to have collapsed for the most part and hangs down from the roof creating a dense obstacle which looks as though it would impede bats flying through the building. It is not possible to view the ridge from an external check and will require further work. Even without the internal inspection, the building is assessed as being of 'high' roost potential.

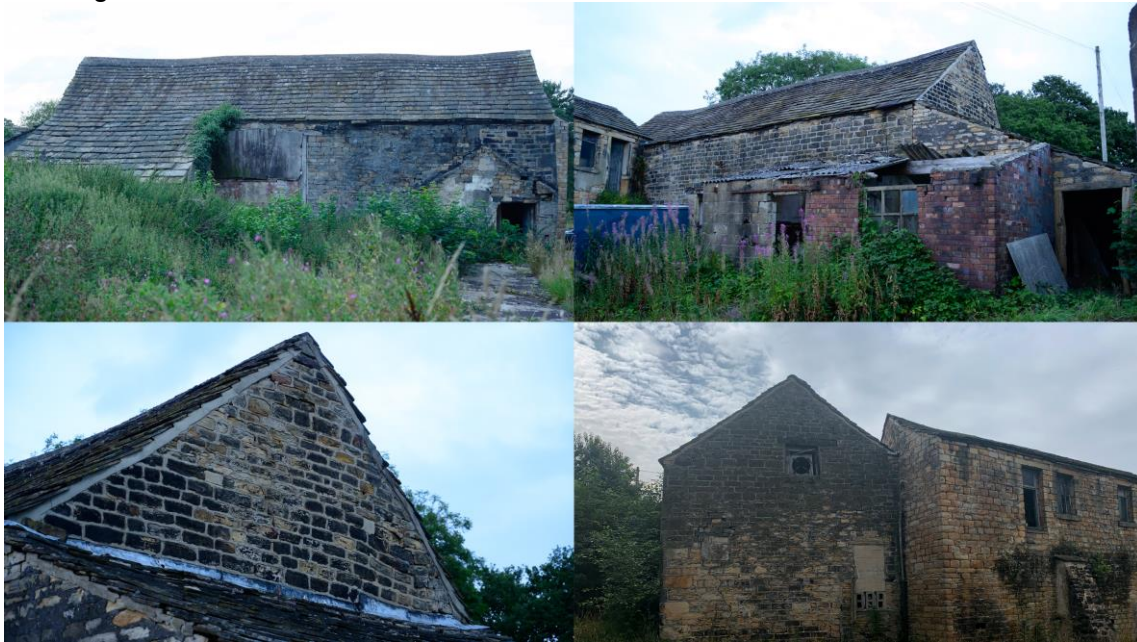
## Building 9

A double storey barn that is full height internally and has no upper floor. The walls are constructed from stone and the roof has stone tiles. The roof is sound and has no missing or slipped tiles and the ridges are present and reasonable well mortared though there are gaps where mortar has failed and also gaps between roof tiles. The east gable has suffered movement and has been repointed and repaired to stem this. Therefore, the dry verges are sound and well pointed and the gable wall has no gaps. Internally the roof is lined with traditional felt but, as with all the older barns here, the timbers are all original. On entering the barn, a cluster of brown long-eared bat droppings was immediately noticeable on a board on the floor, and they were adjacent to a large amount of 'whitewash' and pellets indicating the presence of a barn owl. The ridge is covered by the roofing felt and had no light ingress and the building is very dark inside. In addition to the owl pellets near the entrance, there was also a large collection of barn owl pellets indicating use over many years. Some of the pellets appeared fresh. The barn was previously used for battery chickens and has a mesh 'ceiling' with plastic insulation just above the chicken cages. This has fallen away only at the entrance of the barn, so it is only possible to view the ridge from one end of the barn by looking along the length. There were also bat droppings adhered to the gable wall. Given the style of the building and the amount of bat droppings, this building was assessed as being of 'high' bat roost potential and was later 'confirmed' as a roost. Barn owl was not present during the survey.

site and a soprano pipistrelle flew over the site at 21:00. Sorties into building 6 did not reveal any presence of brown long-eared bats but on entering building 9 at around 20:45, a brown long-eared bat was seen flying inside the barn. As soon as the torch light was turned on the bat, it disappeared onto the wall top at the east gable. Entering the barn again 10 minutes later also recorded brown long-eared bat flying inside the barn but again it went onto the wall top when subjected to light. Unfortunately, the barn is so dark inside, it is not possible to enter without switching on the torch which then disturbs the bats so it was not possible to get an accurate assessment of numbers of this species. It is unlikely to be a single bat given the amount of droppings on both the floor and the walls. A red filter will probably avoid this disturbance in future surveys. The presence of bat droppings and animals flying inside the barn at dusk confirm building 9 as a roost site.

Compensation and enhancements may include leaving parts of the attic void as a flight chamber for brown long-eared bats or creating a standalone flight chamber on site, inclusion of integral bat roosting features within walls, leaving suitable gaps in the pointing at eaves level and possibly access gaps in ridge pointing.
