**BUTTERNAB FARM, BUTTERNAB ROAD,
BEAUMONT PARK, HUDDERSFIELD**

DAYTIME BAT SURVEY.

Ref No: 210633.

Date: 23rd June 2021.

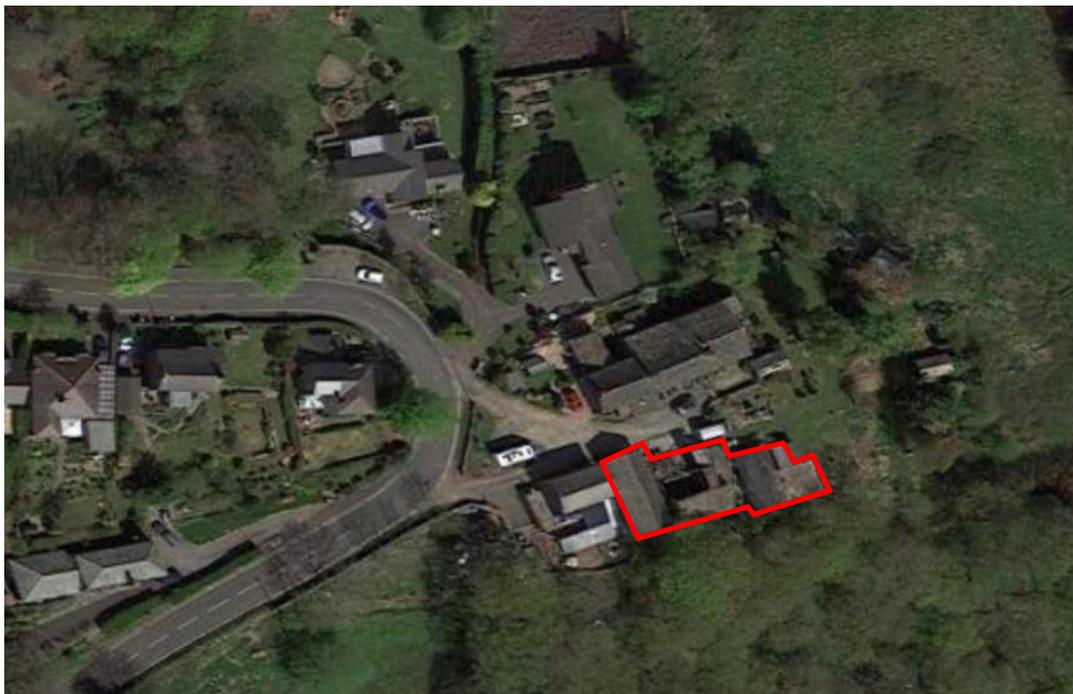
3.2.1. The survey area is five old farm buildings, one of which was derelict at the time of survey, at Butternab Farm. The aerial photograph below shows the survey site with surveyed buildings outlined in red.

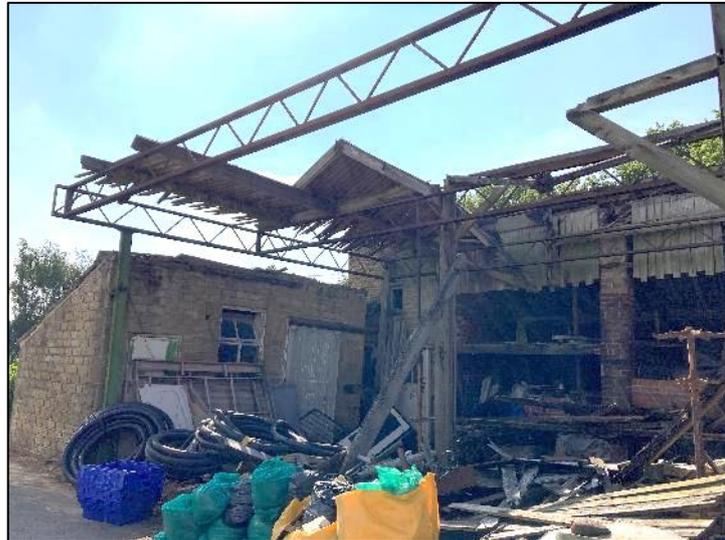
3.2.6. Building 2 is made up of several adjoining structures with the main section in a dilapidated state with the majority of the pitched timber roof and wooden frame laid on the ground within the footprint of the building. The metal frame of the building skeleton still supports what remains of the timber joists and is shown in the photograph below.

3.2.7. The smallest lean-to structure of Building 2 has stone walls and a pitched stone tiled roof, internally lined with concrete cladding. Few cracks exist in the stonework with some small crevices in the mortar on the eastern face. A small hole was seen on its eastern aspect created for cable access from the adjacent building. This structure was also used for the storage of farm goods and materials and is shown in the left of the above image.

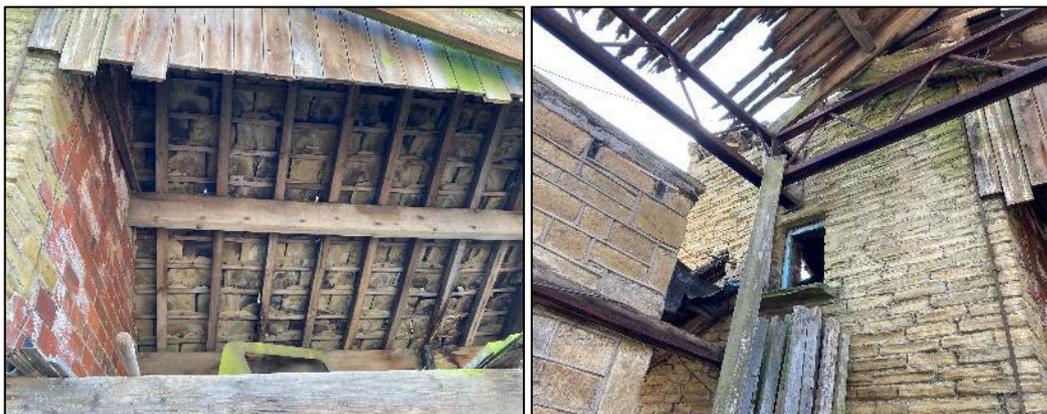
3.2.8. The largest lean-to structure lies on the southern aspect of Building 2 with walls constructed of stone and brick. The roof is double layered stone tiles supported by timber joists and beams with several light gaps between the tiles as shown in the photographs below.

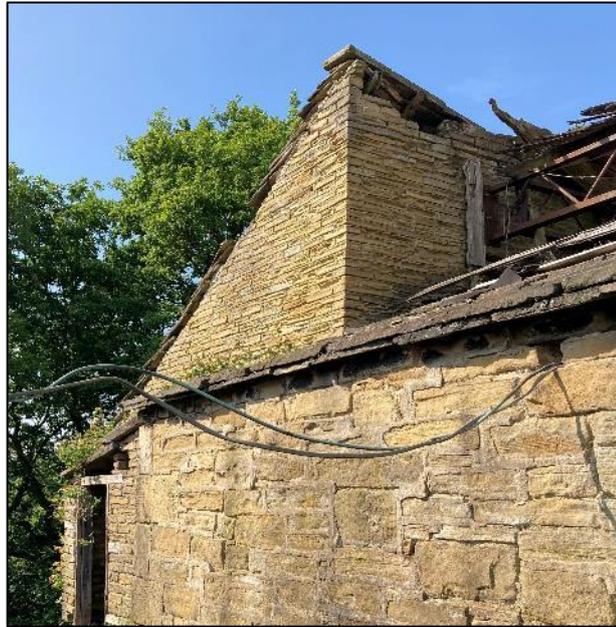
3.2.9. There is a second floor on the eastern side of this structure but is inaccessible from the doors due to the amount of discarded debris at ground level. The north-eastern corner of the structure has large gaps under the ridge tiles and a few missing roof tiles visible from ground level. It was not possible to view the southern face of the roof due to overgrown vegetation and an unsafe gradient behind this building.

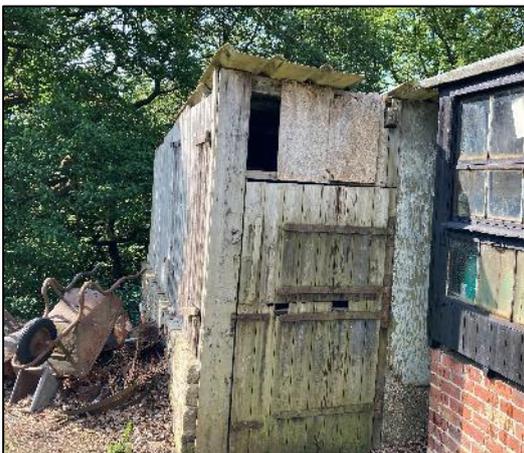
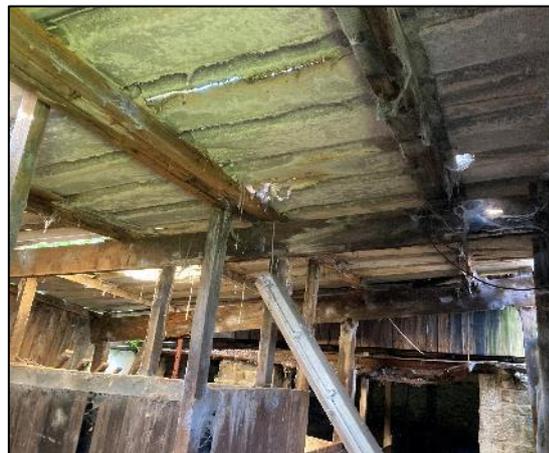
3.2.11. Building 5 houses a small number of geese with the wooden panels of the walls supported by a stone base. The roof is corrugated metal sheets with several sizeable gaps existing between it and the wooden wall panels. The roof of this building also has many light gaps with a large panel gap above the door, as shown in the photographs below.

3.3.3. Buildings 1 & 5 were each found to have multiple gaps between their roofs and walls providing ample access into and out of these structures. Both buildings are poorly insulated however and are likely to exhibit high temperature fluctuations depending on the external environment suggesting low suitability for roosting bats.

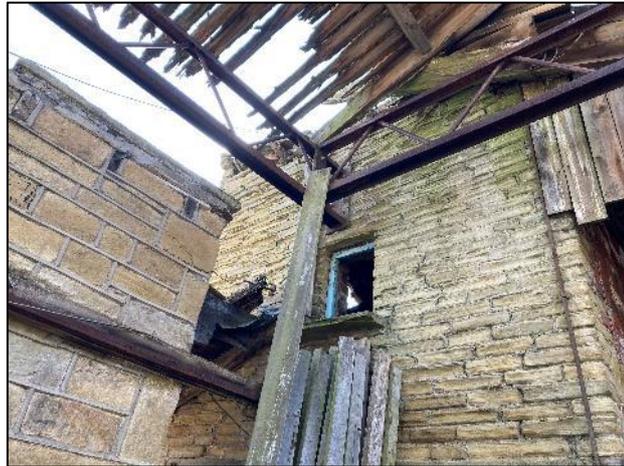
3.3.1. The walls of Building 2 are in a somewhat good condition with few cracks and mortar gaps but sizeable spaces could be seen in the north-eastern corner, which could provide access to crevice dwelling bats.

3.3.2. The roof of Building 2, with the exception of the smallest lean-to structure, are in a relatively poor condition with multiple light gaps between the stone tiles and a sizeable gap at ridge height, see right photograph. The roof-space of the building and its largest lean-to is too exposed to be suitable for bats.

4.1. **Building 2 provides low potential for roosting bats** due to the numerous access points found throughout the structure.

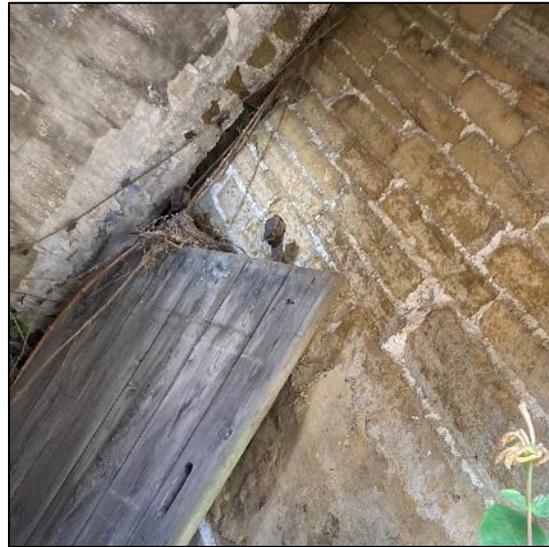
3.3.8. A Wren (*Troglodytes troglodytes*) was seen exiting the entrance way of the largest stone lean-to of Building 2. The following internal inspection revealed a nest in the corner atop a wooden board, see right photograph. No chicks were heard from the nest and a closer inspection for eggs was not possible due to the doorway being blocked by disused construction materials. This is likely to be an active nest and will need to be considered during construction works.

5.2. If any works are carried out during the nesting bird season, which extends from March to September, a nesting bird survey should be carried out by a suitably experienced surveyor, before any works are undertaken.

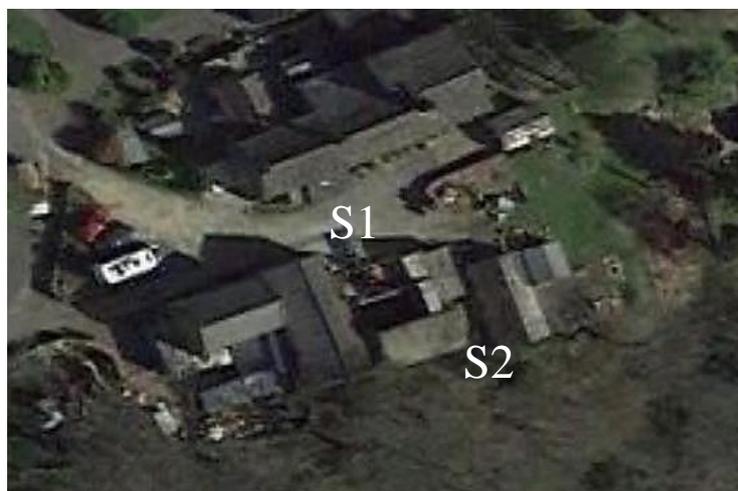
3.4.2. The two surveyors were positioned to allow for clear and unhindered views of the exterior walls and roof. The position of each surveyor (S) is shown on the aerial photograph below. Each surveyor was equipped with a Batbox Duet detector, a two-way radio and a static Anabat recorder to record bat activity for subsequent computer analysis using Analook software.

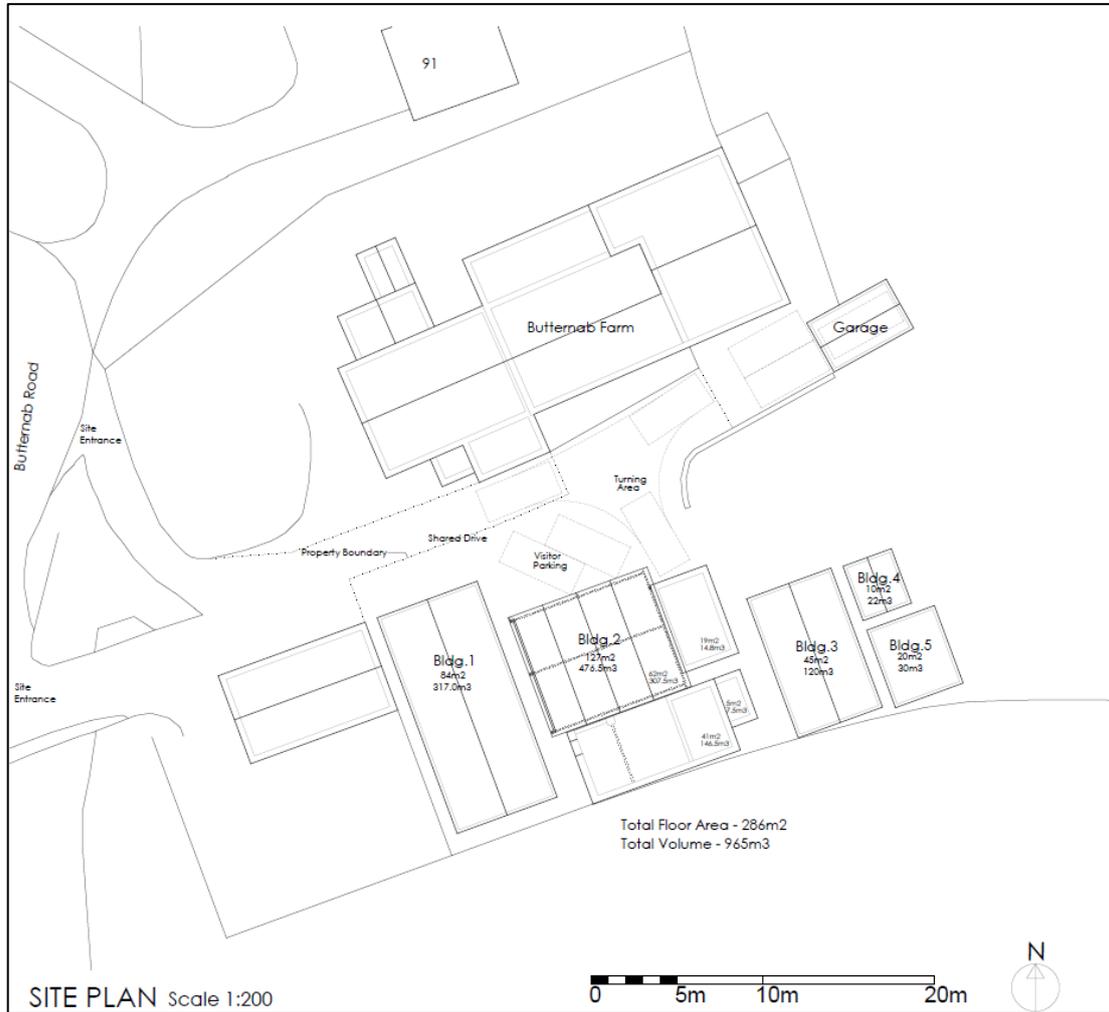
Existing site plan with numbered buildings

3.2.4. The survey area is five old farm buildings, see Appendix II for existing site plan, with Building 2 and its attachments being the largest of those on the property. Each building on site has been used for different purposes and as such vary in their construction materials and structural integrity.
