# Arboricultural Method Statement

## **WC-168.1a**

East Bank House, 2 Stubbin Fold, Holmbridge HD9 2BD

| <b>Report type:</b> | Arboricultural Method Statement |

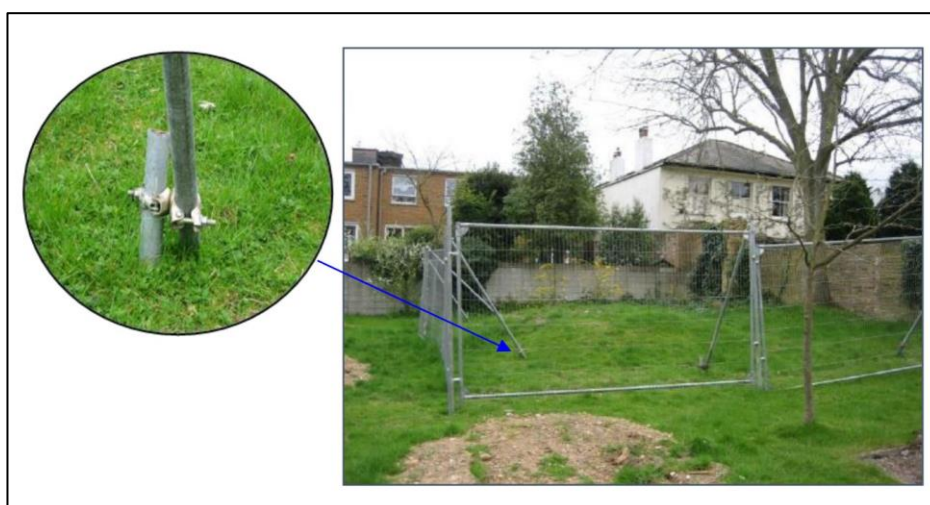
**Figure 4.1:** Example of mesh welded type barriers in-situ

- 4.4.2. Specification:** Barriers shall be a minimum 2 m high, and should consist of a vertical and horizontal scaffold framework, well braced to resist impacts, as is illustrated in **Fig. 4.1**, on the previous page, and **Fig. 4.2**, below.

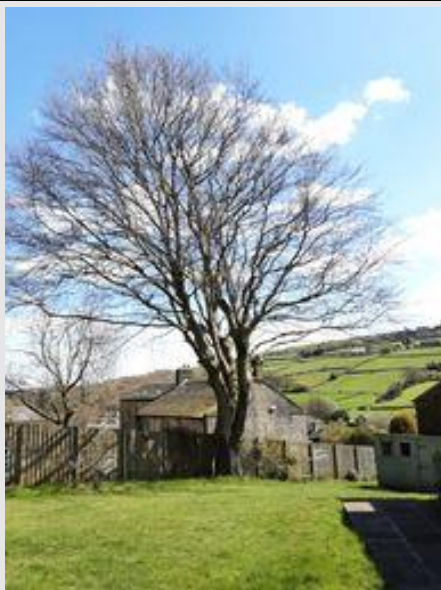
**Plate 1:** T001

| Tree Ref: | Species | Age | SULE | Ht. | DBH | CS | | | | CC | Comments | V | SC | BS 5837:2012 Category | Recommendations |
|---|---|---|---|---|---|---|---|---|---|---|---|---|---|---|---|
| T001 | Common Beech<br>( <i>Fagus sylvatica</i> ) | M | 40-80 | 18 | 1020 | 10 | 9 | 8 | 9 | 4 | Bifurcates at 2 m into three co-dominant primary stems; unions are acute and possibly included. Lapsed pollard, previously reduced to 7 m, with approx. 10 m regen. growth. | G | PD | B2 | No works recommended |

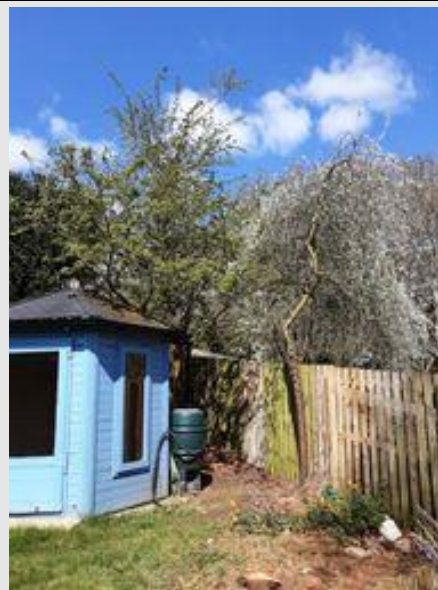
**Plate 2:** T002 (right) & T003 (left)

| Tree Ref: | Species | Age | SULE | Ht. | DBH | CS | | | | CC | Comments | V | SC | BS 5837:2012 Category | Recommendations |
|---|---|---|---|---|---|---|---|---|---|---|---|---|---|---|---|
| T002 | Cultivar Apple<br>( <i>Malus domestica</i> ) | Y | 10-20 | 5 | 120 | 2 | 1 | 1 | 1.5 | 1.5 | Suppressed by adjacent tree, with asymmetrical crown spread to north in result. | F | PD | C1 | No works recommended |

| Tree Ref: | Species | Age | SULE | Ht. | DBH | CS | | | | CC | Comments | V | SC | BS 5837:2012 Category | Recommendations |
|---|---|---|---|---|---|---|---|---|---|---|---|---|---|---|---|
| T003 | Common Hawthorn<br>( <i>Crataegus monogyna</i> ) | SM | 40-80 | 6 | 160 | 2.5 | 2.5 | 2.5 | 2.5 | 2 | No obvious significant defects, though lacks qualities for higher BS 5837 categorisation. | G | G | C1 | No works recommended |

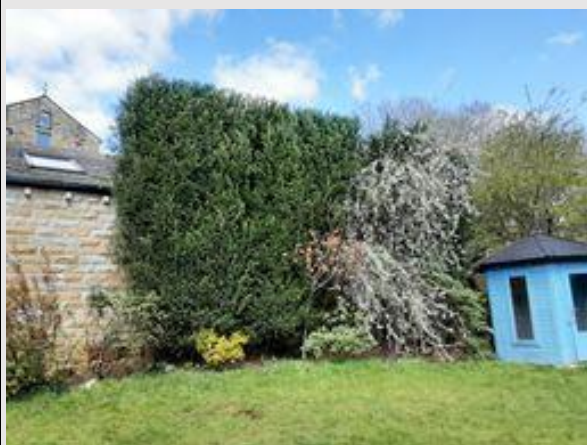
**Plate 3:** T004 & G001

| Tree Ref: | Species | Age | SULE | Ht. | DBH | CS | | | | CC | Comments | V | SC | BS 5837:2012 Category | Recommendations |
|---|---|---|---|---|---|---|---|---|---|---|---|---|---|---|---|
| T004 | Cultivar Apple<br>( <i>Malus domestica</i> ) | Y | 10-20 | 5 | 110 | 1.5 | 2.5 | 2 | 1 | 0 | Suppressed by adjacent tree, with asymmetrical crown spread to north in result. | F | PD | C1 | No works recommended |

| Group Ref: | Species Composition | Age | SULE | Av. Ht. | Av. DBH | Approx. No. of Stems | CC | Comments | V | SC | BS 5837:2012 Category | Recommendations |
|---|---|---|---|---|---|---|---|---|---|---|---|---|
| G001 | Lawson Cypress<br>( <i>Chamaecyparis lawsoniana</i> ) | SM | 20-40 | 5 | 100 | 10 | 0 | Linear group forming hedge. No obvious significant defects, though lacks qualities for higher BS 5837 categorisation. | F | G | C1 | No works recommended. |

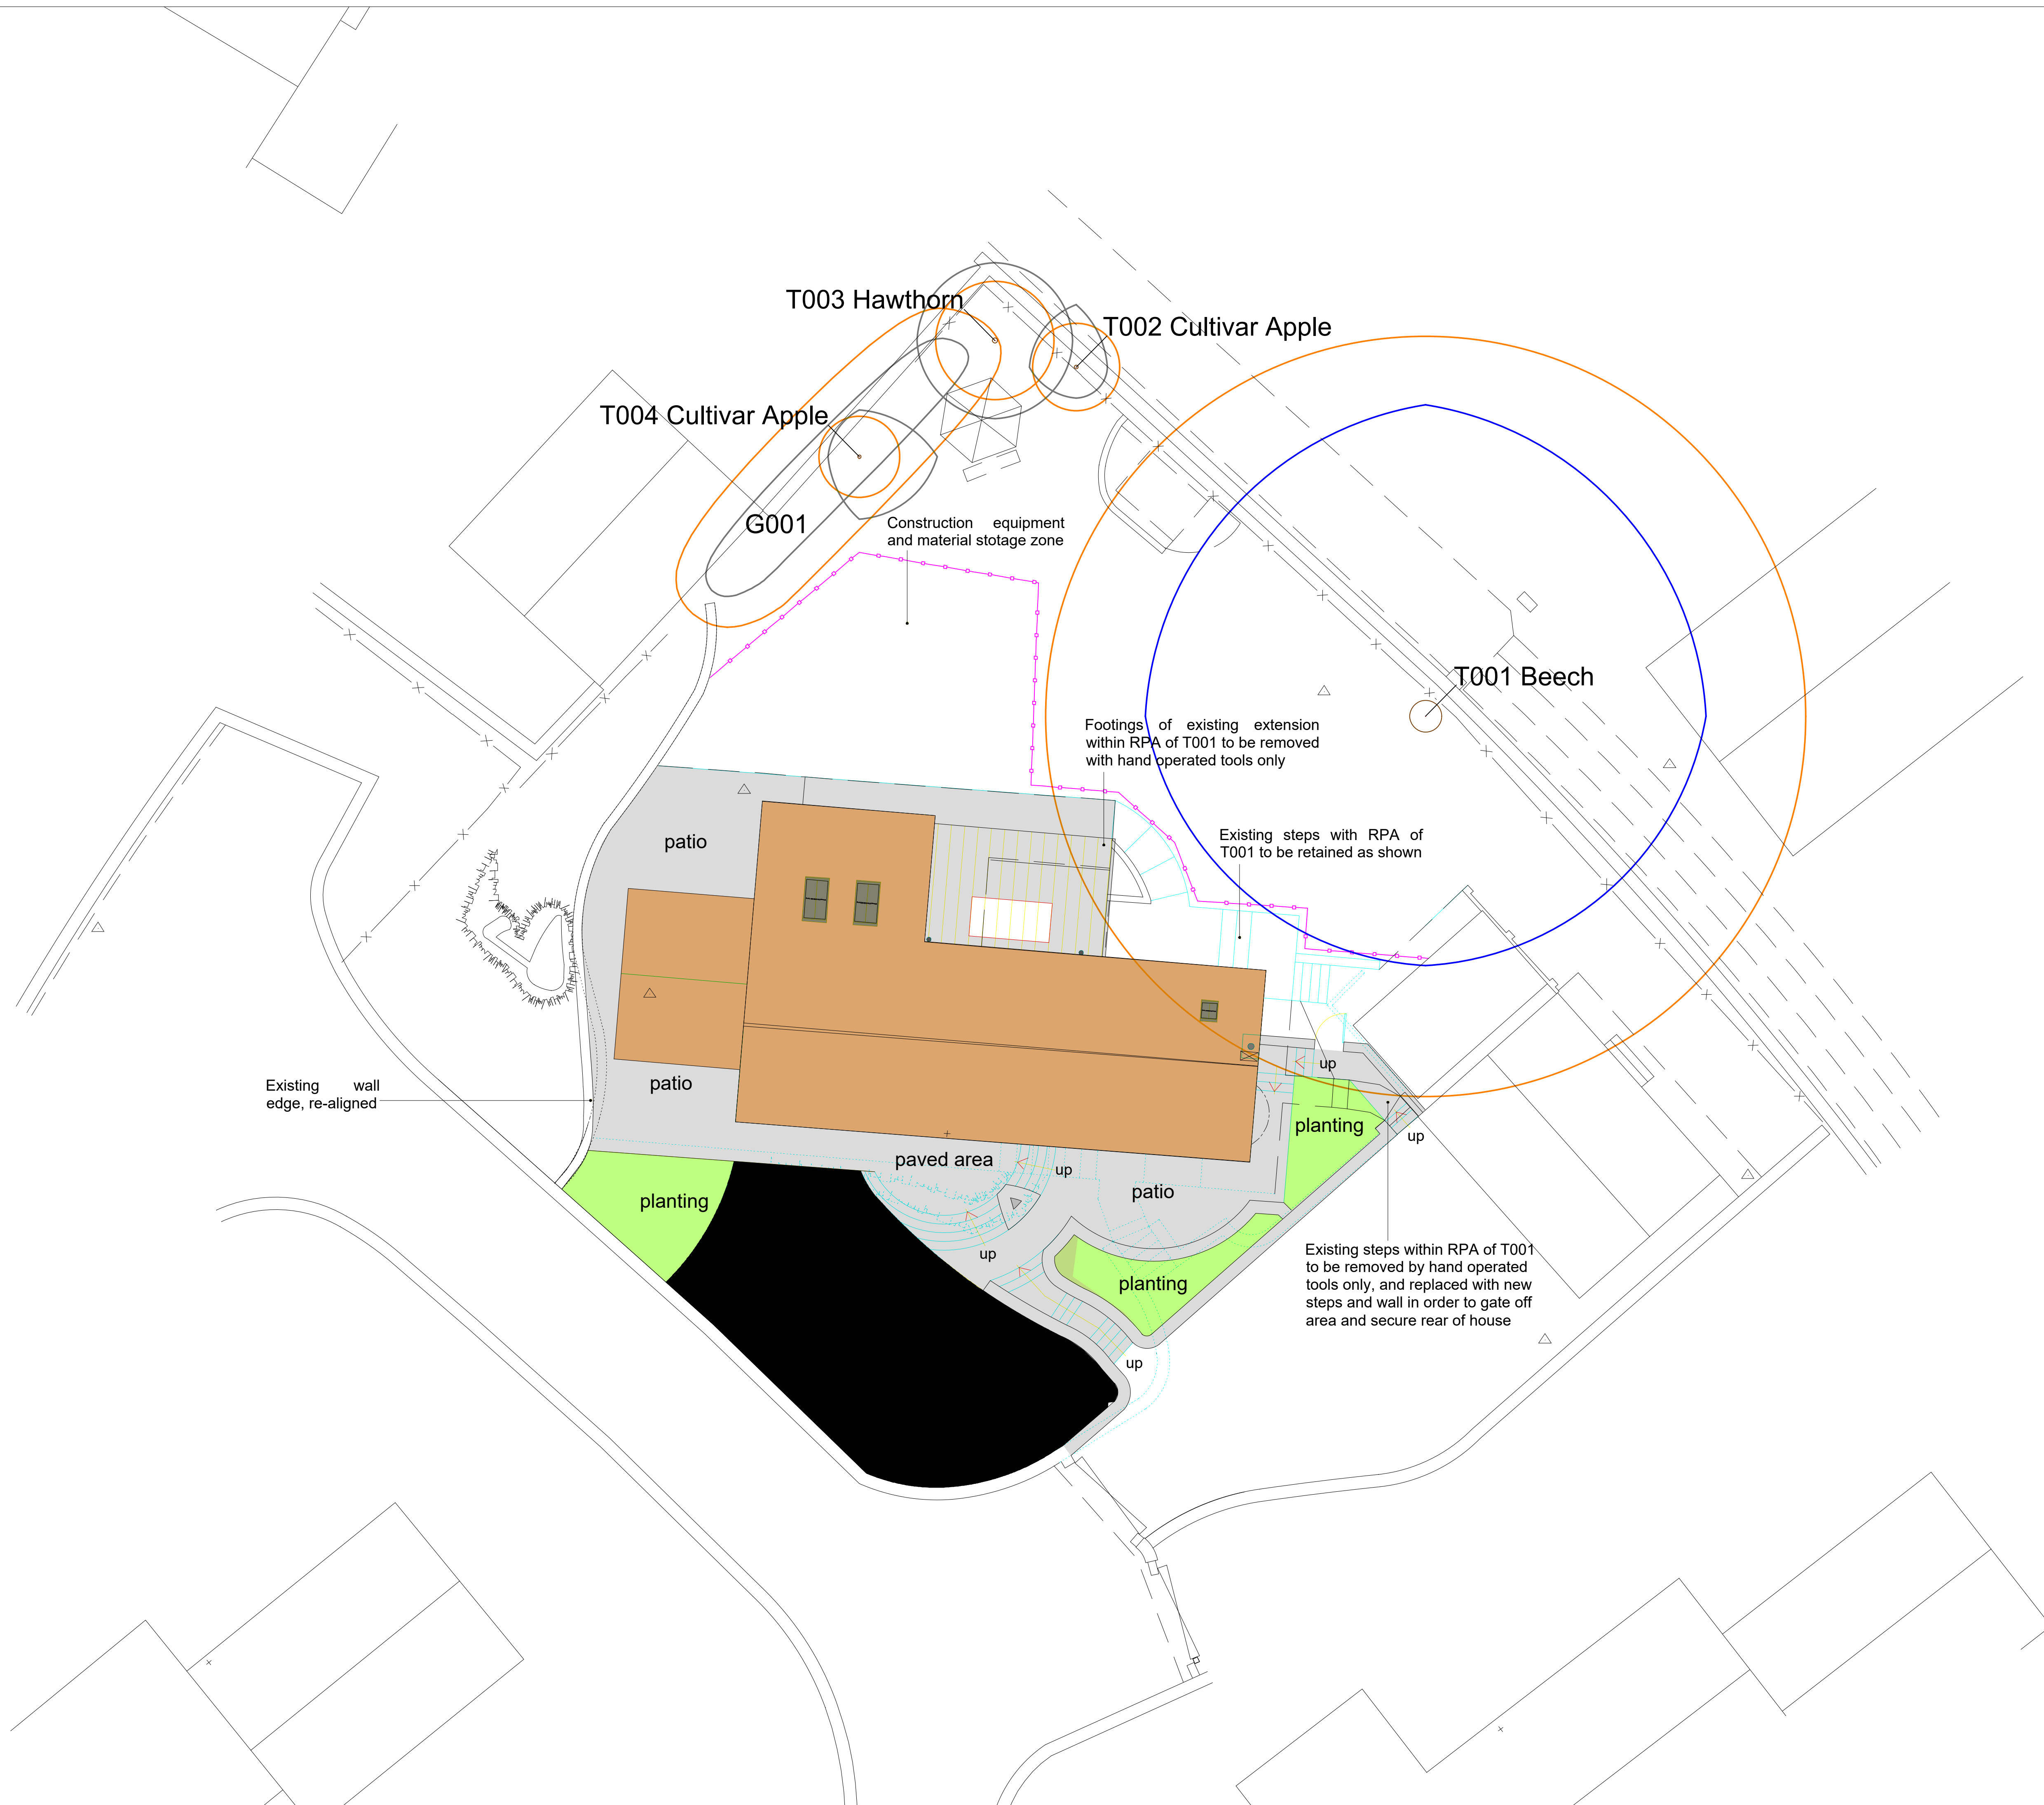
| Drawing Number: | WC-168.1a.6 |

Temporary tree protection fencing, to BS 5837: 2012 specification, as detailed in the **Arboricultural Method Statement**

- 4.4.4.** All-weather notices should be attached to the barriers at 9 m intervals with the words 'TREE PROTECTION ZONE - NO ACCESS' clearly visible.
- 4.4.5. Location:** Barriers shall where possible be positioned on the perimeter of tree RPAs, as is shown in the **Tree Protection Plan** in **Appendix 3**.
