# **Network Rail (Huddersfield to Westtown (Dewsbury) Improvements) Order**

## **Condition 10: Phase 2 Land Contamination Risk Assessment – Stage 4**

**Document reference: 151667-TSA-00-TRU-REP-W-EN-001237**

**June 2023**

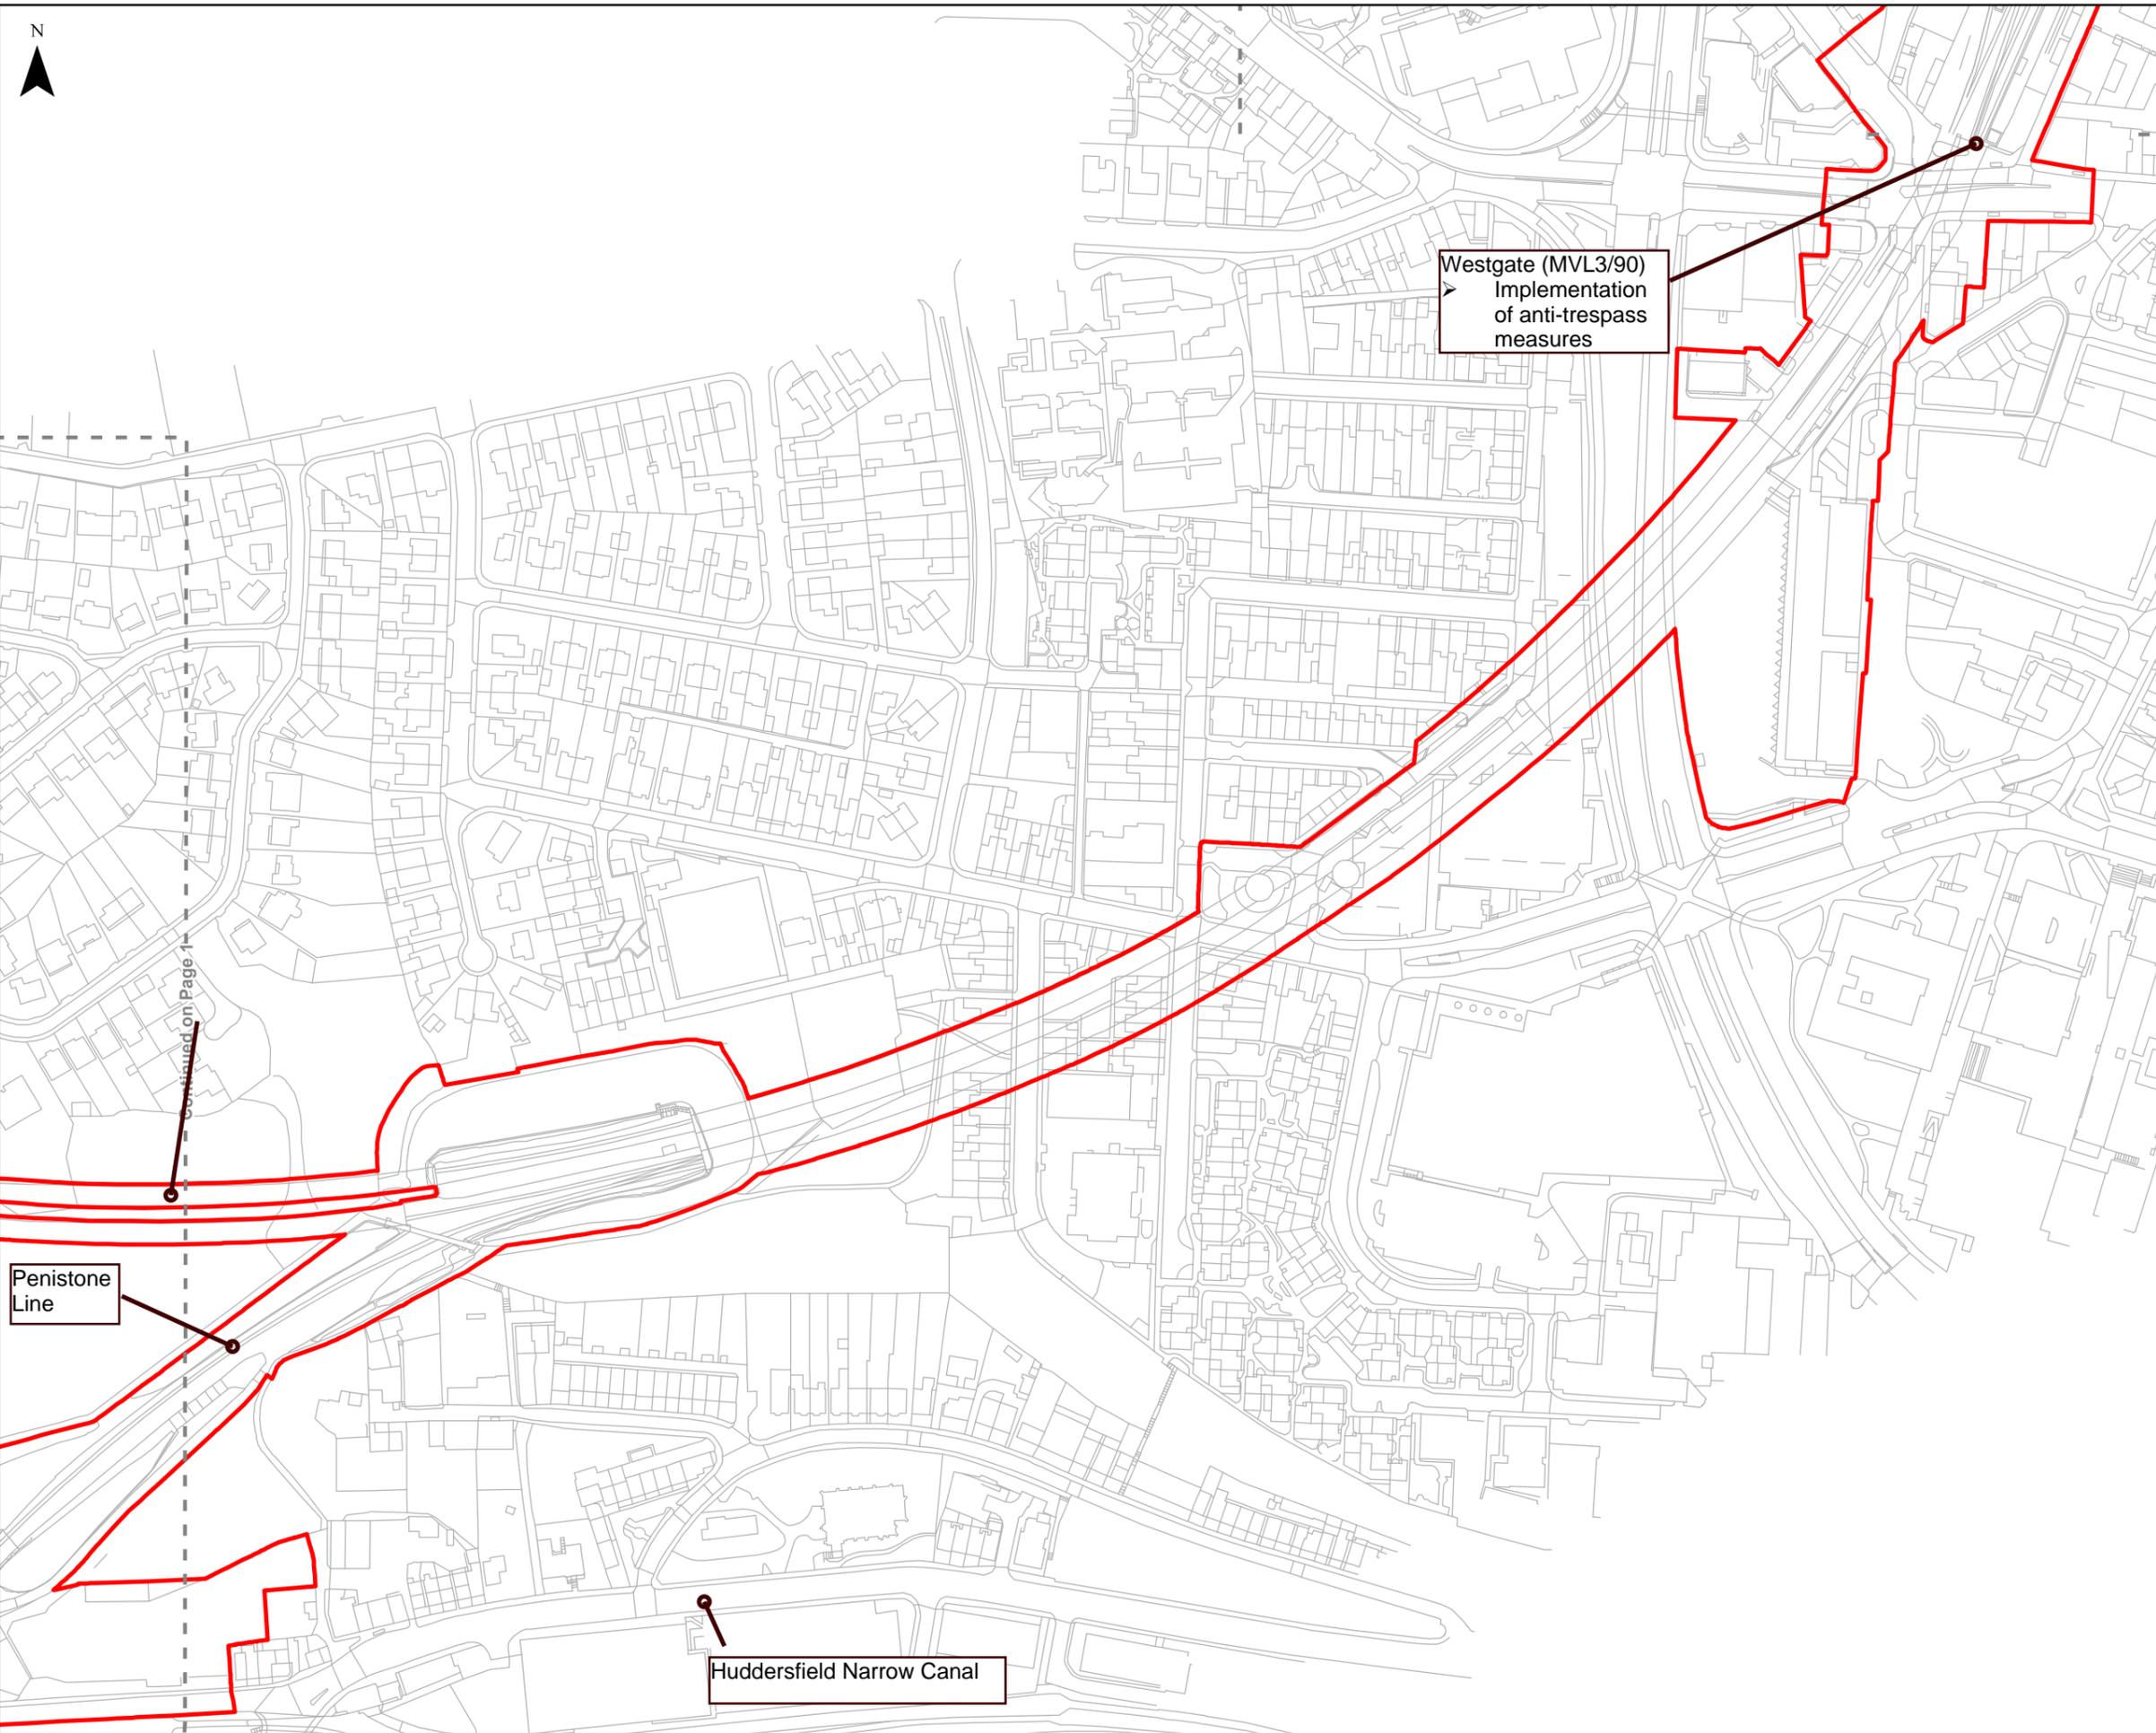
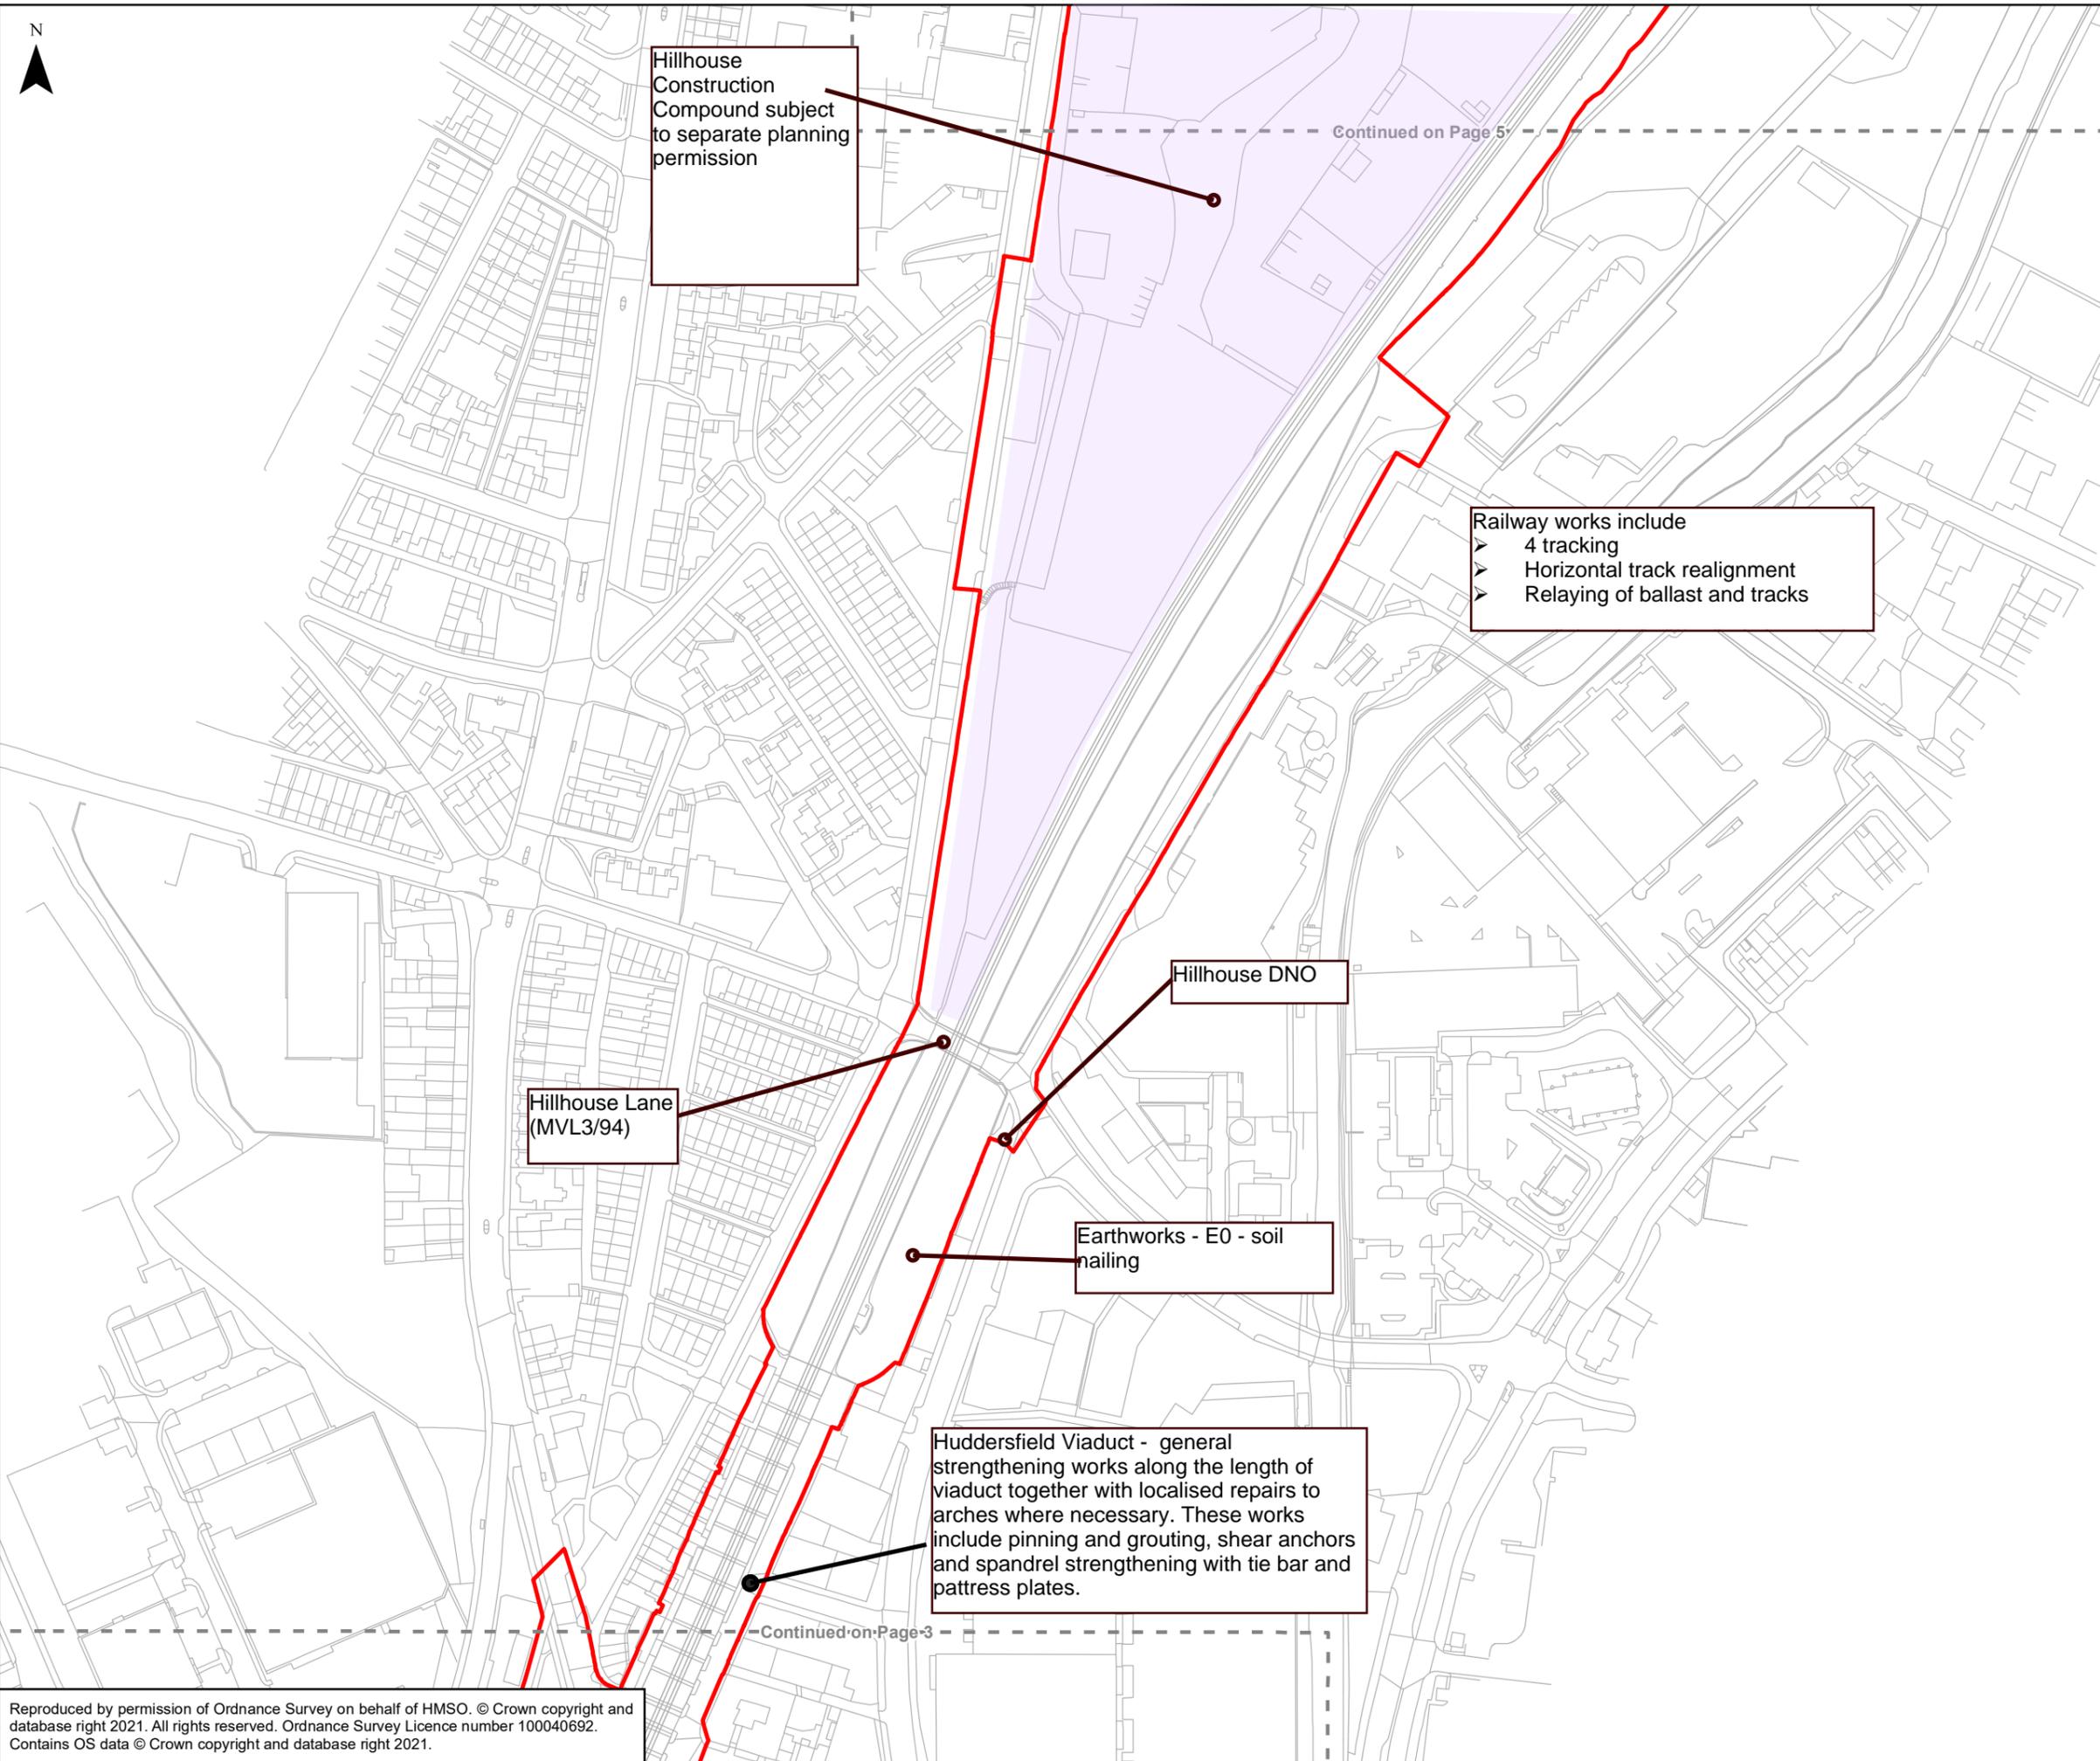
Drawing Title  
**Figure 1  
 Stage 4 works**

- Existing bridge deck to be removed and replaced
- Additional masonry pilasters/butresses will be formed at the corners of the new abutments into which the concrete parapet will join.
- New concrete abutments to be built with stone facing in front of existing sandstone at both ends and, on both elevations.

- Substructure repairs including removal and reinstatement of the pier to the south-western corner of the structure
- Strengthening to cross girders
- Removal of parapet and replacement with replica in cast iron

**Huddersfield Viaduct - general strengthening works** along the length of viaduct together with localised repairs to arches where necessary. These works include pinning and grouting, shear anchors and spandrel strengthening with tie bar and pattress plates.

- existing bridge deck will be removed and replaced with a new single span bridge deck

- main train shed - structural works, two bays at Manchester end of canopy to be demolished, two new bays at Leeds end of platform 1; reinstatement of main train shed lantern;
- smaller train shed (canopies B&C) to be demolished, new roof to be constructed;
- free standing canopies over island platforms
- extension to canopy to service Penistone line;
- tea rooms to be deconstructed and relocated;
- a covered footbridge (with lift and stairs) to be constructed (step free access)
- concrete infill of existing parcel subway
- extension to existing passenger subway to service new island platform to north of station
- Grit blasting of main train shed
- Works to railway lines including provision of new platforms and removal of existing railway sidings
- Demolition of existing relay room
