SOAKAWAY LETTER REPORT

job number	C5760/26/E/8947	date	10.02.26
site address	Kingsley Avenue Crosland Moor Huddersfield HD1 3SR		
written by	S. Hale	checked by	R. Palmer
issued by	S. Hale

Report on Soakaway Testing

Location: **Kingsley Avenue**
Crosland Moor, Huddersfield, West Yorkshire, HD1 3SR

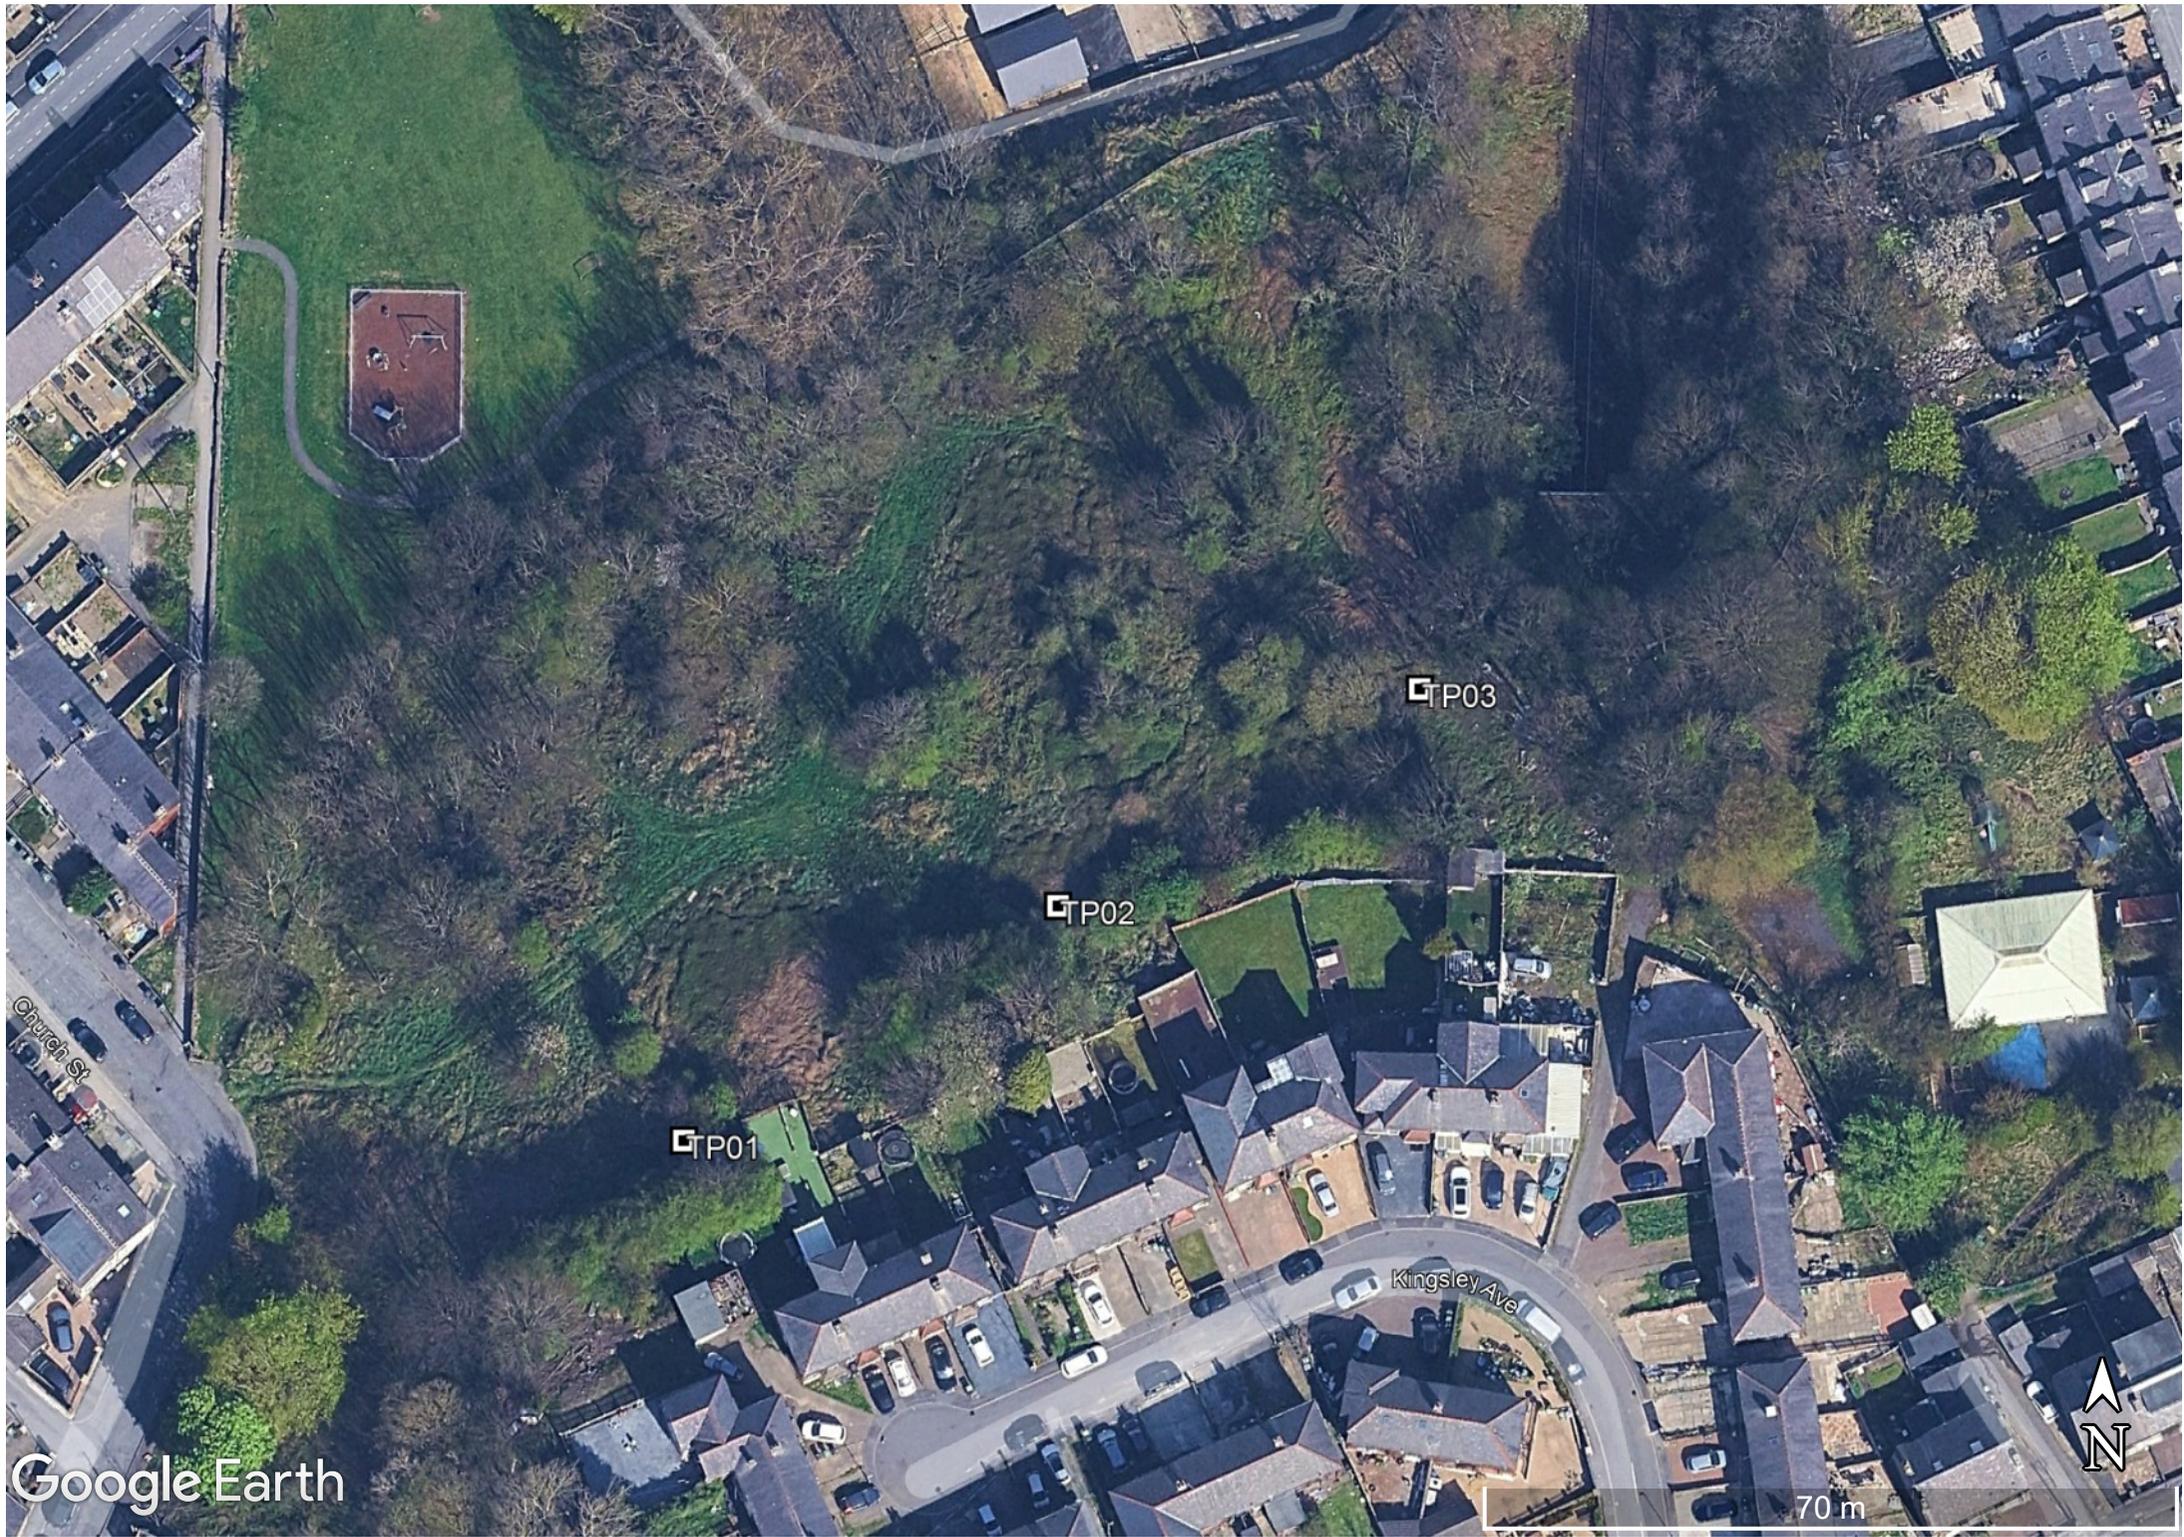
Site Plan

TP01

TP02

TP03

Locations as per Acumen Drawing

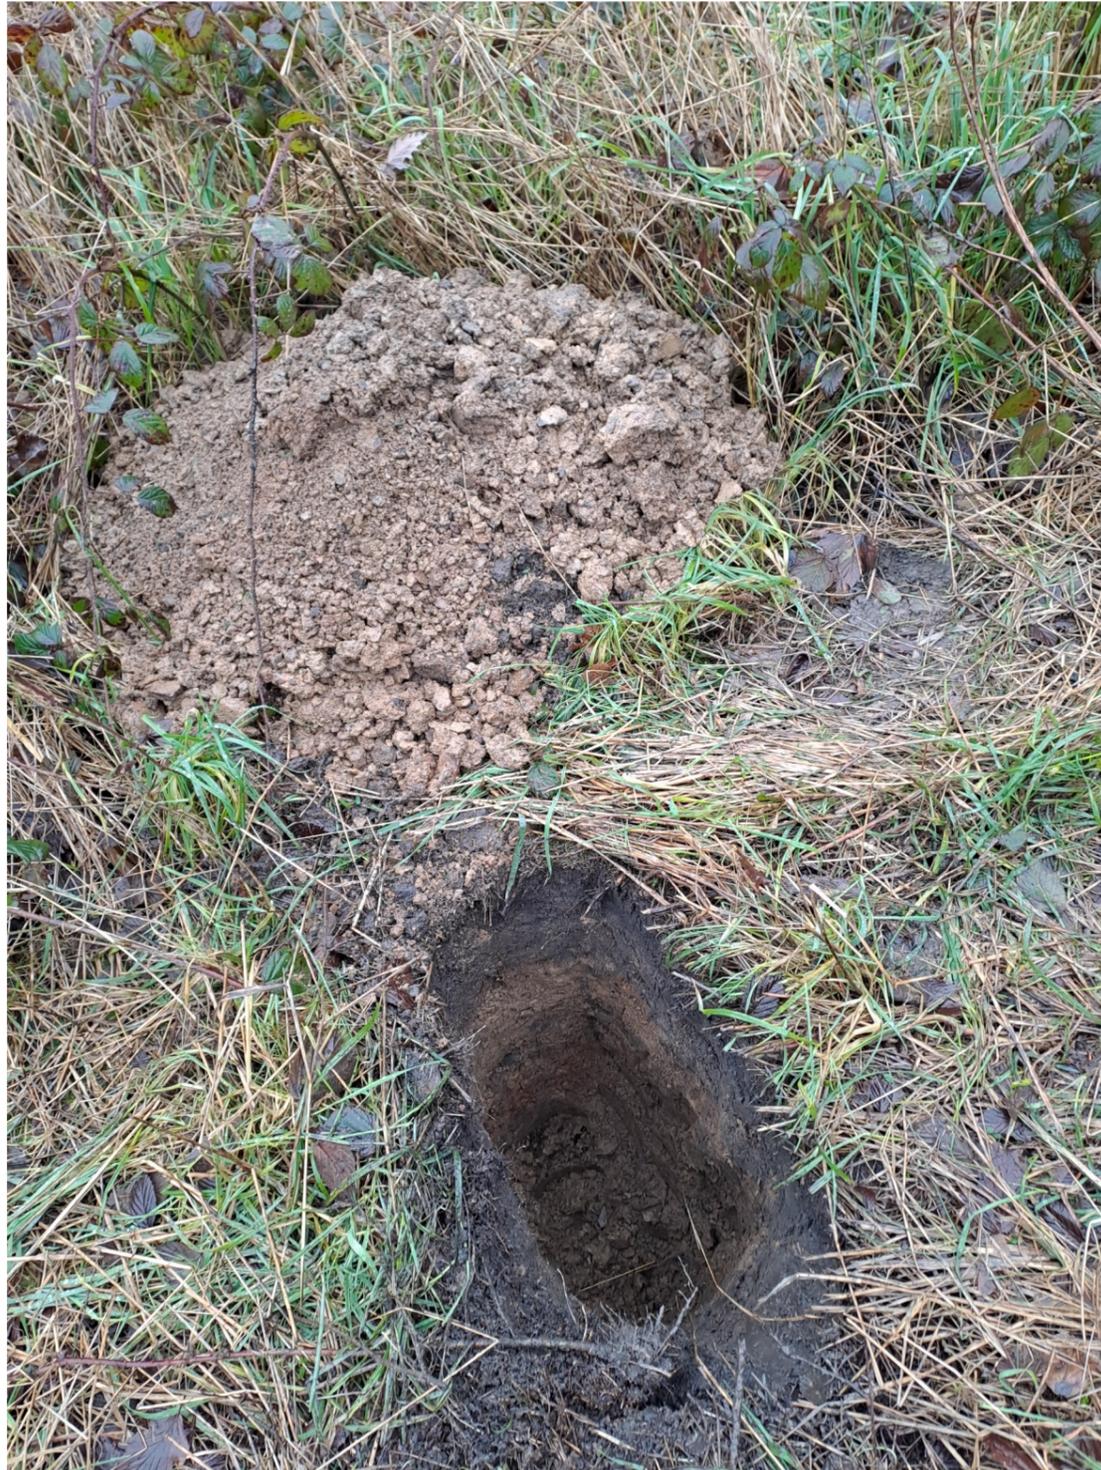
Water Strike	Samples and In Situ Testing			Depth (m)	Level (m)	Legend	Stratum Description
	Depth	Type	Results				
				0.20			TOPSOIL (Dark brown organic sandy silty CLAY).
				1.20			Soft to firm and firm greyish brown slightly gravelly silty CLAY. Gravel is sub-angular and tabular fine to coarse of siltstone and mudstone. WEATHERED PENNINE LOWER COAL MEASURES FORMATION
							----- End of pit at 1.20 m

The soils encountered beneath the topsoil were found to be typical of the weathered fraction of the underlying Pennine Lower Coal Measures Formation. The strata conditions and subsequent drainage characteristics appear to be comparable between trial pit positions TP01 and TP03. In this instance, the infiltration testing has revealed that the soils have poor drainage characteristics. Strata conditions and drainage characteristics were noted to differ within TP02. Despite apparent cohesive conditions, all tests within TP02 were noted to be successful with 'good' infiltration rates. It should be appreciated that while TP01 and TP03 were undertaken directly on top of the undifferentiated Pennine Lower Coal Measures Formation, TP02 was undertaken on the boundary between it and the Soft Bed Flags. This can be seen within the geological site plan presented within Appendix 1. As such, it is considered that this may have had an impact on the drainage characteristics of this location. In conclusion, it is not recommended that soakaways be adopted within the locations of TP01 and TP03. However, soakaways may be considered within the location of TP02 subject to suitable design. Cognisance should be given to the cohesive nature of the local geology and the presence of existing and proposed residential dwellings downslope from the proposed locations.

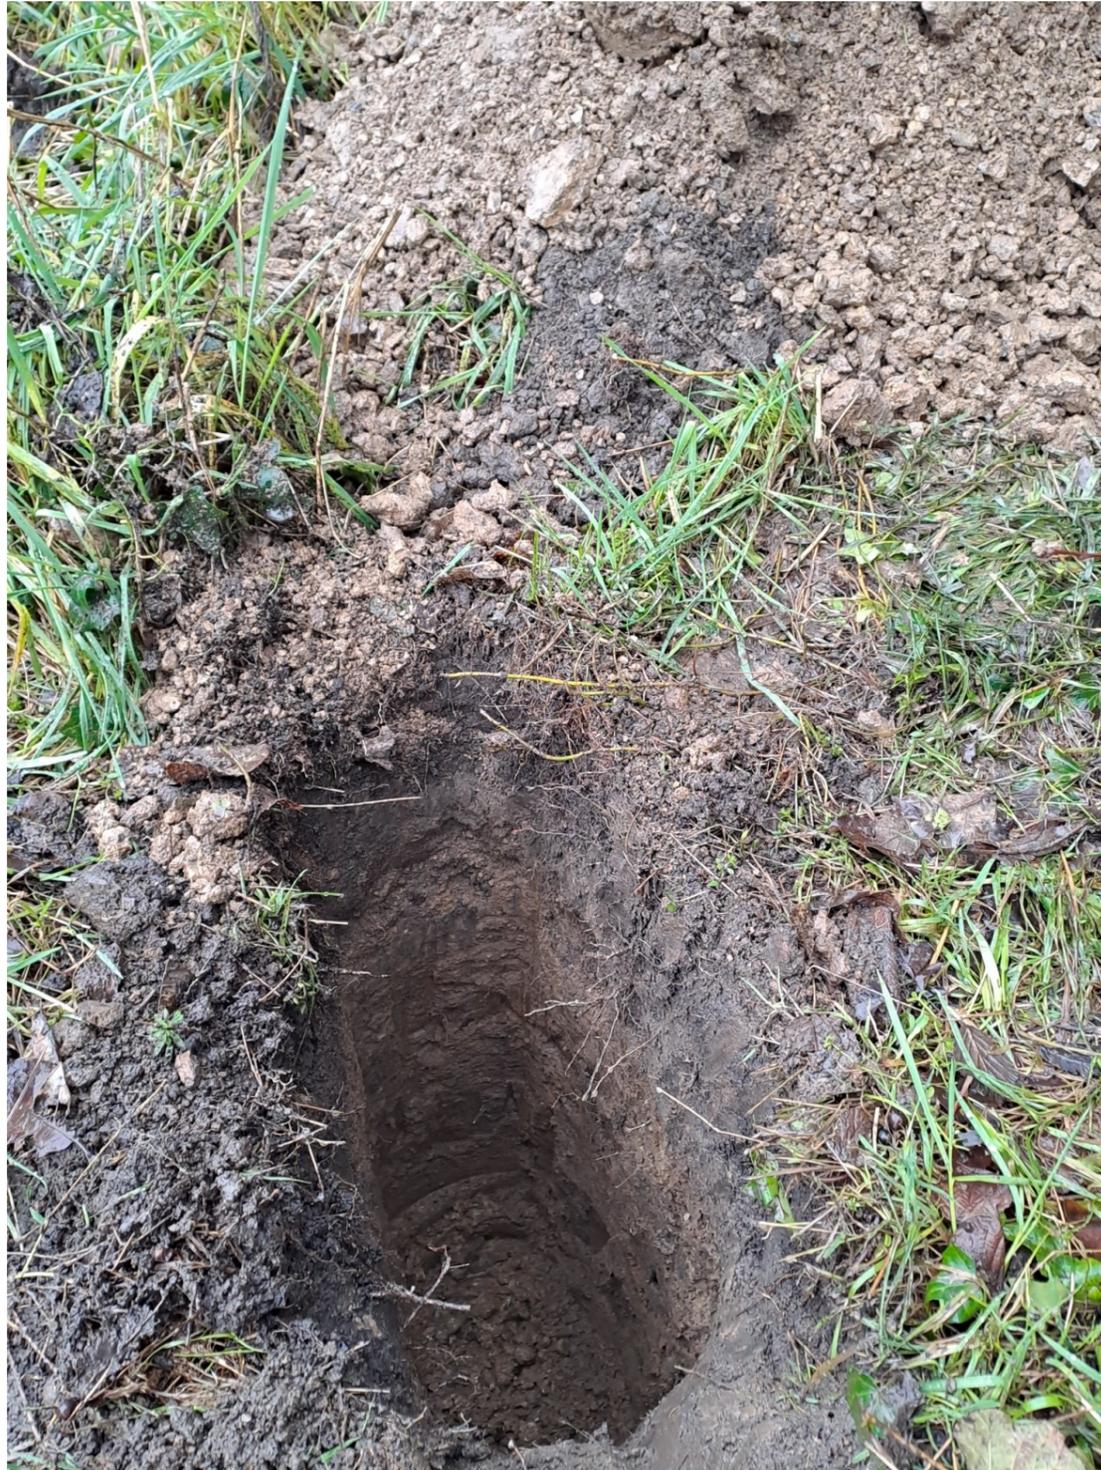
It should be noted that the soils recorded at TP02 were notably more sandy and contained more gravel than the soils exposed at TP01 and TP03.

Water Strike	Samples and In Situ Testing			Depth (m)	Level (m)	Legend	Stratum Description
	Depth	Type	Results				
				0.20			TOPSOIL (Dark brown organic sandy silty CLAY).
				1.00			Firm friable greyish brown slightly sandy gravelly silty CLAY. Gravel is sub-angular and tabular fine to coarse of siltstone and sandstone. WEATHERED PENNINE LOWER COAL MEASURES FORMATION
							End of pit at 1.00 m

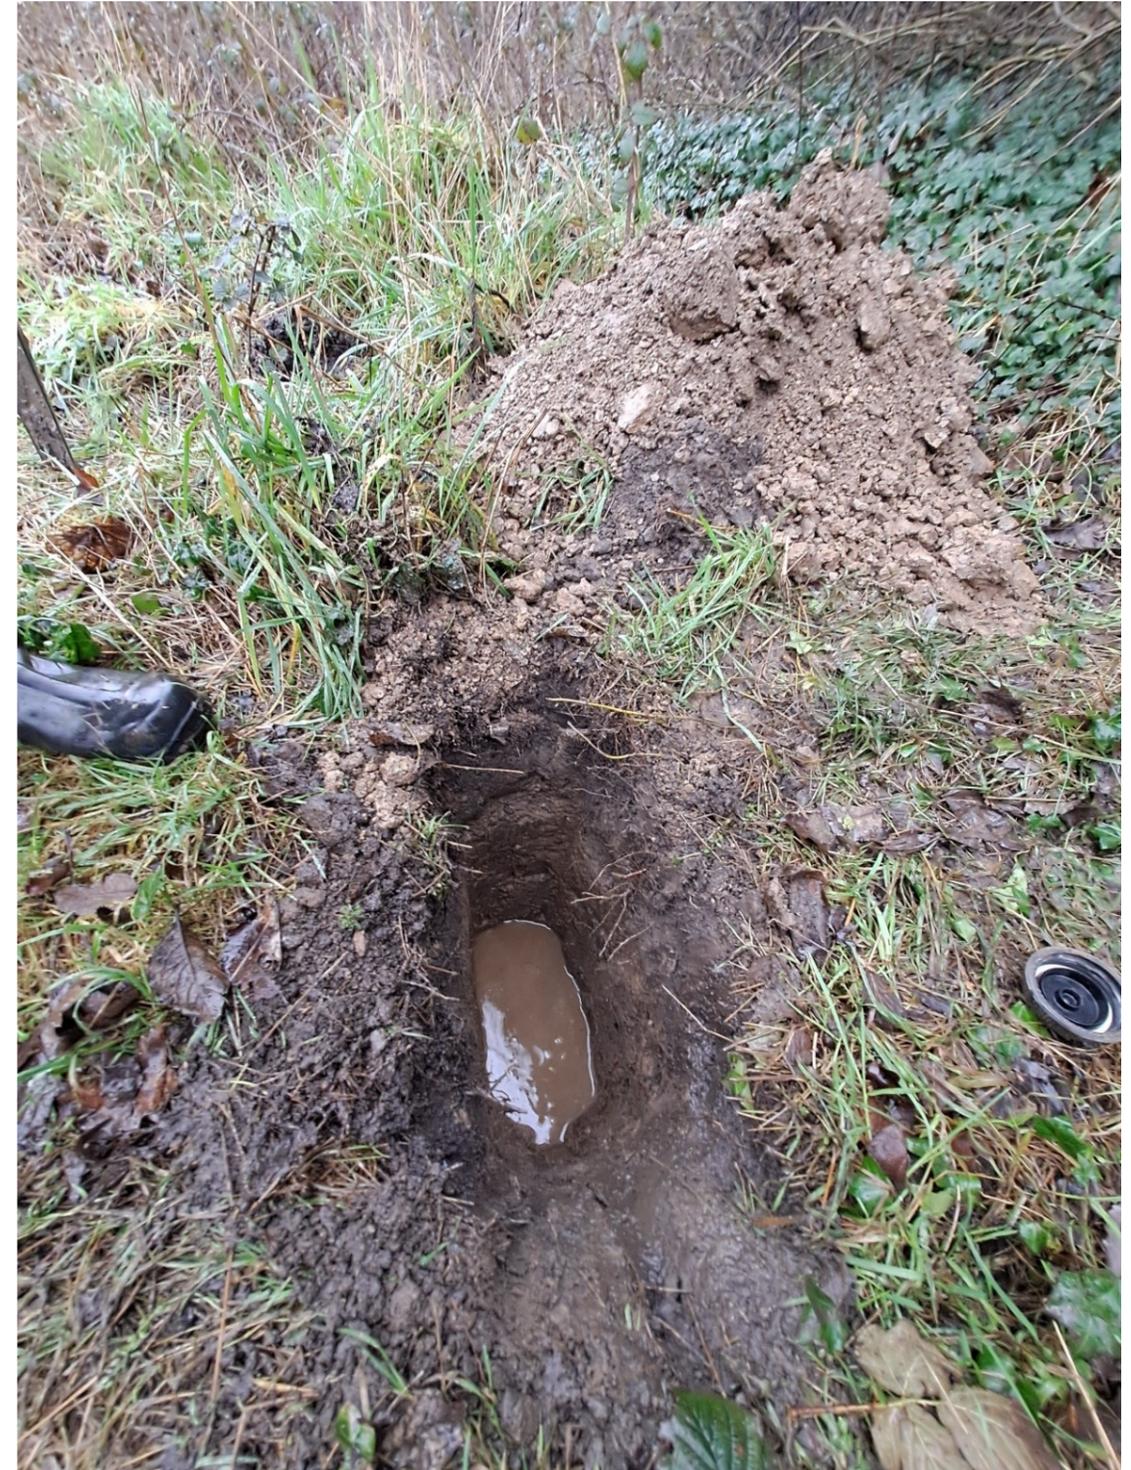
TP02 with water

Three tests were completed within TP02, with the water level achieving a fall from 75% to 25% of the effective depth of the storage volume each time.
