Risk Assessment and Conceptual Site Model

Peace Wood Quarry

Naylor Industries PLC

Document Reference: 320/1—R1.1 – RiskAssessment_CSM

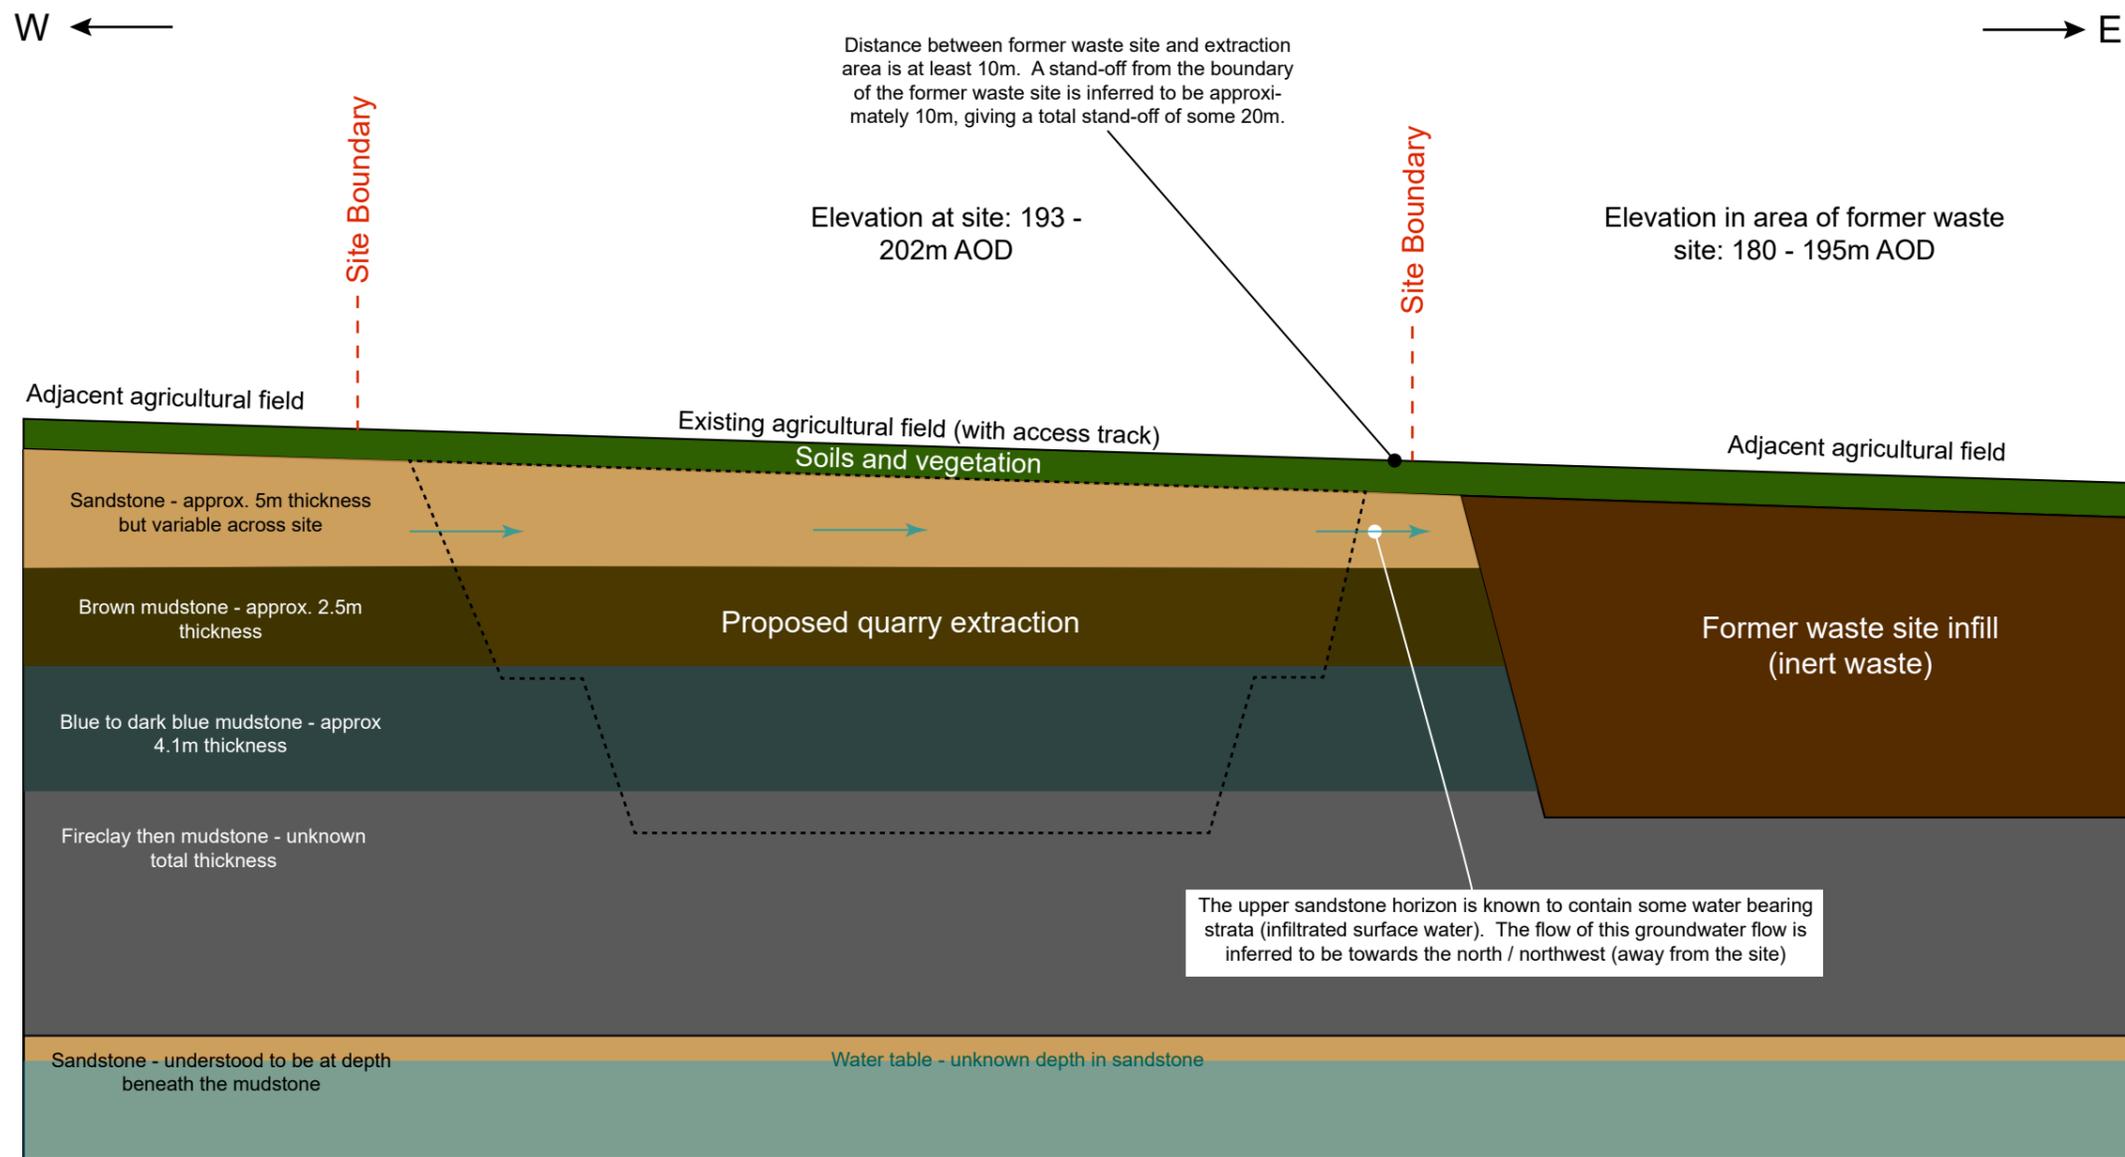
Drawing Number: 320/1 - CLRA-1	Rev: 1.0
-----------------------------------	-------------

Conceptual Site Model - Contaminated Land

Notes:
Drawing is schematic and not to scale, and is not intended to accurately represent topography, depths of extraction or infilling, or relative distances.

- 2.4 As shown in the Conceptual Site Model (CSM), referenced *320/1-CLRA-1*, there are no identified Sources of contamination. Theoretically, contaminants could have been deposited at the former waste site, through non-conforming waste that may have unintentionally been tipped ('rogue loads'). However, there is no Pathway by which this could have contaminated The Site.

- 3.1 It is concluded that there is no connection between Source and Receptor. This is predominantly because no Source can be identified that has caused contamination at The Site. Even if the adjacent former waste site is considered to be a Source, there is no pathway by which any contamination could have reached The Site.
