# GEO-ENVIRONMENTAL REPORT

## Report on a Phase 2 Geo-environmental Investigation

Location:	Gomersal Hall, Oxford Road, Gomersal	
For:	Martin Walsh Architectural Ltd	
Report No.	C1772/21/E/4286	Report date: June 2023

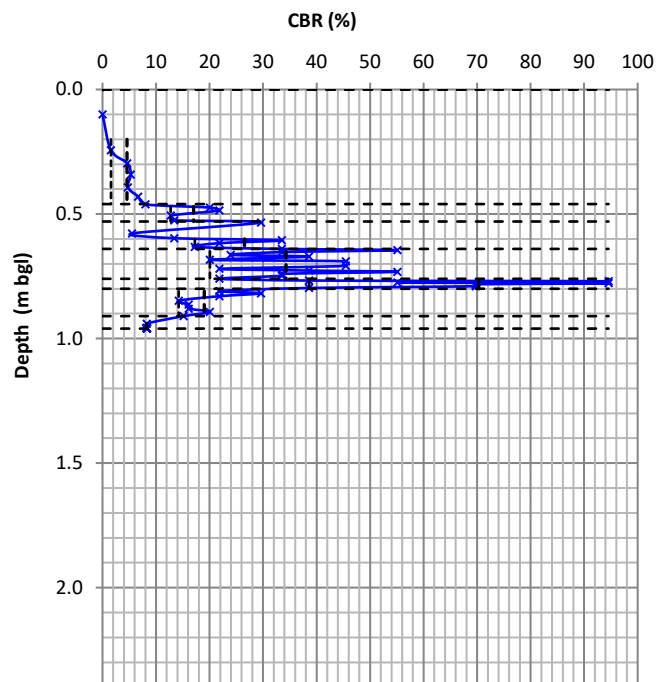
## IMPACT (TRL) Dynamic Cone Penetrometer SL970, TRL Road Note 8, 60° cone.

Blow Count	Total Blows	Depth (mm)	CBR (%)	Blow Count	Total Blows	Depth (mm)	CBR (%)	Blow Count	Total Blows	Depth (mm)	CBR (%)
0	0	100	-	1	20	664	24	1	42	818	30
1	1	244	2	1	21	671	39	1	43	830	22
1	2	296	5	1	22	684	20	1	44	848	14
1	3	342	5	1	23	690	45	1	45	864	16
1	4	393	5	3	26	708	45	1	46	880	16
1	5	430	7	1	27	720	22	1	47	893	20
1	6	461	8	1	28	727	39	1	48	910	15
1	7	474	20	1	29	732	55	1	49	940	8
1	8	486	22	1	30	740	34	1	50	959	8
1	9	506	13	1	31	748	34				
1	10	525	13	1	32	760	22				
1	11	534	30	1	33	767	39				
1	12	578	6	1	34	770	95				
1	13	597	13	1	35	775	55				
1	14	605	34	1	36	778	95				
1	15	617	22	1	37	782	70				
1	16	632	17	1	38	786	70				
1	17	640	34	1	39	790	70				
1	18	645	55	1	40	797	39				
1	19	653	34	1	41	809	22

<b>Table 5: CBR Test Results</b>			
Location	Depth (m)	Average CBR (%)	Comments
TRL 1	0.15 – 0.32	7	CBR values noted to be variable but generally increasing with depth.
	0.34 – 0.40	13	
	0.41 – 0.66	15	
	0.72 – 0.82	6	
	0.83 – 0.88	10	
	0.89 – 0.90	75	
TRL 2	0.20 – 0.46	3	High CBR values noted from around 0.5m depth.
	0.48 – 0.83	33	
TRL 3	0.07 – 0.15	10	Variable but generally high CBR values throughout.
	0.16 – 0.18	29	
	0.62 – 0.65	5	
	0.66 – 0.80	15	
	0.85 – 0.88	11	
	0.89 – 0.92	26	
TRL 4	0.16 – 0.56	6	High CBR values from 0.5m depth.
	0.57 – 0.59	23	
	0.70 – 0.91	11	
TRL A	0.15 – 0.32	3	CBR values steadily increasing with depth.
	0.33 – 0.48	8	
	0.50 – 0.66	19	
	0.68 – 0.74	36	
	0.76 – 0.81	35	
	0.82 – 0.87	37	
	0.91 – 0.96	39
