Report on a Phase 2 Geo-environmental Investigation

Location:	Land at Halifax Road, Liversedge WF15 8HE	
For:	Mr S. Nixon	
Consultants:	Studio91 Architecture	
Report No.	C2764/22/E/4214	Report date: January 2023

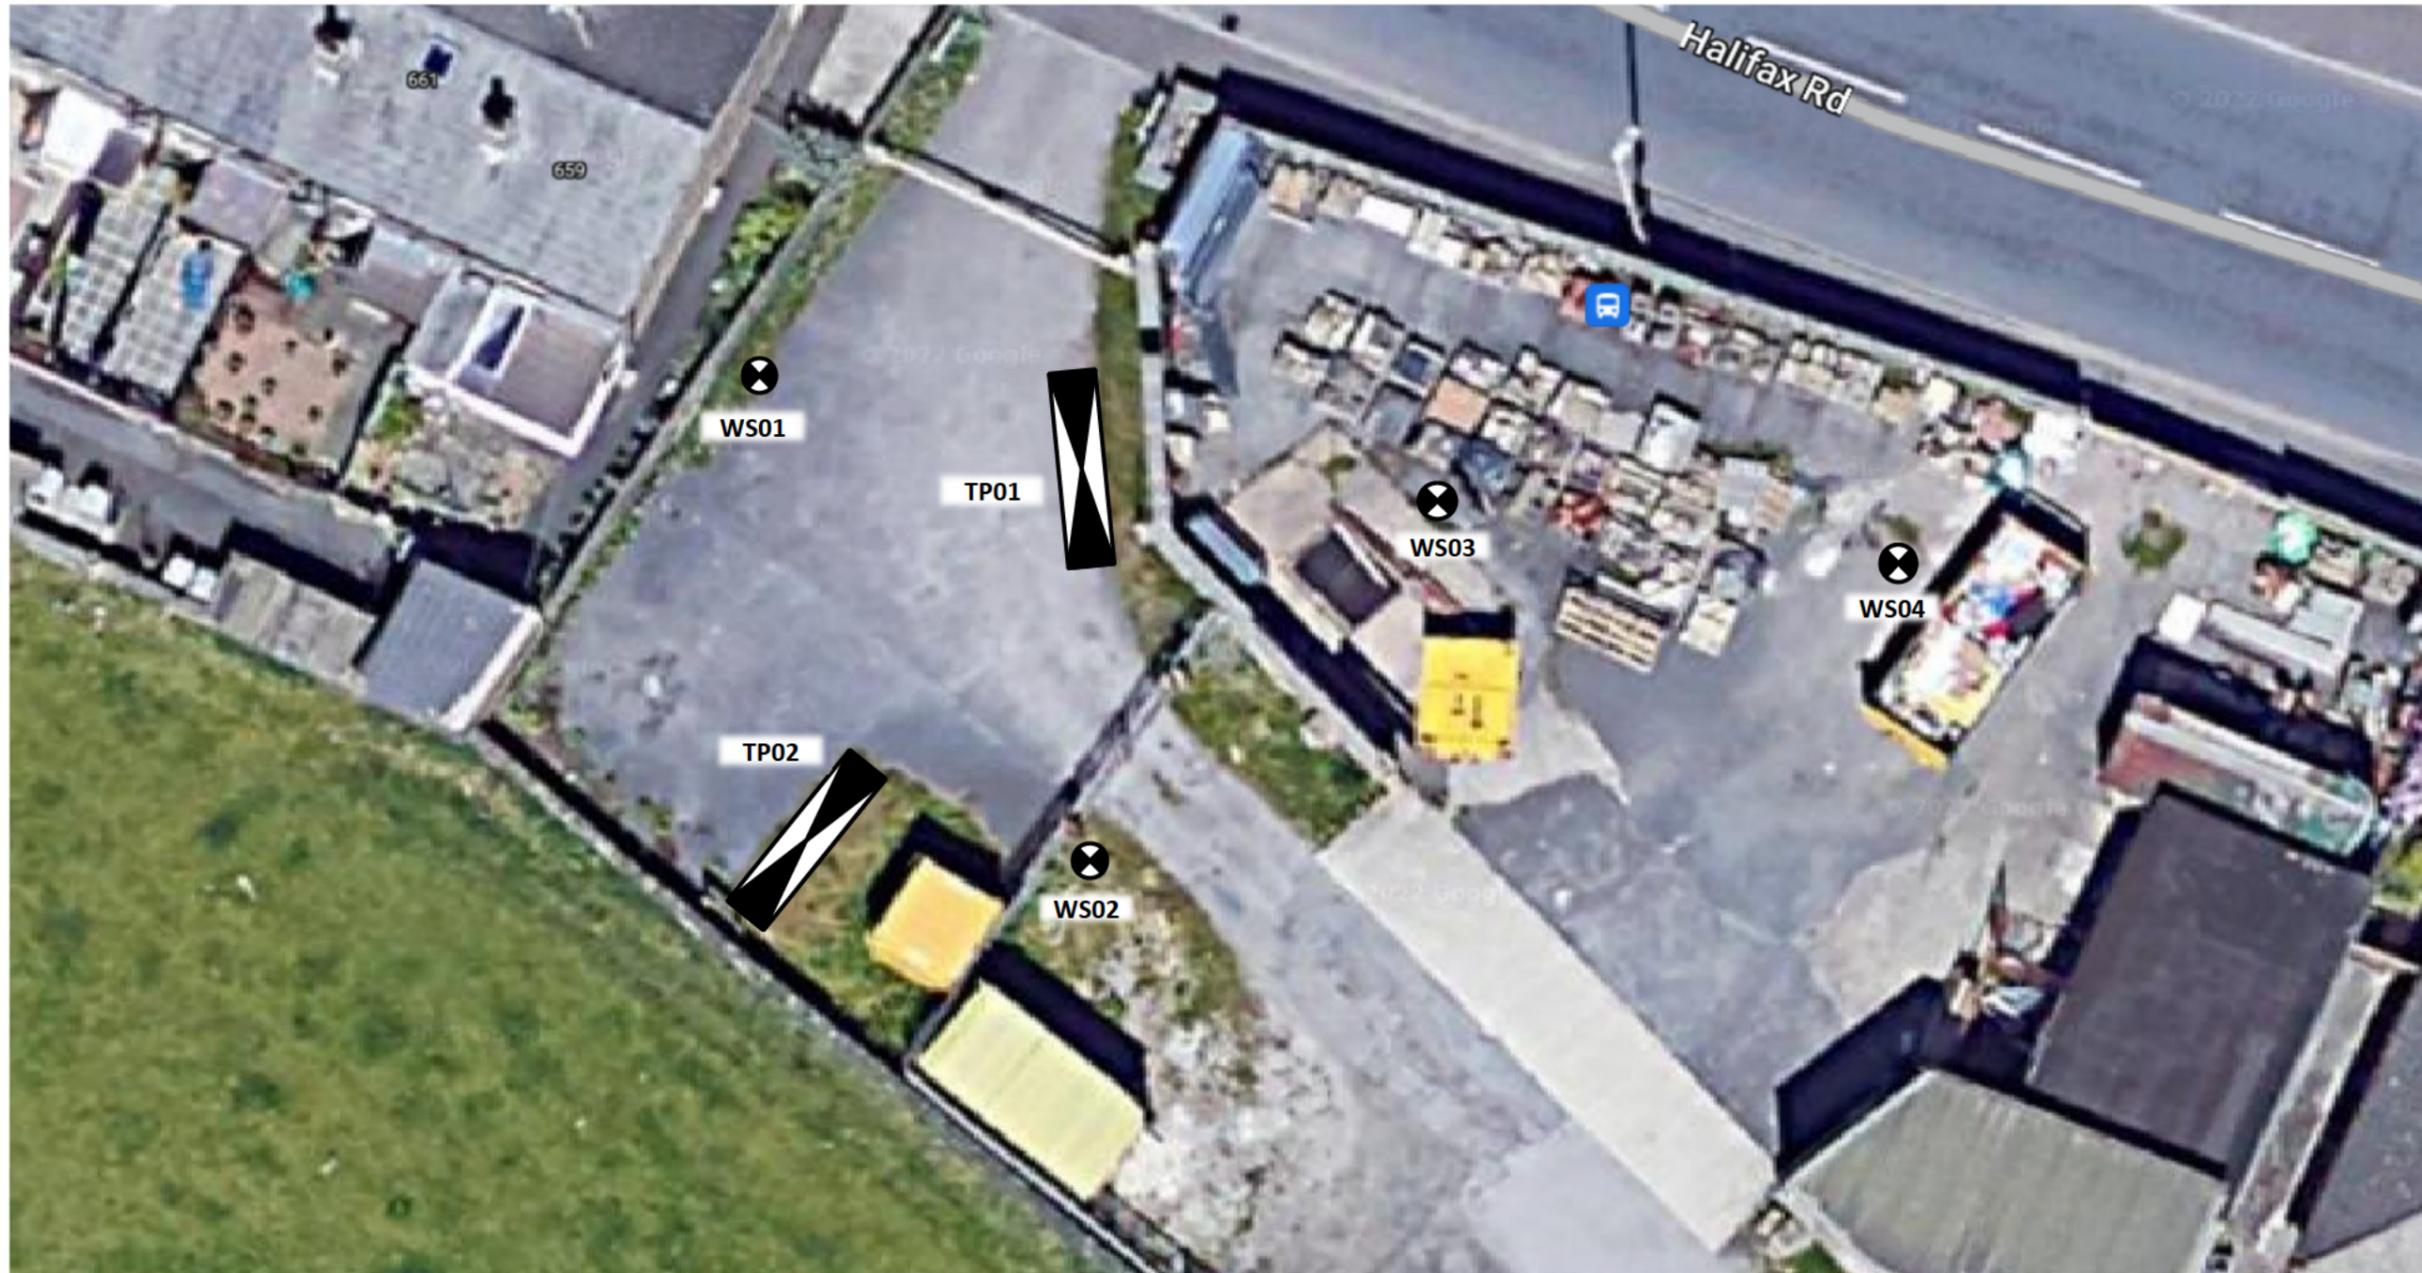
Site Plan

Investigation positions approximated from site operative's notes.

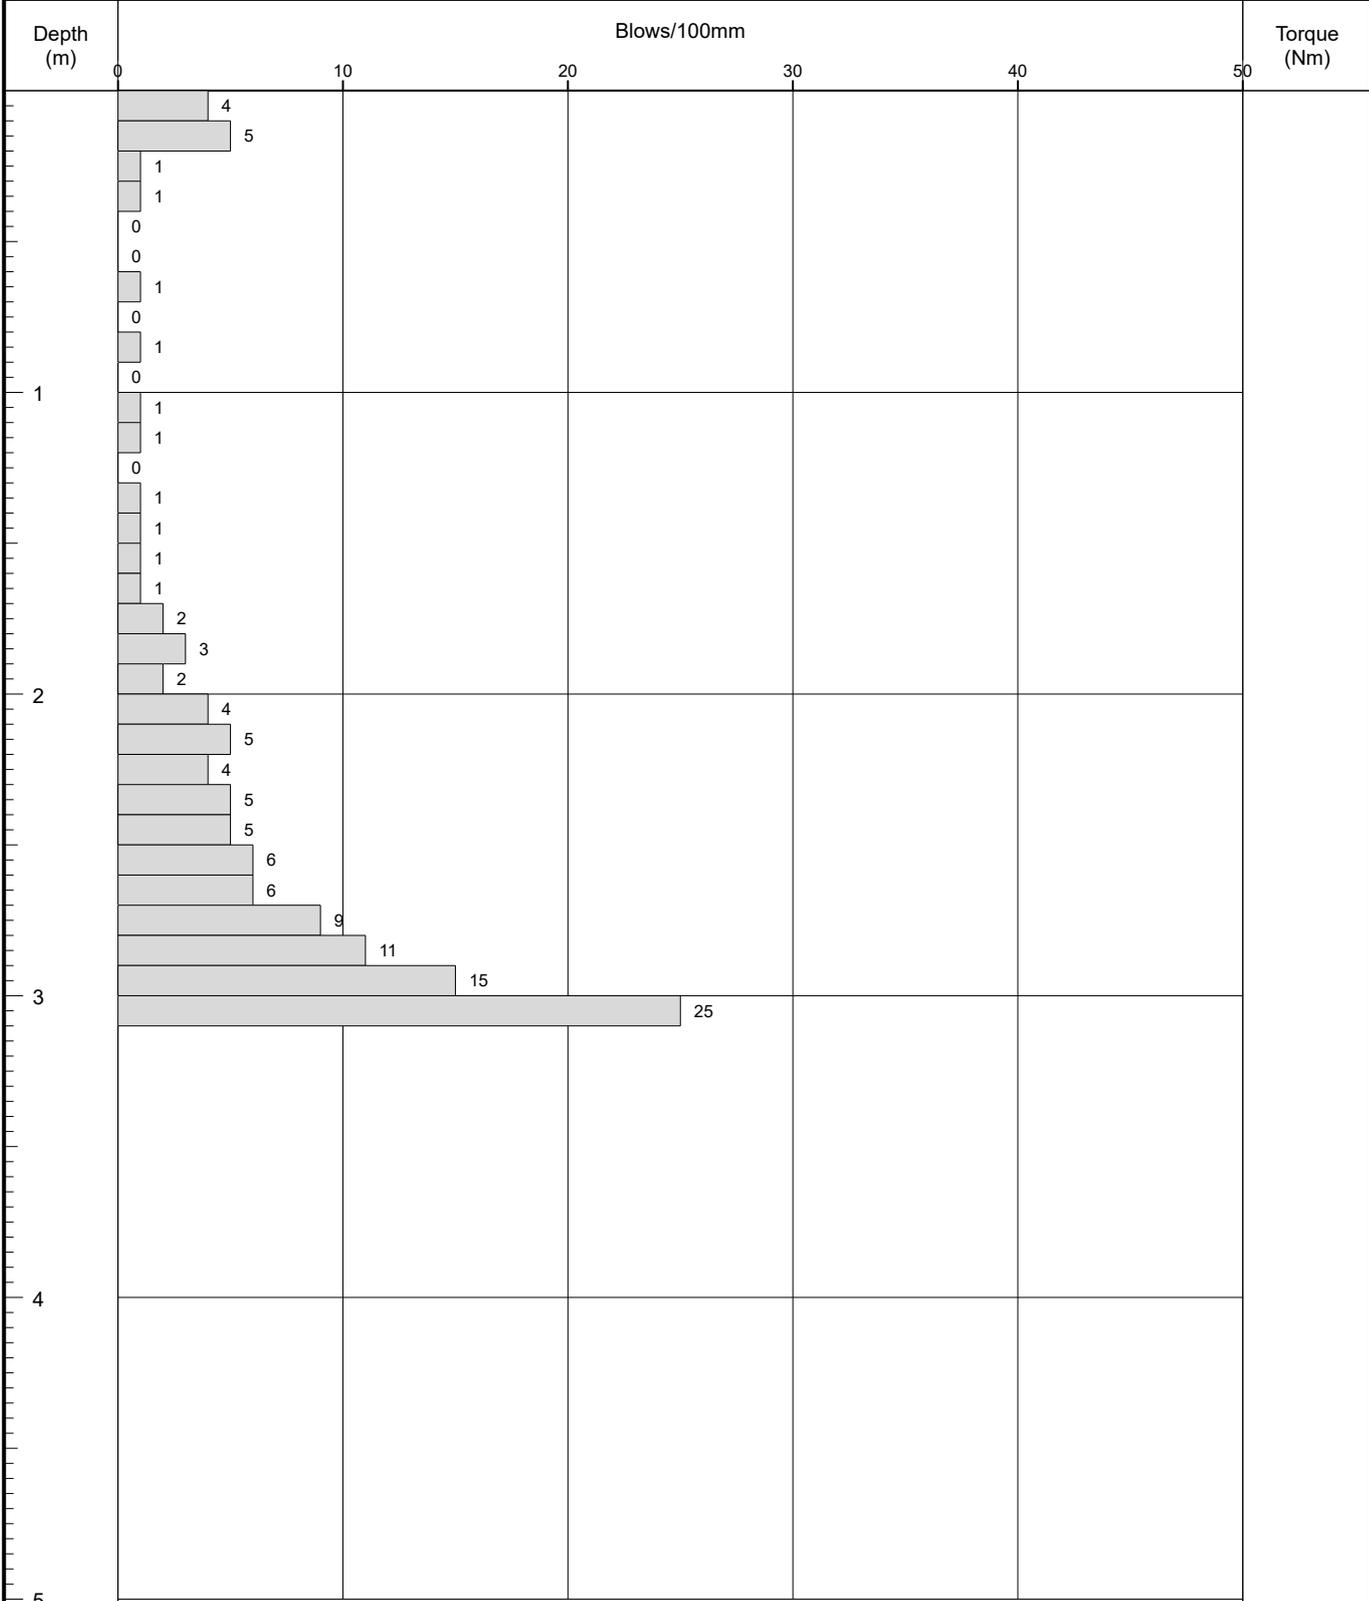
Sheet 1 of 1

Project Name: Land at Halifax Road, Liversedge	Project No. C2764/22/E/4214	Co-ords:	Hole Type DCP
Location: Land at Halifax Road, Liversedge, West Yorkshire, WF15 8HE	Level:		Scale 1:25
Client: Studio91 Architecture	Dates: 10/10/2022		Logged By RMc

Remarks: Effective refusal	Fall Height	750mm	Cone Base Diameter	50.5mm
	Hammer Wt	63.5kg	Final Depth	3.1m
	Probe Type	DPSH-B

Position	Blows/100mm			Refusal type (Effective/ Abrupt) ⁴	Comments
	0 - 2	3 - 10	10+		
	Depth to which blow count range was observed (m)				
DP1	1.8 2.0	0.2 1.9 2.8	3.1	Effective	Initial moderate results to 0.2m, followed by weak material to 2.0m. Results then gradually increased with depth.
DP2	0.1 2.2	0.3 2.9	3.9	Effective	Generally weak material to 2.2m, follow a gradual increase in blow count with depth to refusal.
DP3	0.2 0.5 0.8 1.2 2.5	0.3 0.6 1.1 1.6 3.0	3.6	Effective	Generally poor but variable to 1.6m followed by weaker material to 2.5m. Then gradual increase in results with depth.
DP4	0.6 1.0 1.4 2.6	0.3 0.8 1.3 1.5 2.8	2.86	Abrupt	Slightly stronger near surface count, followed by low blow counts to 2.8m.

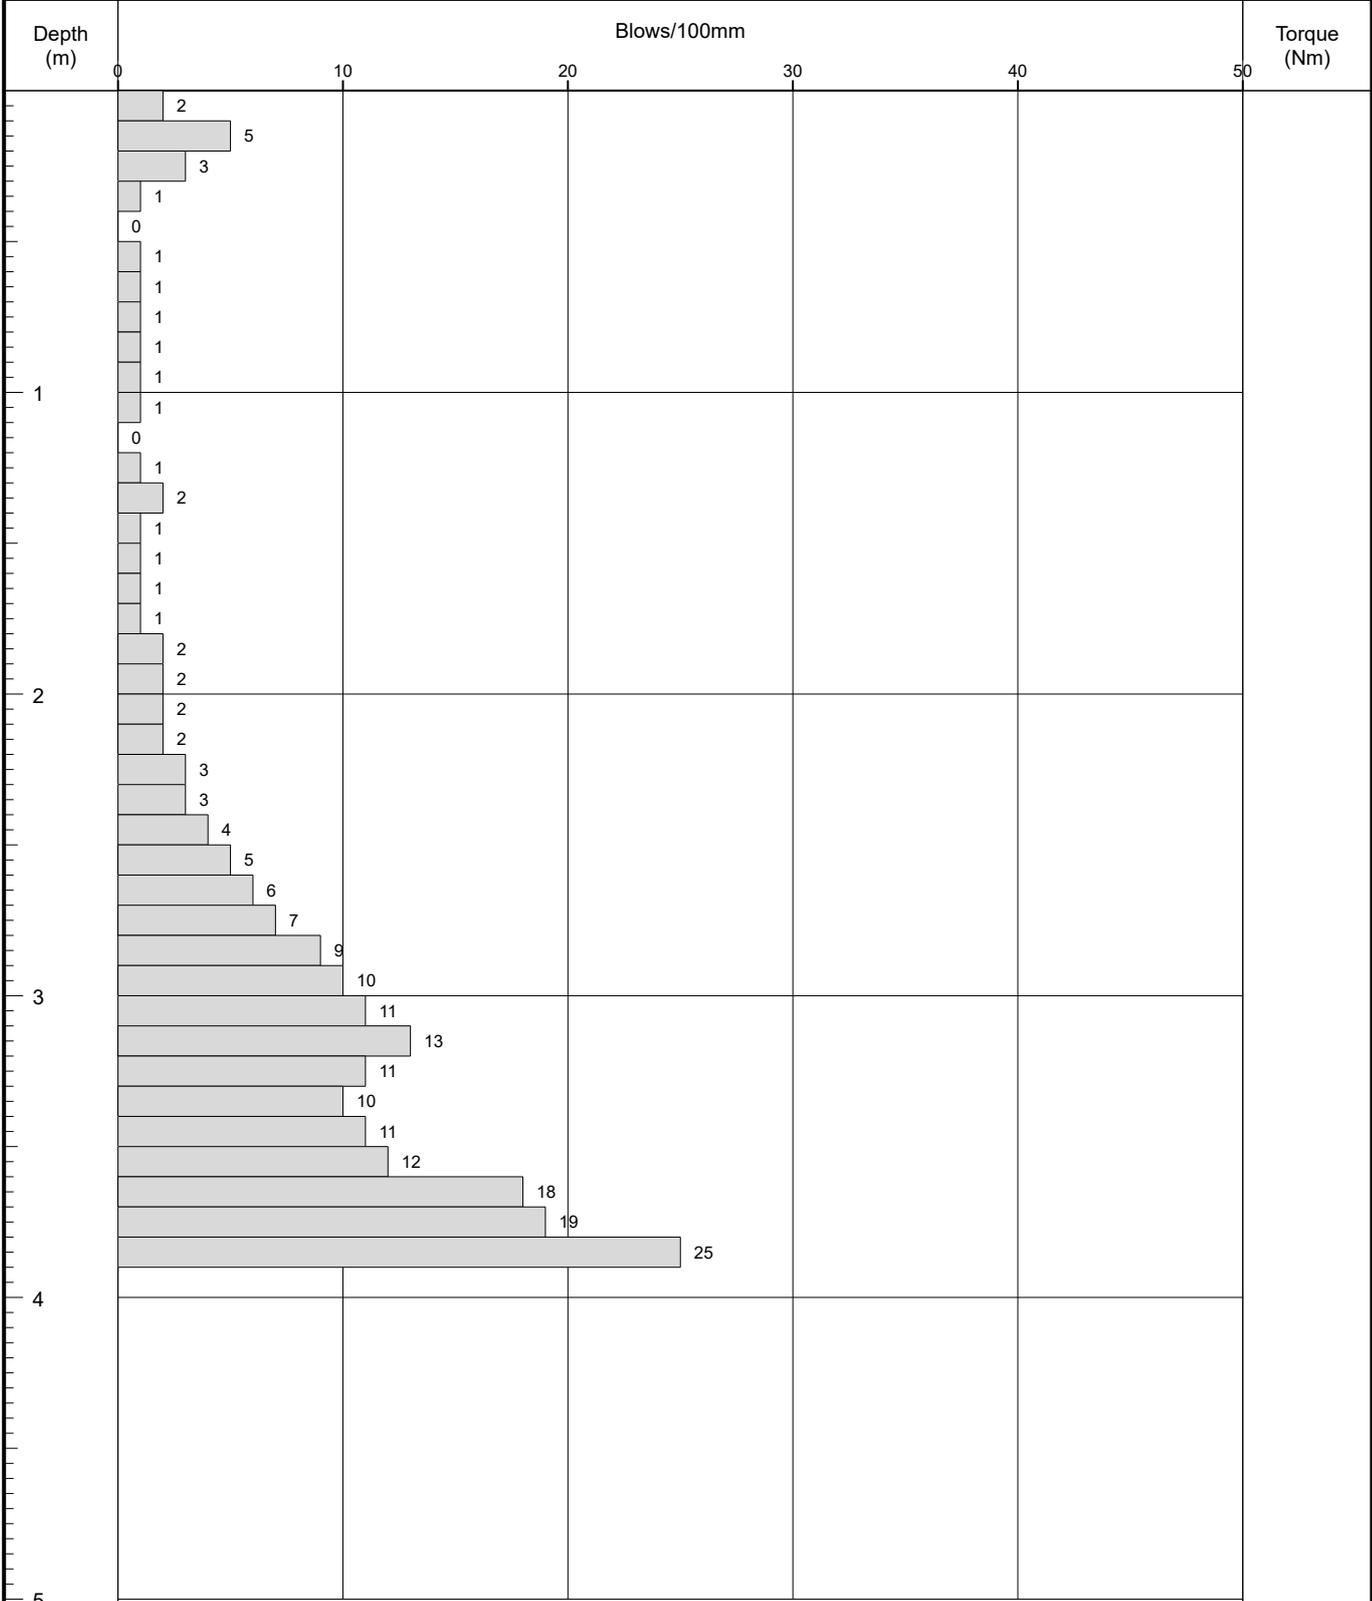
Sheet 1 of 1

Project Name: Land at Halifax Road, Liversedge	Project No. C2764/22/E/4214	Co-ords:	Hole Type DCP
Location: Land at Halifax Road, Liversedge, West Yorkshire, WF15 8HE	Level:		Scale 1:25
Client: Studio91 Architecture	Dates: 10/10/2022		Logged By RMc

Remarks: Effective refusal	Fall Height	750mm	Cone Base Diameter	50.5mm
	Hammer Wt	63.5kg	Final Depth	3.9m
	Probe Type	DPSH-B

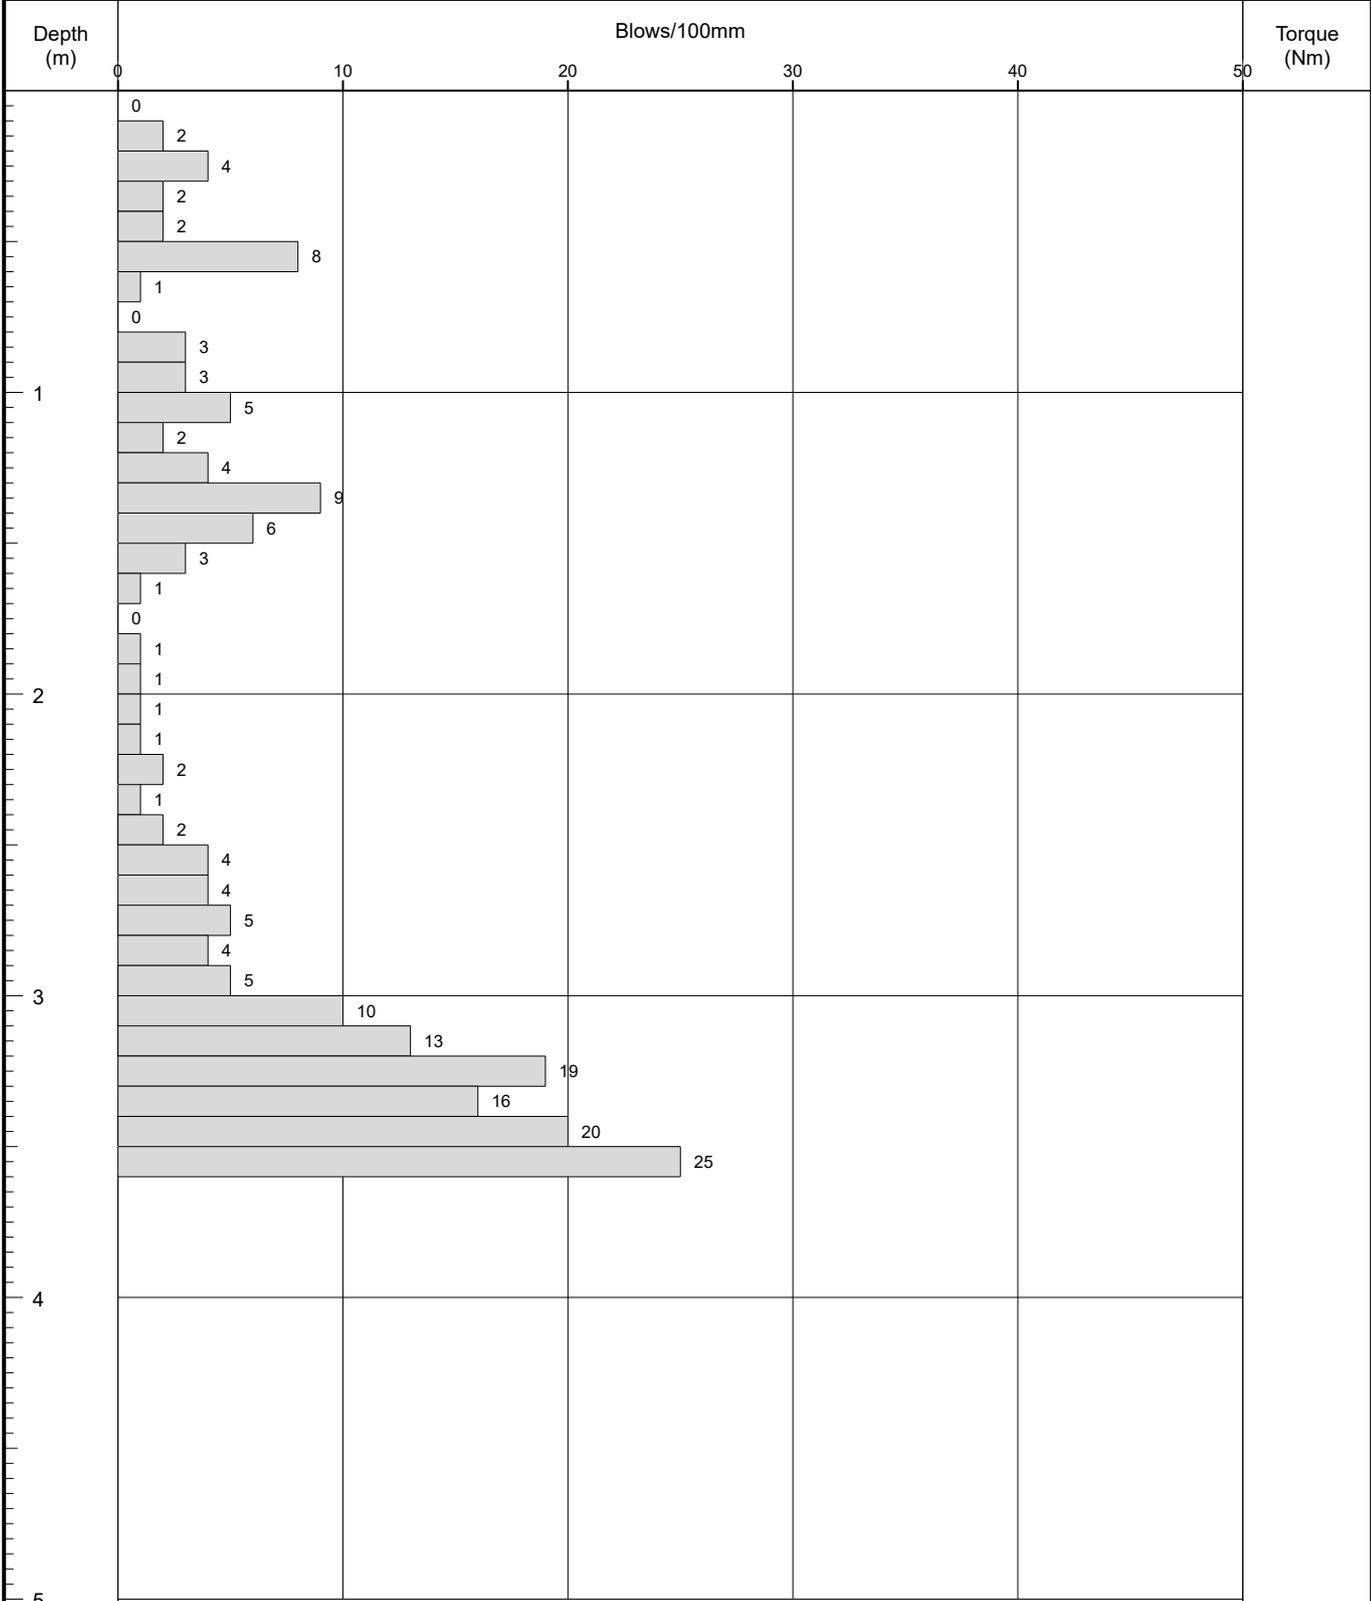
Sheet 1 of 1

Project Name: Land at Halifax Road, Liversedge	Project No. C2764/22/E/4214	Co-ords:	Hole Type DCP
Location: Land at Halifax Road, Liversedge, West Yorkshire, WF15 8HE	Level:		Scale 1:25
Client: Studio91 Architecture	Dates: 10/10/2022		Logged By RMc

Remarks: Effective refusal	Fall Height	750mm	Cone Base Diameter	50.5mm
	Hammer Wt	63.5kg	Final Depth	3.6m
	Probe Type	DPSH-B

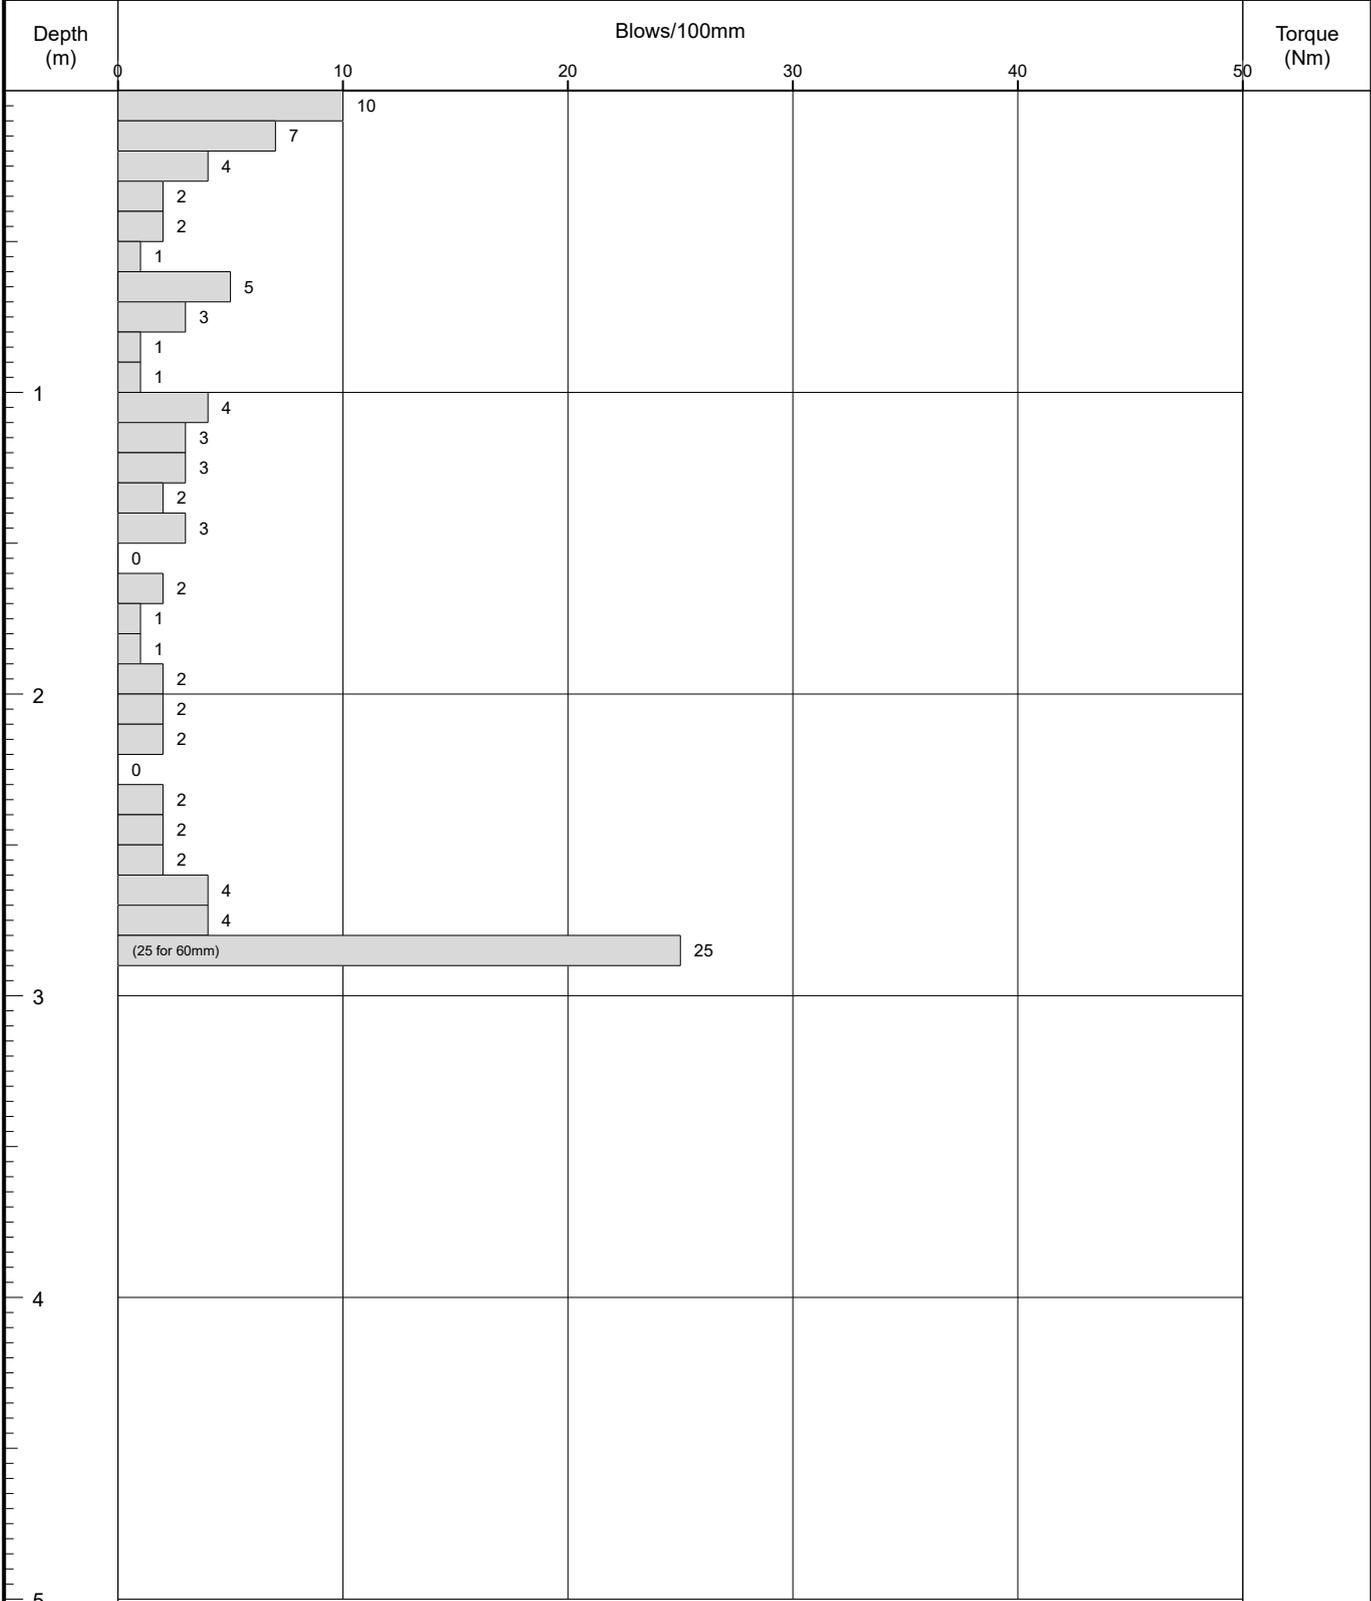
Sheet 1 of 1

Project Name: Land at Halifax Road, Liversedge	Project No. C2764/22/E/4214	Co-ords:	Hole Type DCP
Location: Land at Halifax Road, Liversedge, West Yorkshire, WF15 8HE	Level:		Scale 1:25
Client: Studio91 Architecture	Dates: 10/10/2022		Logged By RMc

Remarks: Effective refusal	Fall Height	750mm	Cone Base Diameter	50.5mm
	Hammer Wt	63.5kg	Final Depth	2.86m
	Probe Type	DPSH-B

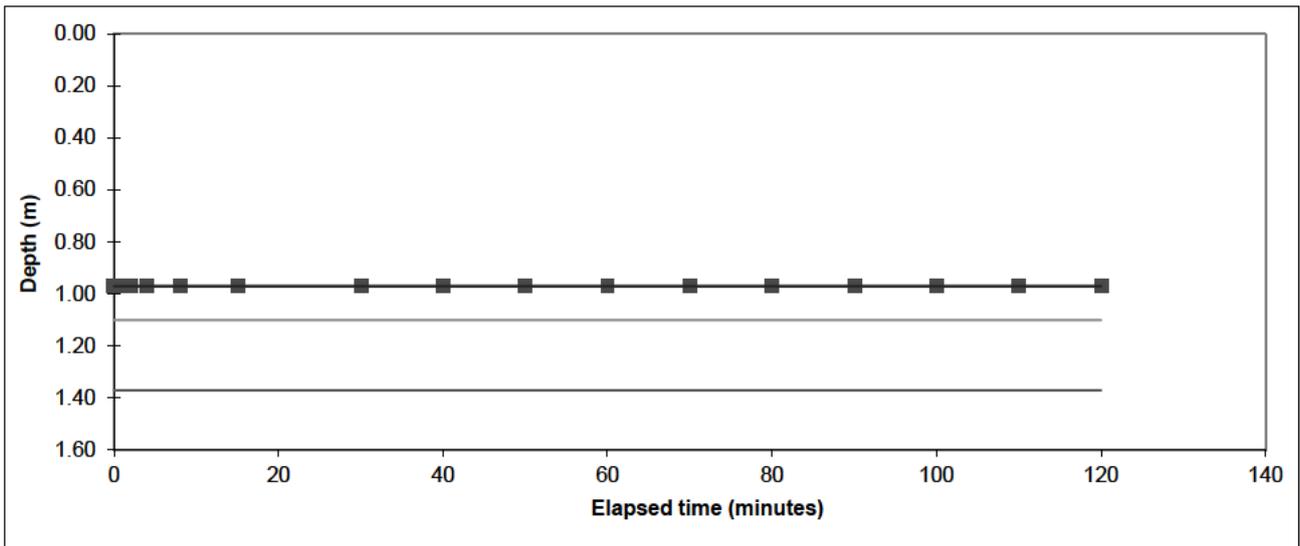
Trial Pit No:	TP01	Test No:	1	Date:	10/10/2022
Length (m):	1.800	Datum Height:			0.00 m agl
Width (m):	0.35	Granular infill:	None		
Depth (m):	1.50	Porosity of infill:	1	(assumed)

Elapsed time (minutes)	Water Depth (m below datum)	Elapsed time (minutes)	Water Depth (m below datum)
0	0.970	110	0.970
1	0.970	120	0.970
2	0.970		
4	0.970		
8	0.970		
15	0.970		
30	0.970		
40	0.970		
50	0.970		
60	0.970		
70	0.970		
80	0.970		
90	0.970		
100	0.970

Start water depth for analysis (mbgl):	0.97	Elapsed time (mins):	#N/A
75% effective depth (mbgl):	1.10		
50% effective depth (mbgl):	1.24	Elapsed time (mins):	#N/A
25% effective depth (mbgl):	1.37		
Base of soakage zone (mbgl):	1.50		
Volume outflow between 75% and 25% effective depth (m ³):			
Mean surface area of outflow (m ²):			1.75
(side area at 50% effective depth + base area)			
Time for outflow between 75% and 25% effective depth (mins):

Soil infiltration rate (m/s):	Test incomplete as 25% effective depth not achieved. Unable to reliably determine soil infiltration rate.
--------------------------------------	--

Table 6: Soakaway Test Results					
Location	Soakage Area Dimensions (average) (m)	Depths of soaked strata (m)	Soil Description (of soaked strata)	Infiltration Rate (m/sec)	Drainage Characteristics
TP01	0.35 x 1.80	0.97 to 1.50	Side – Silty CLAY Base – As above	Not obtained	Practically Impermeable
TP02	0.40 x 1.85	1.06 to 1.85	Side – Silty CLAY Base – Siltstone	Not obtained	Practically Impermeable

During the soakaway tests the water level did not achieve a fall from 75% to 25% of the effective depth of the storage volume in the trial pit. Indeed, the water level was not observed to move for the duration of the test. On this basis, the tests could not be completed within the scope of the method provided in BRE Digest 365 due to the poor soakage rate of the exposed soils. Due to the negligible water movement it was not possible to extrapolate the results obtained in order to obtain a soil infiltration rate and as such such the strata deemed to possess practically impermeable drainage characteristics.

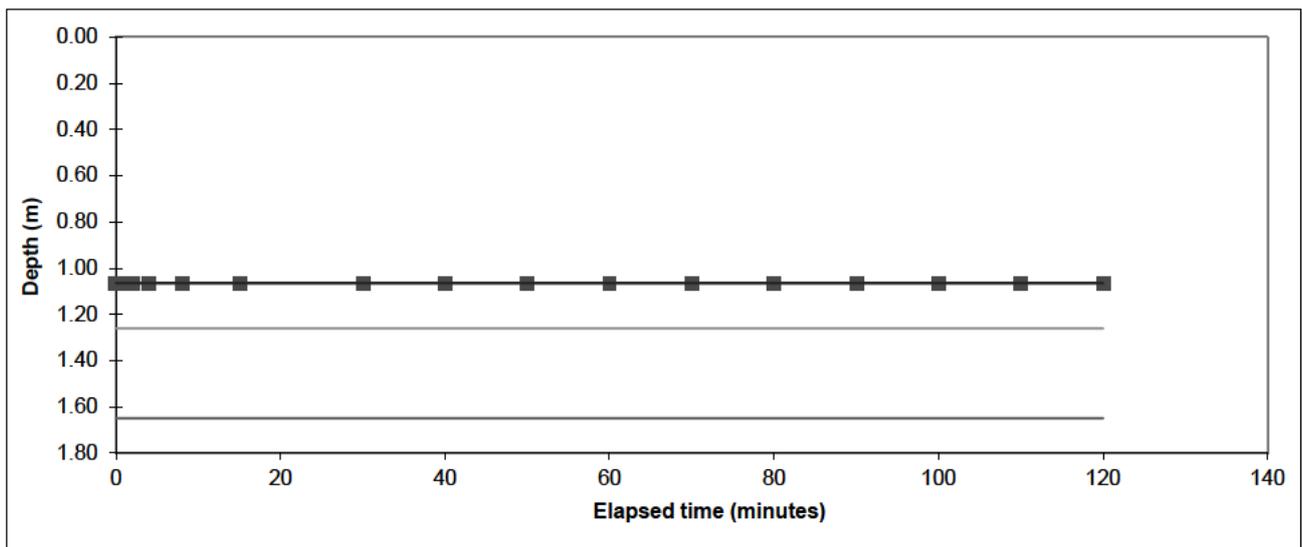
Trial Pit No:	TP02	Test No:	1	Date:	10/10/2022
Length (m):	2.100	Datum Height:			0.00 m agl
Width (m):	0.40	Granular infill:	None		
Depth (m):	1.85	Porosity of infill:	1	(assumed)

Elapsed time (minutes)	Water Depth (m below datum)	Elapsed time (minutes)	Water Depth (m below datum)
0	1.065	110	1.065
1	1.065	120	1.065
2	1.065		
4	1.065		
8	1.065		
15	1.065		
30	1.065		
40	1.065		
50	1.065		
60	1.065		
70	1.065		
80	1.065		
90	1.065		
100	1.065

Start water depth for analysis (mbgl):	1.07	Elapsed time (mins):	#N/A
75% effective depth (mbgl):	1.26	Elapsed time (mins):	#N/A
50% effective depth (mbgl):	1.46	Elapsed time (mins):	#N/A
25% effective depth (mbgl):	1.65	Elapsed time (mins):	#N/A
Base of soakage zone (mbgl):	1.85		
Volume outflow between 75% and 25% effective depth (m ³):			
Mean surface area of outflow (m ²):			2.79
(side area at 50% effective depth + base area)			
Time for outflow between 75% and 25% effective depth (mins):

Soil infiltration rate (m/s):	Test incomplete as 25% effective depth not achieved. Unable to reliably determine soil infiltration rate.
--------------------------------------	--

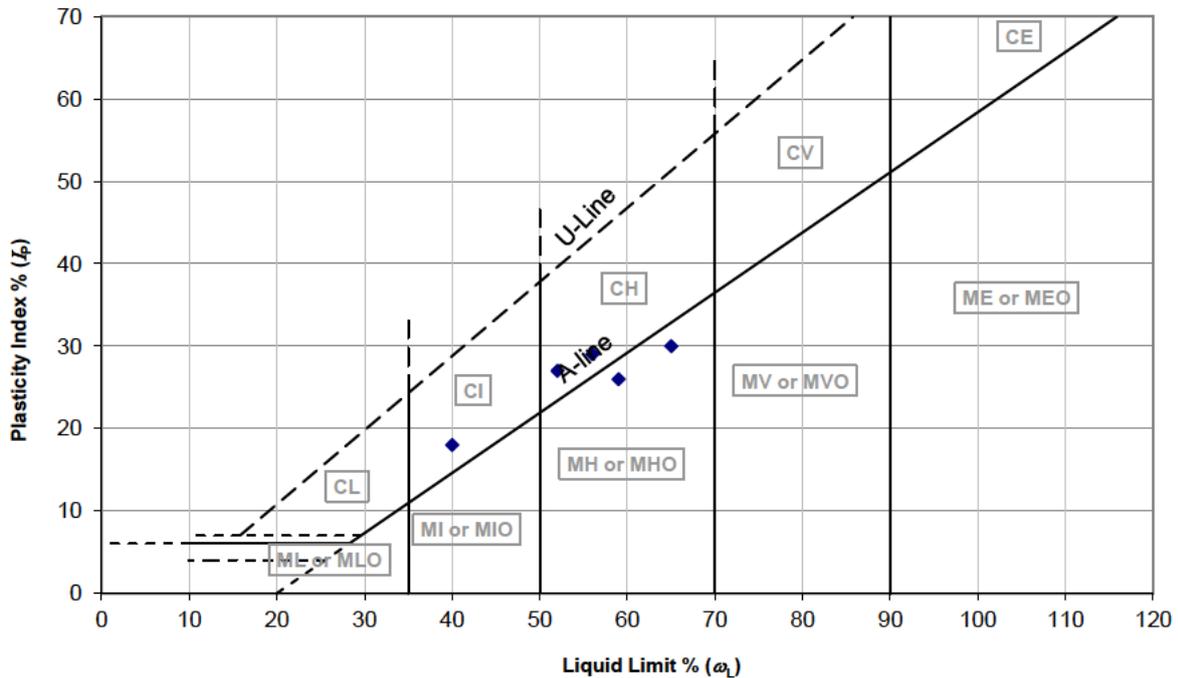
Location	Depth (m)	Water Content (w) (%)	Liquid Limit (wL) (%)	Plastic Limit (wP) (%)	Plasticity Index (IP) (%)	Retained by 0.425mm (%)	Modified (w) (w') (%)	Modified (IP) (IP') (%)	Liquidity/ Consistency		Casagrande Class	N.H.B.C Class (%)
									(IL) (%)	(IC) (%)		
WS01	0.80	25.3	40	22	18	2	26	18	0.2	0.8	C I	LOW
WS01	1.50	23.1	52	25	27	4	24	26	-0.1	1.1	C H	MEDIUM
WS02	1.00	21.2	56	27	29	5	22	28	-0.2	1.2	C H	MEDIUM
WS03	1.20	38.3	59	33	26	49	75	13	0.2	0.8	M H	LOW
WS03	1.80	44.3	65	35	30	2	45	29	0.3	0.7	M H	MEDIUM

It should be appreciated that the cohesive soils revealed at this site possess a predominantly medium volume change potential under the guidance of the NHBC standards. Therefore, it is will be necessary to ensure that the depths of the foundations are designed in accordance with the Chapter 4.2 of the NHBC standards⁷. The methodology provided in the guidance will require the identification of any trees, still present at, or recently removed from, the site and the distance from the proposed foundations. This may result in foundation depths greater than those given above and the requirement for heave protection to be employed against footings and below the underside of the floors and beams.
