**CONTRACT NO. E13431/1**
**GEO-ENVIRONMENTAL APPRAISAL OF A  
 SITE AT 119 HUDDERSFIELD ROAD,  
 MIRFIELD**

Prepared by  
 DTS Raeburn Limited

<b>Client:</b>	Morbaine Limited	
<b>Report Issue No.</b>	1	
<b>Report Status:</b>	<b>FINAL</b>	
<b>Date:</b>	March 2021	
<b>Prepared by:</b>	T. Dentith-Barnard BSc(Hons) Geo-environmental Engineer

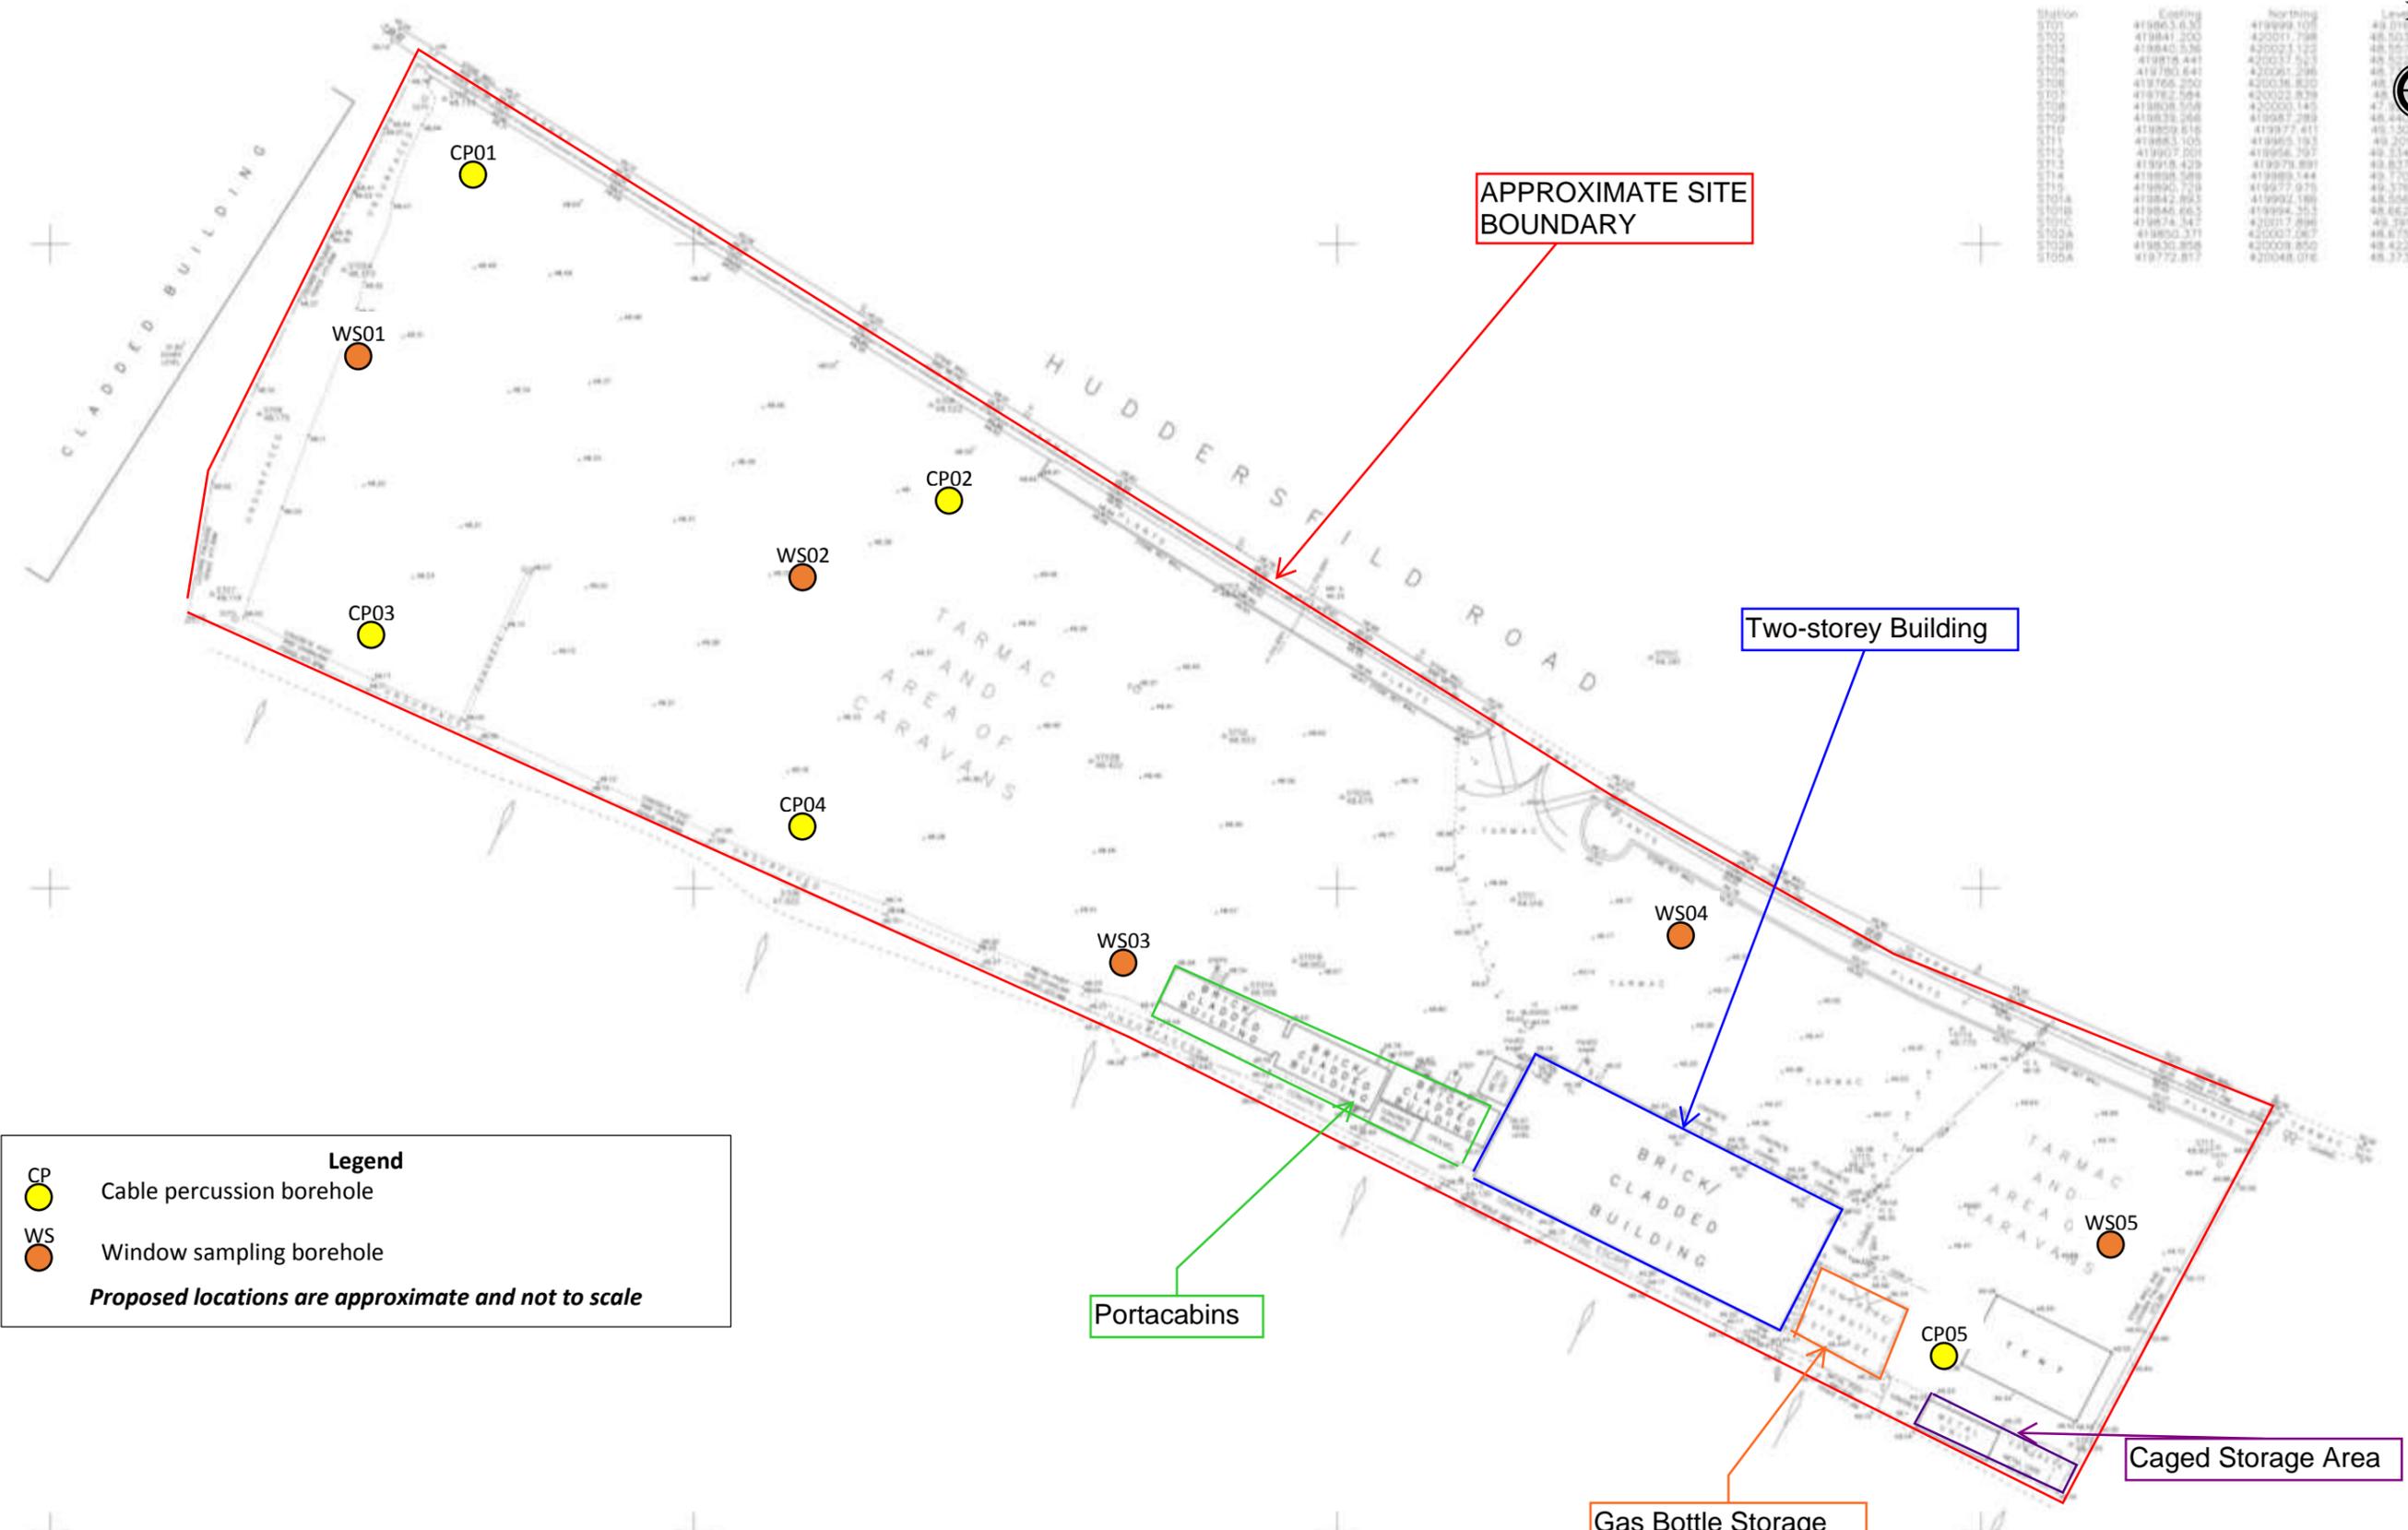
Exploratory Hole Location Plan  
 Scale 1:500 @ A3

Cable percussion boreholes CP1-CP4 were positioned at approximately the four corners of the proposed retail store building, to provide geotechnical data for the design of foundations for this structure. Boreholes CP4 and CP5 were also located close to the proposed retaining walls in the southern part of the site.

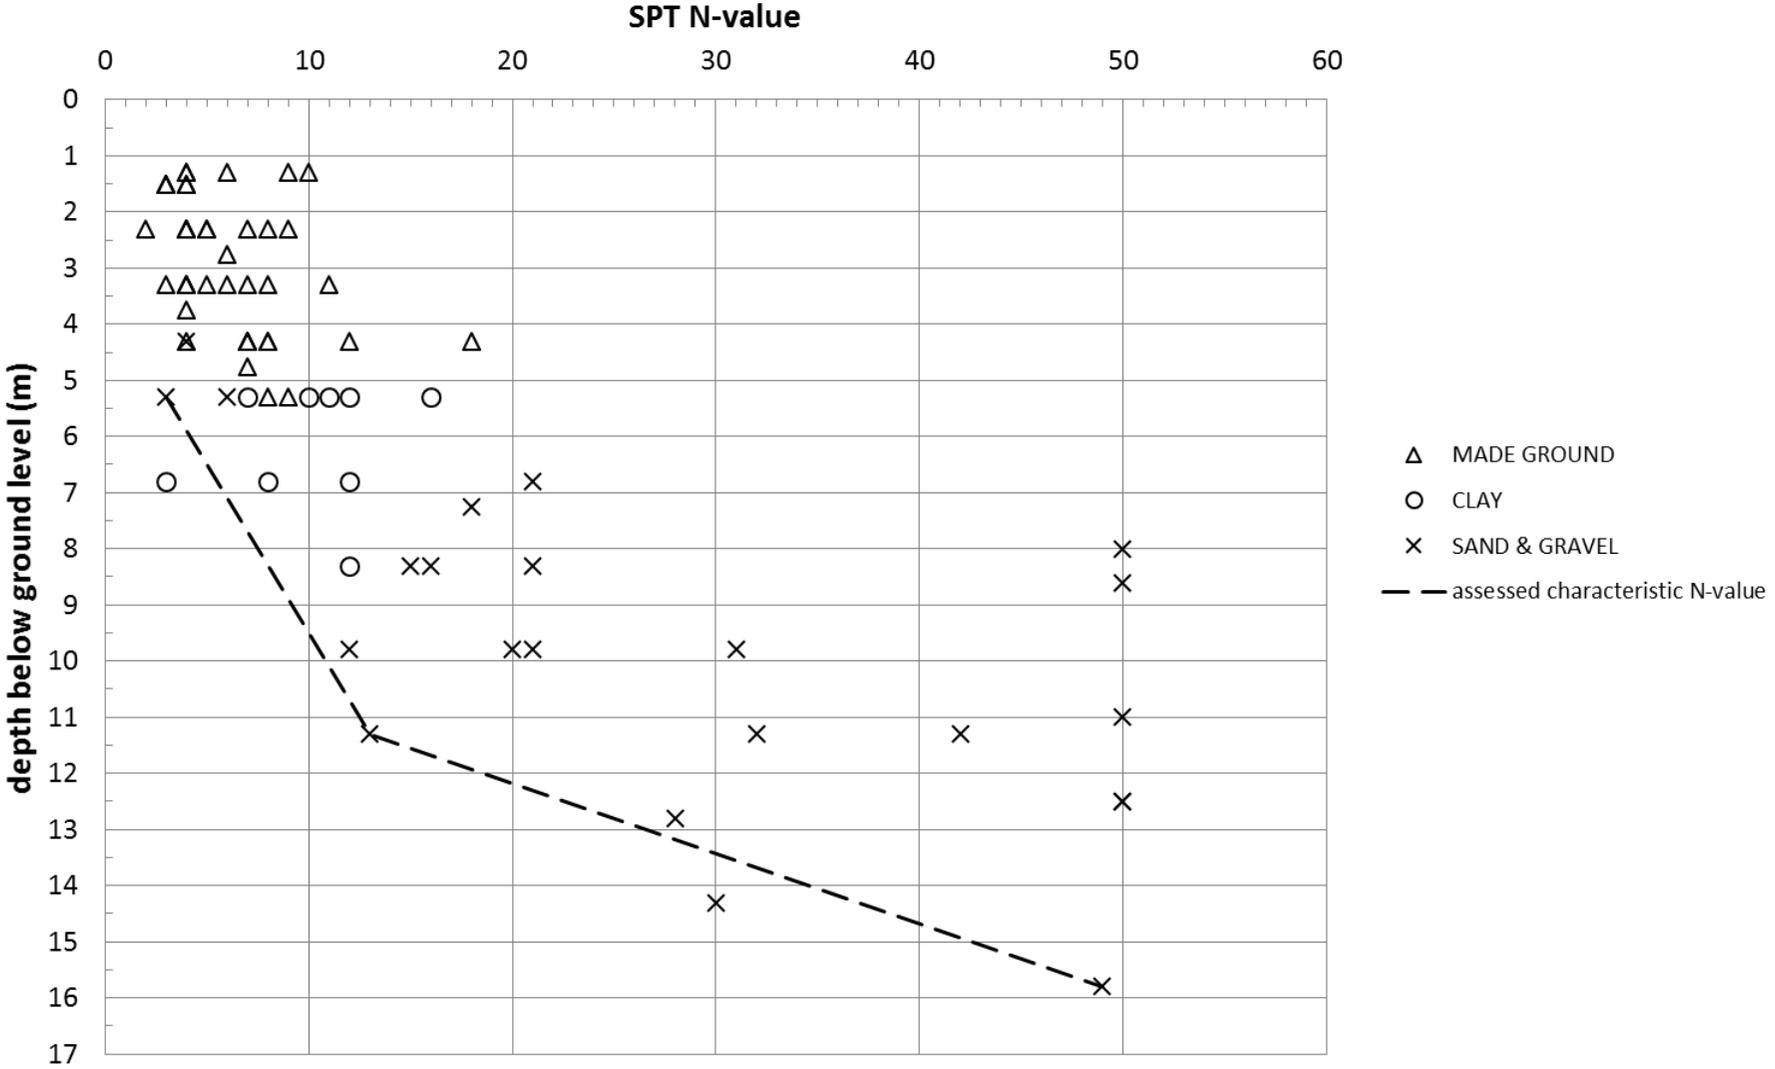
### Plot of SPT N-value versus Depth (mbgl)

Standard Penetration Tests (SPTs) were performed at regular depth intervals during drilling of the boreholes. Each test result is expressed as an N-value, which is the blow-count from a calibrated drop hammer needed to cause a standard penetrometer to advance 300mm into the ground.

The plot shows that in the top 5m the soils (which consist predominantly of made ground) are mostly soft or loose, while from about 7m bgl the natural soils are firm or medium dense. Mudstone/siltstone and sandstone rock was encountered in Boreholes CP2 at 11m bgl and CP5 at 8m bgl, and SPT N-values of 50 or greater were recorded in these materials.
