## Dewsbury Bus Station Refurbishment

Dewsbury Bus Station Refurbishment - Stage 1 Road Safety Audit

B2382808/RSA1/01 | 1

West Yorkshire Combined Authority

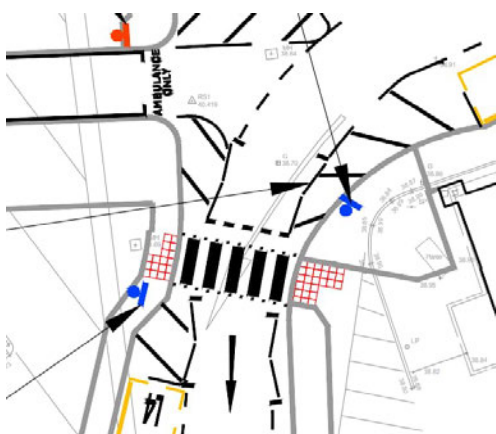
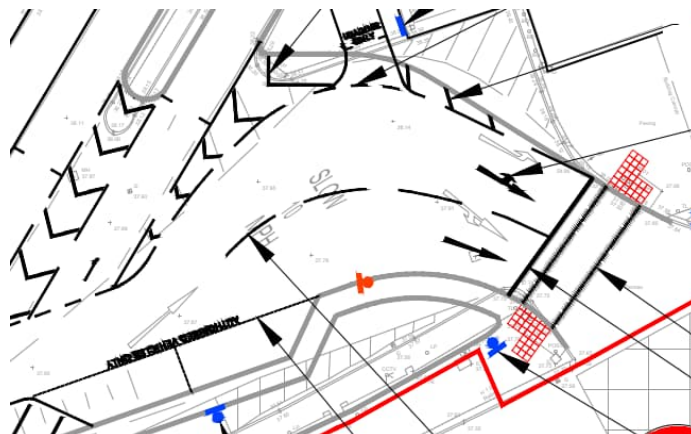
Location: B – Proposed crossing close to the ambulance waiting area

Location: F – Bus station exit onto Aldams Road

Summary: Insufficient space provided within the 'roadway' through the bus station

There are two locations where the audit team considers there may be an increased likelihood of collisions due to insufficient space being provided within the 'roadway' through the bus station. The first of these is at the proposed crossing close to the ambulance waiting area and the second is the 2-lane approach to the station exit. Insufficient space at the proposed crossing would increase the likelihood of vehicles striking pedestrians waiting to use the crossing. Insufficient space at the bus station exit would increase the risk of side swipe collisions.

The designer should satisfy themselves that the whole of the proposed internal network can accommodate the movements of the largest anticipated vehicle type, undertaking any swept path analysis as necessary.

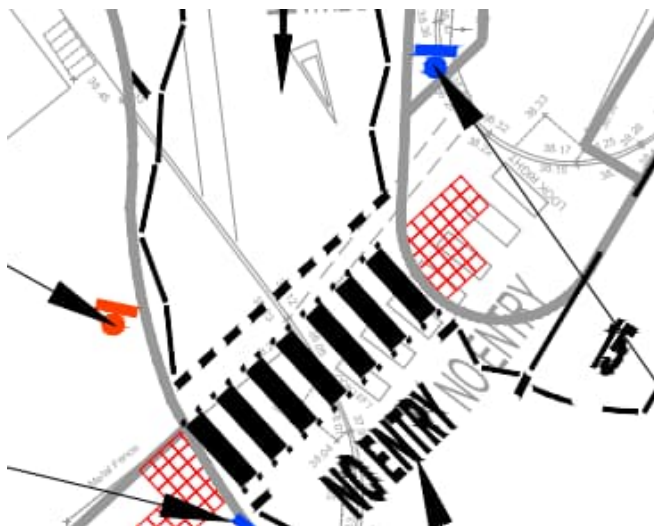
Location: C – Southbound approach to zebra crossing that links the south-western entry from Aldams Road with the south-western pedestrian entrance to the bus station

Summary: Warning sign would provide drivers with limited advance warning of the presence of the crossing

The zebra crossing warning sign on the approach to this zebra crossing is proposed to be located close to the crossing itself and would therefore provide drivers with limited advance warning of the presence of the crossing. There is therefore an increased risk of collisions involving vehicles striking pedestrians using the crossing.

The zebra crossing warning sign, together with the proposed 'No right turn' sign which is proposed to be mounted on the same post, should be located further north on the approach to the crossing.

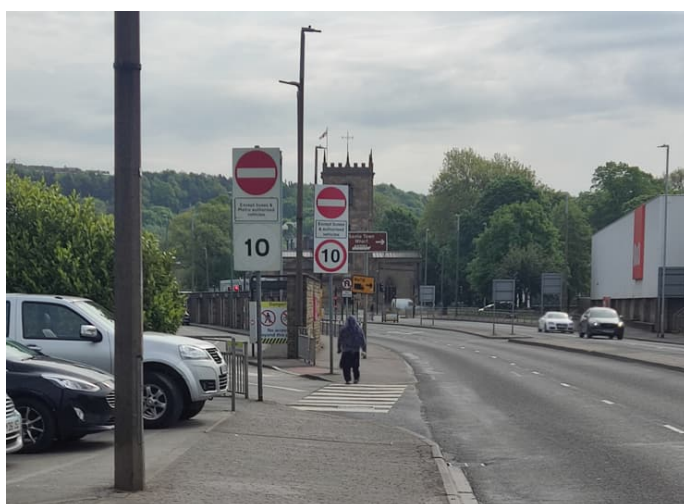
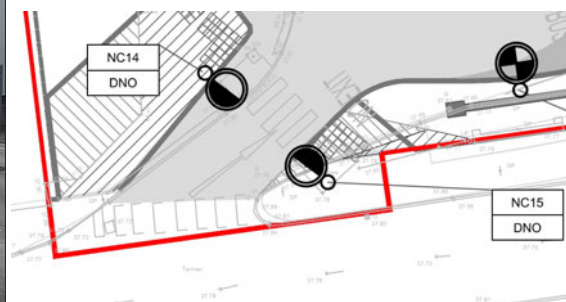
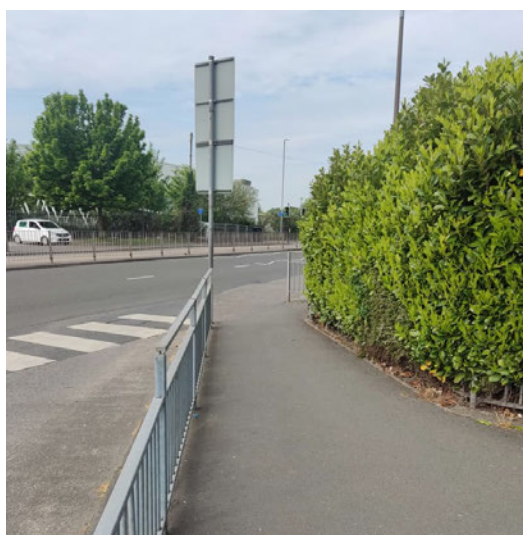
Location: D – Zebra crossing at Aldams Road entry to bus station

Summary: Reduced intervisibility between drivers and pedestrians using the crossing

Driver visibility of the proposed crossing will be reduced due to the number of signs at this entry to the bus station. However, it is not clear, from the proposals, which, if any, signs are being removed. The belisha beacon that is proposed on the south-eastern side of the crossing appears to be very close to an existing No Entry sign, which may reduce the visibility of both these elements to drivers. Reduced driver visibility to the crossing will reduce

driver awareness of the crossing and is likely to increase the risk of shunt (nose to tail) collisions, noting the potential for queued vehicles at the proposed crossing to block back onto Aldams Road.

Intervisibility is particularly poor between pedestrians waiting to cross from the north-western side of the crossing and drivers of eastbound vehicles approaching the crossing. A large bush obstructs visibility at this location. The bush appears to be within the ownership of the bus station.

- The proposed removal of the nearby existing crossing oriented parallel to Aldams Road will increase the number of pedestrians using the proposed crossing
- During the site visit, a relatively high proportion of elderly pedestrians were observed using the existing crossings close to the south-western entry to the bus station

There is an increased risk of collisions involving vehicles striking pedestrians using the zebra crossing.

The existing bush, west of the crossing, should be cut back and / or reduced in height to improve intervisibility between drivers and pedestrians using the crossing. Traffic signs at this entry to the bus station should be rationalised to maximise the conspicuity of the proposed crossing to drivers.

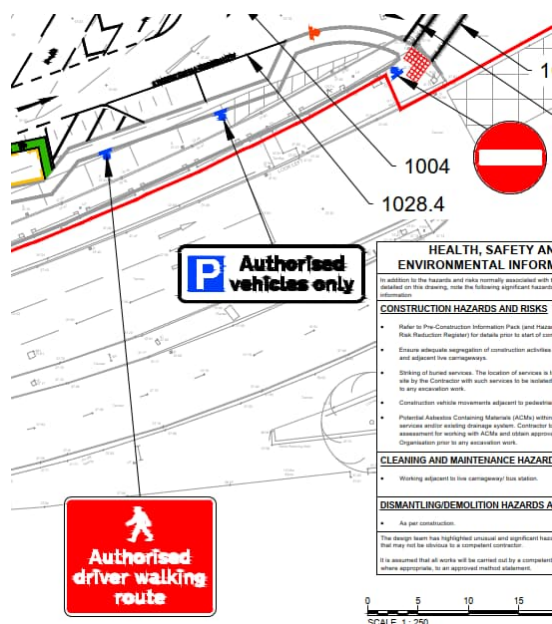
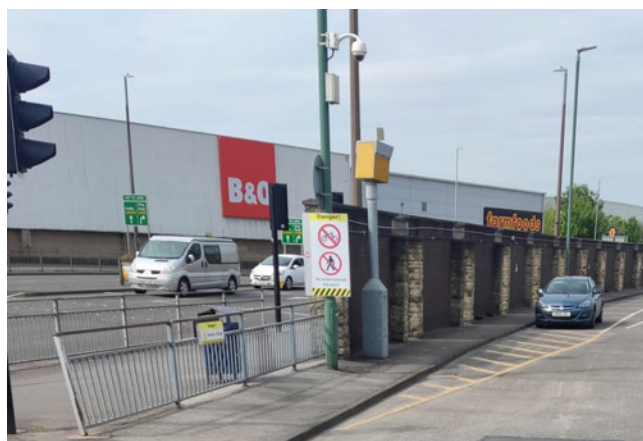
Location: E – Path provided along the southern boundary of the bus station

Summary: Potential for unauthorised pedestrians to walk along the path

A sign is proposed on the path provided along the southern boundary of the bus station to indicate that the path is a walking route for authorised drivers. The sign is proposed to be located approximately 40m west of the signalised crossing at the bus station exit junction. It is not clear whether the existing signing provided close to the crossing, and which indicates no access for pedestrians, is being retained. The proposals may lead to an increased likelihood of unauthorised pedestrians walking along the path provided adjacent to the southern boundary of the bus station. There is therefore an increased risk of pedestrians walking in areas where buses are manoeuvring and associated collisions involving pedestrians being struck by buses.

Signing to advise pedestrians that the path is for authorised users only should be provided close to the signalised crossing at the bus station exit.

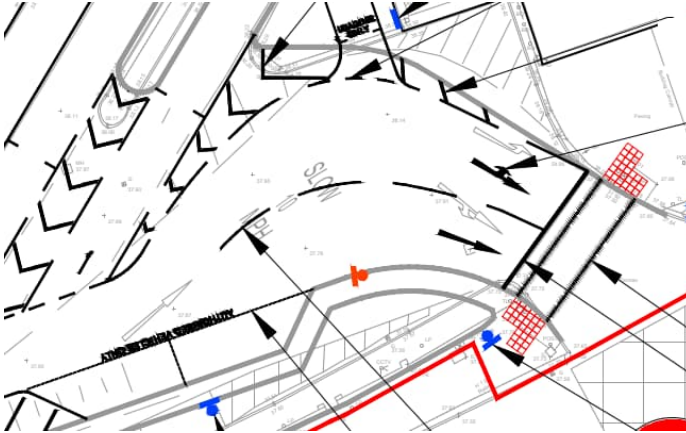
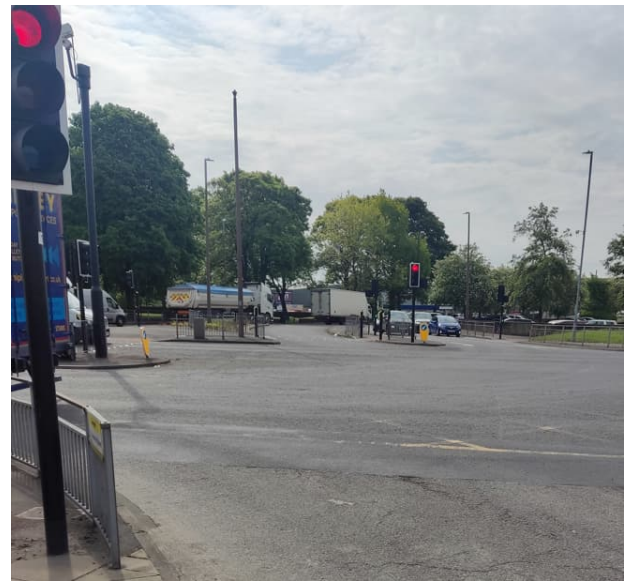
Location: F – Bus station exit onto Aldams Road

Summary: Ahead arrow marking in two lanes but junction exit has only a single lane

An ahead arrow marking is shown in both lanes at the exit from the bus station, however the downstream exit from the signalised junction (B6409) has only a single lane. There is therefore an increased likelihood of side swipe collisions if two vehicles attempt to travel ahead side by side when exiting the bus station.

In addition, the offside lane of the exit from the bus station is marked for the ahead movement only. Drivers seeking to turn right onto Aldams Road may be confused when faced with an ahead arrow, with an increased likelihood of collisions resulting from driver hesitancy or late manoeuvres.

The ahead arrow marking should be omitted from the nearside lane of the bus station approach to the junction. The alignment of the bus station approach lanes and B6409 exit are such that the ahead movement is best accommodated in the offside lane of the bus station approach. The offside lane should be marked for ahead and right turning vehicles.
