Remediation Validation Report

**Project: Block A to Block C,
Huddersfield Waterfront, Manchester
Road, Huddersfield**

Project No: EGE-23-09-18-01

Client: Hexa Consulting Limited

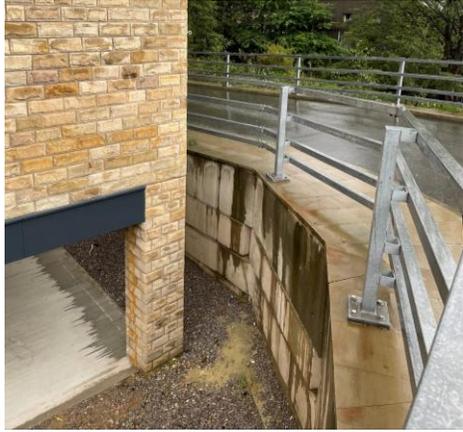
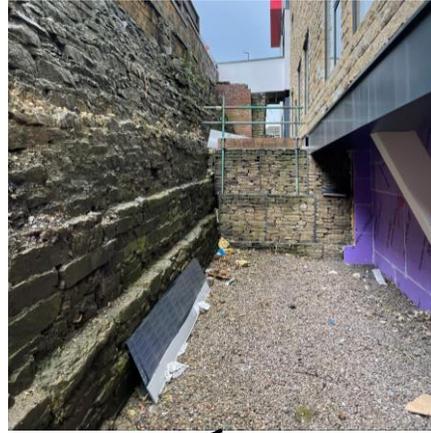
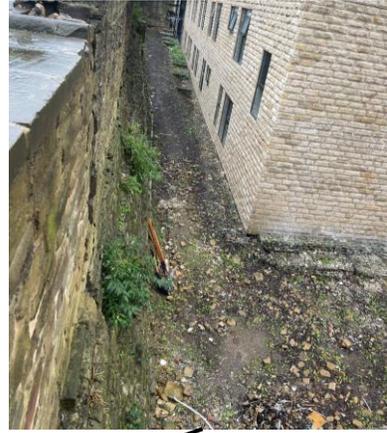
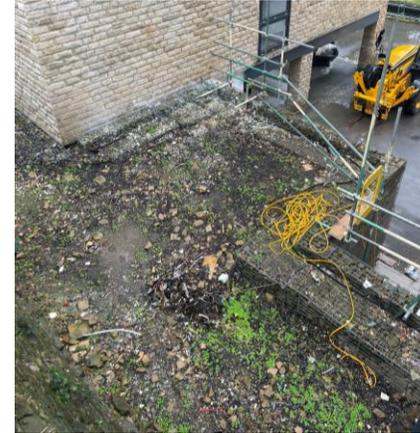
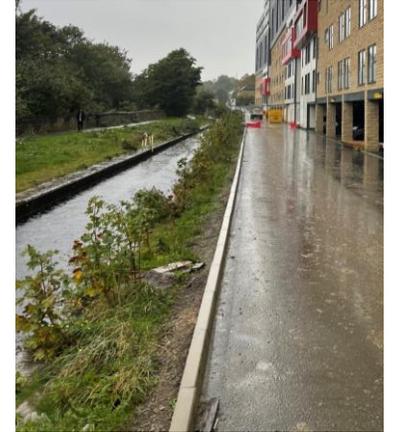
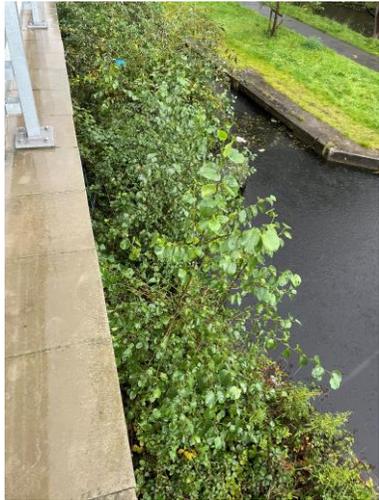
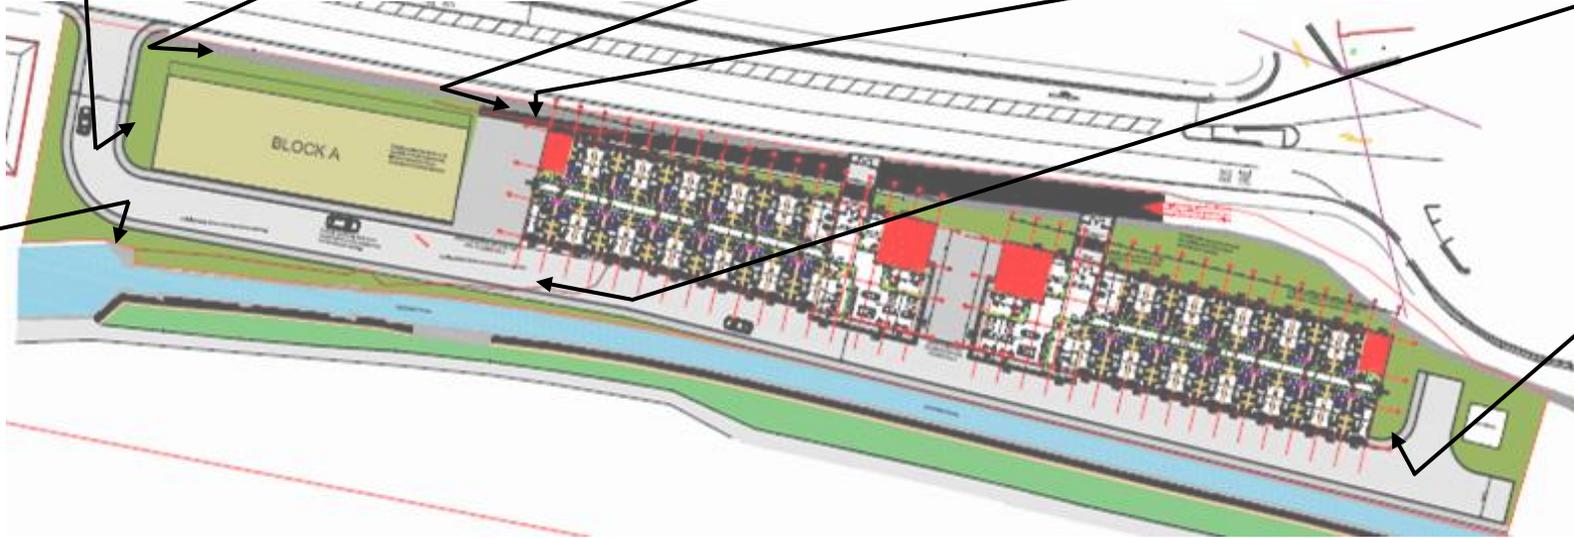
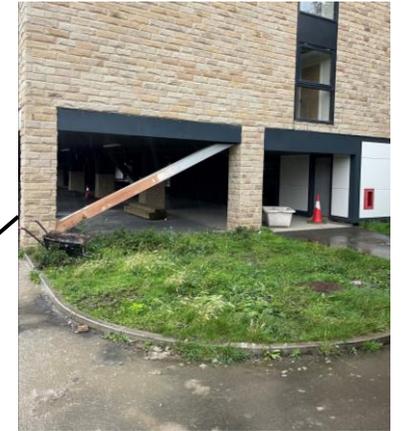
Figure I - Current Landscape and Limitations Plan

Figure No. and Title	I - Existing Landscaping and Limitations Plan
Project Name	Block A to C, Huddersfield Waterfront, Huddersfield
Client	Hexa Consulting Limited
Service	Geo-Environmental Investigation
Date of Issue	October 2023
Project number	EGE-23-09-18-01

<p><i>also no obvious visual evidence of potential asbestos. However, ash and clinker deposits were noted within several of the exploratory positions.</i></p> <p><i>Screening was then carried out as part of their Phase 2 Ground Investigation Report, the intrusive work indicated the presence of contamination required risk assessment and/or remediation, which has been carried out as per instructed in the Remediation Report. Generic and targeted organic soil and water contamination screening was previously carried out.</i></p> <p><i>The total area of soft landscaping is approximately 810m² made up of 6 no. areas across the site ranging from 55m² to 200m². As advised, we have implemented a clean cover system for landscaped areas and it was recommended this cover will not be necessary below areas of hardstanding.</i></p> <p><i>The thickness of cover implemented is 600mm and includes a 300mm thick compacted clean stone layer at its base. Under this is a taram layer (a geotextile membrane) to act as a no dig layer below the clean stone.</i></p> <p>As detailed by the senior contaminated land officer at Kirklees Council, there are no validation photographs evidencing the thickness of topsoil imported or chemical certification to confirm the topsoil is suitable for its intended use.</p> <p>It is also noted that the author of the validation report is an architectural practice with no contaminated land professional, as such the report was not considered that been undertaken in accordance with the following:</p> <p><i>'All evidence and contamination reports must be prepared by a suitably competent person, as defined in Annex 2 of the National Planning Policy Framework 2021. Reports must be prepared in accordance with good practice and guidance'.</i></p> <p>It is noted that the 6 no. landscaped areas are not as existing requirements, for example no landscaping is proposed on top of the gabion basket retaining walls. A current landscape and limitations plan is included as Figure I.</p>

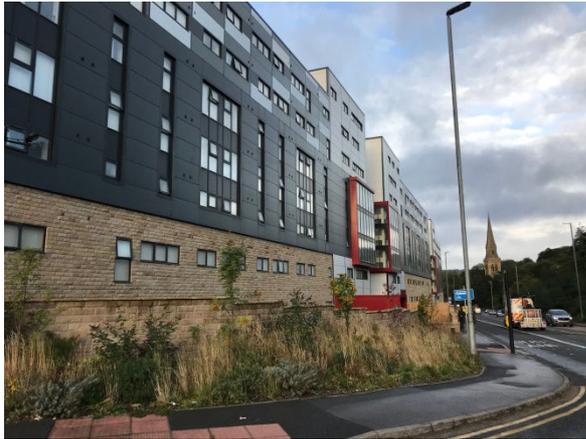
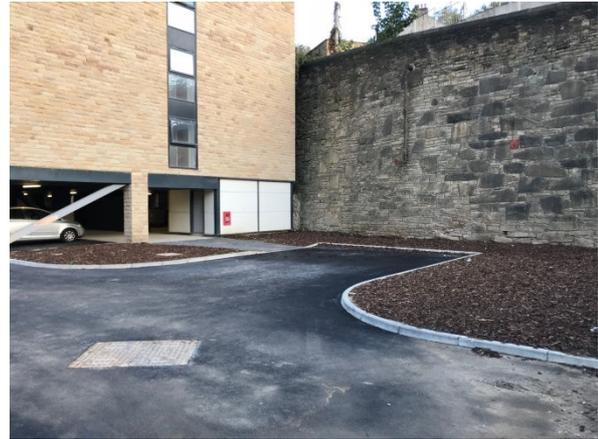
Where we have soft landscaping (Images 3 and 4) we can confirm these areas are backfilled with spoil, topped with taram layer and then 300mm stone and 300mm back mulch on top. Please see Appendix 2 for delivery notes for imported materials showing the imported clean cover materials and where they were sourced, these have been suitably screened and tested for human health prior to delivery. Levels of contaminants within imported materials do not exceed the Updated Level 1 Target concentrations as recommended in the Remediation Report.

Image 3 : Shrubs

Image 2 : Mulch

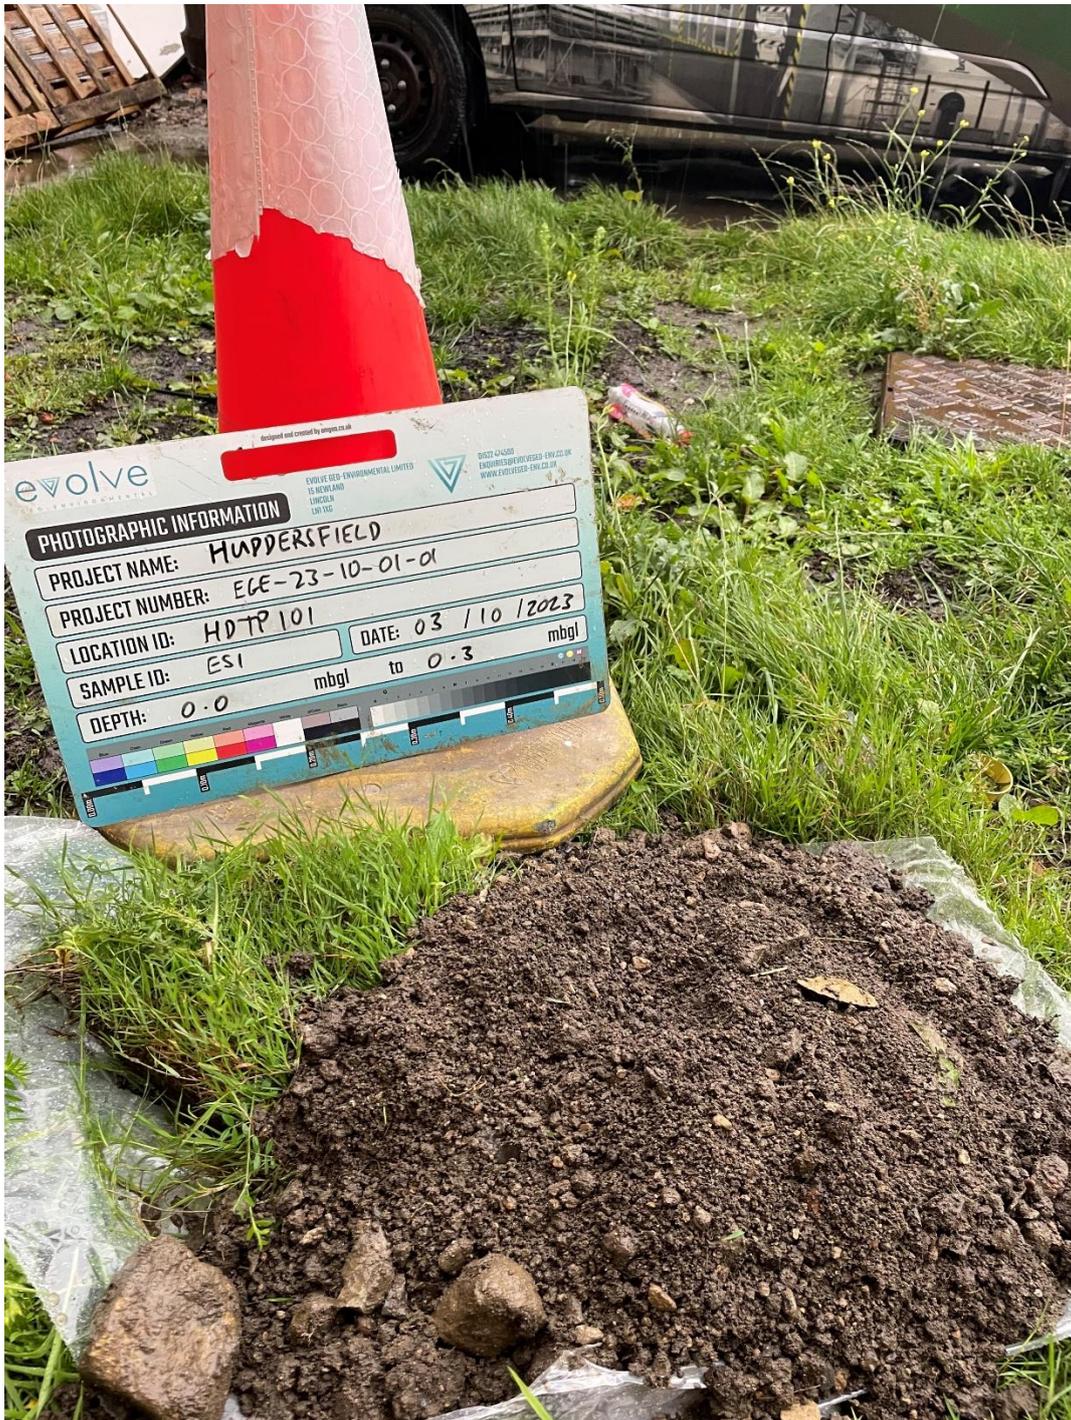
Photograph I - Soil arisings from HDT101

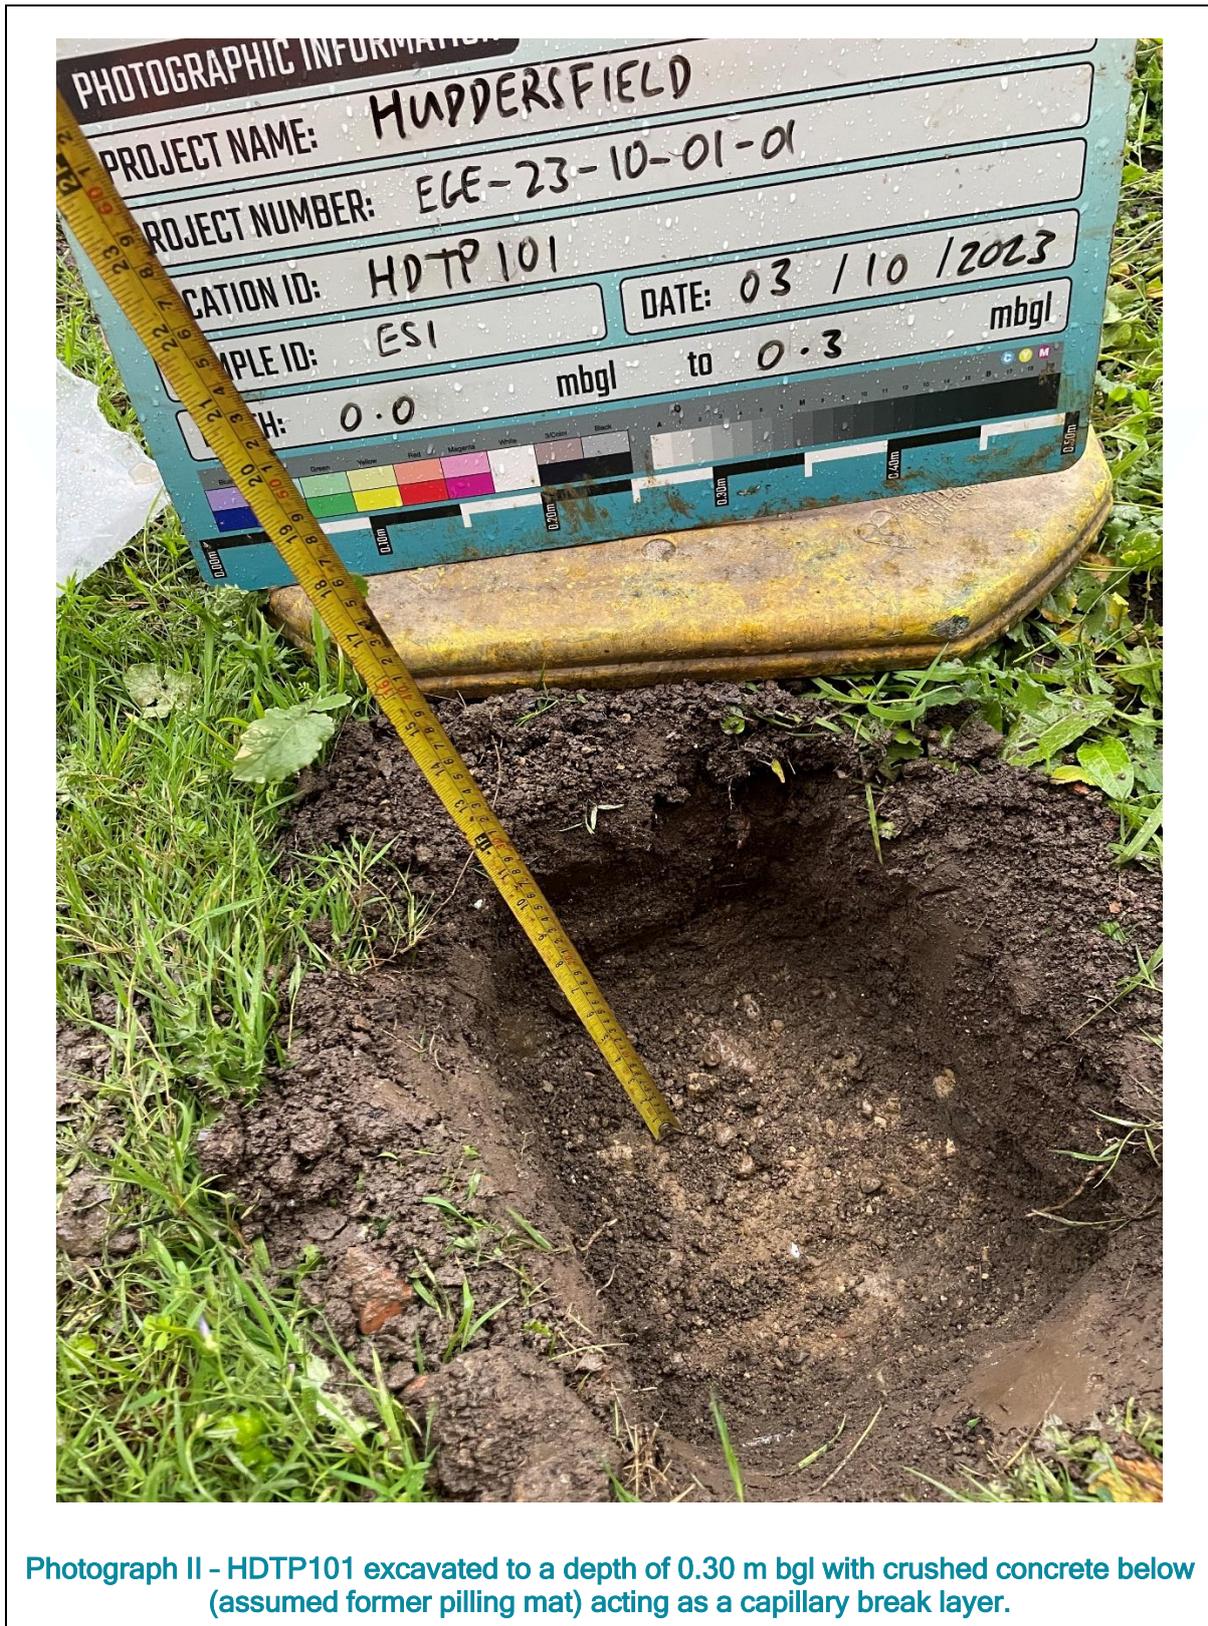
sandstone, slate and rare brick.			
	Crushed concrete gravel	0.30 - Unproven	-	Crushed concrete was identified assumed to be the former piling mat. This is also acting as a capillary 'hard to dig' layer.
HDTP102	Soft dark brown to dark grey gravelly sandy clay. Gravel is fine to coarse sub-rounded to sub-angular mixed lithologies including sandstone, slate and rare brick.	0.00 - 0.10	0.10	-
	Concrete	0.10 - Unproven	-	A concrete layer was identified sloping from the base of the road kerb stone to the top of the canal top keystone, creating a physical barrier between future Site users and underlying soils.
HDTP103	Soft dark brown to dark grey gravelly sandy clay. Gravel is fine to coarse sub-rounded to sub-angular mixed lithologies including sandstone, slate and rare brick.	0.00 - 0.10	0.10	Area was heavily overgrown with buddleia and self-set vegetation.
	Sandy slate gravel	0.10 - Unproven	-	Sandy slate gravel was identified acting as a capillary 'hard to dig' layer. In addition, given the proximity of the canal and ramped access for the development, including retaining features, it is likely that the majority of Made Ground in this area was removed as part of the significant engineering cut required.

Photograph II - HDTP101 excavated to a depth of 0.30 m bgl with crushed concrete below (assumed former pilling mat) acting as a capillary break layer.

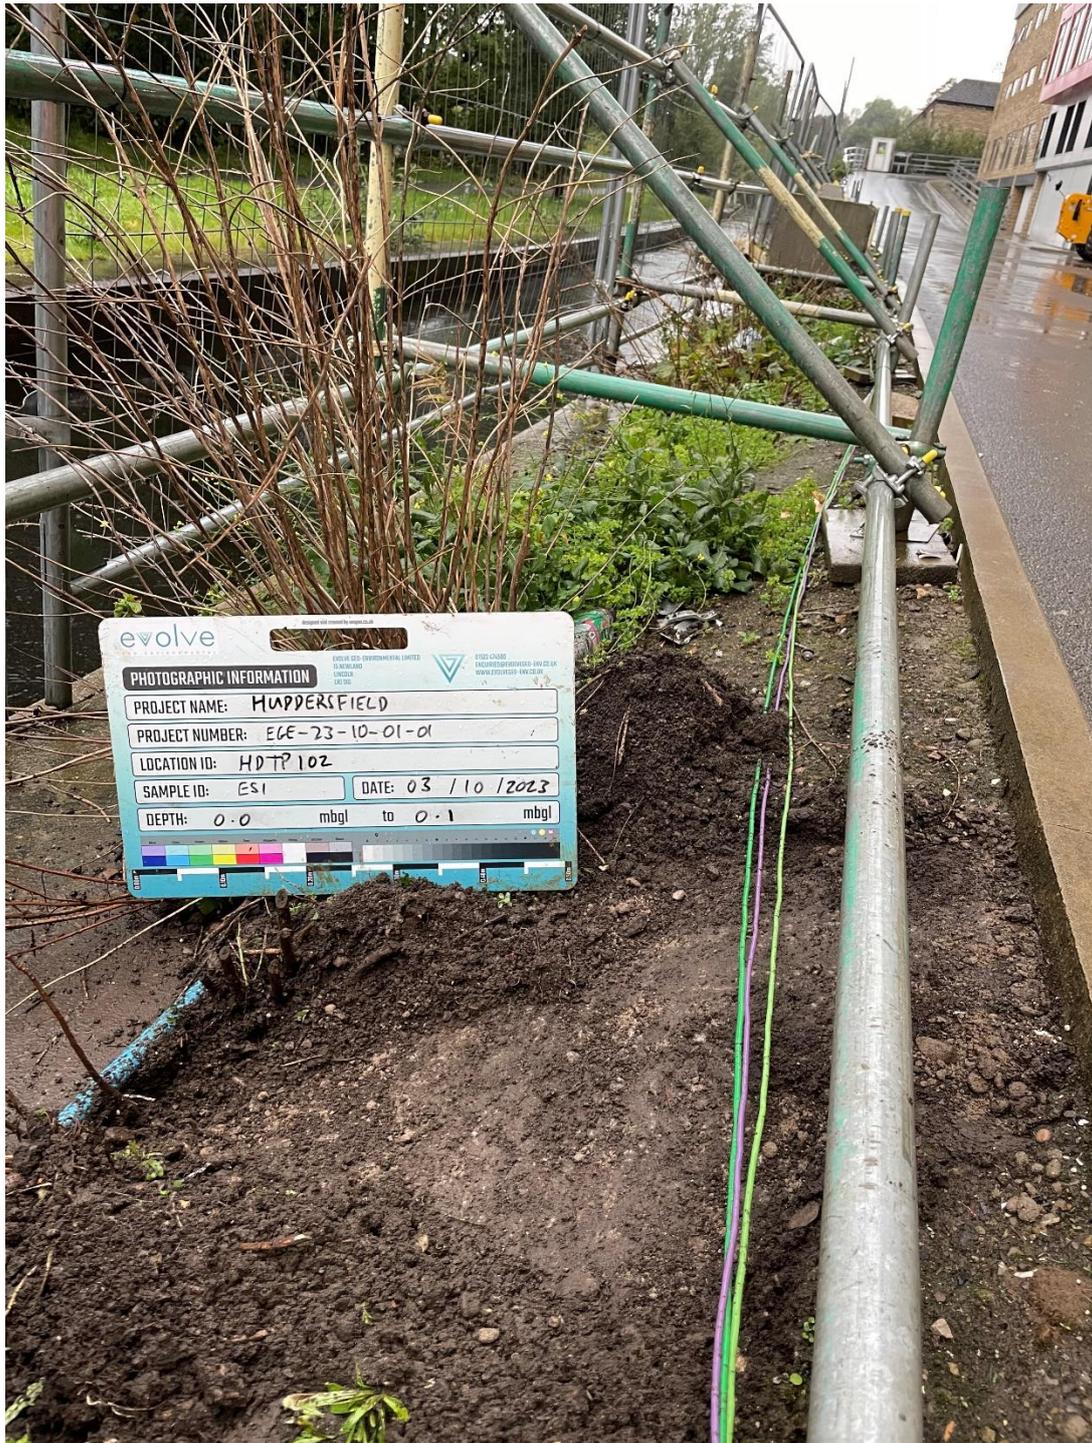
Photograph III - HDP102, 0.1 m of topsoil over sloped concrete from road kerb stone to top keystone of canal.

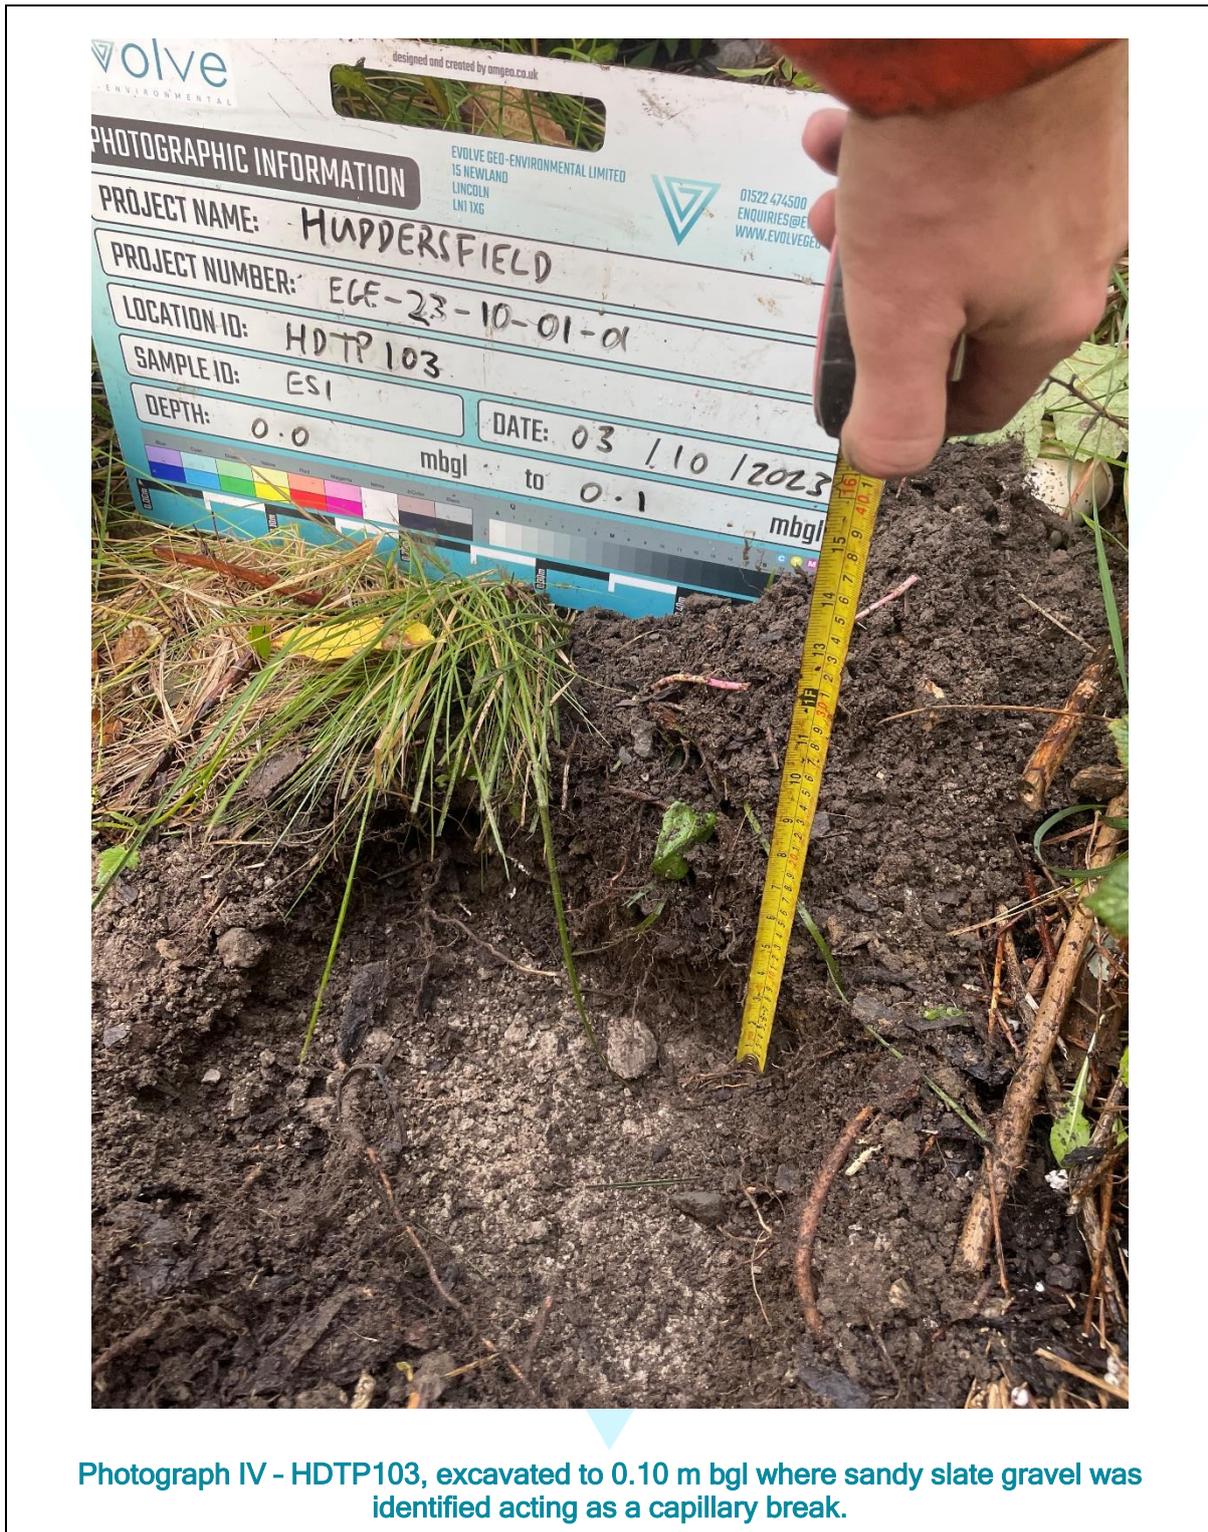
Photograph IV - HDTP103, excavated to 0.10 m bgl where sandy slate gravel was identified acting as a capillary break.

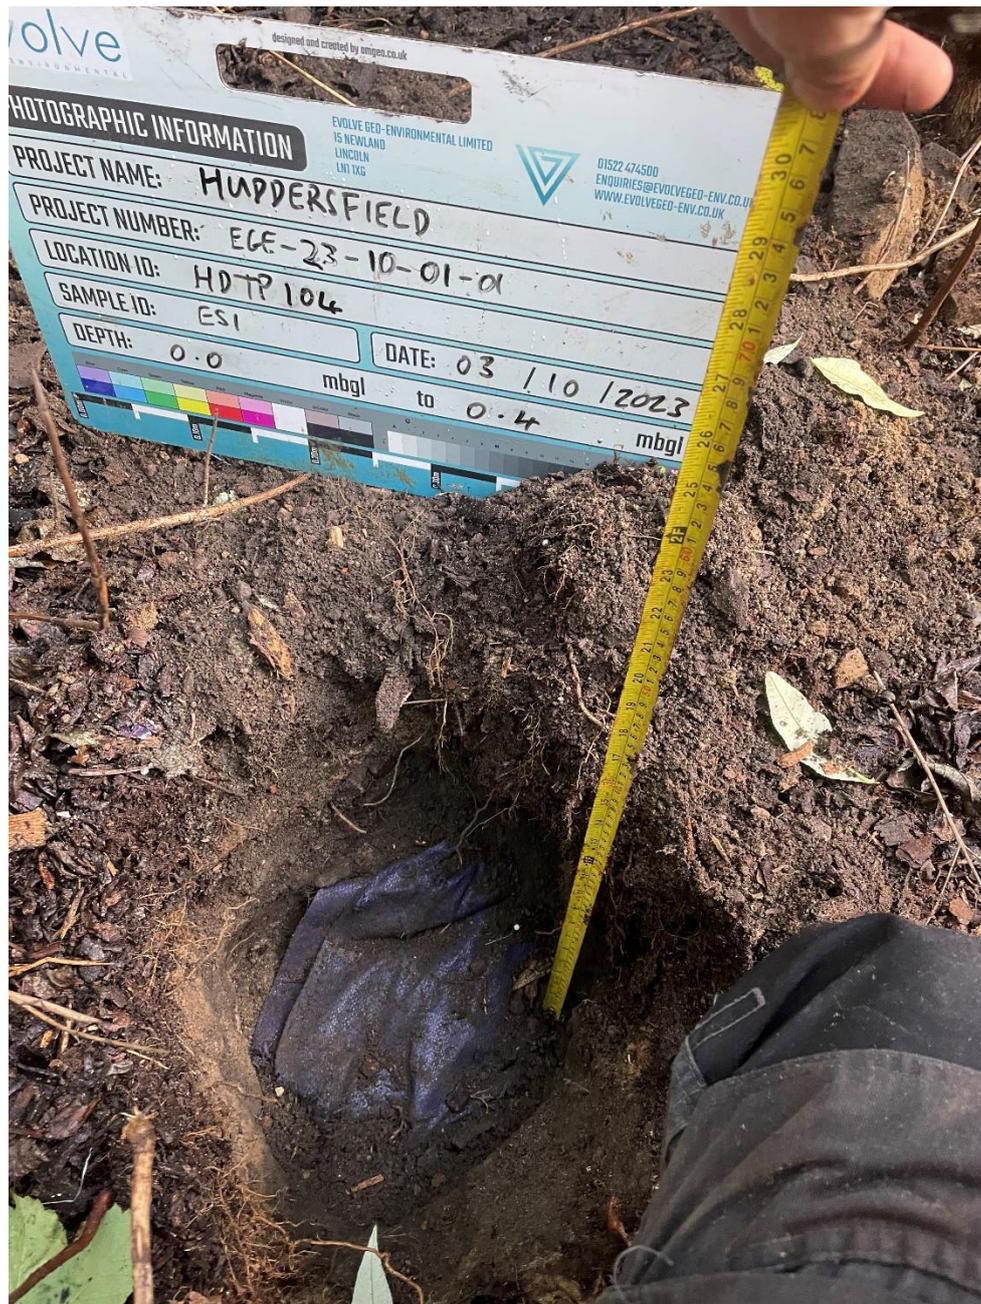
HDTP104	Soft dark brown occasionally grey mottled orange gravelly sandy clay. Gravel is fine to coarse sub-rounded to sub-angular mixed lithologies including sandstone and slate. Some bark mulch noted at surface.	0.00 - 0.40	0.40	Area was heavily overgrown with buddleia and self-set vegetation.
	Blue geotextile membrane and beige sandy sandstone gravel.	0.40 - Unproven	-	Geotextile was identified at 0.40 m bgl, which was slightly removed to confirm materials below, which included a beige sandy sandstone gravel, acting as a capillary break 'hard to dig' layer.

Photograph V - HDTP104 excavated to 0.40 m bgl where blue geotextile was encountered. Geotextile lifted and beige sandy sandstone gravel identified below.

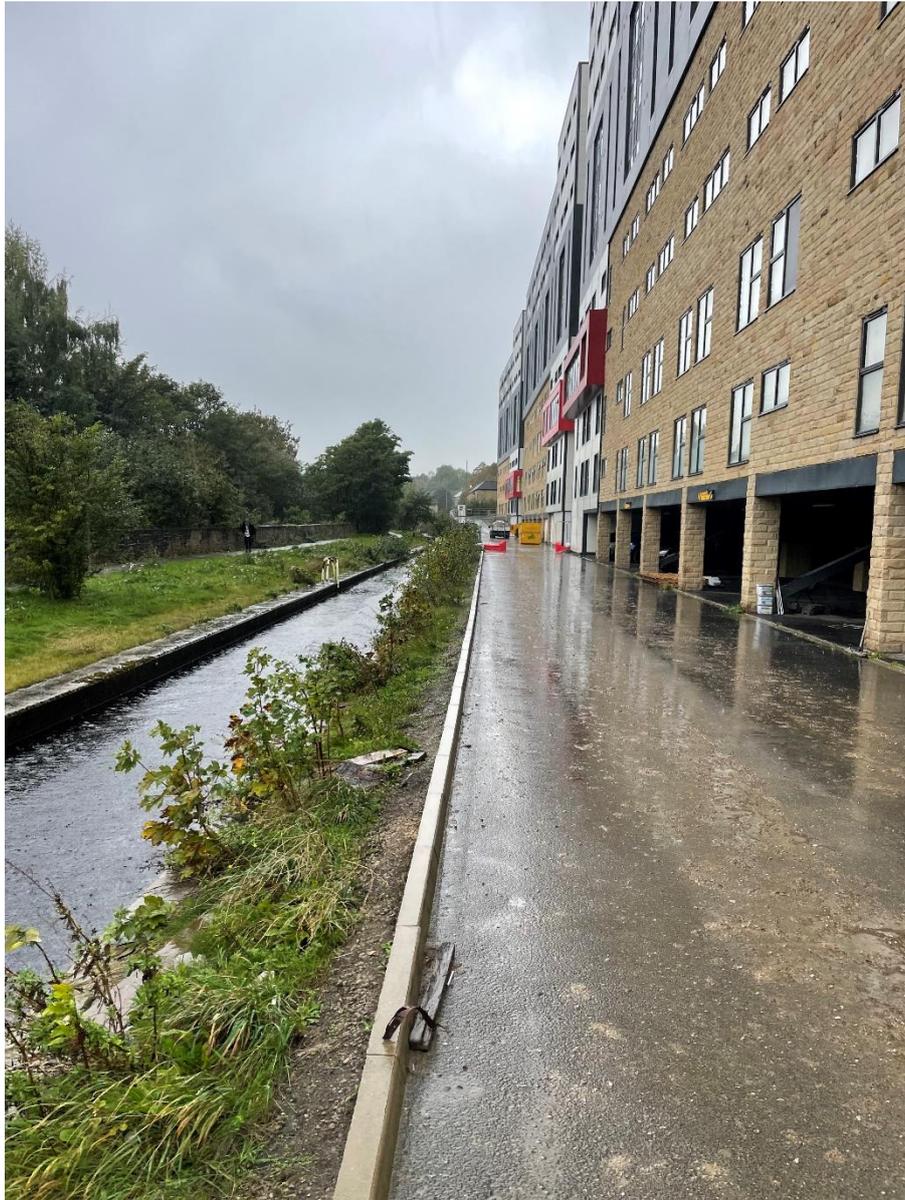
Photograph VI - Viewed west indicating the minimal landscaping between the access road and canal on the southern boundary. Canal to be ultimately fenced for security, limiting access to landscaped area.

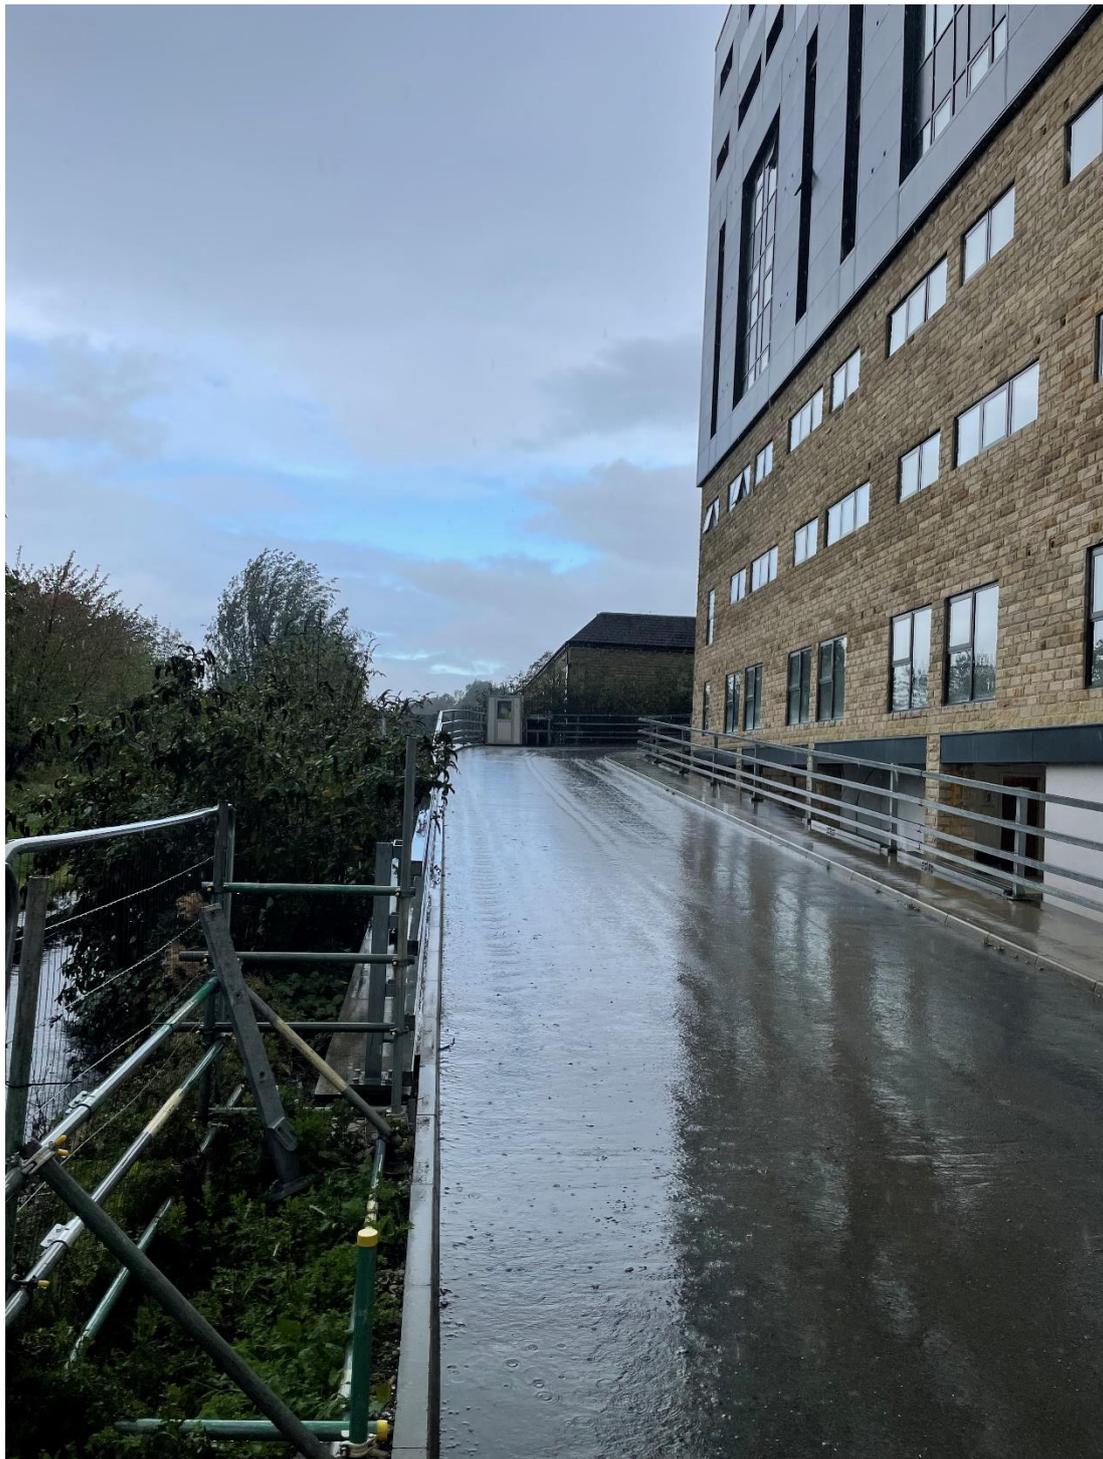
Photograph VII - Ramped access road adjacent to southern elevation of Block A. Area well fenced and no means of access for future Site users to access landscaped areas.

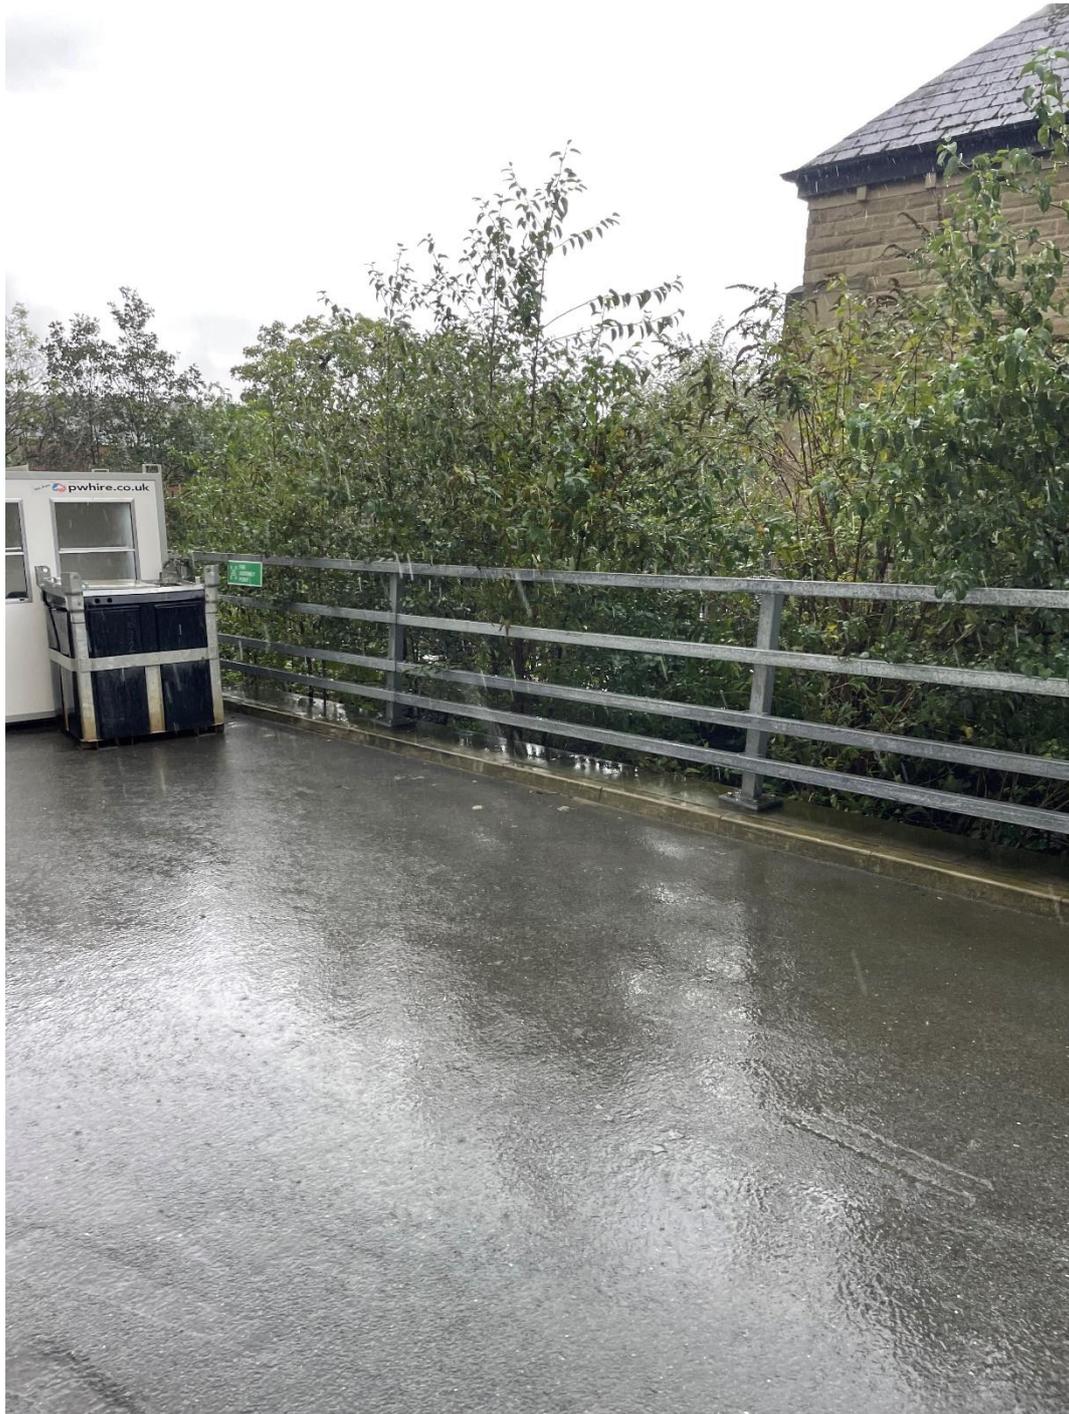
Photograph VIII - Western landscaped area, with no means of access for future Site users to access landscaped areas.

In addition, it is noted that the landscaped areas in the west (HDTP104) are fenced off with heavy duty traffic strength steel fencing, restricting access of future Site users to this area. The thin strip of landscaping between the road and the canal along the southern boundary (HDTP102 and HDTP103) is understood to require fencing for security and as such, will likely be removed and concreted to facilitate the new fence, further mitigating the risk of future Site users encountering any residual contamination in the underlying soils.

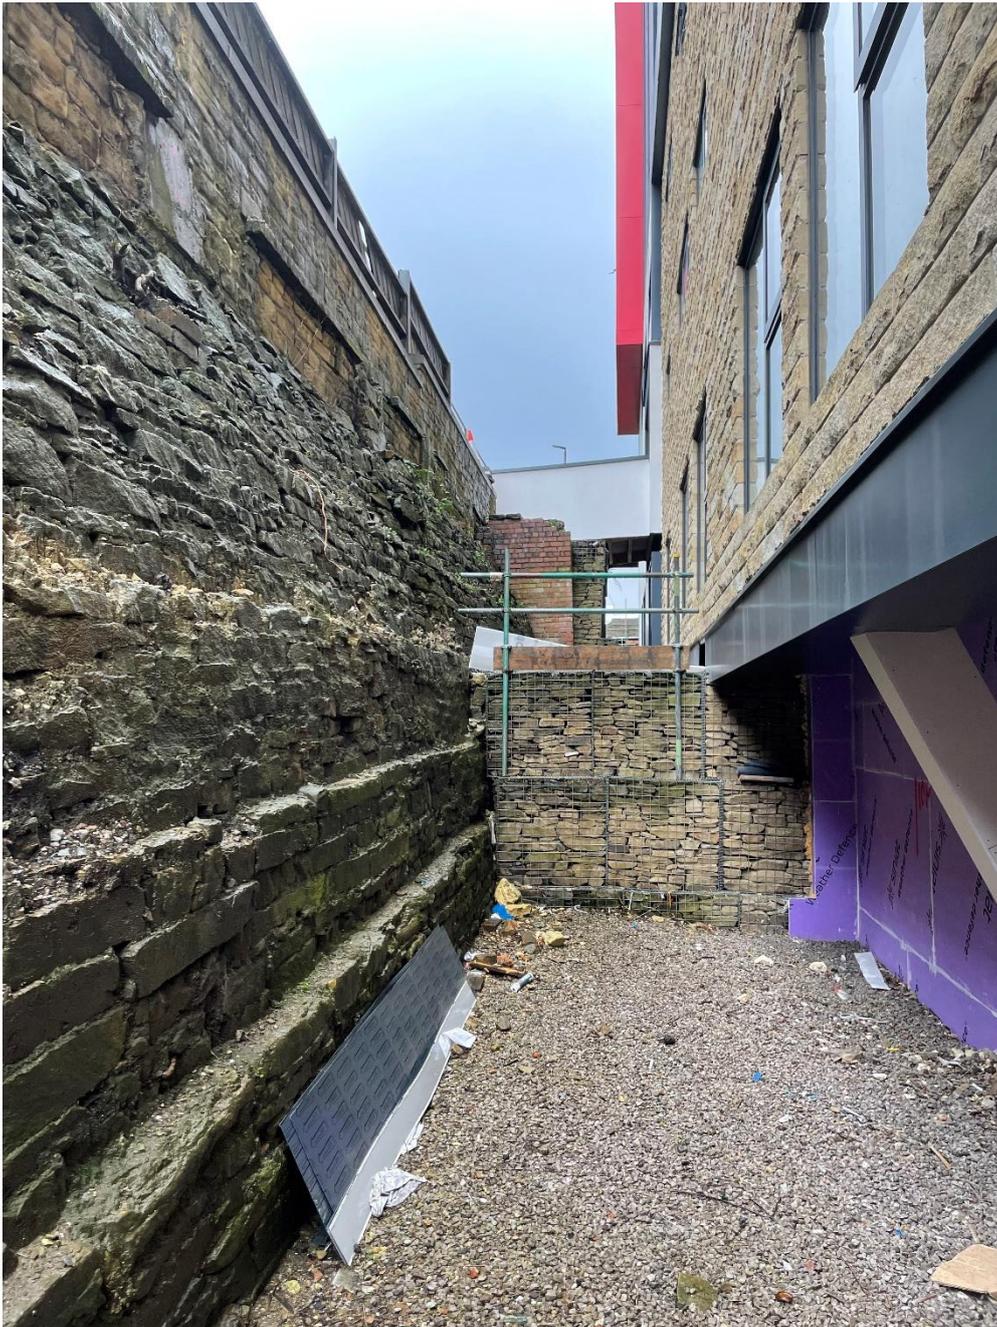
Photograph IX - Northern elevation of Block A with gabion basket wall. Gravelled amenity surface. No landscaping proposed.

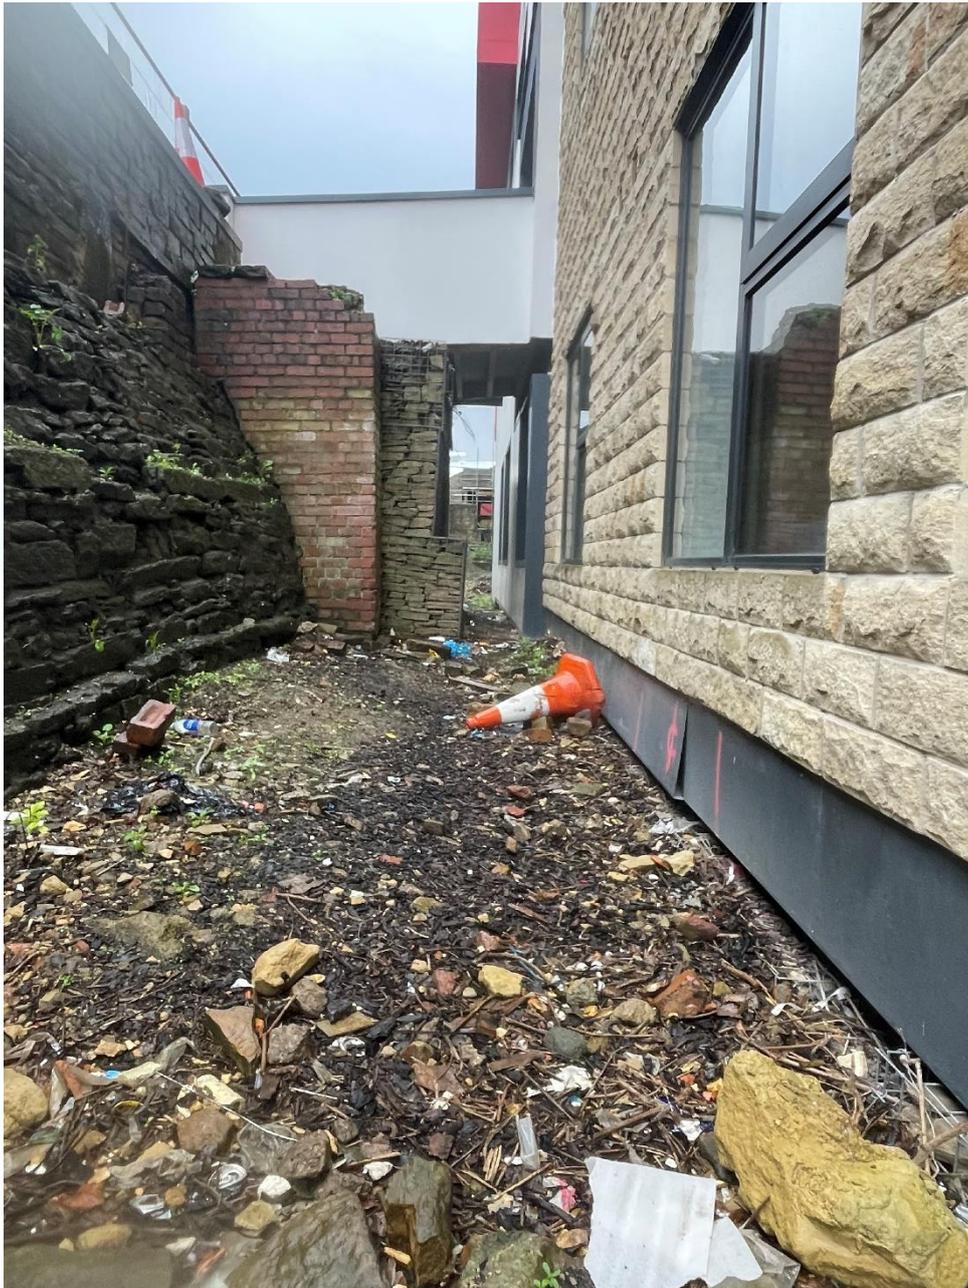
Photograph X - Northern elevation of Block A on top of gabion basket. No landscaping proposed. Litter pick to be undertaken. No physical access for future Site users to enter this area.

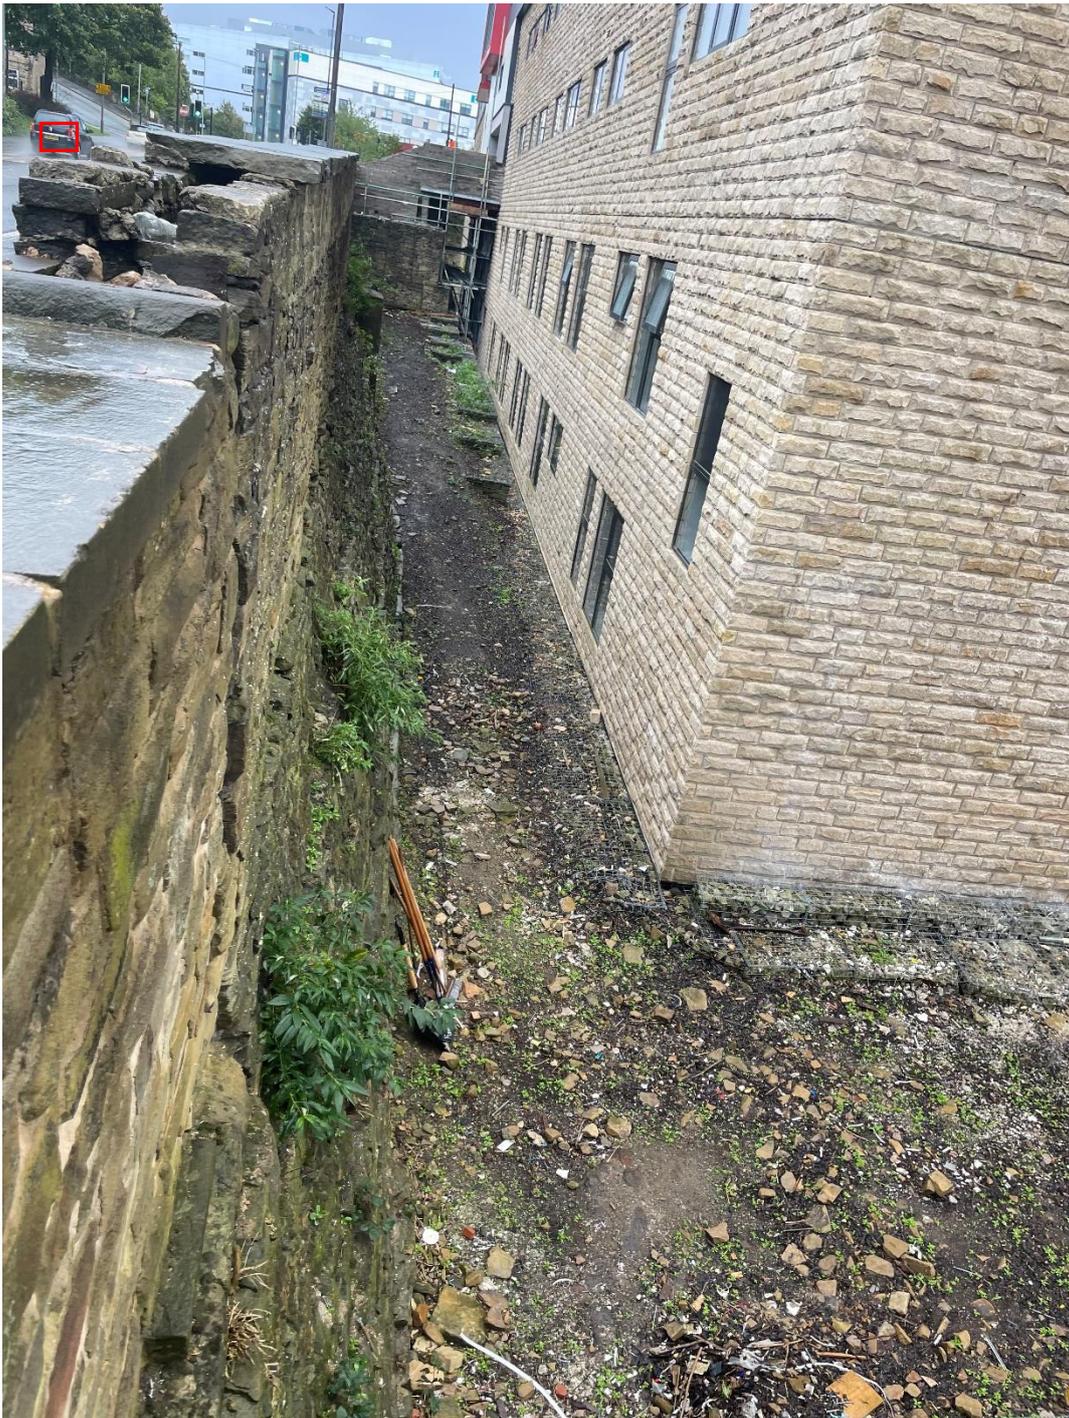
Photograph XI - Northern elevation of Block B viewed from Manchester Road on top of gabion baskets. No physical access for future Site users. No landscaping is proposed.
