# CLIFF HILL, CUMBERWORTH LANE, DENBY DALE

## GROUND STABILISATION REMEDIAL STRATEGY FOR URBAN GROUP (YORK) Ltd.

**Project Ref:**  
P10350

**Date:**  
July 2023

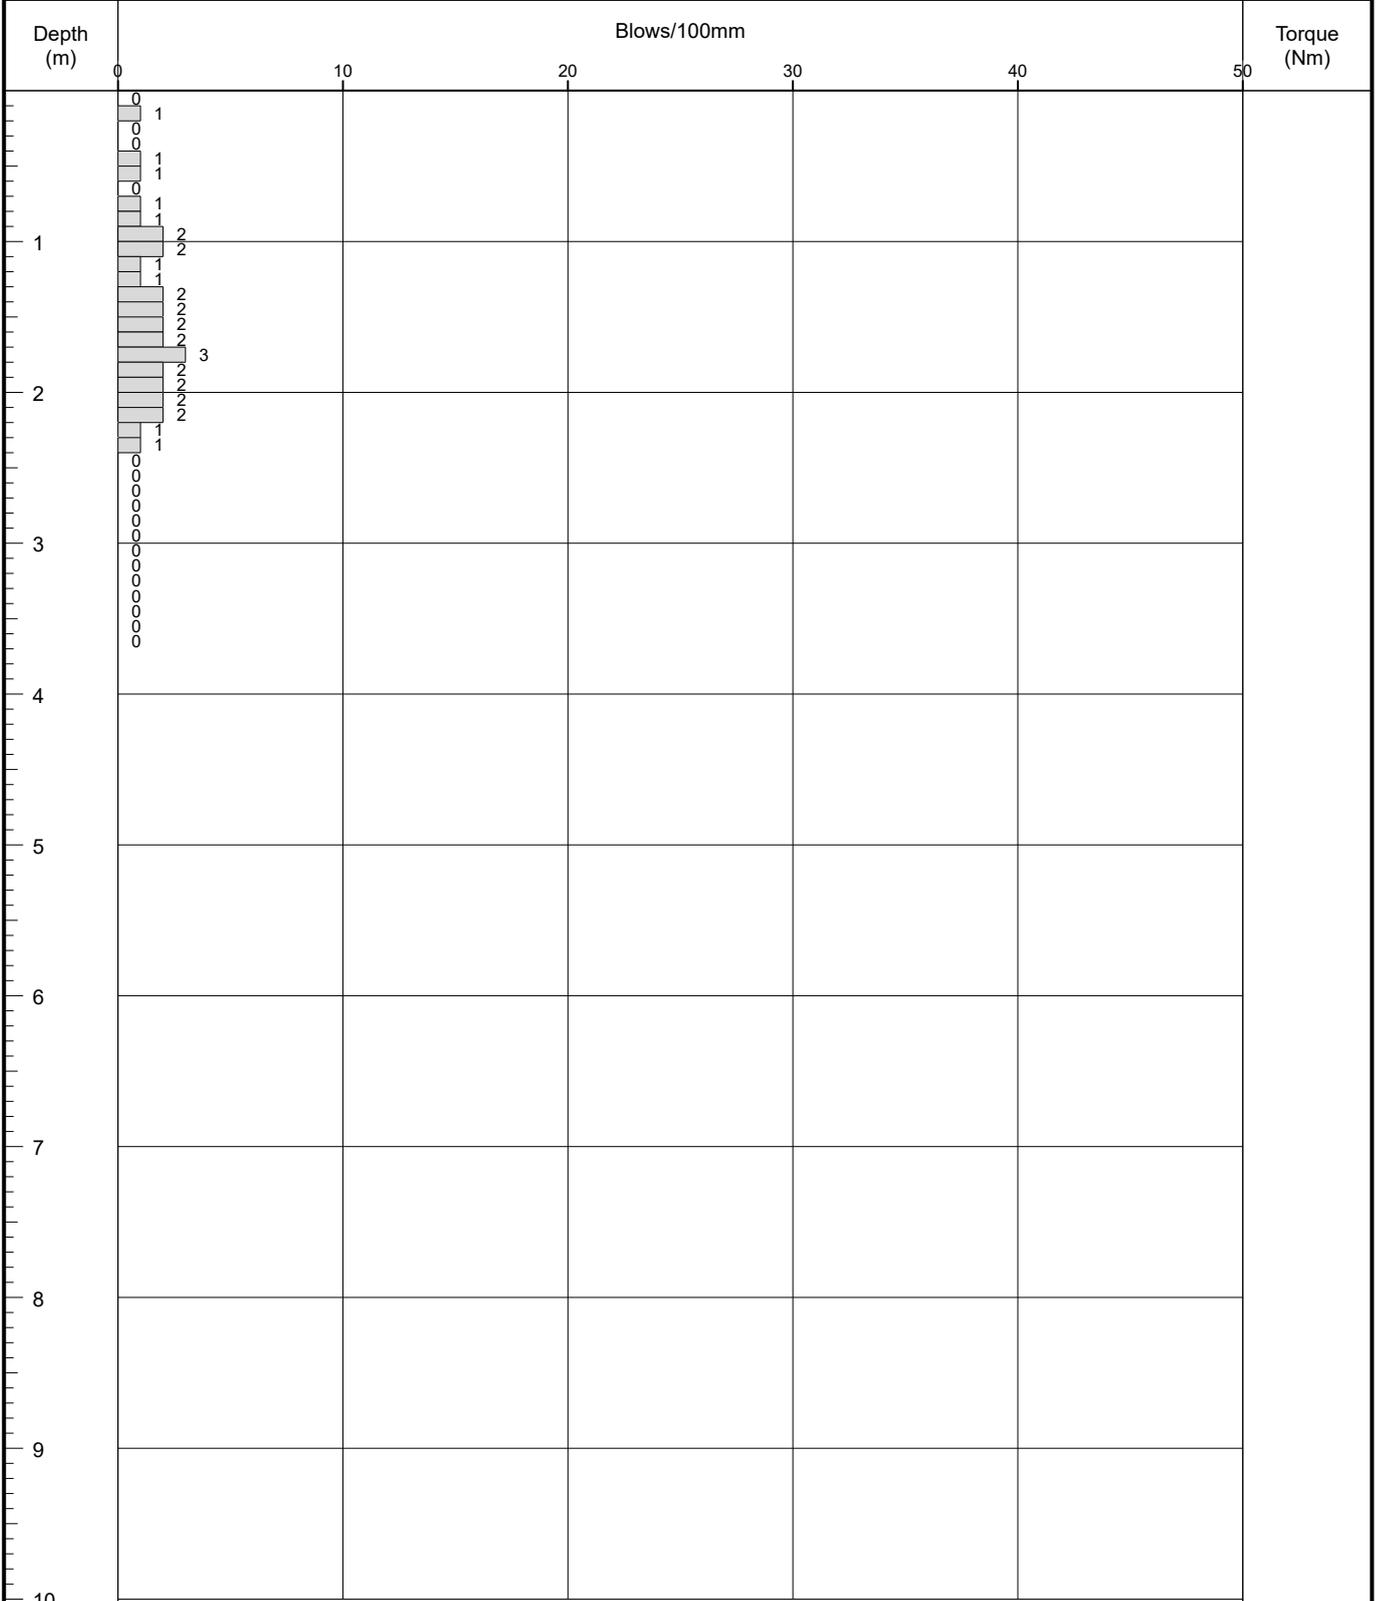
Fall Height	750mm	Cone Base Diameter	50.5mm
Hammer Wt	63.5kg	Final Depth	3.6m
Probe Type	DPSH-B

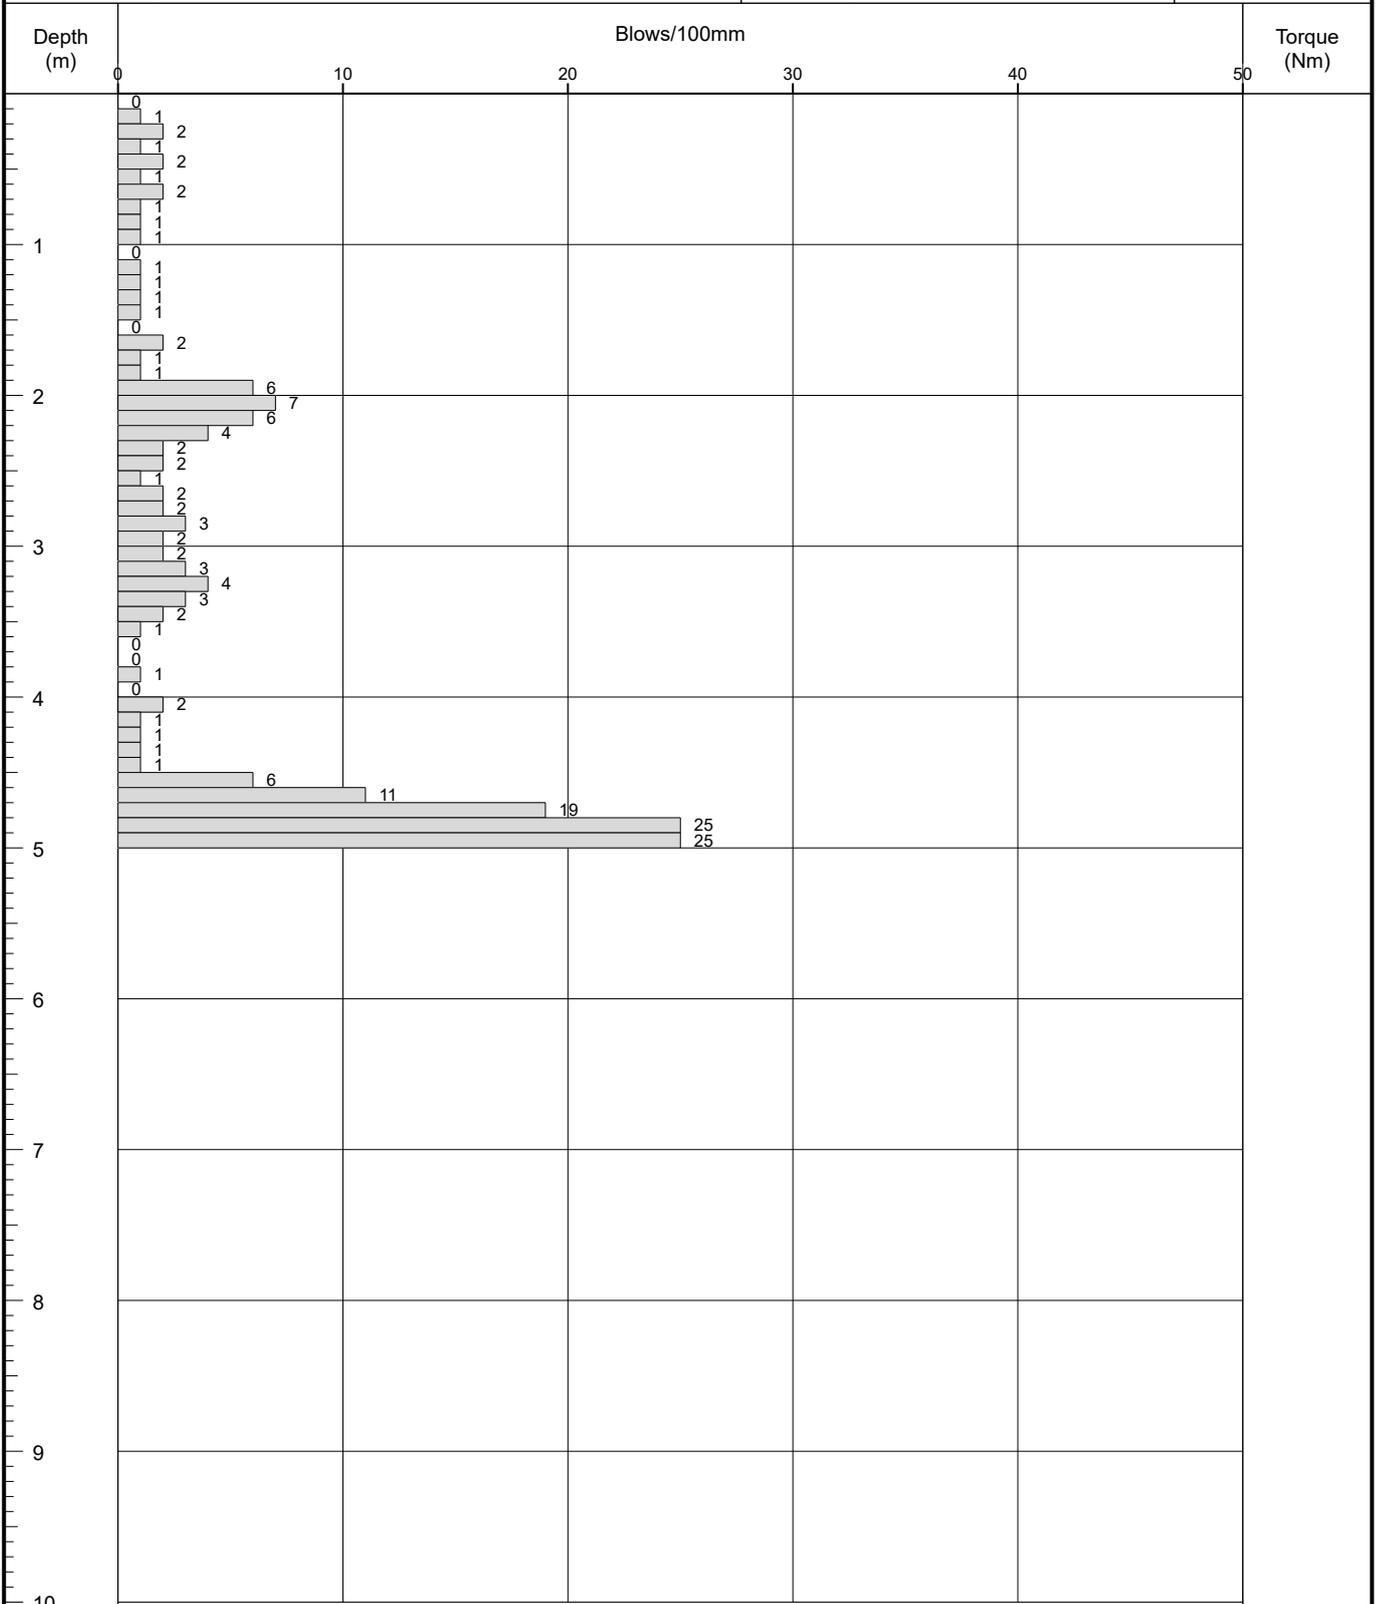
Fall Height	750mm	Cone Base Diameter	50.5mm
Hammer Wt	63.5kg	Final Depth	4.9m
Probe Type	DPSH-B

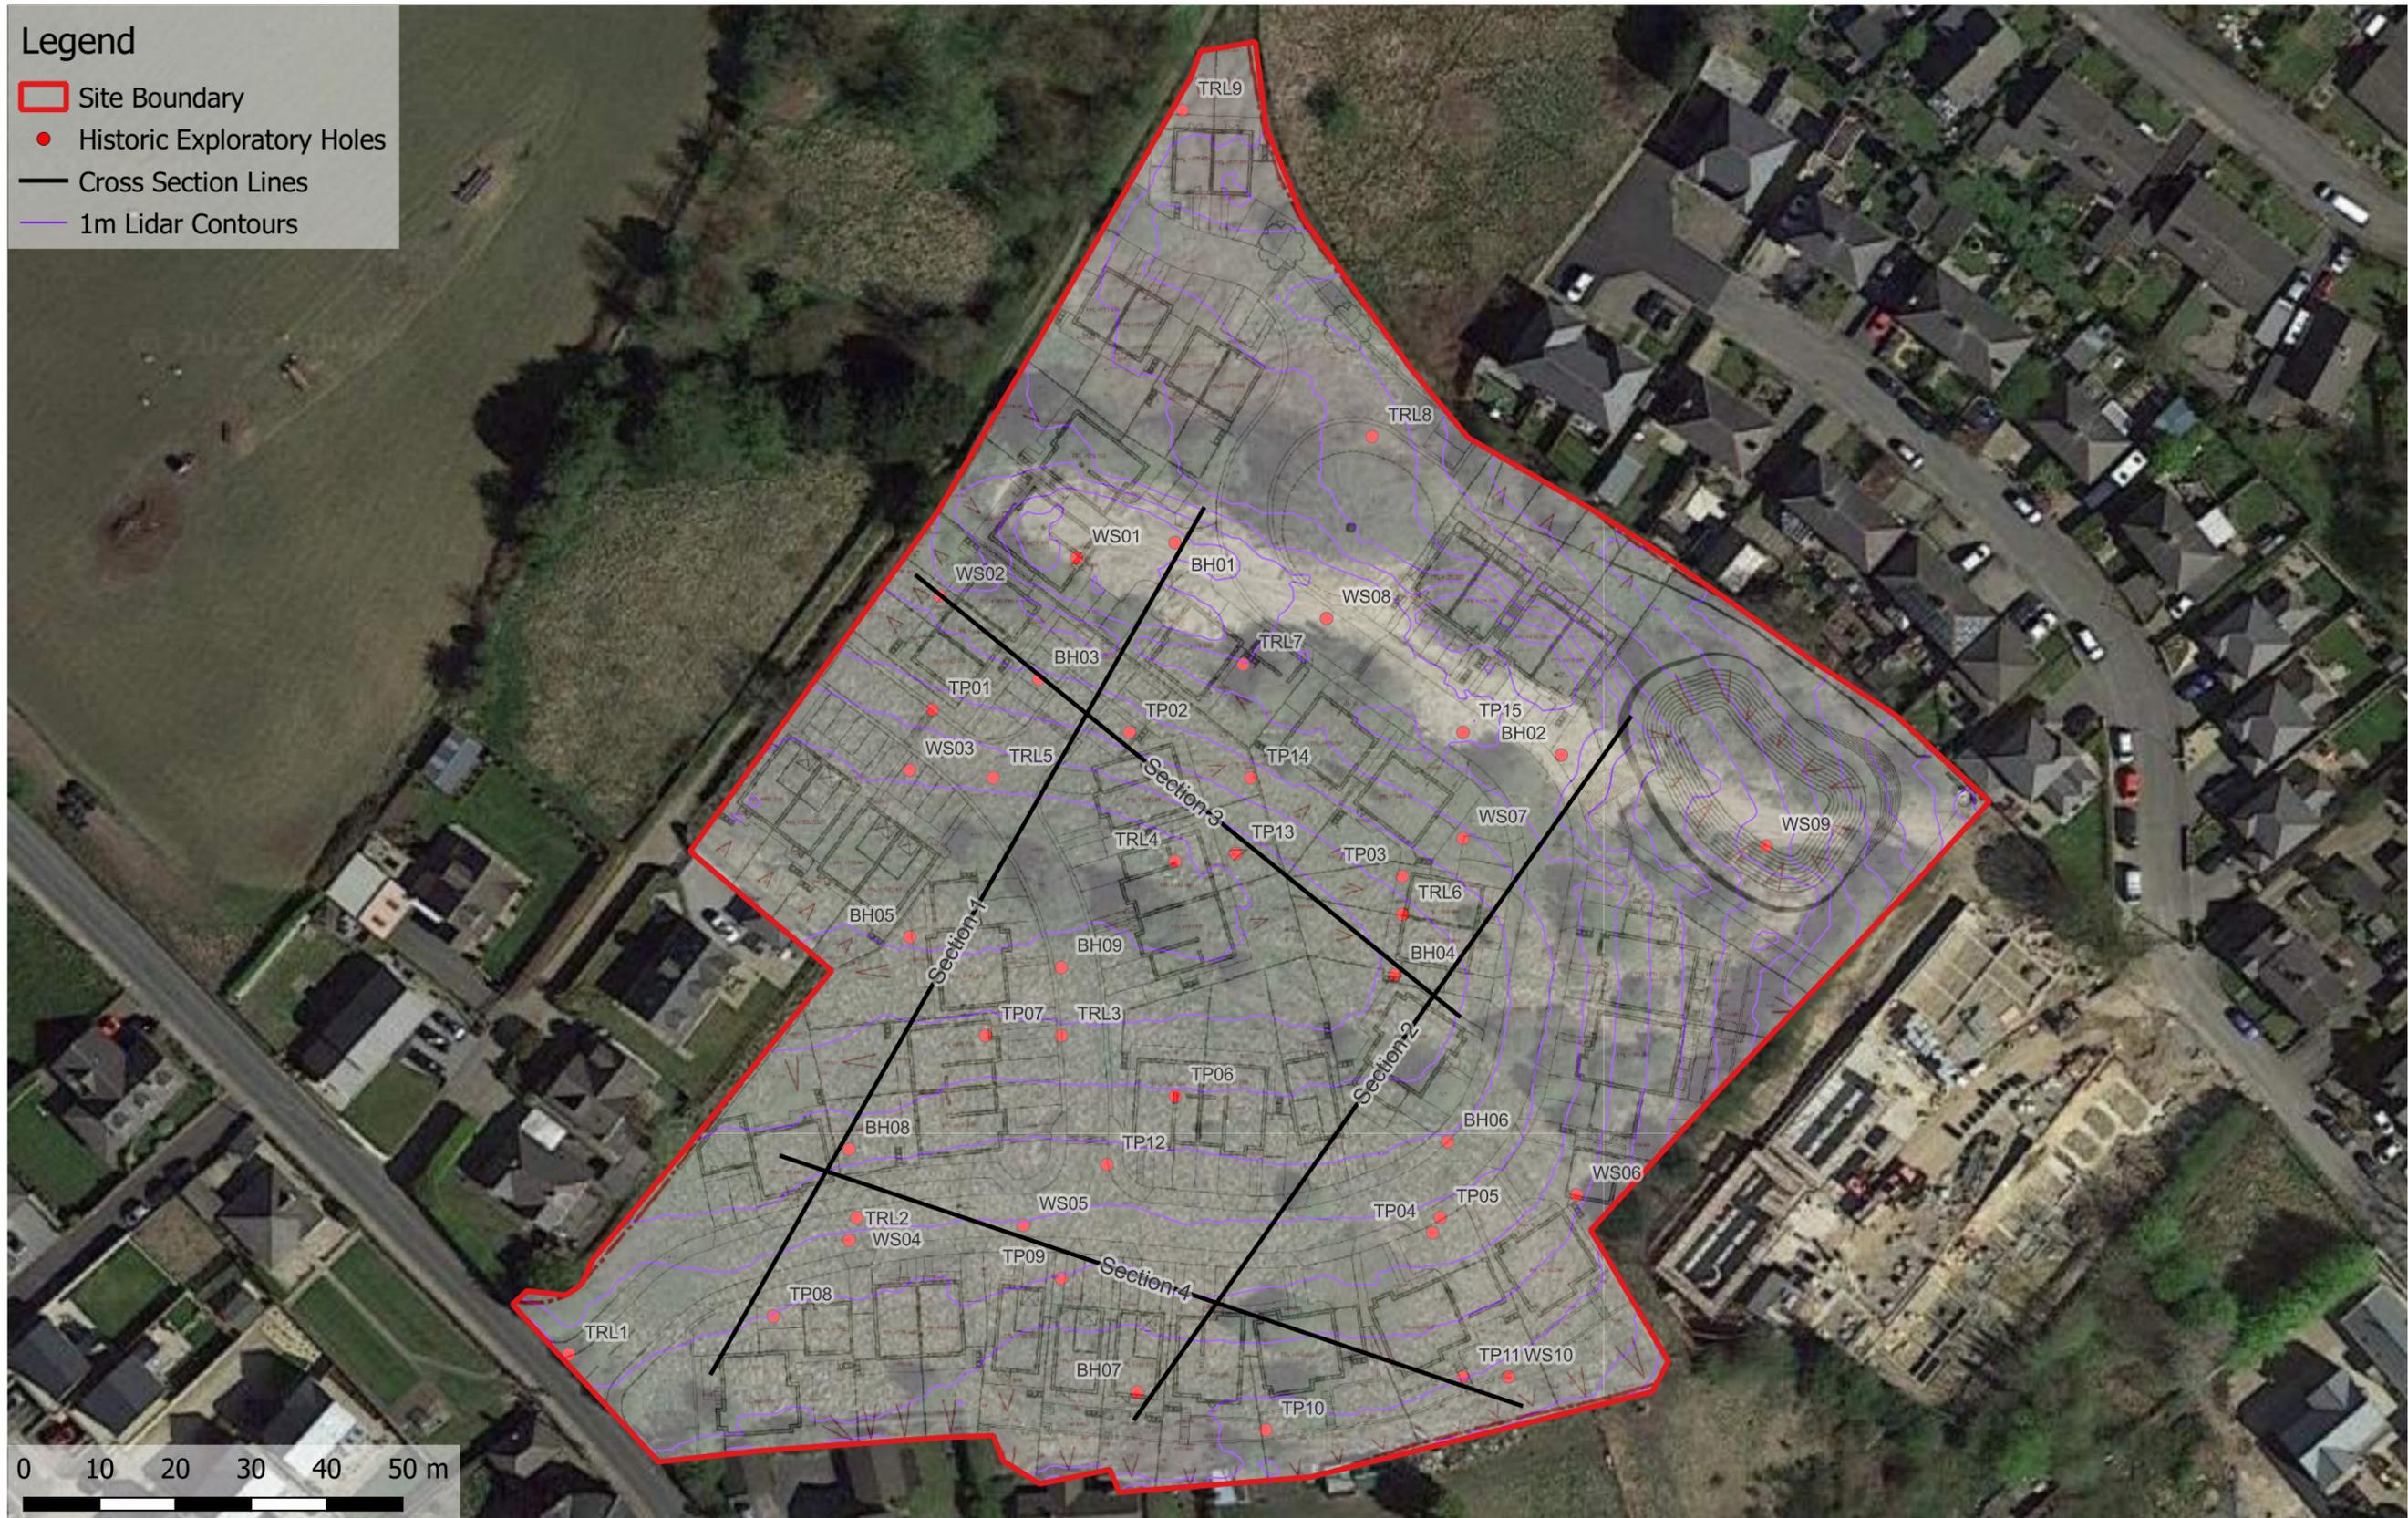
NOTES:	CLIENT:	Urban Group (York) Ltd	PROJECT No:	P10350	DATE:	July 2023	DESIGN/DRAWN:	RDH
	PROJECT:	Cliff Hill, Cumberworth Lane, Denby Dale, Huddersf	DRAWING NUMBER:	Preliminary	ISSUE:	Preliminary

- Legend**
- Site Boundary
  - Historic Exploratory Holes
  - Cross Section Lines
  - 1m Lidar Contours

A section plan and annotated section lines used to interpret the location of coal seams in relation to anticipated finished floor levels are presented in Appendix G.

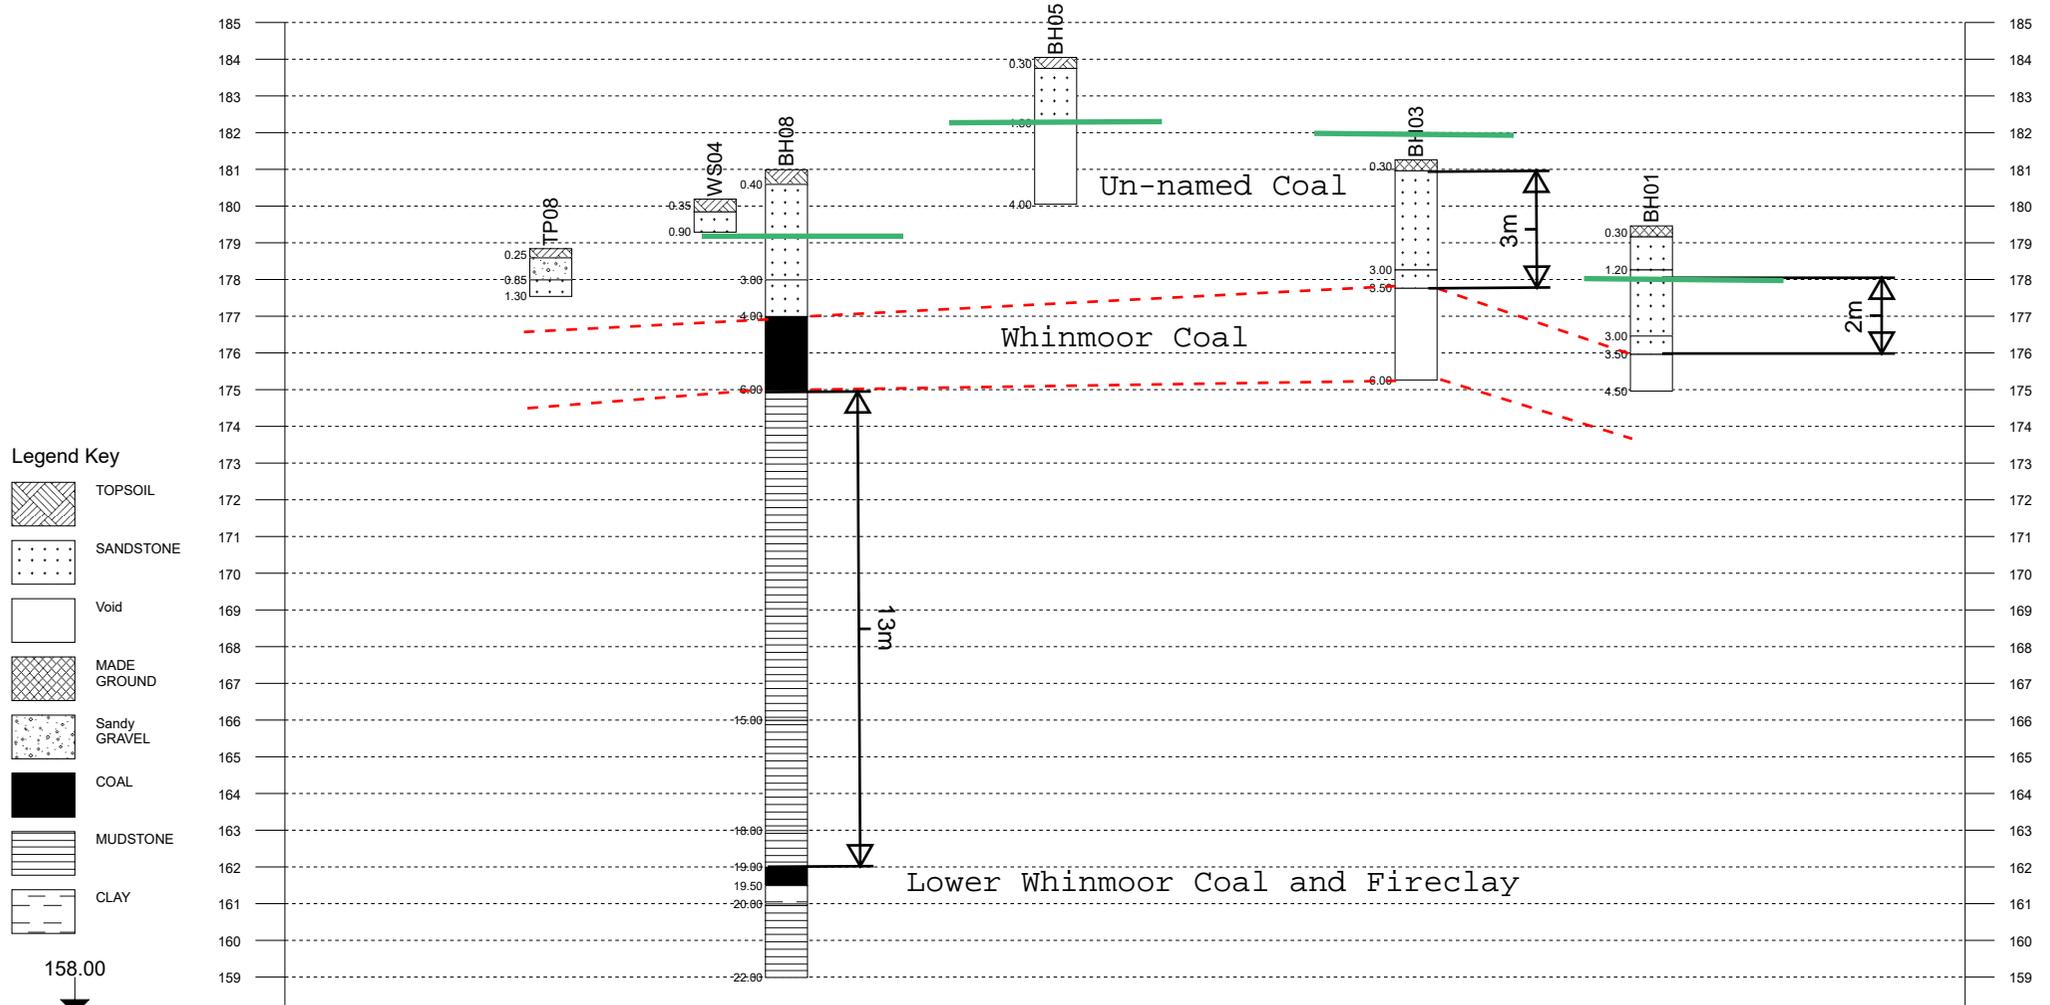
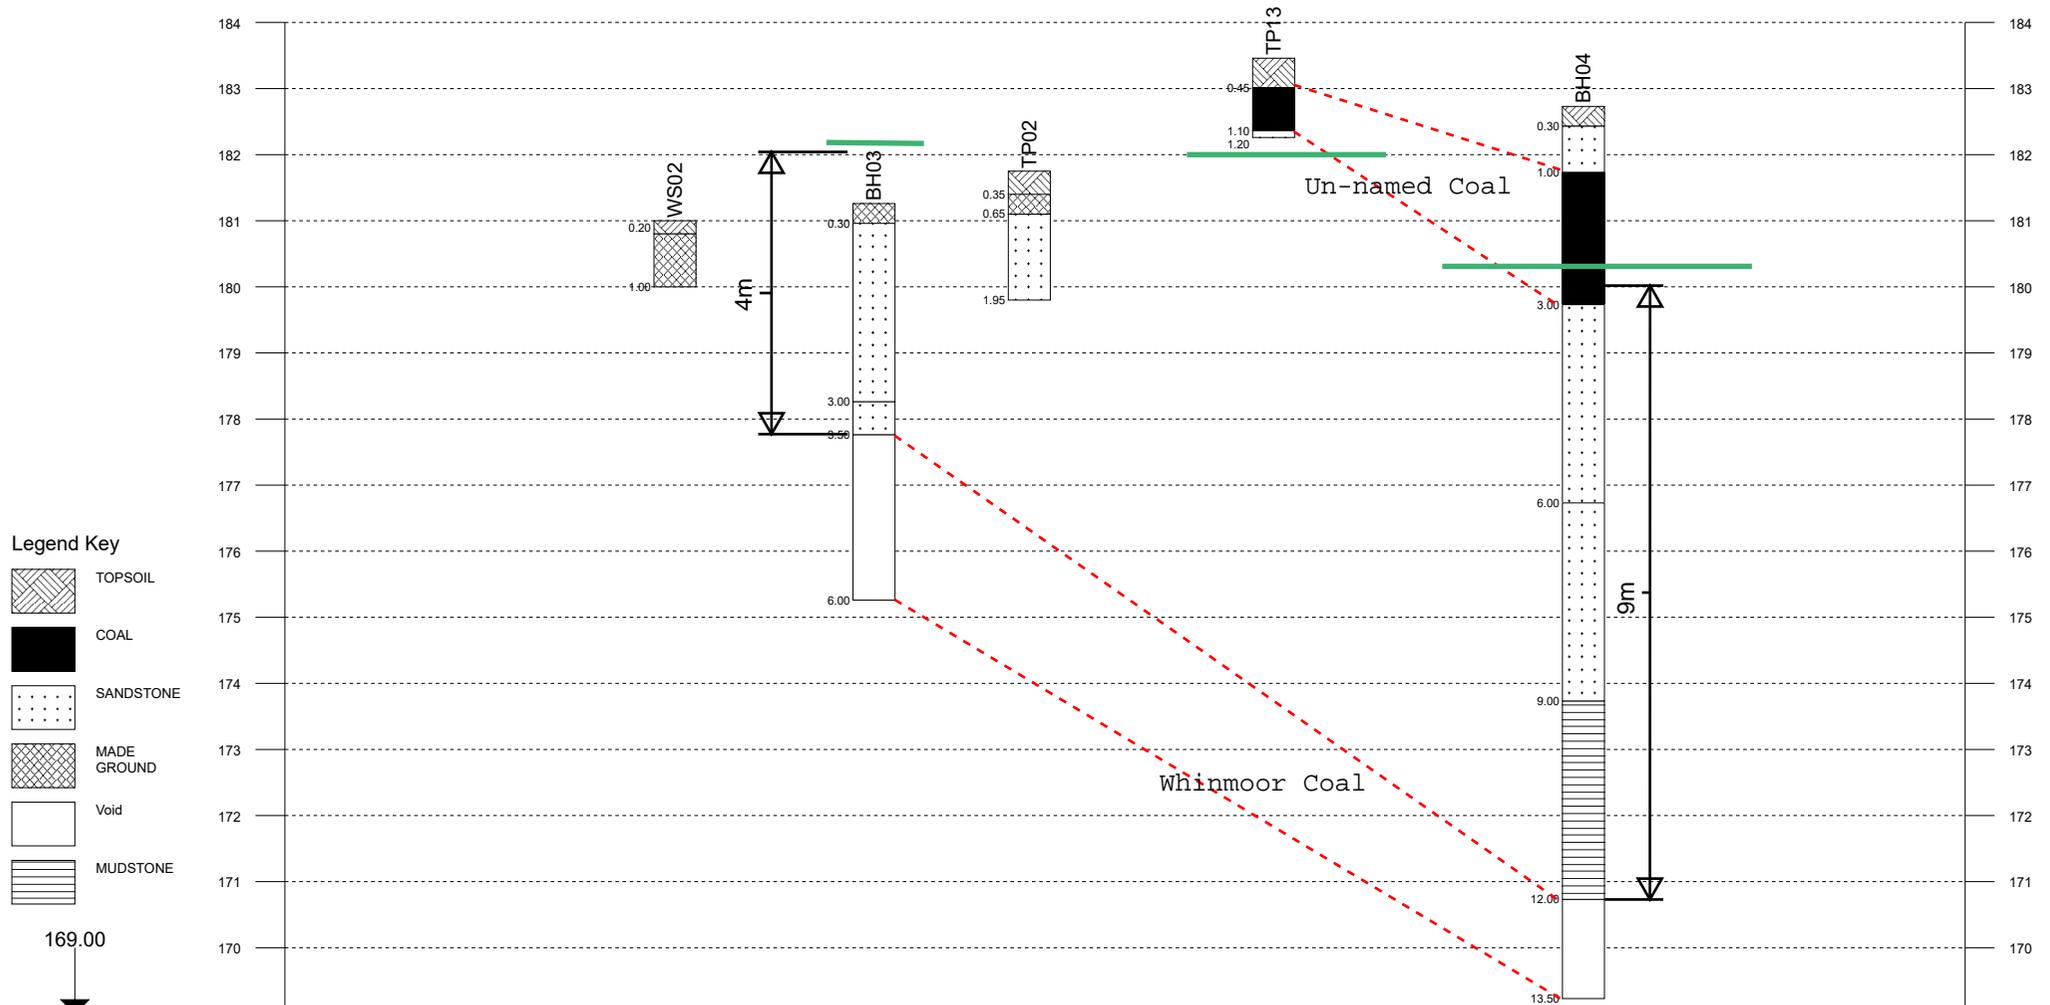
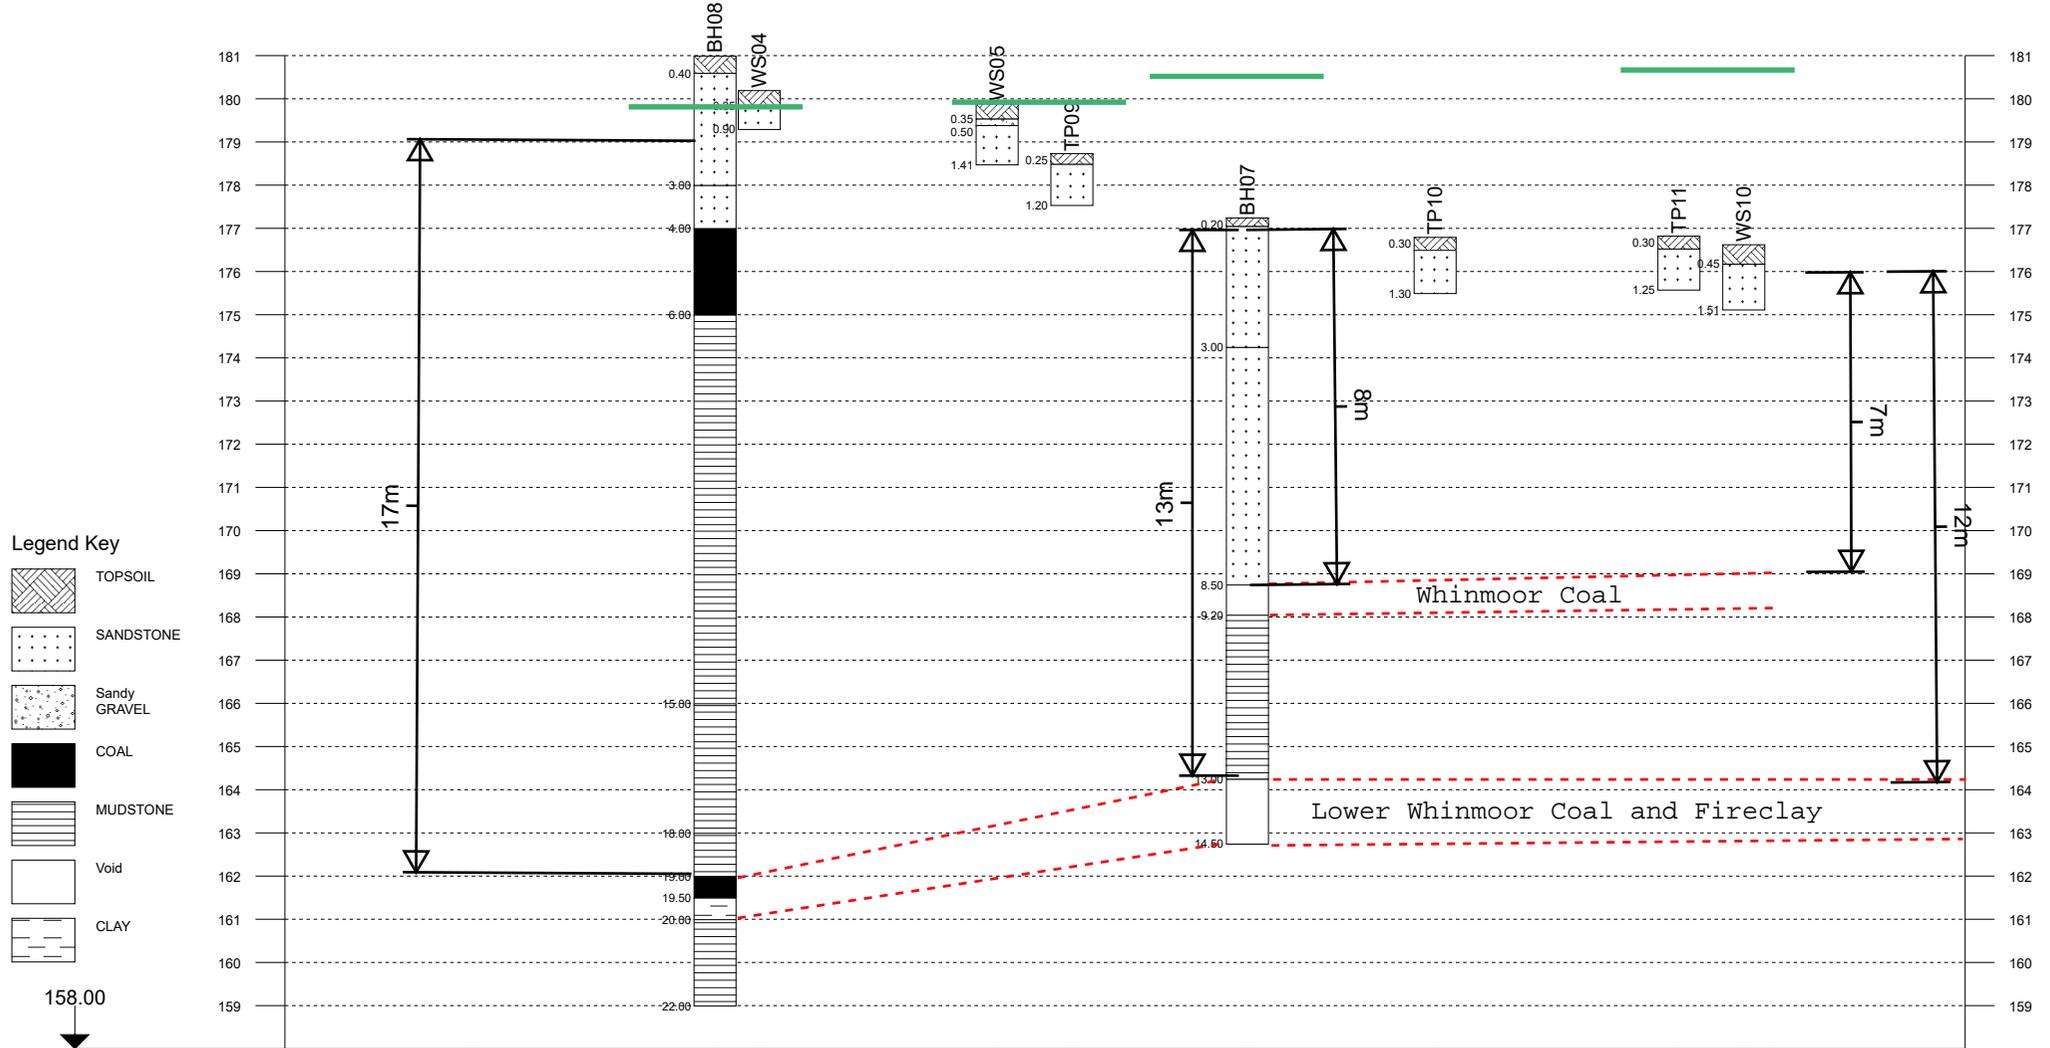
— Approximate FFL from nearby plots

- - - Conjectured coal seam depth

- Legend Key**
- TOPSOIL
  - COAL
  - SANDSTONE
  - MADE GROUND
  - Void
  - MUDSTONE

- Legend Key**
- TOPSOIL
  - SANDSTONE
  - Sandy GRAVEL
  - COAL
  - MUDSTONE
  - Void
  - CLAY

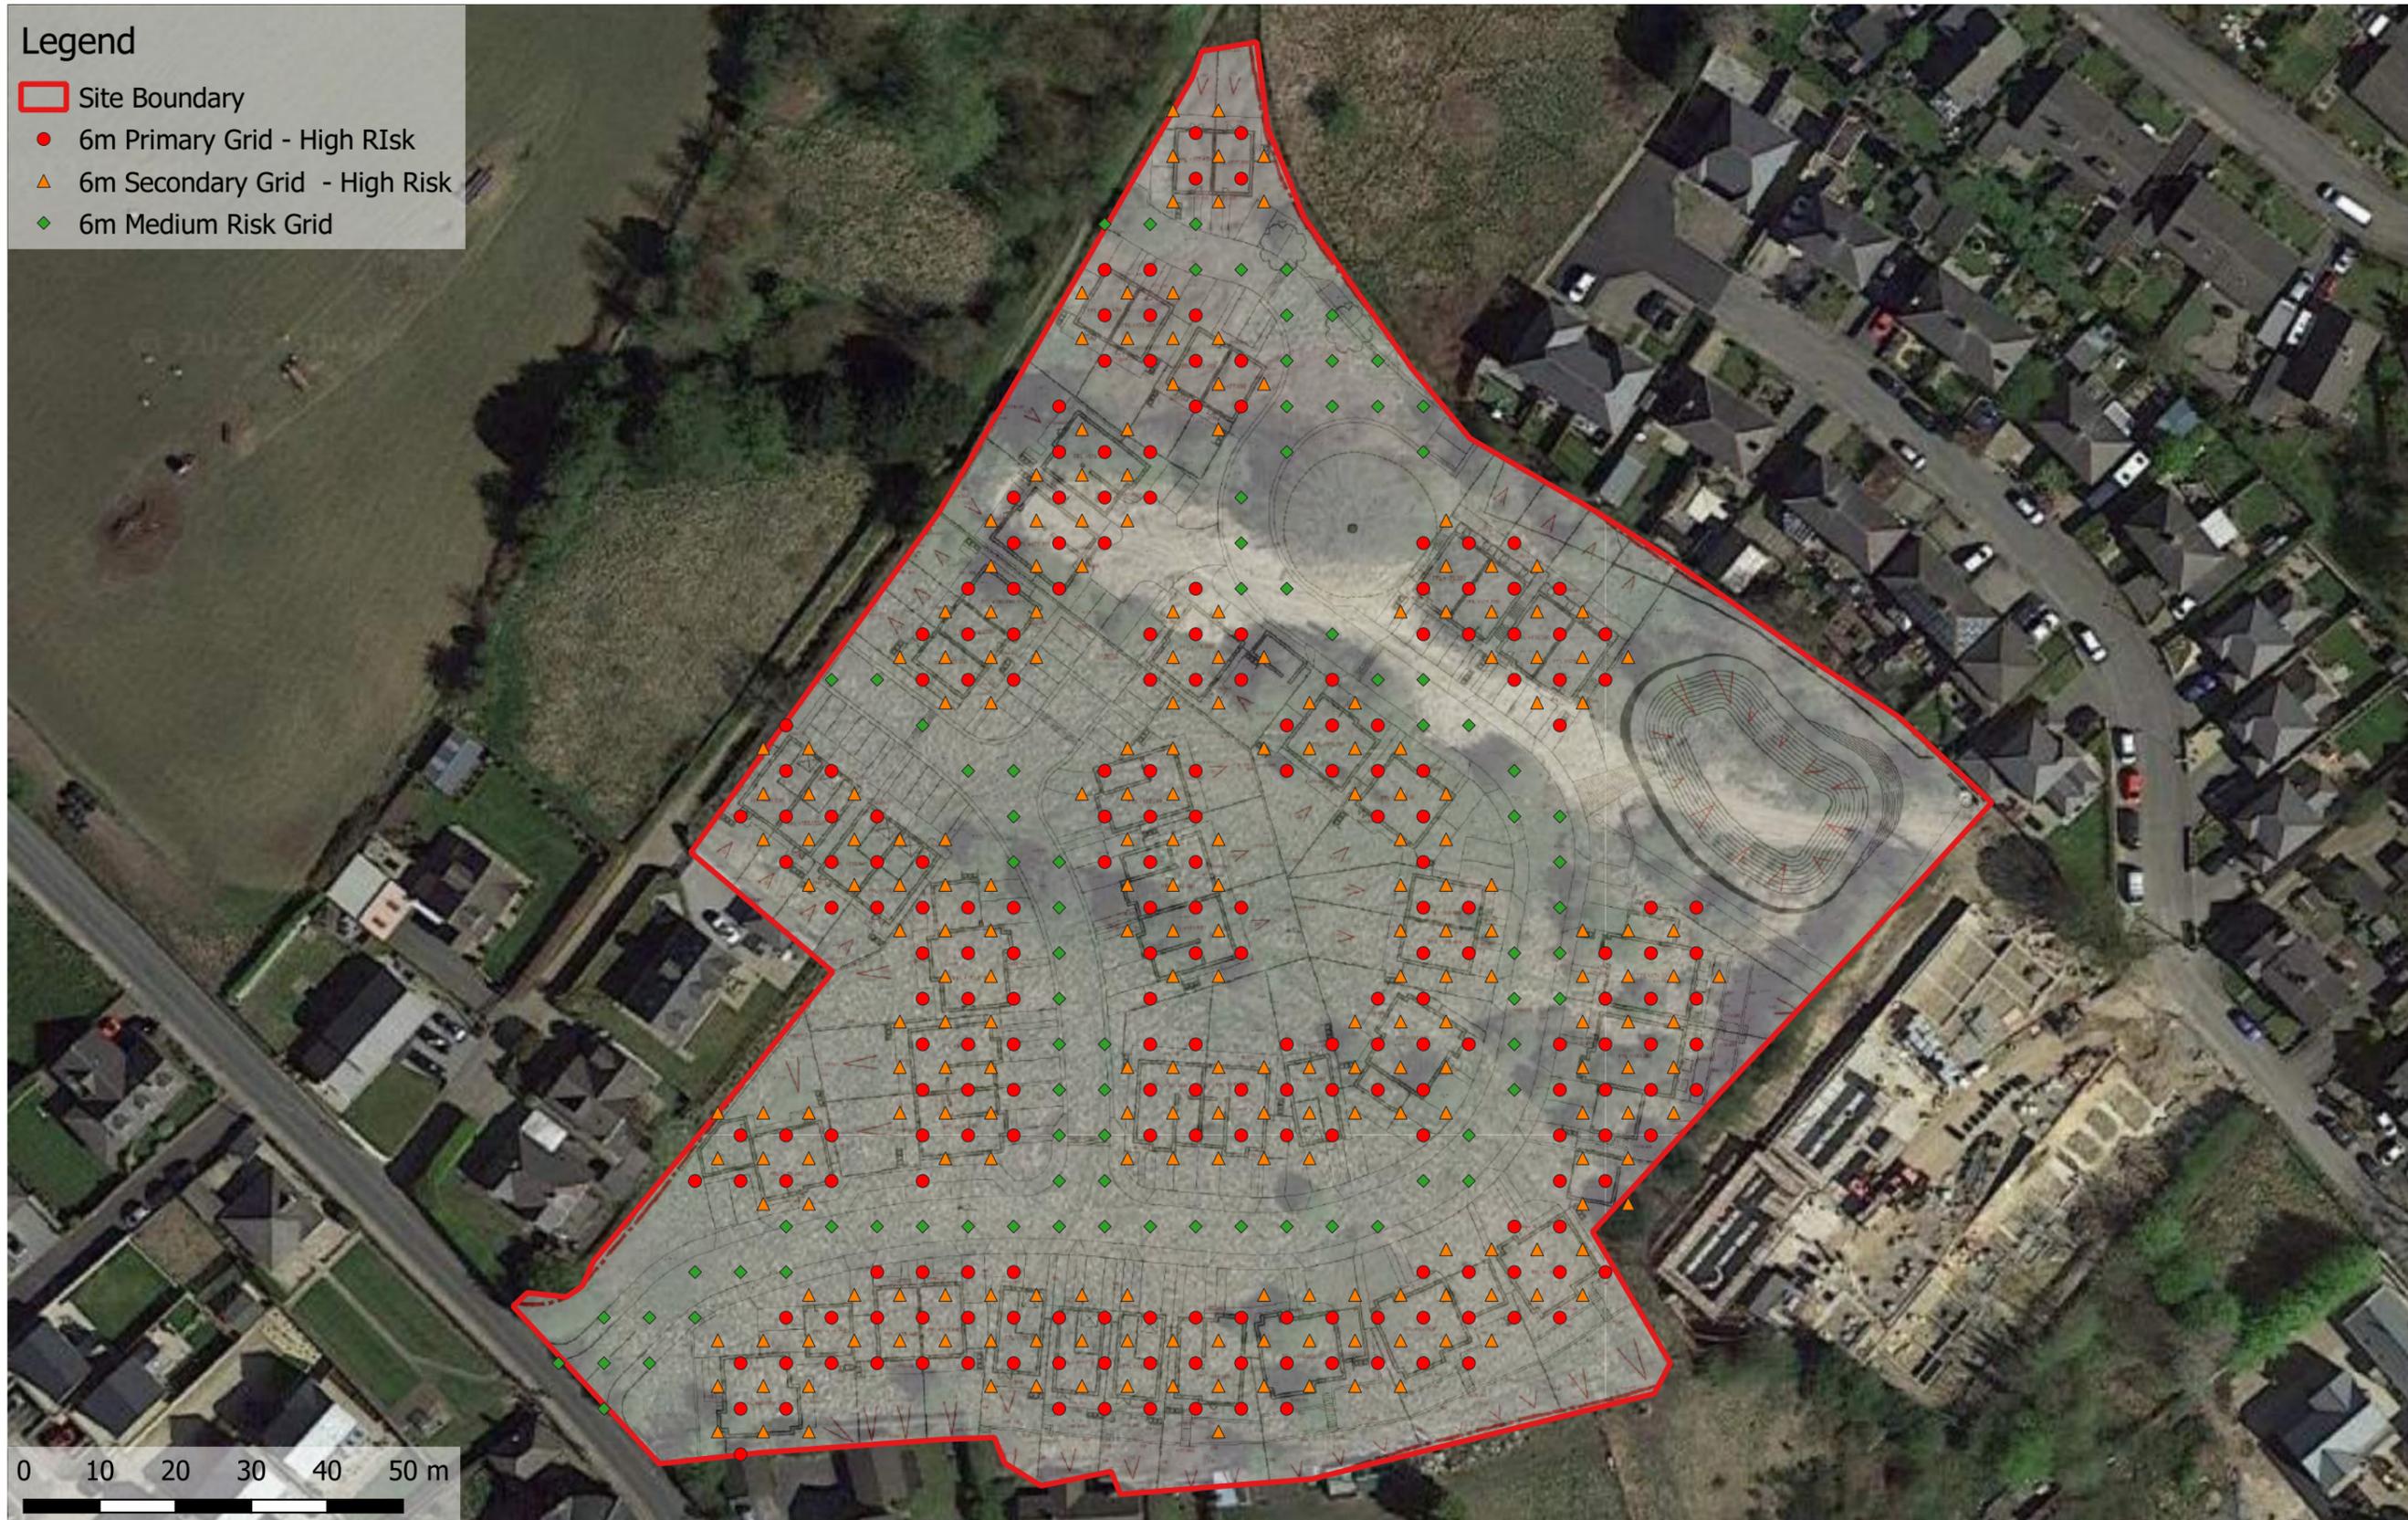
CLIENT:	Urban Group (York) Ltd
PROJECT:	Cliff Hill, Cumberworth Lane, Denby Dale, Huddersf
TITLE:	Proposed Drill and Grout Treatment Grid

- ▭ Site Boundary
- 6m Primary Grid - High Risk
- ▲ 6m Secondary Grid - High Risk
- ◆ 6m Medium Risk Grid

NOTES:  
- Based on 6m primary grid with 3m centres under plots

A proposed treatment grid has been provided in Appendix H, based on zoning the development into risk categories. Gardens and areas of public open space are considered to be at low risk. Estate roads are considered to be moderate, and the dwellings are considered as high risk areas.

Based on the attached treatment grid, approximately 300no. primary holes are anticipated with an additional 250 secondary holes anticipated below proposed plots. The treatment holes are anticipated to be approximately 20m deep.
