PHASE 2 GEO-ENVIRONMENTAL REPORT

job number C2206/22/E/3401	date 25.05.2022
site address Cliff Hill, Cumberworth Lane, Denby Dale, Huddersfield, HD8 8RZ	
written by C. Mason	checked by C. Kirby
issued by C. Mason

Report on a Phase 2 Geo-environmental Investigation

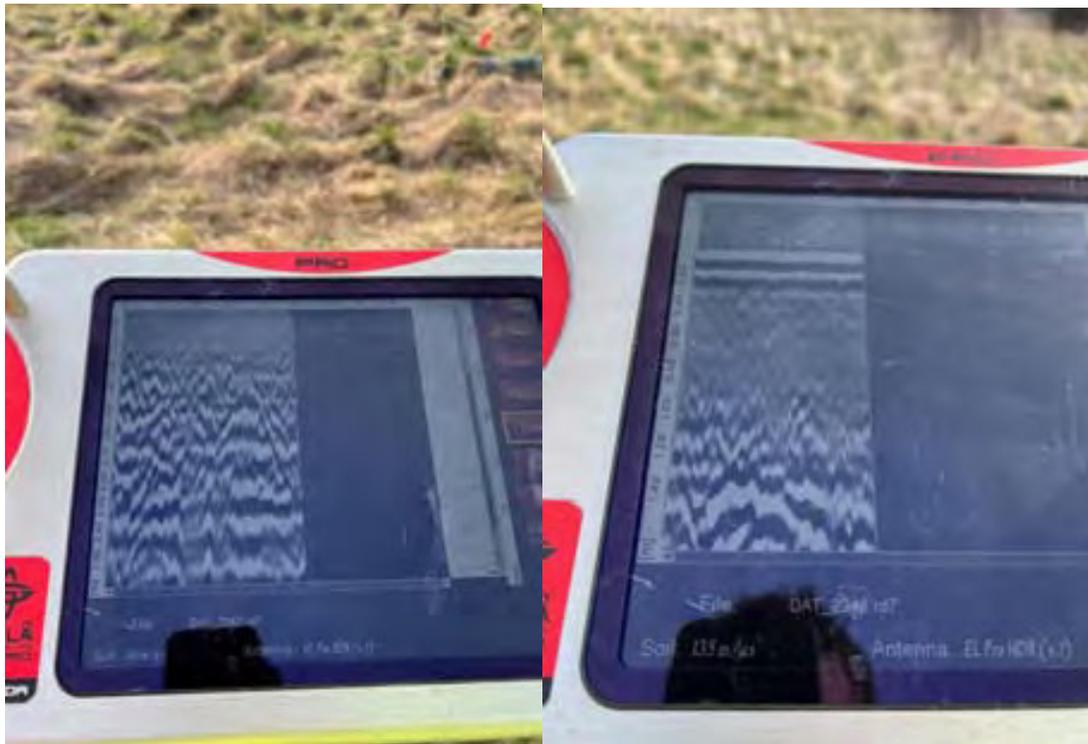
MINE 510

Coordinates to the GPR trace are - EASTING 422843.598 NORTHING 408655.241.

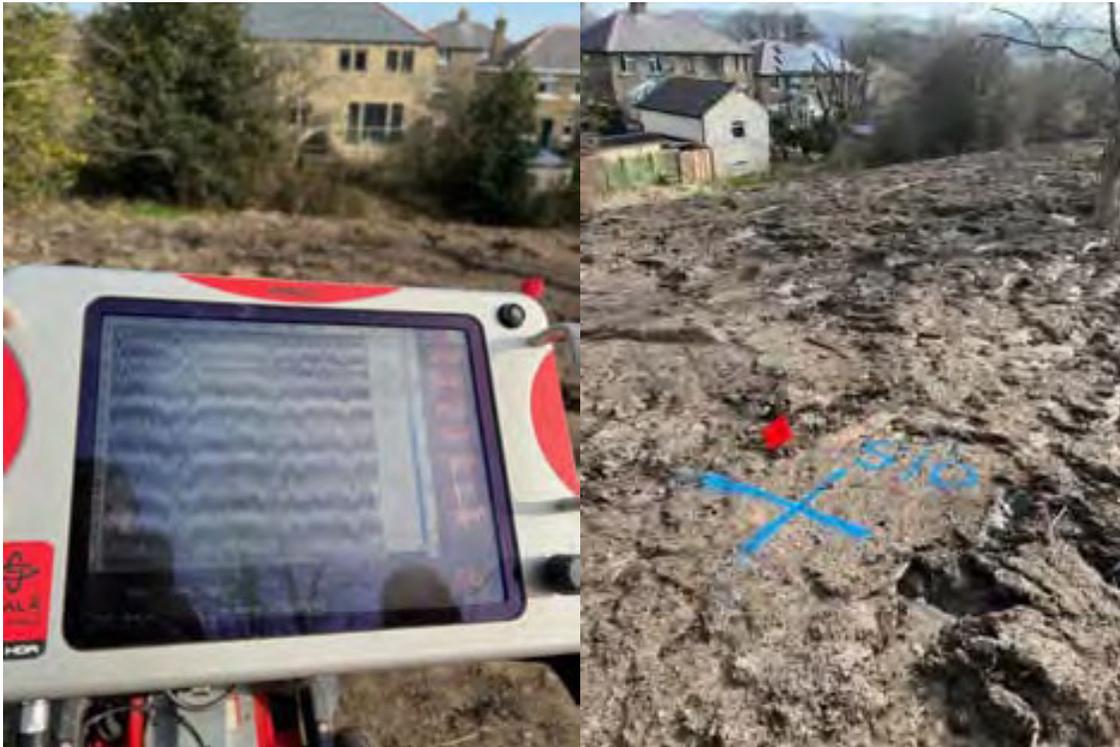
MINE 016

Below images show staked out location of possible mine shaft. No trace of the shaft was detected using GPR techniques. Also below image shows on screen, uniform ground makeup.

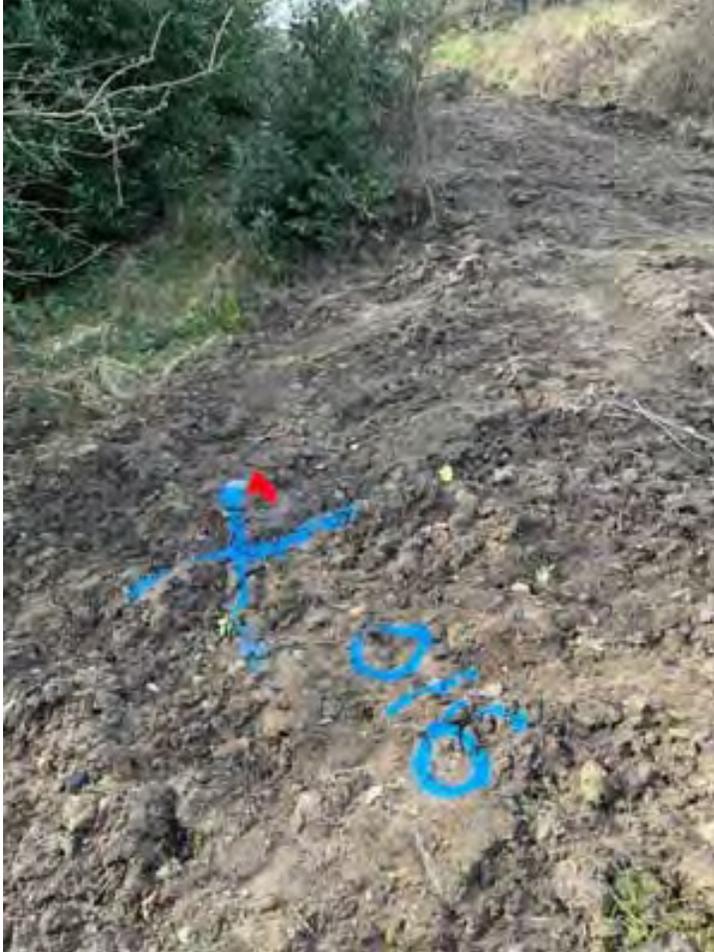
GPR survey around this location was not possible due to ground terrain.

GPR was used as close as possible without any results.

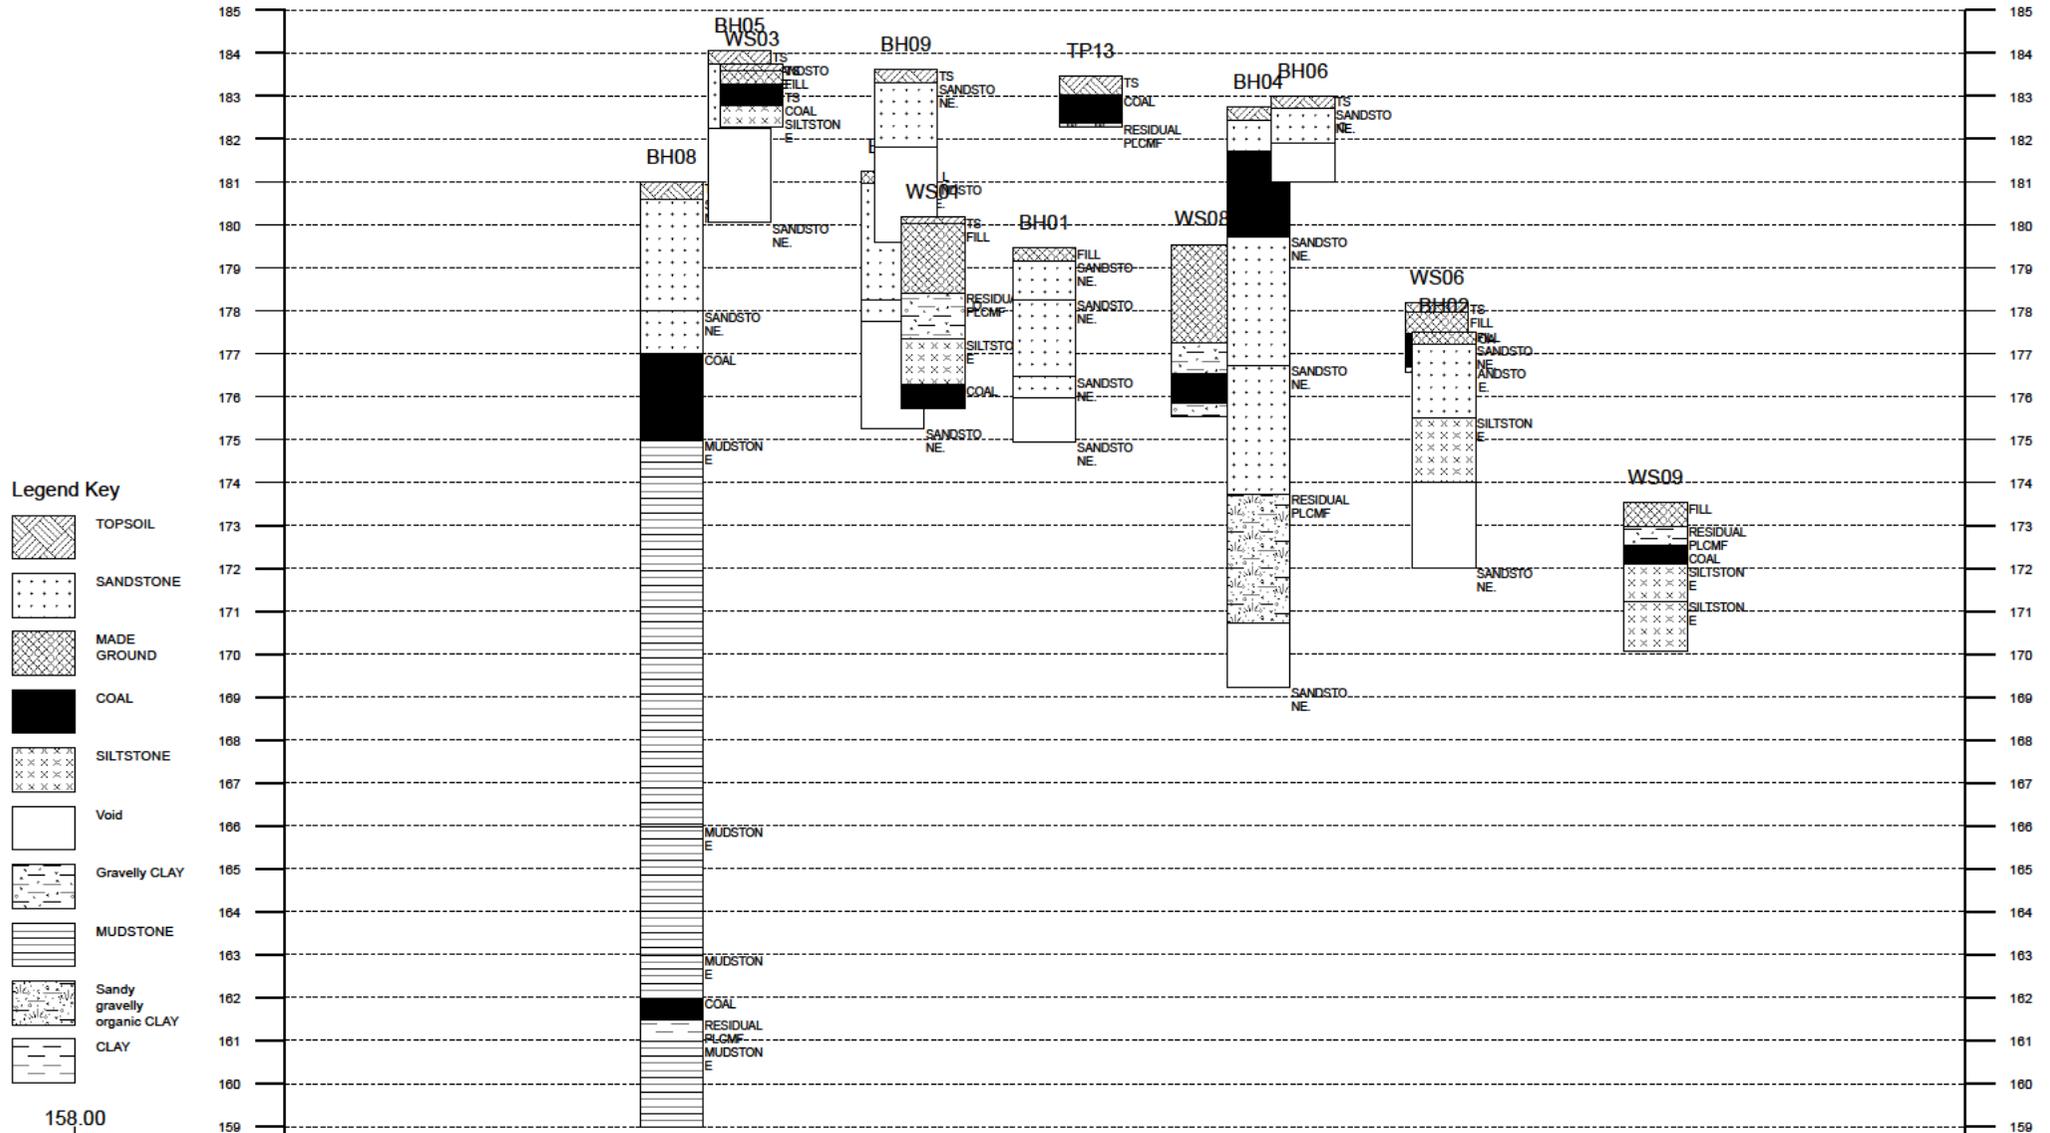
Chainage (m)	0.00	14.07	19.39	21.19	25.38	32.34	35.62	36.34	43.88	52.2	54.65	59.56	65.62	70.67	78.59	87.72	93.48	99.48	100.20	108.20	111.49	115.82	125.28	129.72	
Elevation (mAOD)		179.80	181.18	181.00	179.55	181.26	182.47	183.47	183.78	183.1	180.3	181.69	184.05	183.80	182.73	181.79	180.30	180.53	178.07	179.40	178.73	178.84	176.52

Legend Key

- TOPSOIL
- SANDSTONE
- MADE GROUND
- COAL
- SILTSTONE
- Void
- Gravelly CLAY
- MUDSTONE
- Sandy gravelly organic CLAY
- CLAY
