Heritage Statement & Heritage Impact Assessment

Rev A – Jan 2024

For the Conversion Of
Wooldale Methodist Chapel,
Wooldale Road, Wooldale

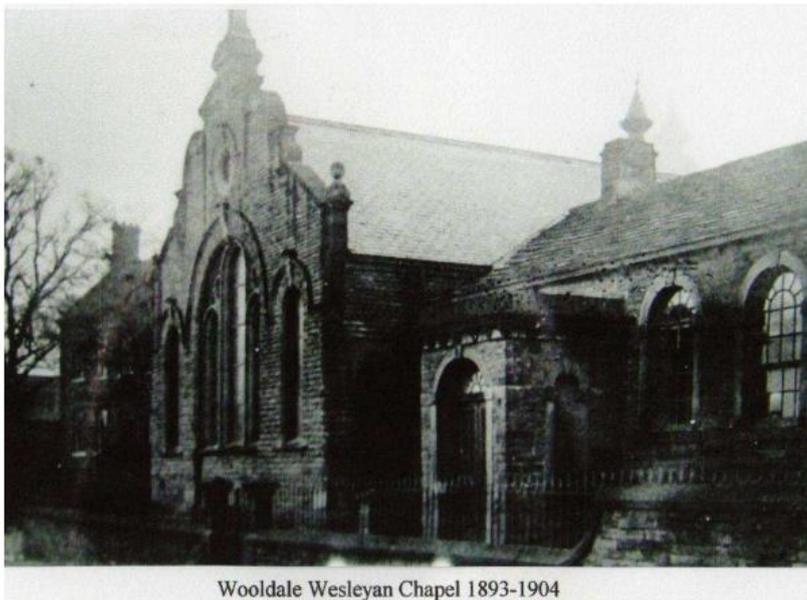
Wooldale Wesleyan Chapel 1893-1904

- 4.7 During the building work undertaken in the renovations of the premises in 1905 the porch, as it was built originally (shown below), was moved to its present position. These renovations were mainly concerned with improvements to the Sunday Schoolroom. During the ceremony held on January 14th. 1905, having been invited to perform the re-opening of the premises Mr. Heap of Honley was presented with the silver key he had used.

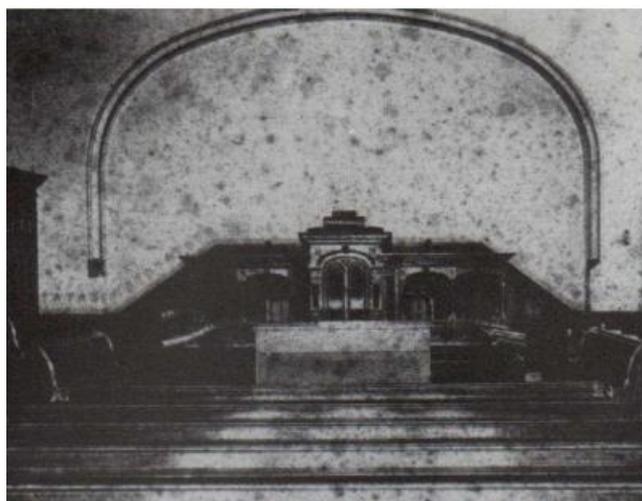
- 4.8 Congregational hymn singing and choir singing, those essential elements of Chapel worship, were first accompanied by a harmonium. This was replaced in 1903 by an organ purchased from Peter Conacher of Huddersfield. During the following years the original mechanism that worked the organ's bellows (this involving the flow of water achieved by a special motor) was not proving satisfactory so the decision was taken to replace it with a paid organ player. Subsequently in 1932 electric power was installed and in 1973 the organ was fully renovated. In 1933 students from Cliffe College visited Wooldale to lead an evangelistic campaign in the area. After a similar visit the following year it was decided that this initiative was to be supported by the formation of a Mission Band. In 1943 the Chapel was registered for the Solemnisation of Marriage. Prior to this date those wishing to marry had to go to the Wesleyan Church in Holmfirth.

The Chapel in 1903 prior to the installation of the Organ

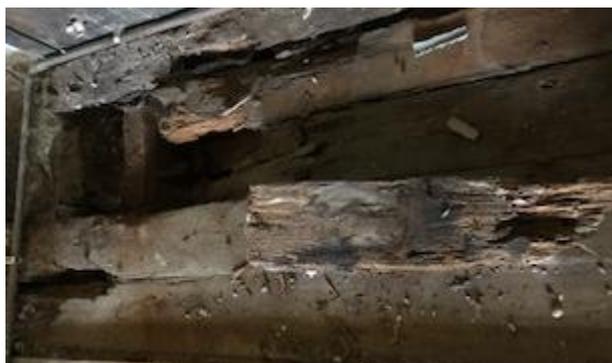
The timber floors and pew platforms are also subject to considerable decay by suspected wet rot and at present pose a health and safety risk, where large sections have collapsed/rotted through (see photograph below). The building has evidently suffered from moisture ingress for many years

The impact of the loss of the decayed original historic flooring is significantly outweighed by benefits brought to the project by the then possibility of installing a practical floor, to allow the building to be brought into beneficial use. Failure to do so considerably prohibits the any viable future use of the building.

*The benefits of removal of the pew platforms on **health and safety** grounds and in terms of allowing beneficial use of the building and thus giving it a future of re-use and maintenance far outweighs the loss of the already decaying fabric of the platforms.*

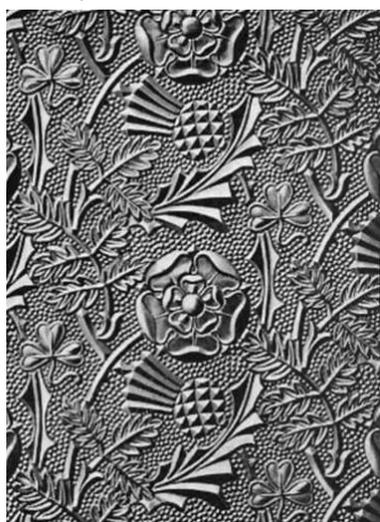
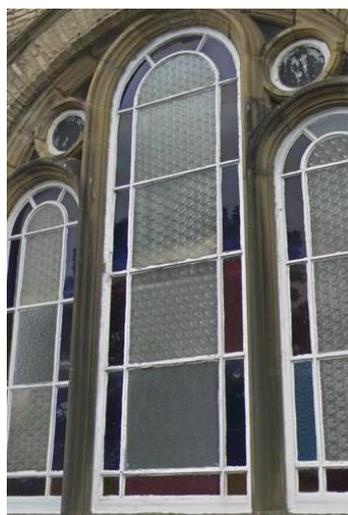
- 4.15 The existing timber framed windows date from the Victorian period and there is evidence that the vestry windows to the front elevation were replaced in 2018. There is further evidence showing that the rear chapel windows were replaced in 1980 after a charitable donation. The windows to the front elevation of the school room have also been replaced at some stage as they differ from the boxed sash shown previously. The windows are single glazed throughout. The central glazing in the front elevation of the vestry is believed to be original rose and thistle figured rolled glass, surrounded by coloured glass. Many of these panels have been replaced with modern alternatives and the vast majority are cracked. The distortion within the timber, coupled with the exposure and ongoing neglect, has resulted in the opening up of the joints and deterioration of the decoration and now significant decay of the timber frames, which are beyond salvage or re-use.

Image of Glass & Windows

6.8 The **windows** are, as previously recorded, beyond economical repair and are proposed to be replaced. The proposals are to replace the existing windows with new timber units, with slim line double glazing.

While the removal of the timber windows does result in the loss of historic fabric, they are beyond economical repair and as such, their replacement is unavoidable. Once lost, their replacement with single glazing is unrealistic and unfeasible for windows of such size and number to allow the building to be beneficially brought into residential (or other) use.

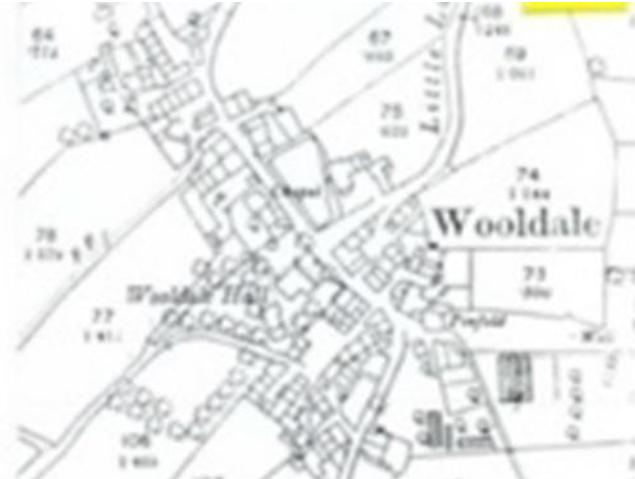
Ordnance Survey 1886 (shows the original three buildings)

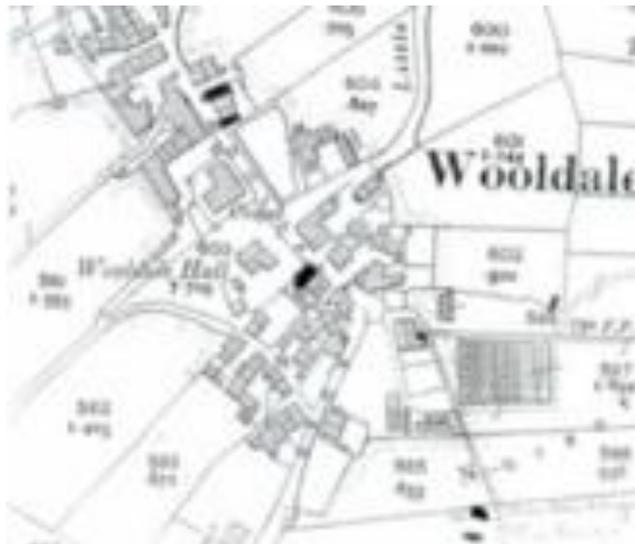
Wooldale Ordnance survey 1903 (shows the school house and Chapel)

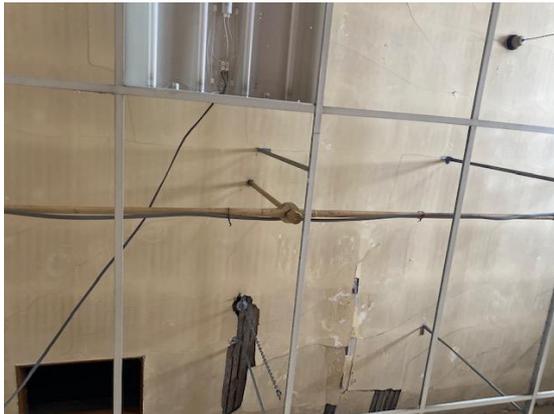
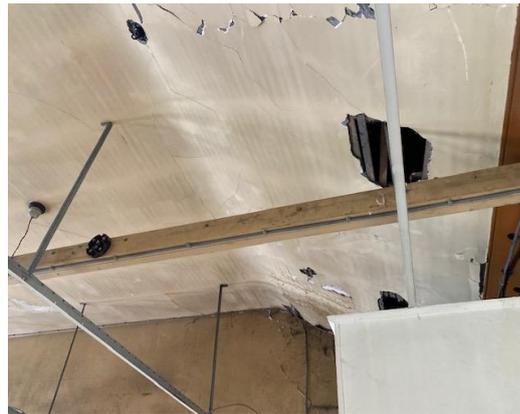
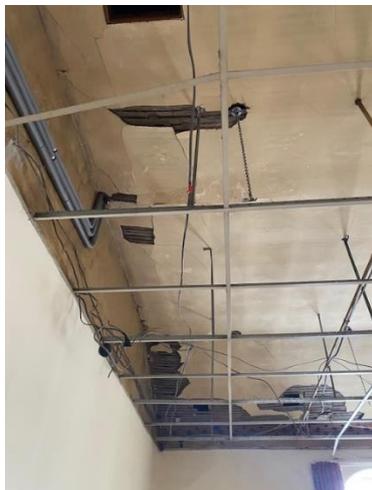
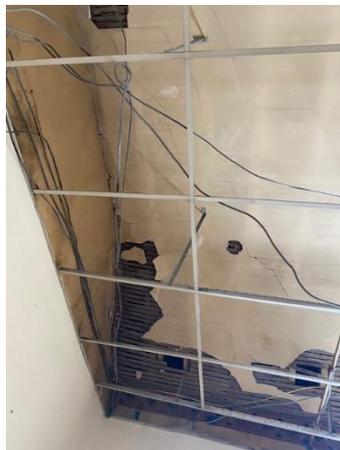
Images showing damage to ceiling plasterwork.

- 6.15 The existing **ceiling's** in the chapel are a mixture of plaster and lath and modern plaster and is to be retained. A small opening is to be formed for the bedroom staircases up to their Second Floor's within the roof void. The existing ceilings within the Vestry and schoolroom are to be replaced with plasterboard as they are beyond repair

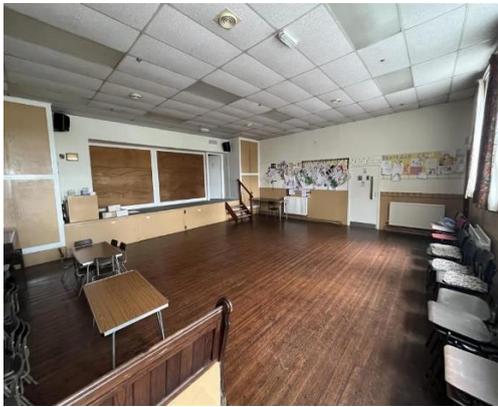
Figure 1 - School room Auction image

The albeit sagging considerably/damaged, white plaster ceiling in the schoolroom has been damaged over the years by water ingress and the addition of a suspended ceiling and under-draws a trussed timber frame roof structure above, containing some historic timbers.

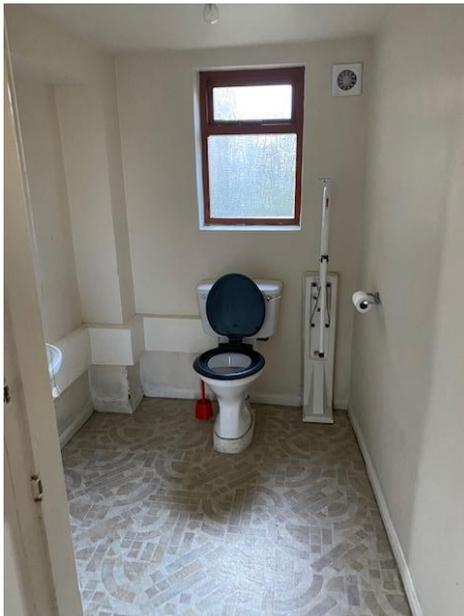
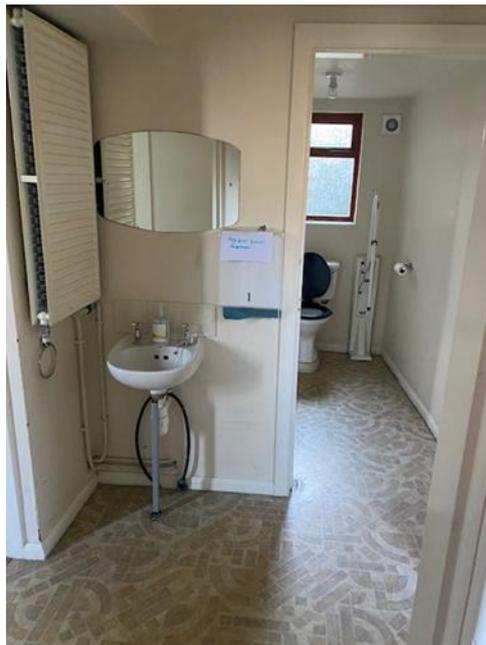
Toilets

Large single door, leads to a small sink area with a large disabled toilet and sink to the right. To the left are two urinals with a small toilet room to the far side.

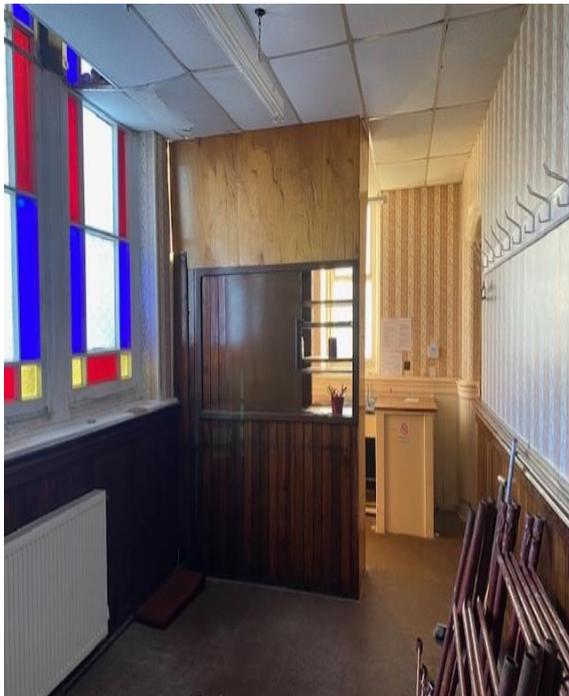
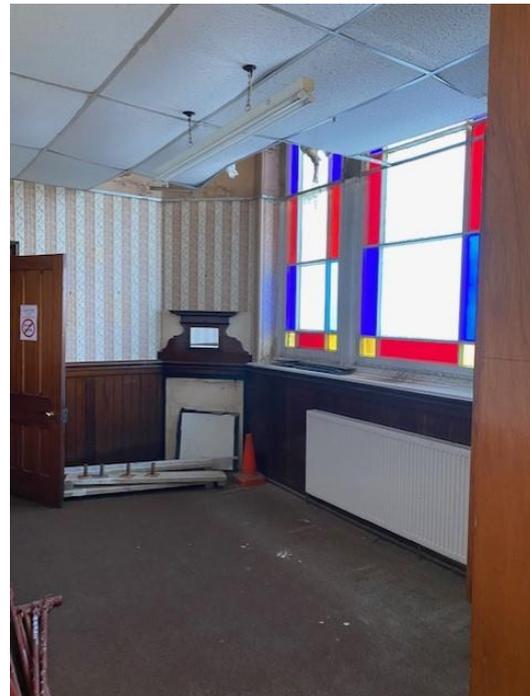
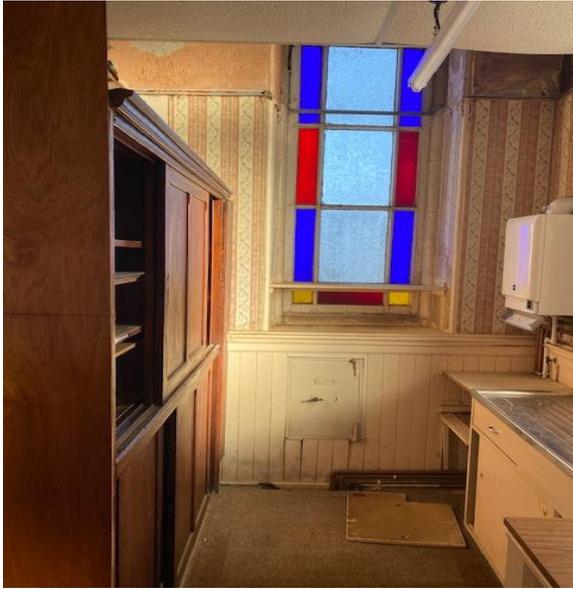
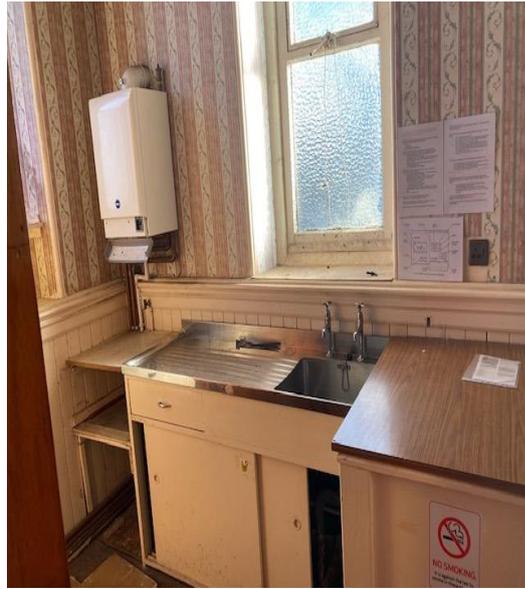
Vestry

Large open room with original cladding, church windows two large entry doors and small kitchenette.

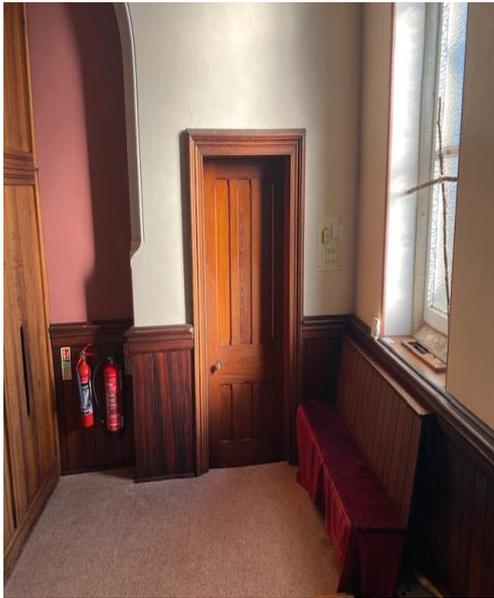
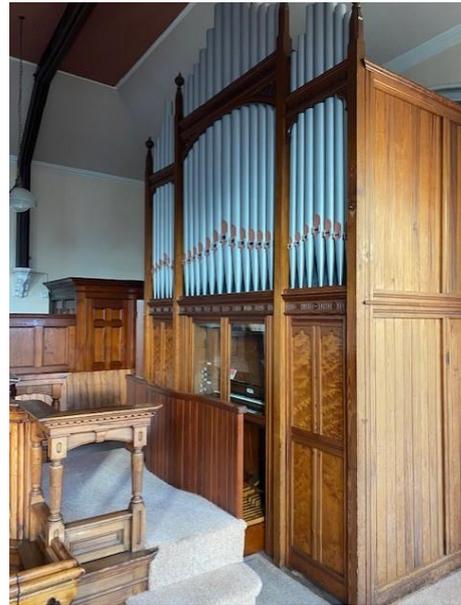
Church

20 pews (2 sizes), pipe organ, Wooden Vestibule and panelled entry. Large stained windows (x3) to the rear of the room. Two internal windows (originally external) and 6 large windows running along the left side. One internal door. Wooden floor with carpets in areas. Raised platform to the front.

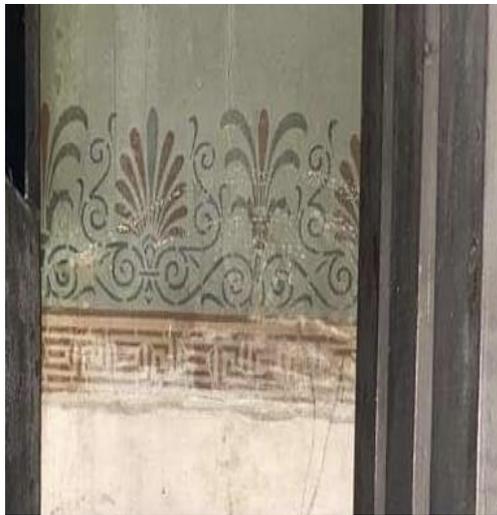
The Chapel before the organ was installed in 1903
