**Former Longley Park Motors,
Huddersfield**

**PHASE ONE ENVIRONMENTAL ASSESSMENT REPORT
(PRELIMINARY RISK ASSESSMENT)**

Client: Enterprise Rent-A-Car UK
Ltd

Report	EN22119 CL 001
Date	November 2022
Page	1

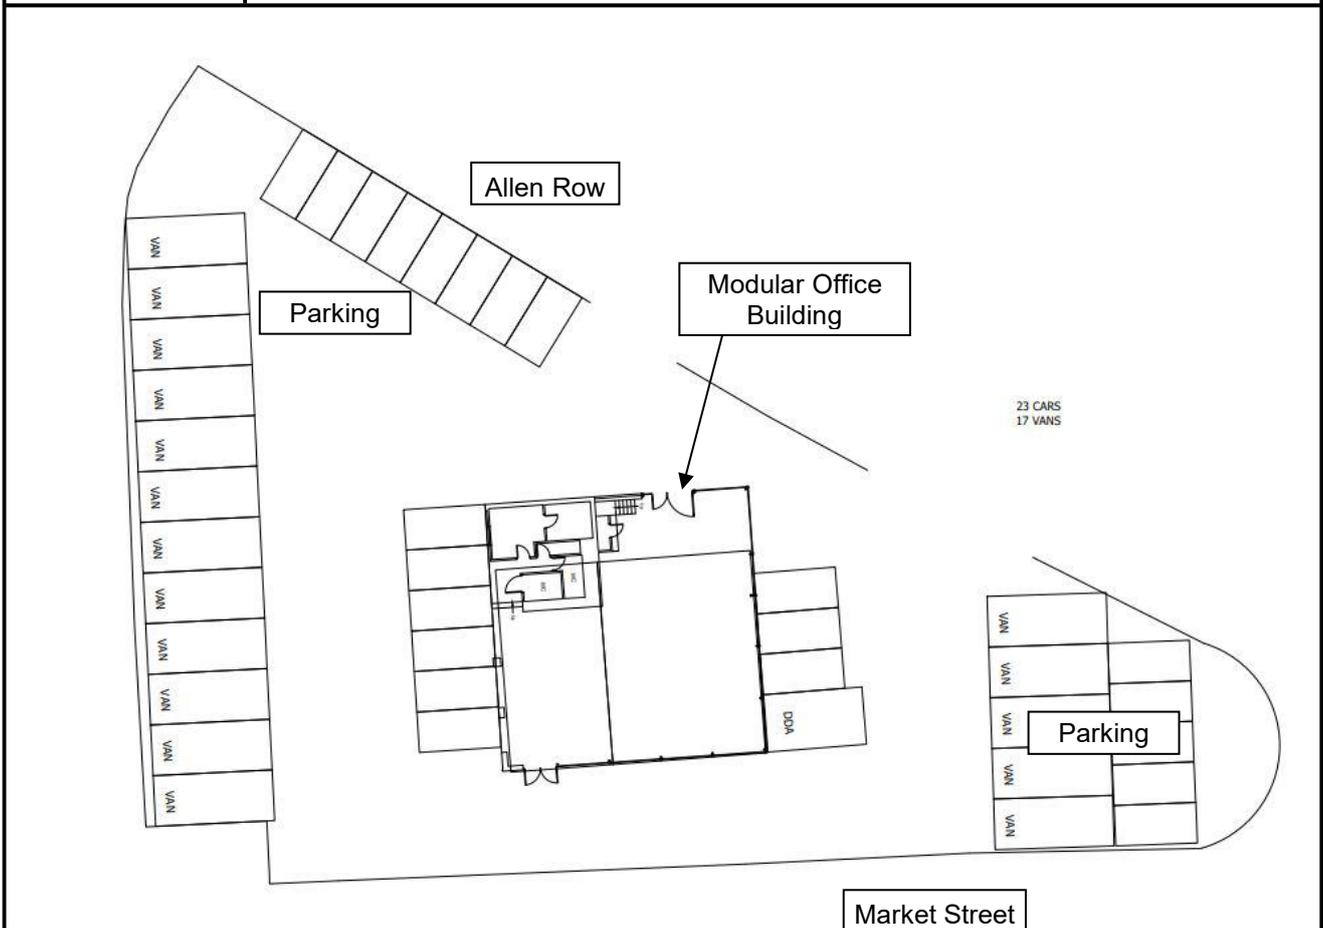
Table One: Proposed Development Plans

Proposed Developments	We understand that Enterprise propose to develop the site for use as a vehicle rental depot. A site plan showing the proposed development plan is provided below.
Active Planning Applications	We understand that this report is to be submitted in support of a planning application for the site's redevelopment, as detailed above. Whilst our assessment has not been compiled to directly satisfy any specific planning conditions the information contained in this report may assist in satisfying any such requirements. Further works may be required, however.

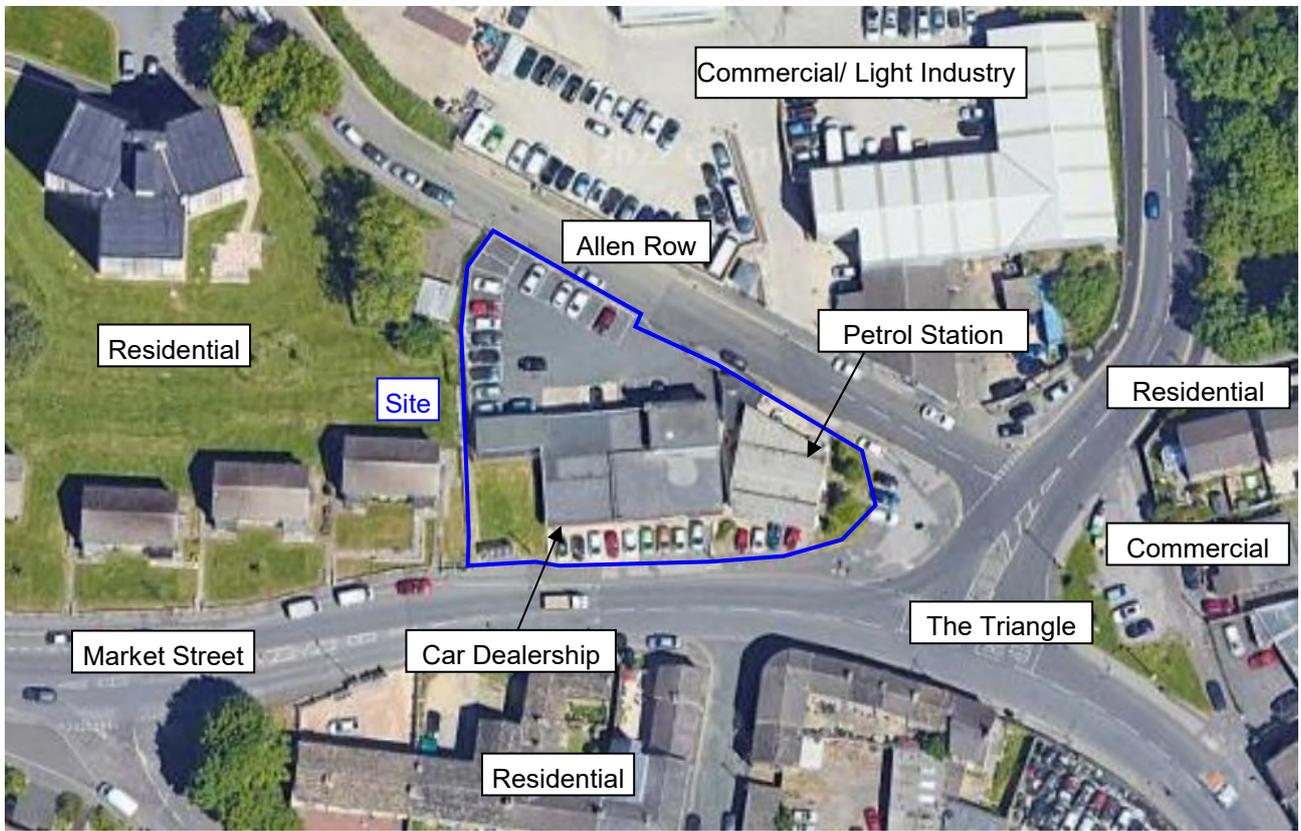
Figure Two: Aerial Photograph Showing Site Layout

Direction	Details
North	Allen Row forms the site's northern boundary with commercial business park beyond (~20m).
East	Directly to the east lies a road junction ('The Triangle') and then residential/commercial properties beyond (~40m).
South	Market Street forms the site's southern boundary with residential properties beyond (~10m).
West	Residential properties and landscaped area to the west (>5m).

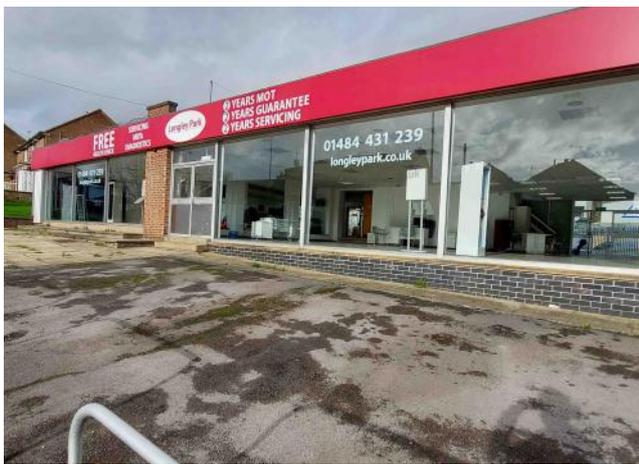
Location	Details
Car dealership building	<ul style="list-style-type: none"> ➤ The sales building is predominantly single storey, with a small second floor area used for offices. ➤ The building looks to be of steel portal frame construction, with glazing and some brick/metal cladding. The roof is flat. ➤ The interior of the showroom floor is tiled and in a good state of repair.
Workshop	<ul style="list-style-type: none"> ➤ No access possible on day of inspection.
Front forecourt / parking area	<ul style="list-style-type: none"> ➤ Comprises a combination of paving and concrete hardstanding, with metal bollards along the southern boundary.
Rear yard of car dealership	<ul style="list-style-type: none"> ➤ Metal palisade fence forms the rear / northern boundary, with a gate to Allen Row. ➤ Part of the western boundary (nearest the workshop) comprises a low brick retaining wall (~1m), with fencing on top. ➤ We noted a single steel drum (205litres) with labels to indicate it formerly contained a 'flammable liquid'. The cap was not present and the drum looked to be full of water. No drip tray or bunding present.

Photograph One: Front forecourt area of the car showroom.

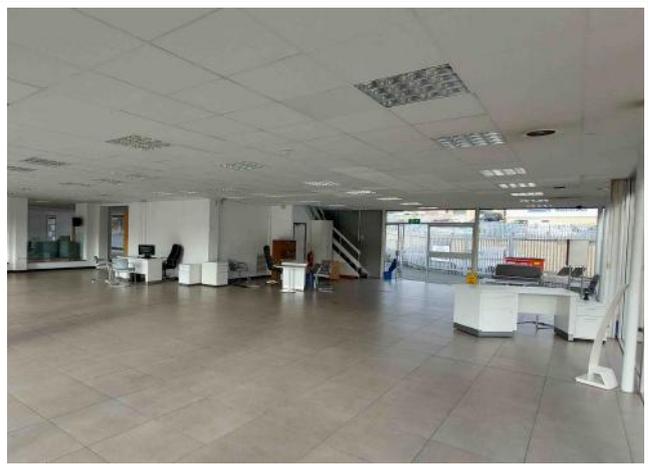
Photograph Two: Interior of the car showroom. Stair leading to first floor offices to rear of area.

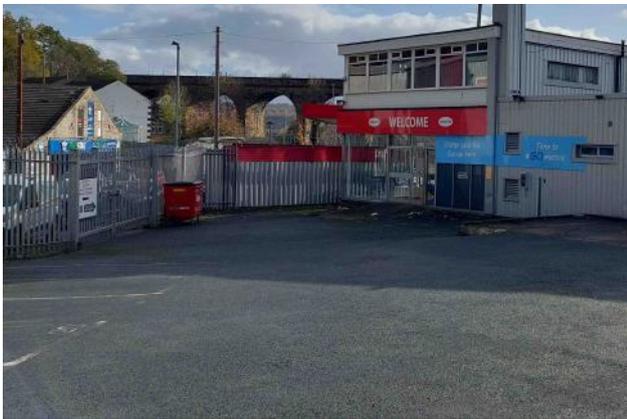
Photograph Three: Rear yard of car showroom (eastern half)

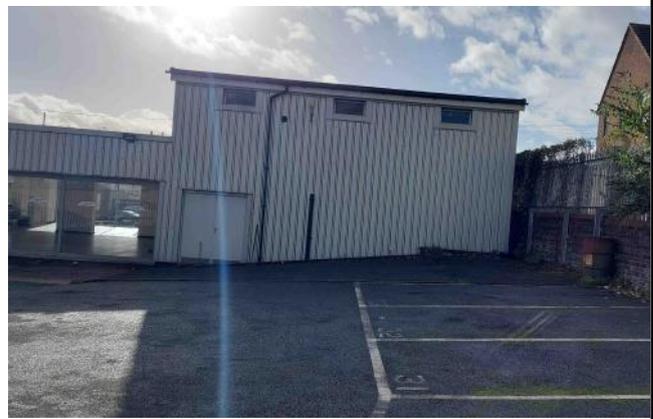
Photograph Four: Rear yard of car showroom (western half) - steel clad vehicle maintenance workshop. Steel drum with labels to indicate it formerly contained a 'flammable liquid'.

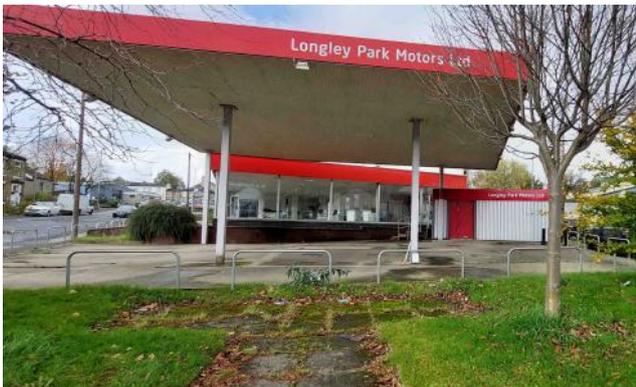
Location	Details
Sales kiosk (former)	➤ There is a small metal clad building located in the northern corner of the forecourt area, which was the former sales kiosk (when the petrol station was operational).
Canopy	➤ Canopy extends across forecourt area and looks to be in good condition (no obvious vehicle strikes). Clearance height indicated to be 4.2m (based on Google Streetview images). Four stanchions observed, and canopy not linked to the adjacent car dealership building.
Hardstanding	➤ Forecourt hardstanding constructed from concrete. Hardstanding was generally in good condition, although various scars/repairs have been carried out. Low metal railings present around perimeter of forecourt, to prevent unauthorised vehicle access.
Fuel supply pipework	➤ An inspection of the tank access chamber (for Tank 2) indicate the pipework was constructed from single skin steel.
Fill points	➤ Fill points are off-set and located between the two canopy stanchions nearest The Triangle.

Photograph Five: Forecourt area

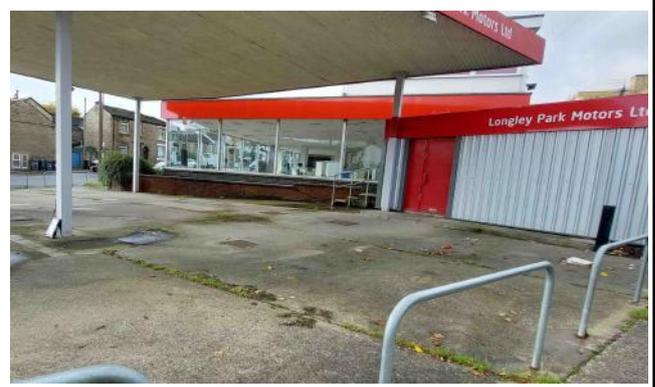
Photograph Six: Central forecourt area and former sales kiosk.

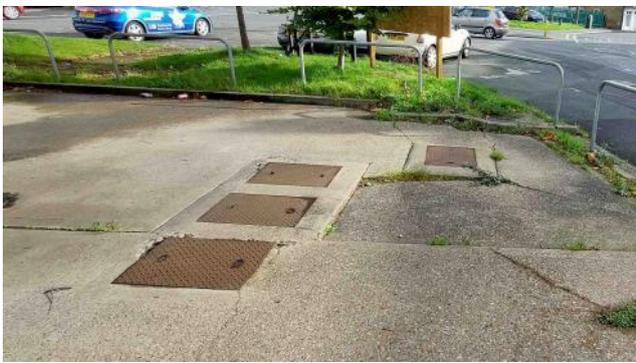
Photograph Seven: Three-chambered forecourt drainage interceptor (unconfirmed - chamber lids rusted/silted shut).

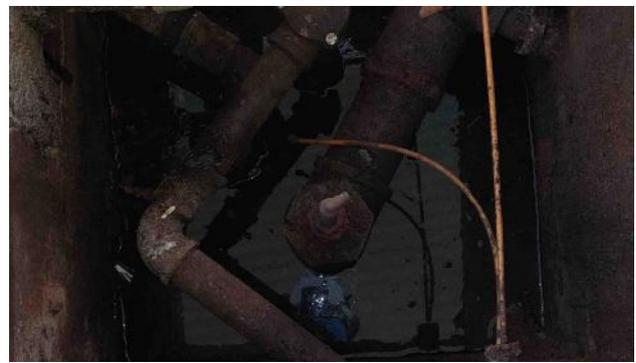
Photograph Eight: Fuel pipework - constructed from steel

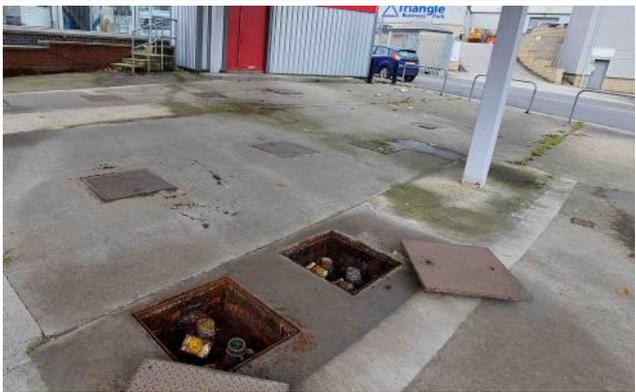
Photograph Nine: Off-set fill point chambers

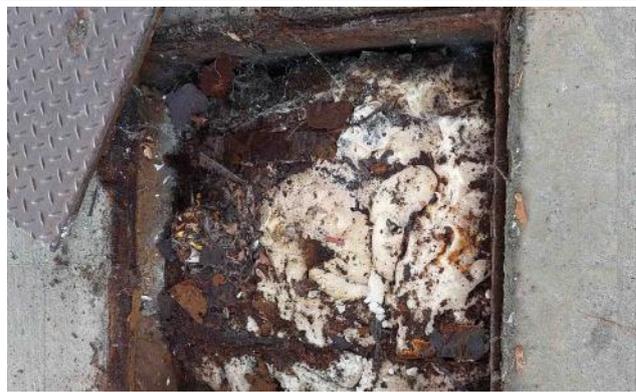
Below ground tanks	<ul style="list-style-type: none"> ➤ Several of the tank access chambers have been filled with expandable foam; ➤ The tank access chamber for Tank 2 (diesel) has not been filled with foam. ➤ Tank details below. 			
	Tank Number	Capacity	Former Contents	Current Status
	One	9,506 litres	Petrol	Hardfoam*
	Two	9,056 litres	Diesel	Unknown (presume empty)
	Three	9,506 litres	Diesel	Unknown (presume empty)
	Four	4,656 litres	Petrol	Hardfoam*
	Five	9,506 litres	Diesel	Unknown (presume empty)
	Six	18,818 litres	Petrol	Hardfoam*
Note: * - according to foam filling certificate provided by the Petroleum Officer.				
Forecourt interceptor	<ul style="list-style-type: none"> ➤ Drainage interceptor identified on forecourt (in former access route from Market Street). The metal chamber lids we seized (due to rust/silt), so we were unable to inspect the inside of the interceptor. ➤ Interceptor vent has been cut off at ground level. Formerly constructed from steel and located in the south-east corner of the forecourt (based on Google Streetview images).

Photograph Ten: Foam in tank access chambers
