KEYLAND DEVELOPMENTS LTD

LAND AT COOPER BRIDGE, HUDDERSFIELD

PHASE II GEO-ENVIRONMENTAL INVESTIGATION REPORT

DATE ISSUED: SEPTEMBER 2016
JOB NUMBER: SH10243
REPORT NUMBER: RPT-003

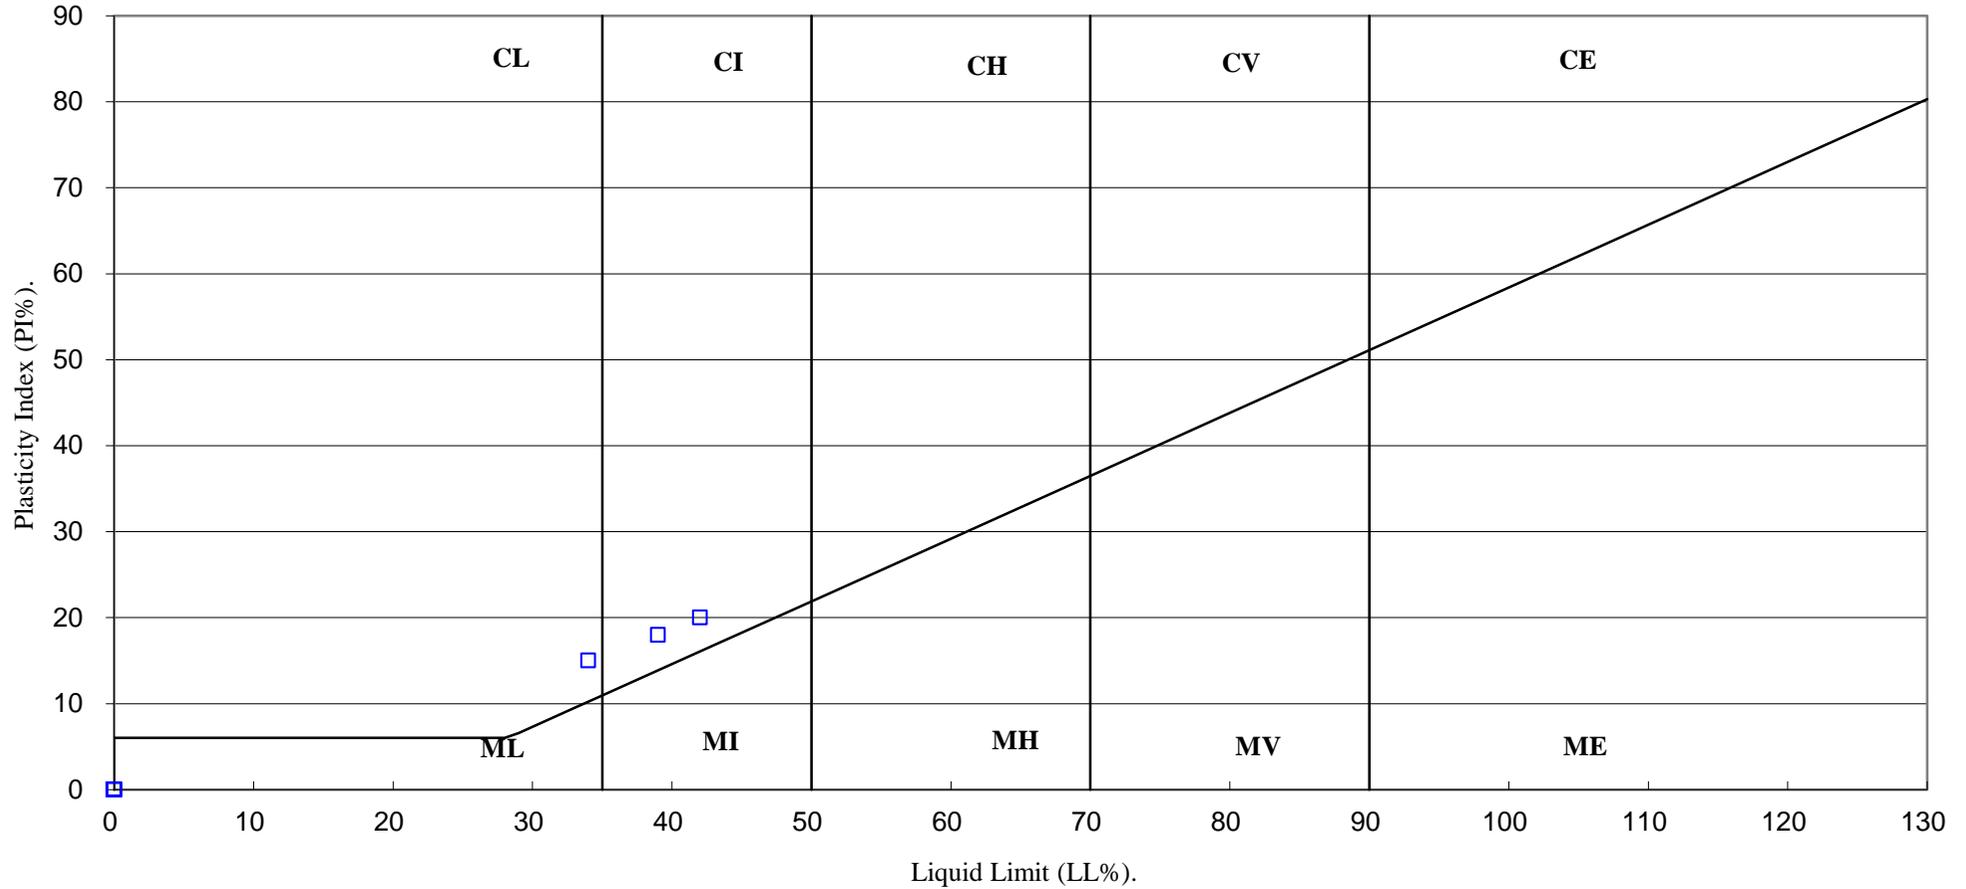
PLASTICITY CHART FOR CASAGRANDE CLASSIFICATION.

(BS5930 :2015)

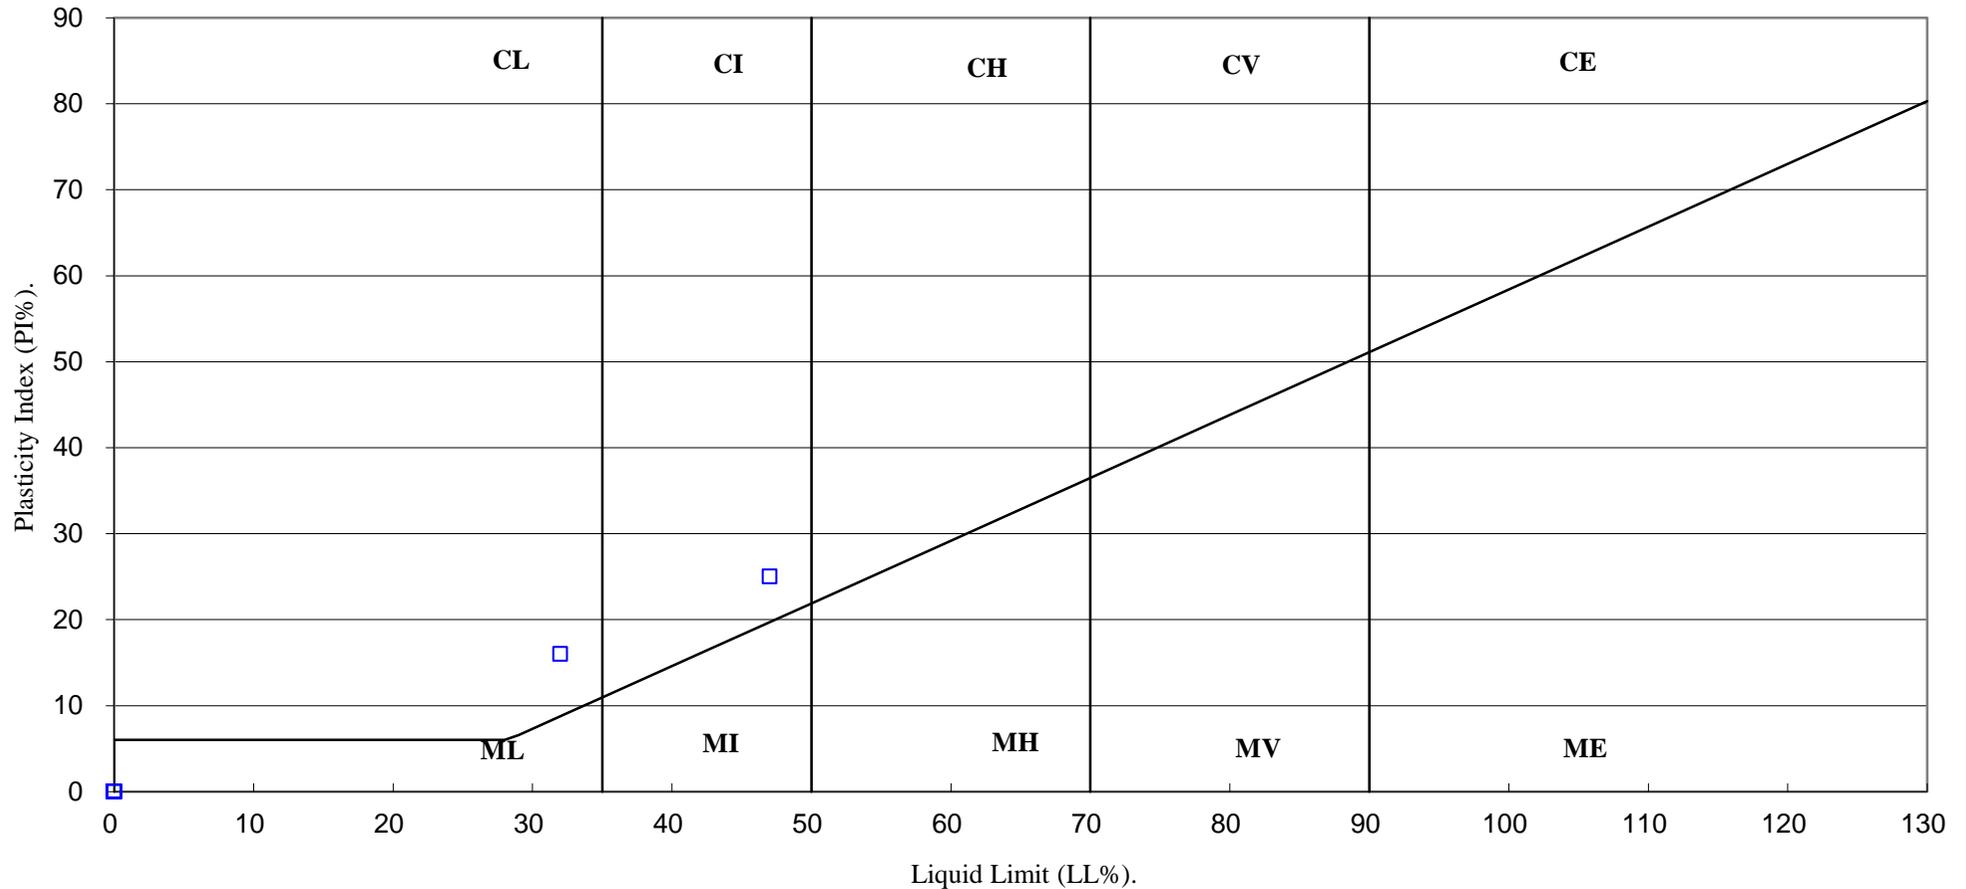
PLASTICITY CHART FOR CASAGRANDE CLASSIFICATION.

(BS5930 :2015)

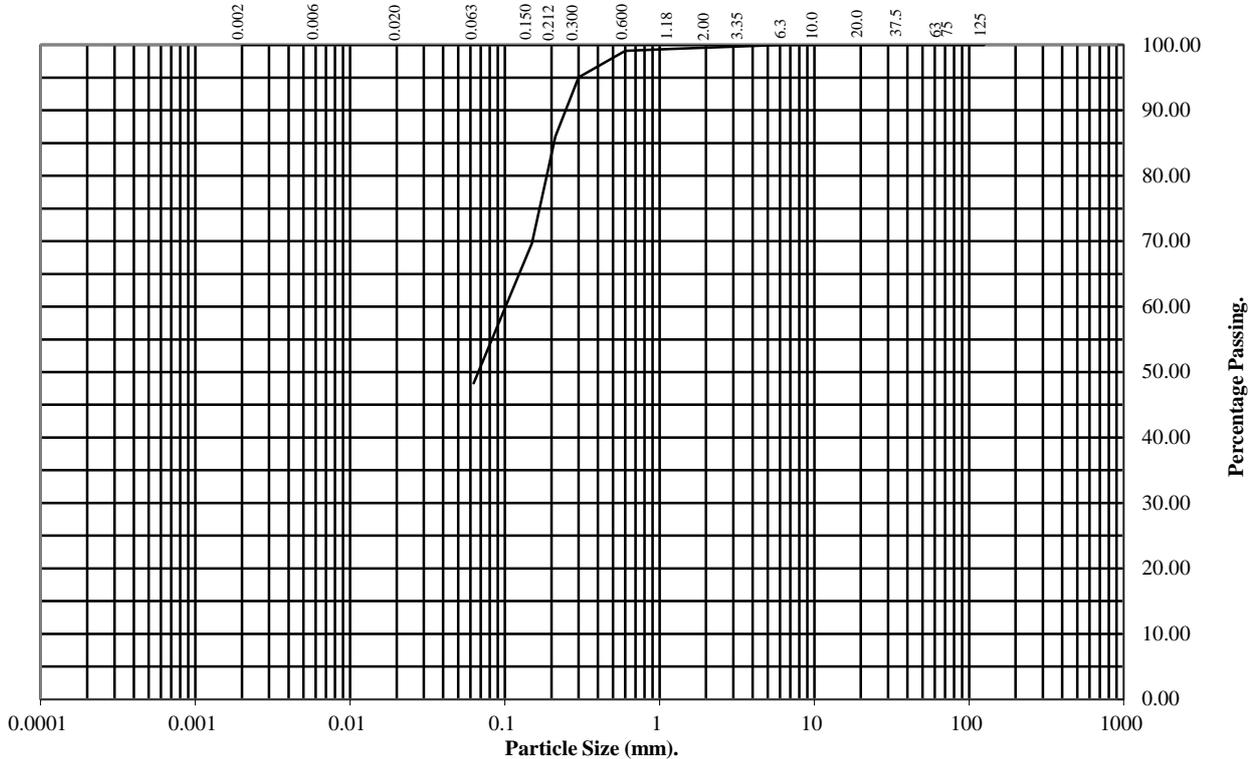
Sample Number: **5** **Base Depth(m):** **1.70**

Sample Type: **B**

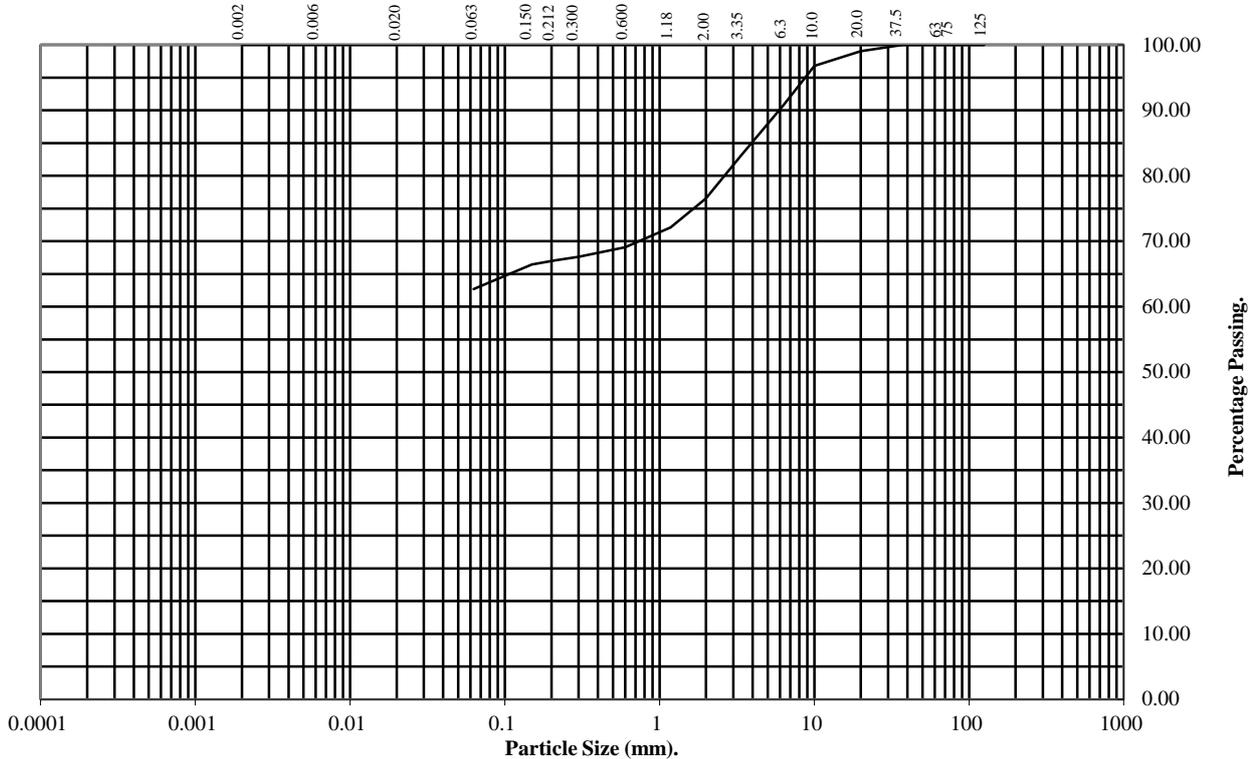
Sample Number: 18 **Base Depth(m):** 8.40

Sample Type: B

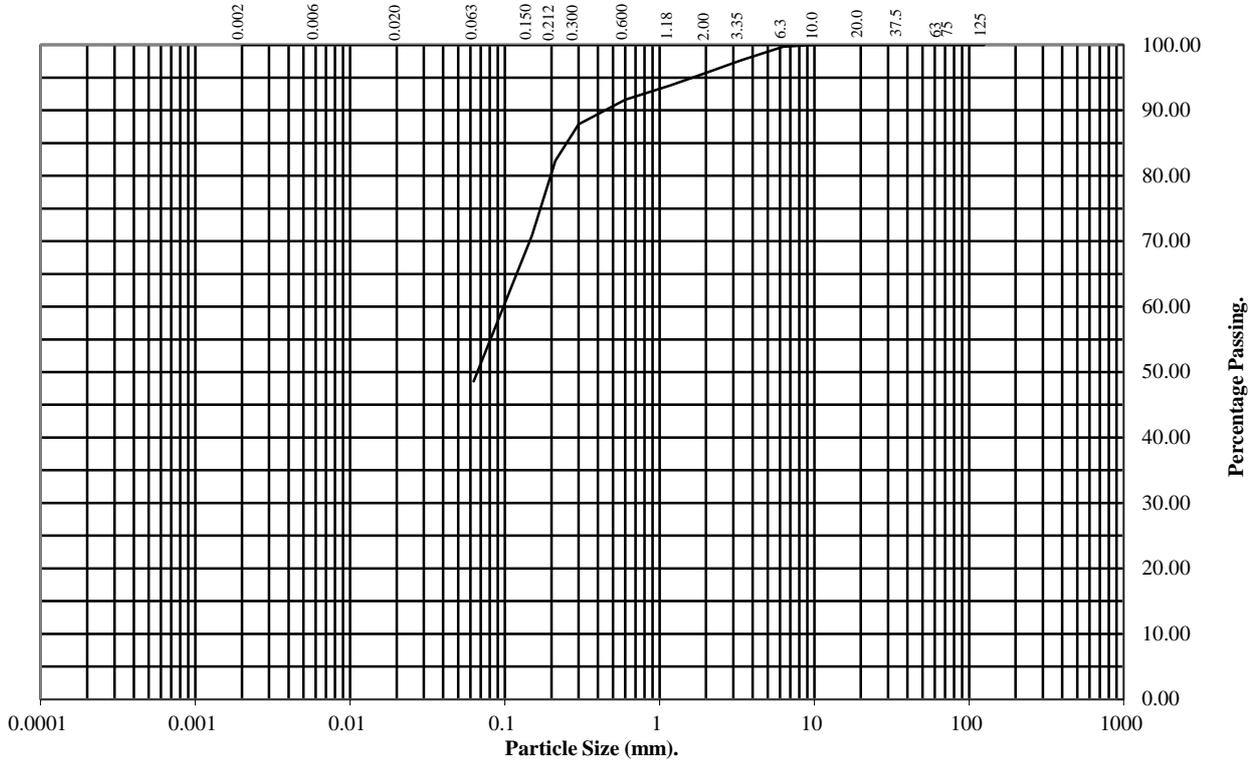
Sample Number: **5** **Base Depth(m):** **2.00**

Sample Type: **B**

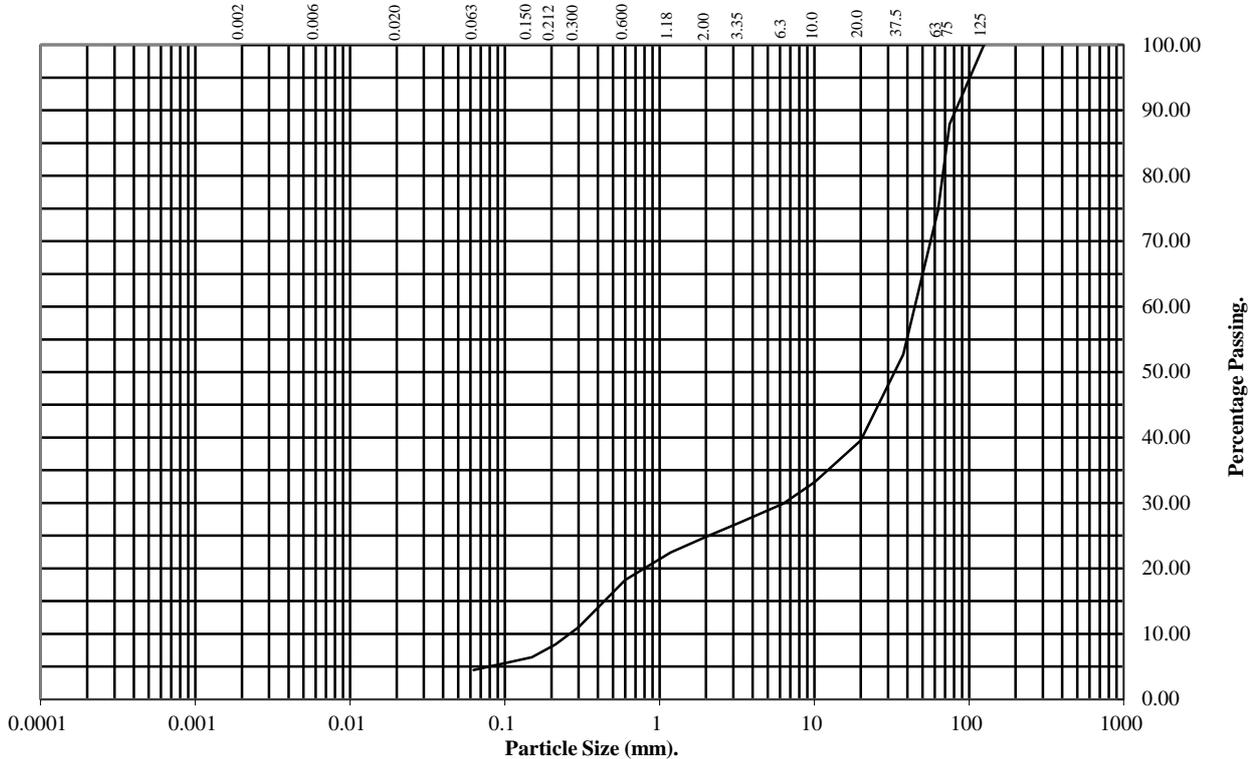
Sample Number: **14** **Base Depth(m):** **8.00**

Sample Type: **B**

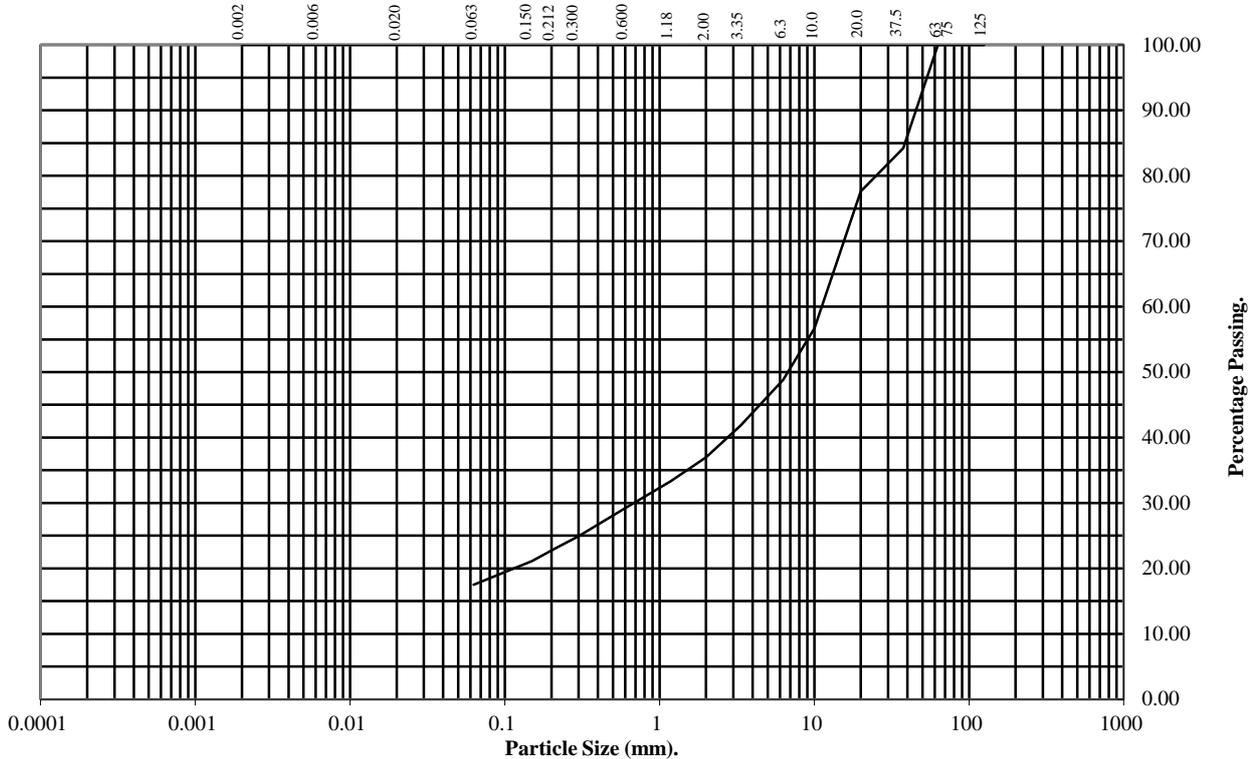
Sample Number: 4 **Base Depth(m):** 2.20

Sample Type: B

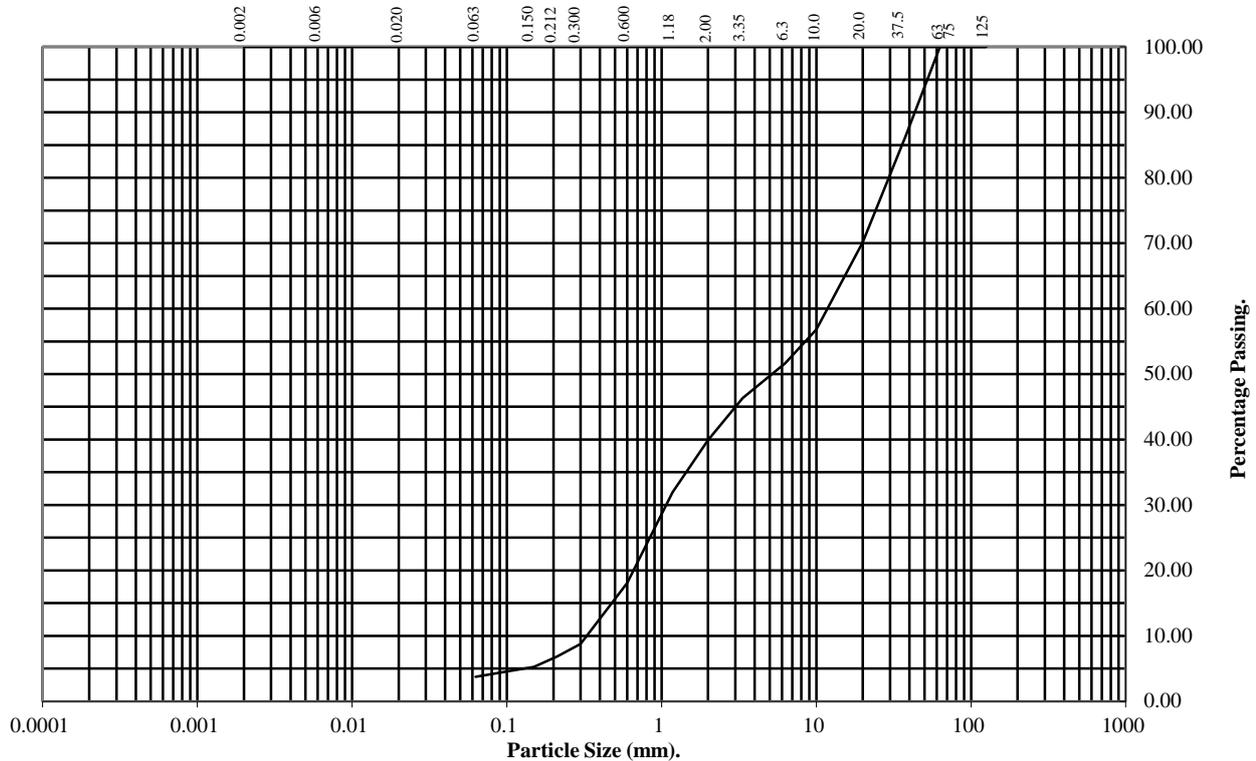
Sample Number: 14 **Base Depth(m):** 9.80

Sample Type: B

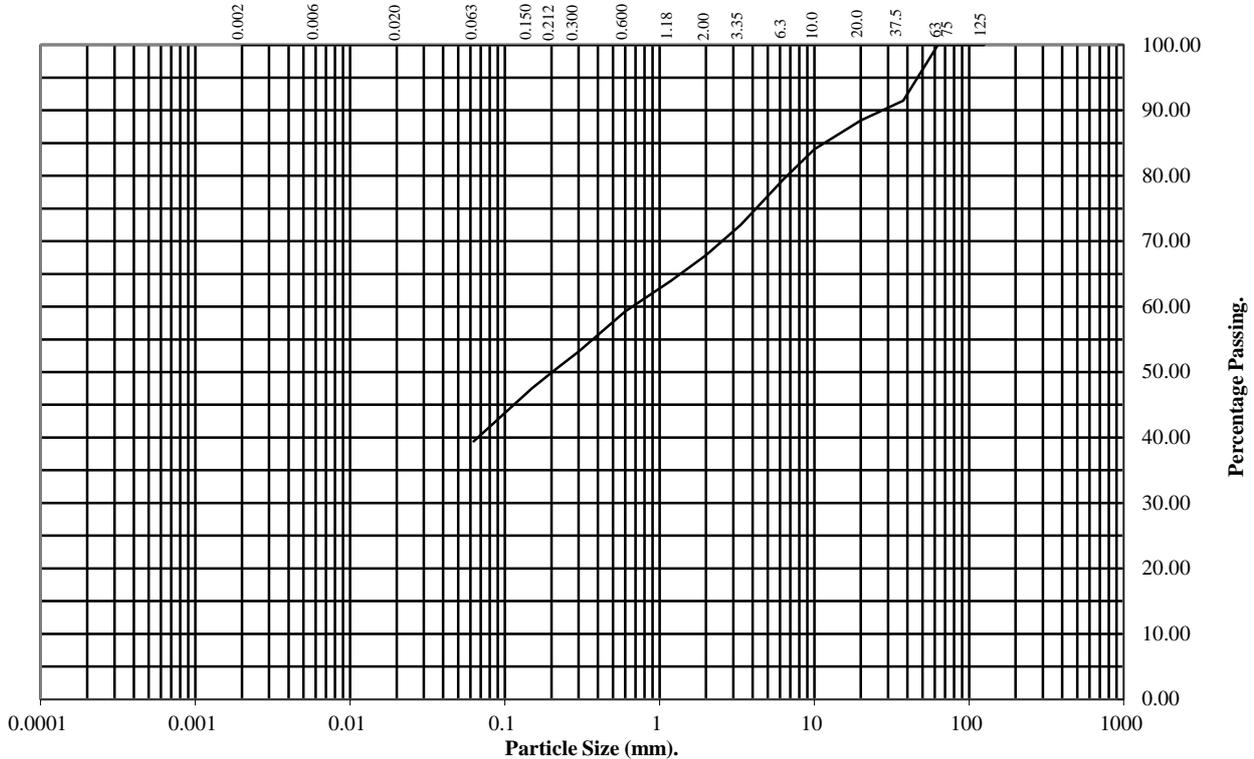
Sample Number: **3** **Base Depth(m):** **1.50**

Sample Type: **B**

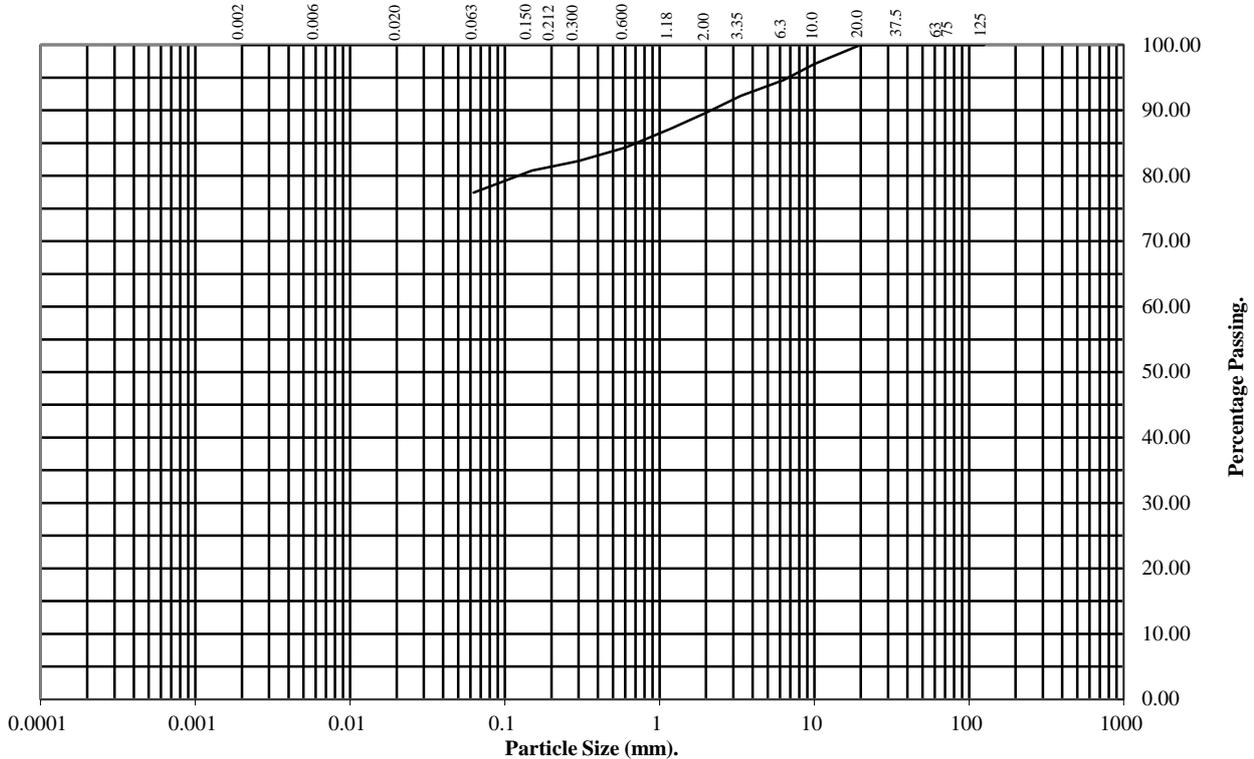
Sample Number: **6** **Base Depth(m):** **5.70**

Sample Type: **B**
