**KEYLAND DEVELOPMENTS LTD**

**LAND AT COOPER BRIDGE, HUDDERSFIELD**

**PHASE II GEO-ENVIRONMENTAL INVESTIGATION REPORT**

**DATE ISSUED:** SEPTEMBER 2016  
**JOB NUMBER:** SH10243  
**REPORT NUMBER:** RPT-003

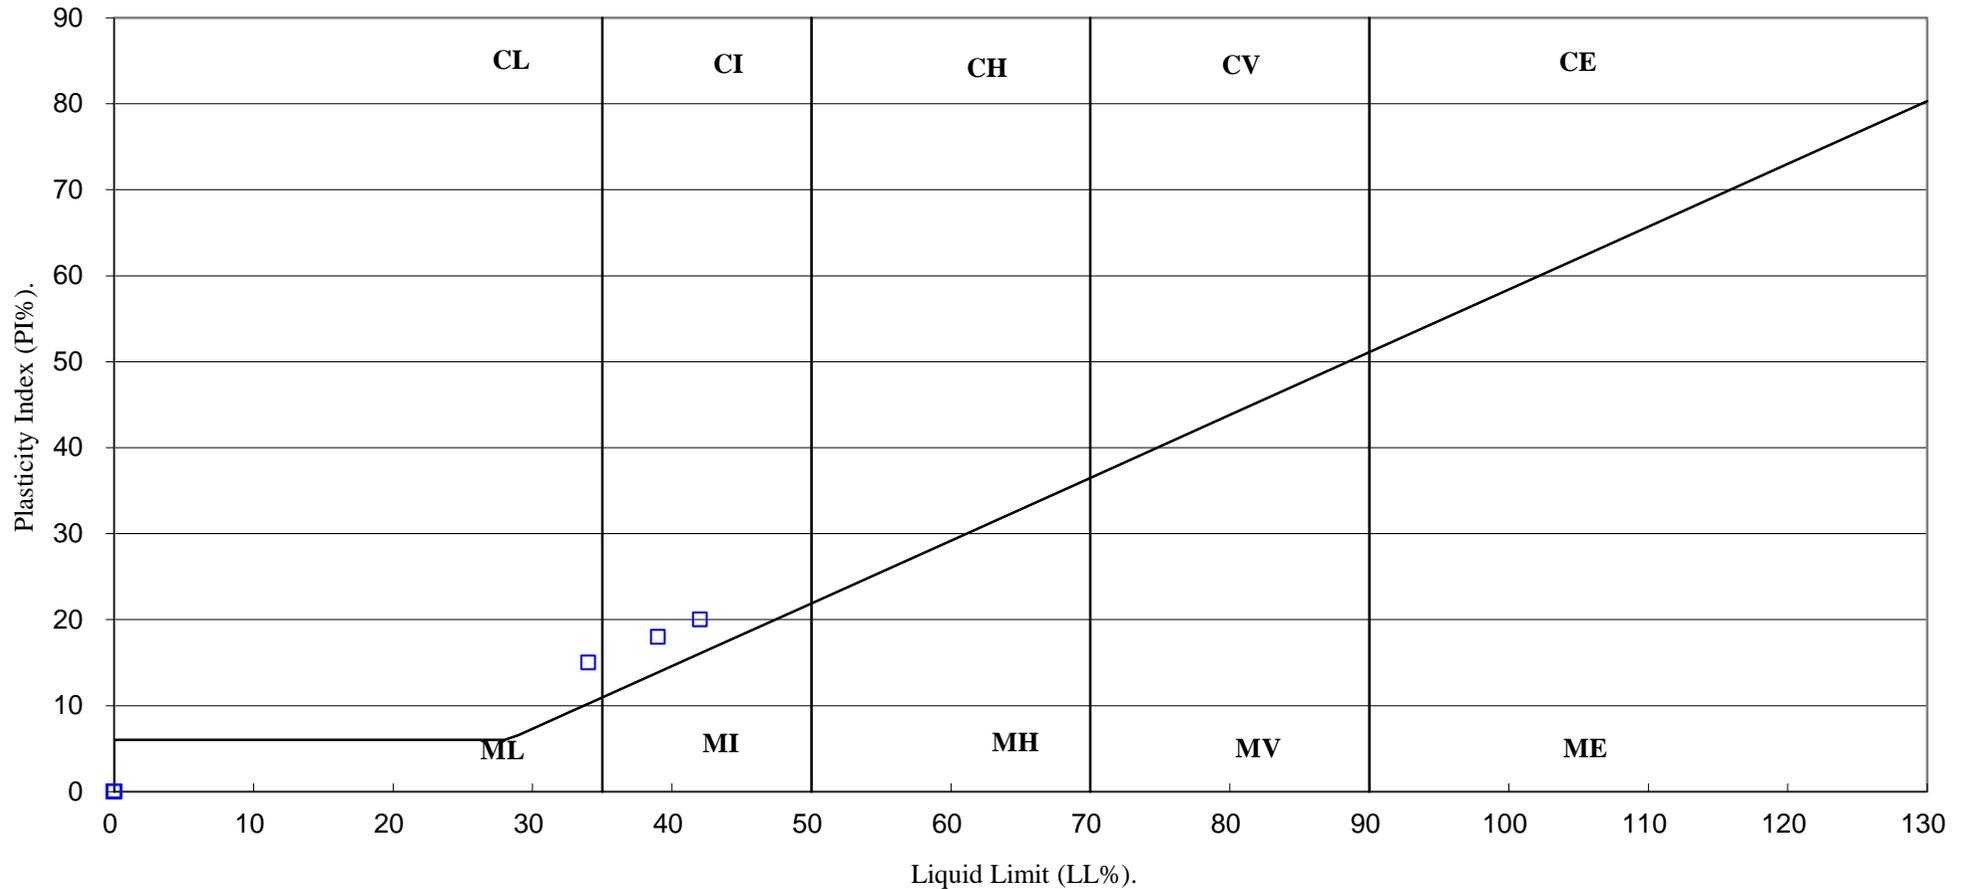
# PLASTICITY CHART FOR CASAGRANDE CLASSIFICATION.

(BS5930 :2015)

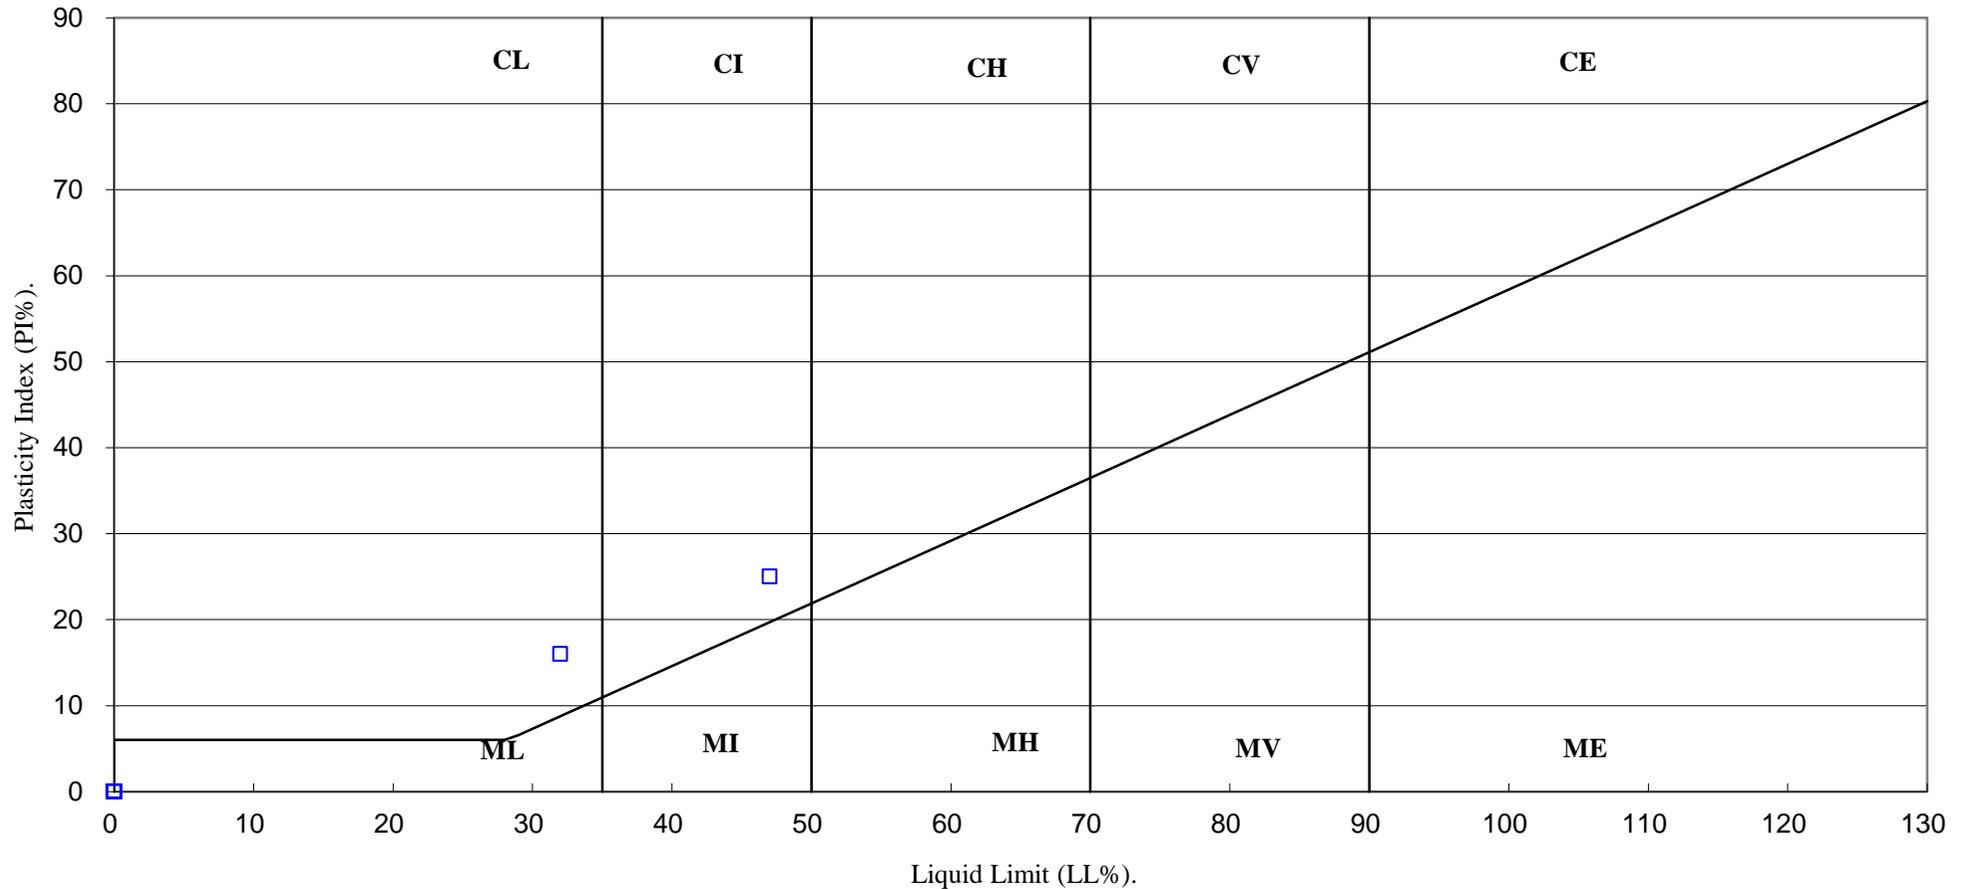
# PLASTICITY CHART FOR CASAGRANDE CLASSIFICATION.

(BS5930 :2015)

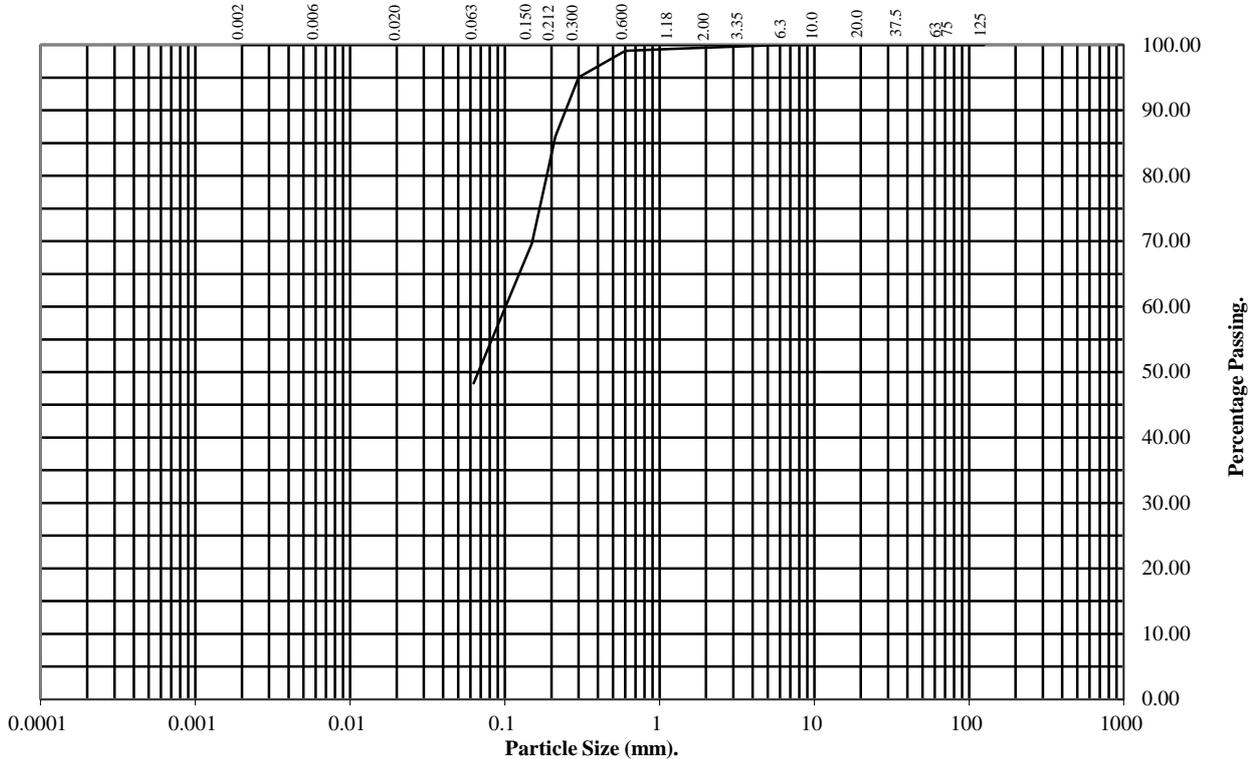
**Sample Number:**                      **5**    **Base Depth(m):**                      **1.70**

BS Test Sieve	Percentage Passing
125	100
75	100
63	100
37.5	100
20	100
10	100
6.3	100
3.35	100
2	100
1.18	99
0.6	99
0.3	95
0.212	86
0.15	70
0.063	48

Soil Fraction	Total Percentage
Cobbles	0
Gravel	0
Sand	52
Silt/Clay	48

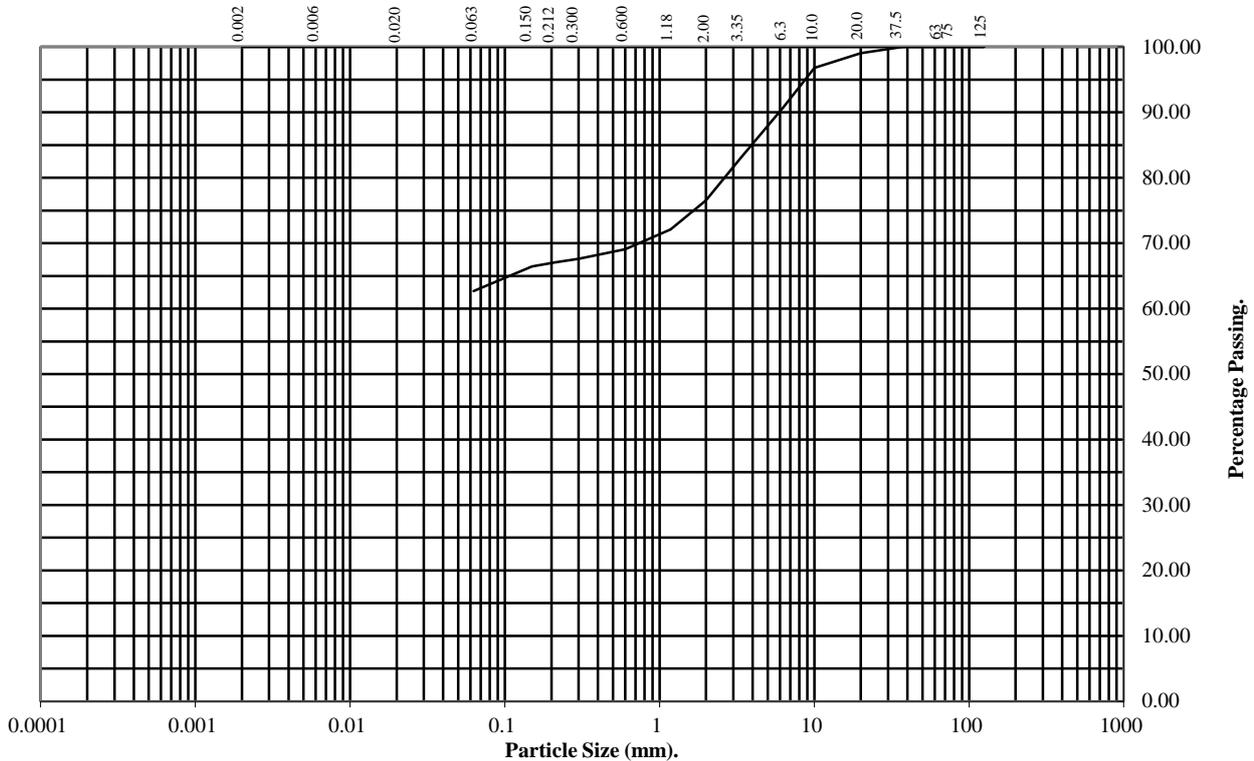
**Sample Number:** **18** **Base Depth(m):** **8.40**

BS Test Sieve	Percentage Passing
125	100
75	100
63	100
37.5	100
20	99
10	97
6.3	91
3.35	83
2	77
1.18	72
0.6	69
0.3	68
0.212	67
0.15	66
0.063	63

Soil Fraction	Total Percentage
Cobbles	0
Gravel	23
Sand	14
Silt/Clay	63

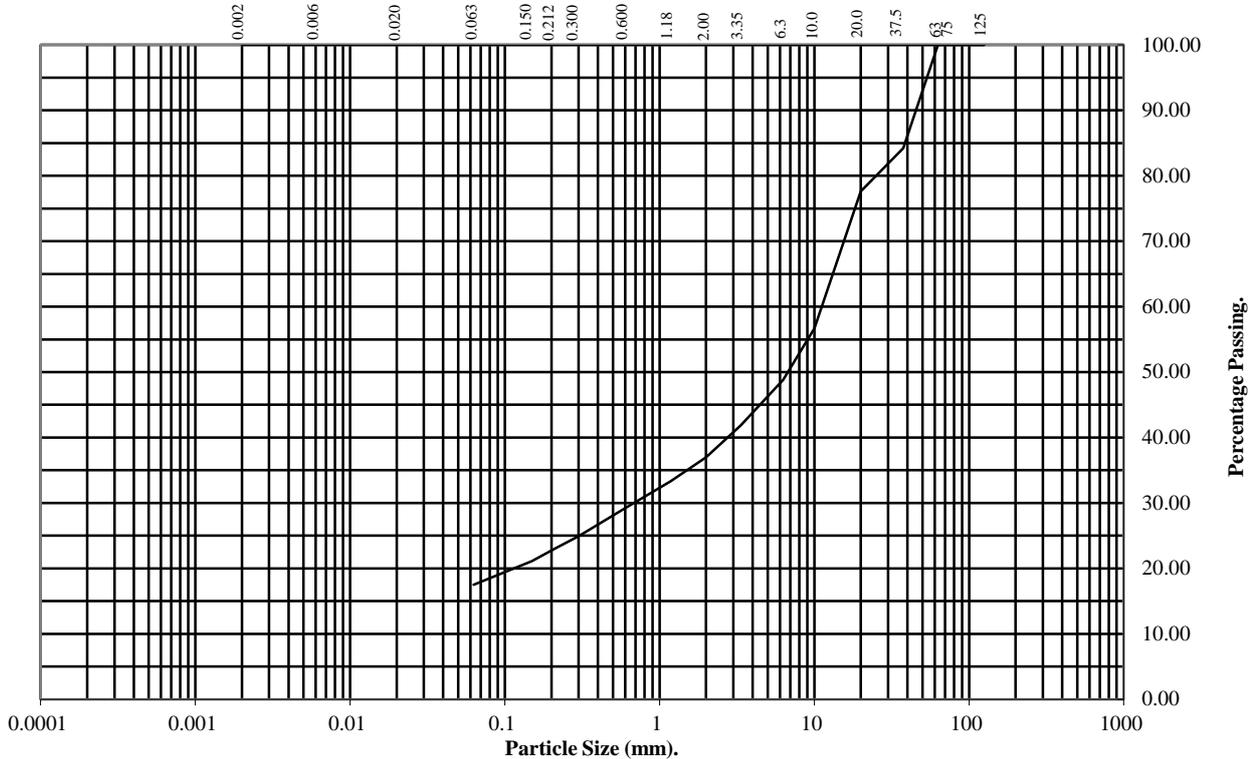
**Sample Number:** 4 **Base Depth(m):** 2.20

BS Test Sieve	Percentage Passing
125	100
75	100
63	100
37.5	84
20	78
10	57
6.3	49
3.35	42
2	37
1.18	33
0.6	29
0.3	25
0.212	23
0.15	21
0.063	18

Soil Fraction	Total Percentage
Cobbles	0
Gravel	63
Sand	19
Silt/Clay	18

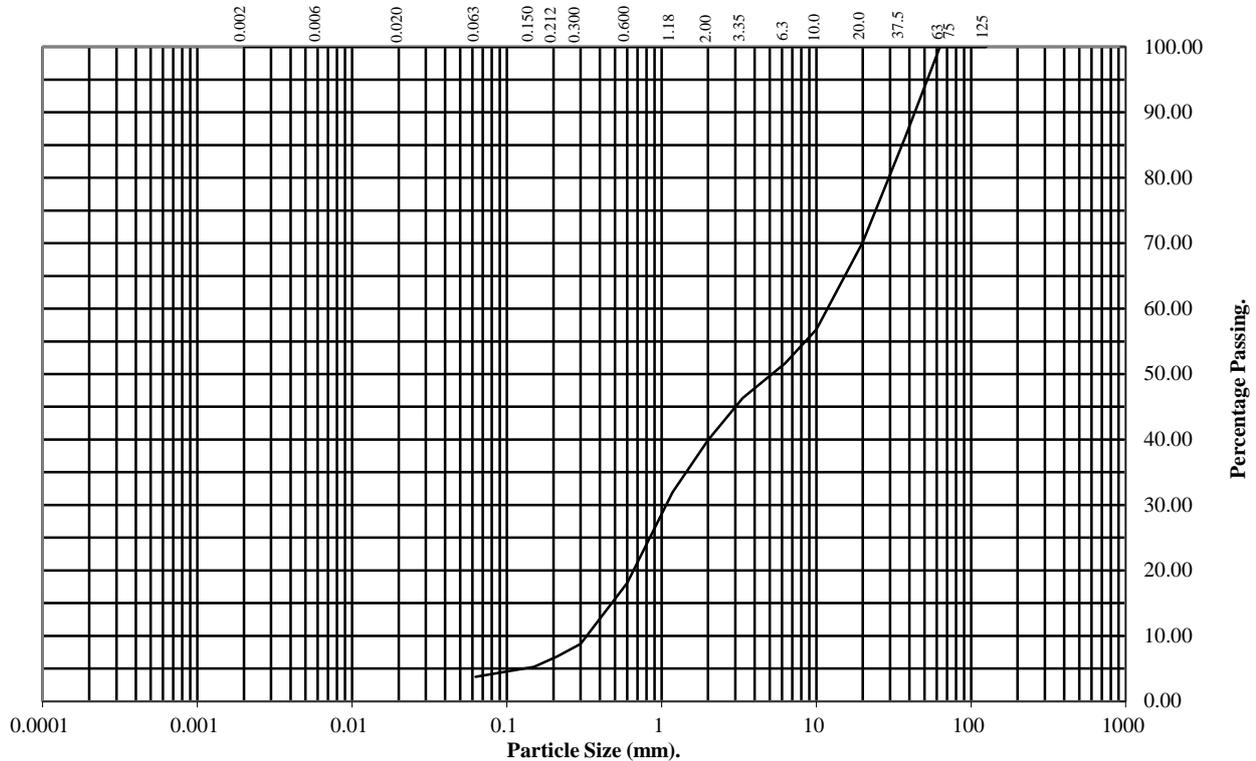
**Sample Number:** 14 **Base Depth(m):** 9.80

BS Test Sieve	Percentage Passing
125	100
75	100
63	100
37.5	86
20	70
10	57
6.3	52
3.35	46
2	40
1.18	32
0.6	18
0.3	9
0.212	7
0.15	5
0.063	4

Soil Fraction	Total Percentage
Cobbles	0
Gravel	60
Sand	36
Silt/Clay	4

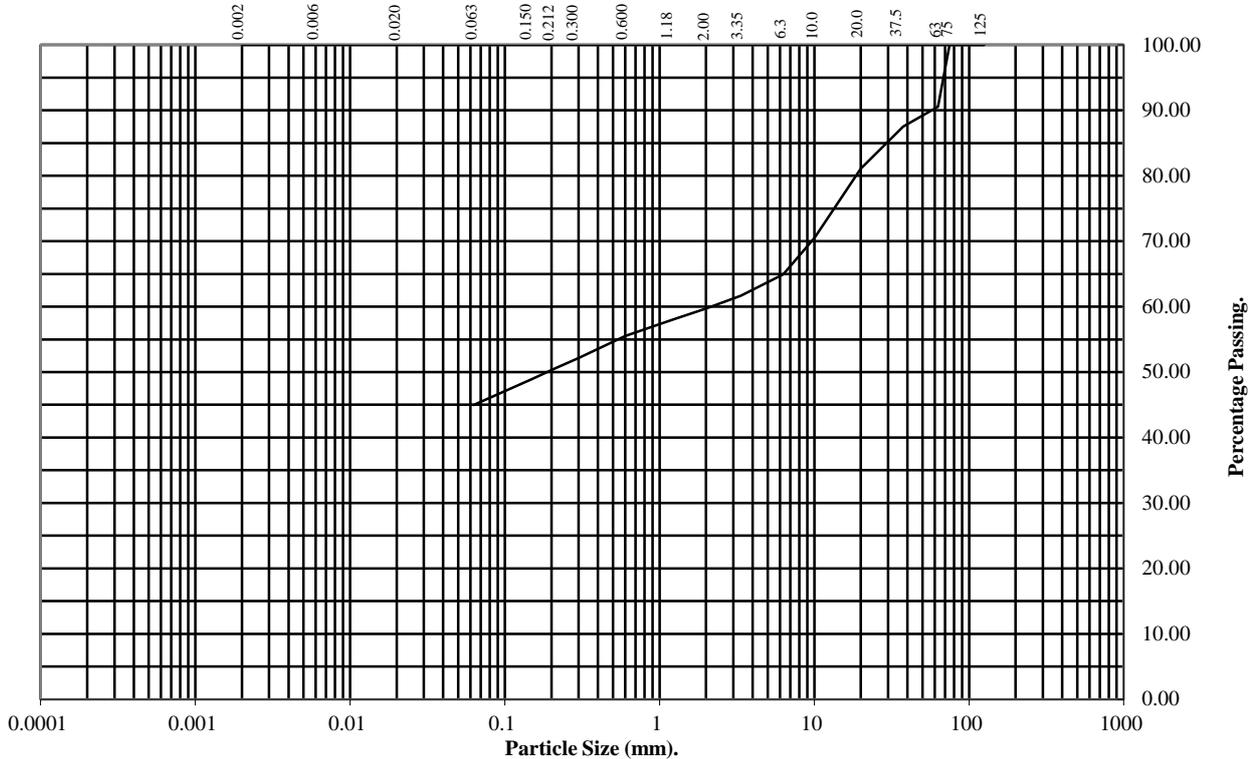
**Sample Number:** **1** **Base Depth(m):** **0.50**

BS Test Sieve	Percentage Passing
125	100
75	100
63	91
37.5	88
20	81
10	71
6.3	65
3.35	62
2	60
1.18	58
0.6	55
0.3	52
0.212	51
0.15	49
0.063	45

Soil Fraction	Total Percentage
Cobbles	9
Gravel	31
Sand	15
Silt/Clay	45

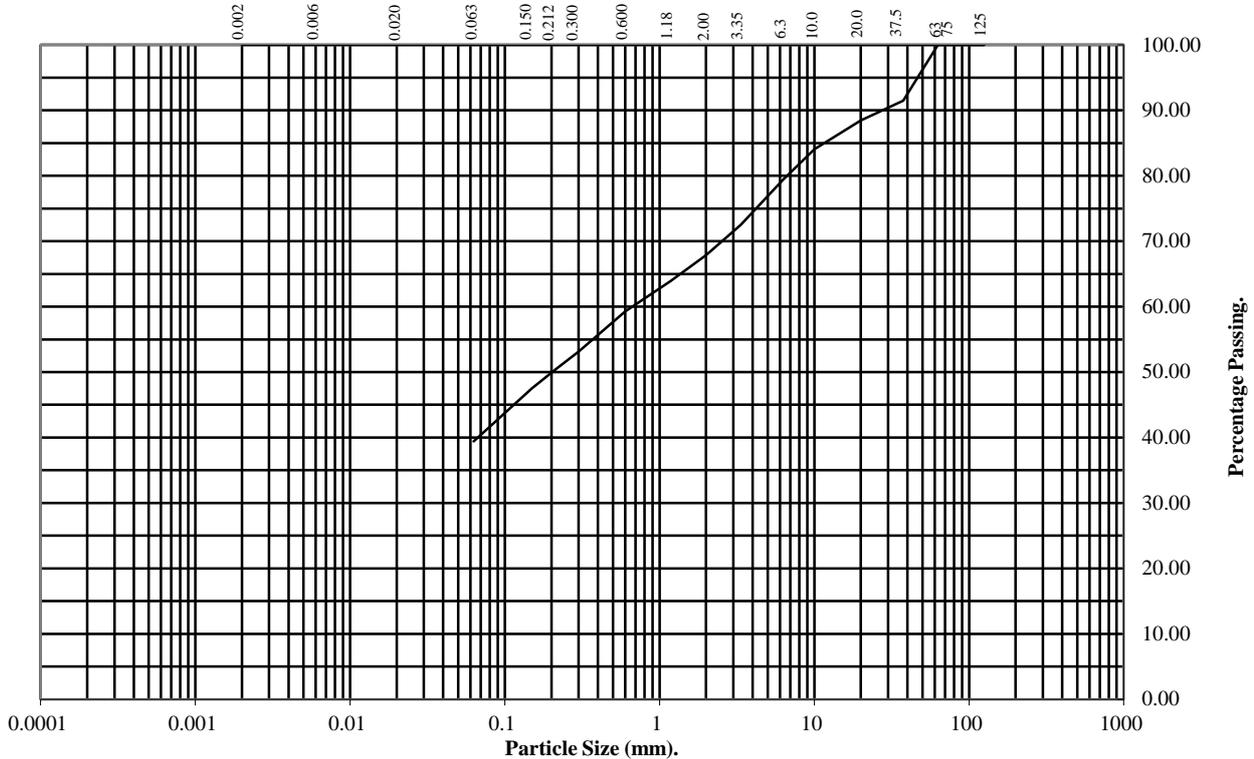
**Sample Number:**                      **3**                      **Base Depth(m):**                      **1.50**

BS Test Sieve	Percentage Passing
125	100
75	100
63	100
37.5	91
20	88
10	84
6.3	79
3.35	73
2	68
1.18	64
0.6	59
0.3	53
0.212	50
0.15	48
0.063	39

Soil Fraction	Total Percentage
Cobbles	0
Gravel	32
Sand	29
Silt/Clay	39

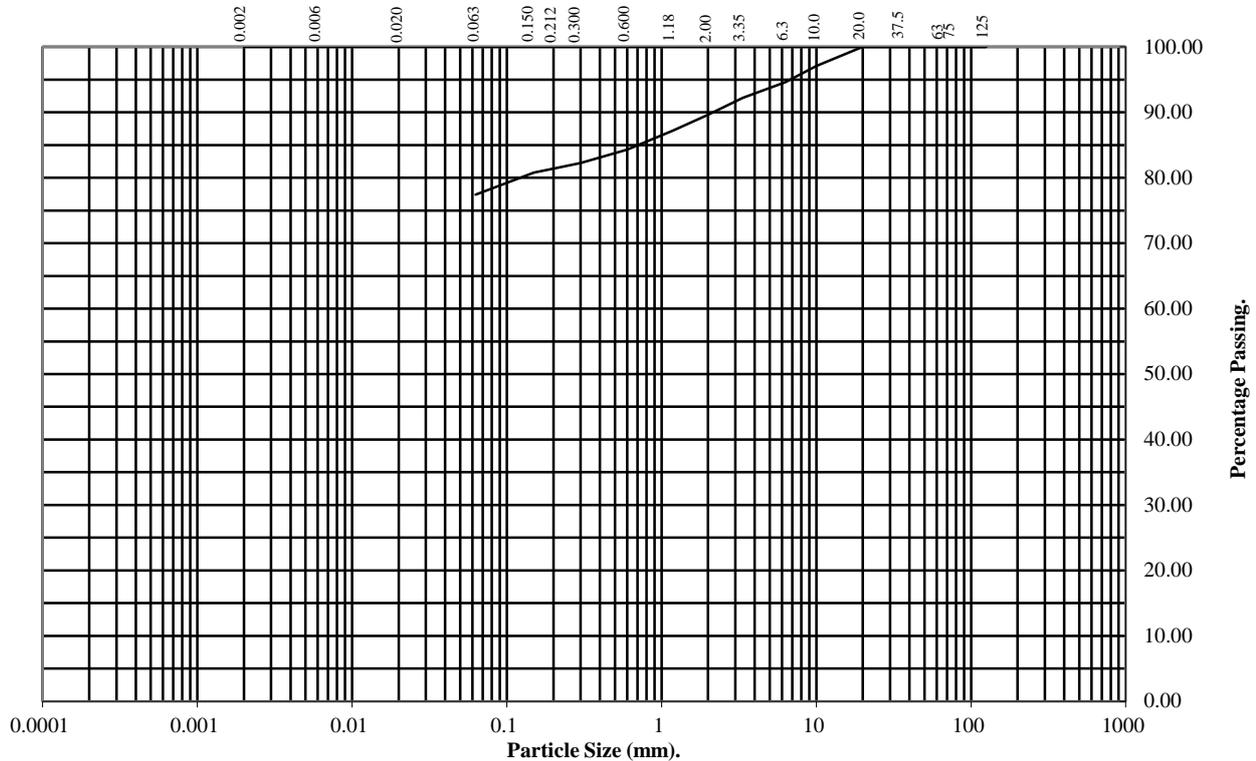
**Sample Number:**                      **6**                      **Base Depth(m):**                      **5.70**

BS Test Sieve	Percentage Passing
125	100
75	100
63	100
37.5	100
20	100
10	97
6.3	95
3.35	92
2	90
1.18	87
0.6	84
0.3	82
0.212	82
0.15	81
0.063	77

Soil Fraction	Total Percentage
Cobbles	0
Gravel	10
Sand	13
Silt/Clay	77

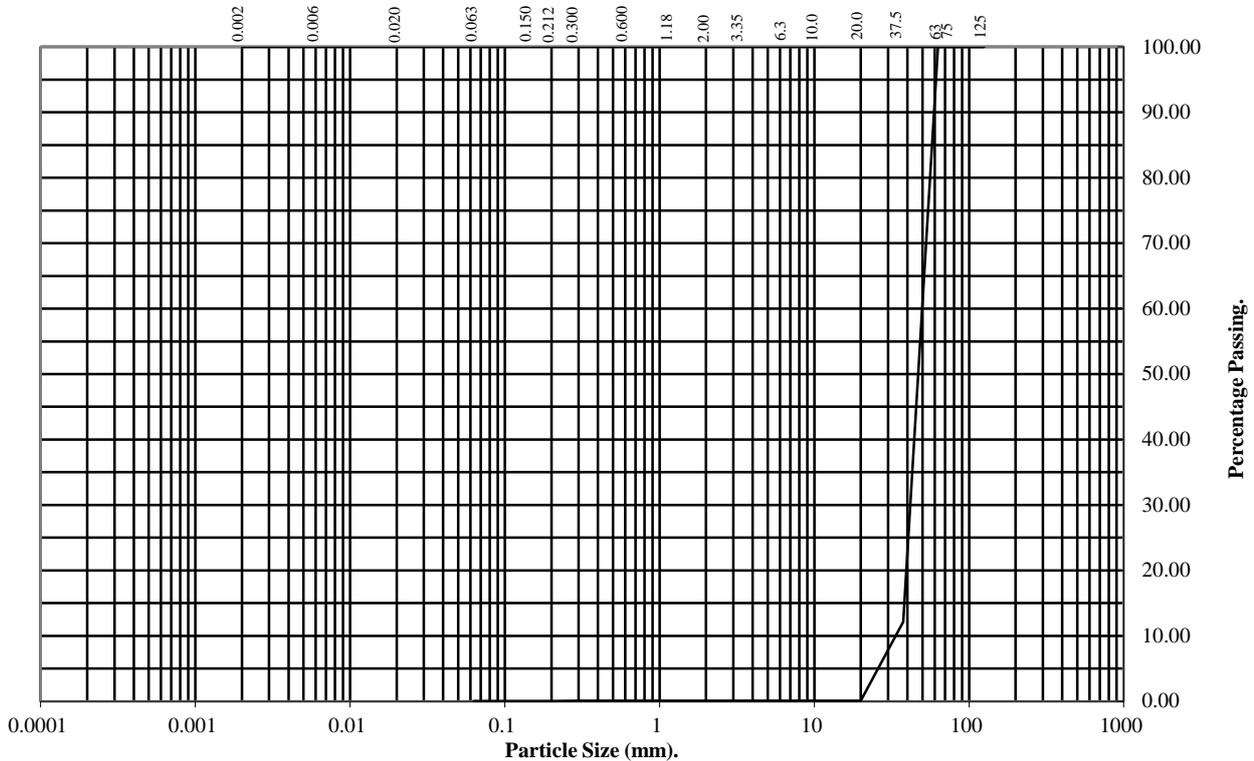
BS Test Sieve	Percentage Passing
125	100
75	100
63	100
37.5	12
20	0
10	0
6.3	0
3.35	0
2	0
1.18	0
0.6	0
0.3	0
0.212	0
0.15	0
0.063	0

Soil Fraction	Total Percentage
Cobbles	0
Gravel	100
Sand	0
Silt/Clay	0

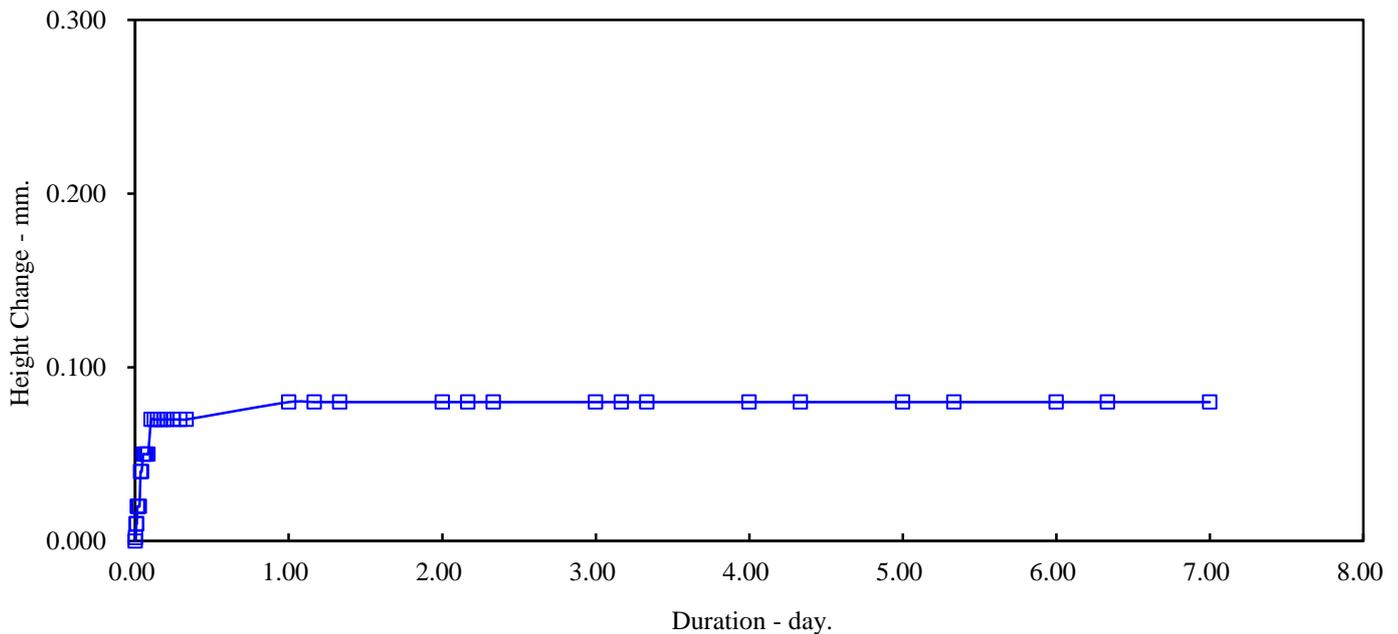
Hole Number / Depth (m):	TP101 / 0.50	Description.:	Dark grey gravel of slag.
<b>INITIAL CONDITIONS.</b>		<b>FINAL CONDITIONS.</b>	
Initial Height - mm:	126.80	Final Height - mm:	126.88
Initial Diameter - mm:	152.00	Final Mass - g:	5097.00
Initial Mass - g:	5029.00	Final Volume - cm <sup>3</sup> :	2302.34
Initial Volume - cm <sup>3</sup> :	2301.00	Dry Mass - g:	4587.00
Dry Mass - g:	4587.00	Final Moisture Content - %:	11.1
Initial Moisture Content - %:	9.6	Final Bulk Density - Mg/m <sup>3</sup> :	2.21
Initial Bulk Density - Mg/m <sup>3</sup> :	2.19	Final Dry Density - Mg/m <sup>3</sup> :	1.99
Initial Dry Density - Mg/m <sup>3</sup> :	1.99	Test Temperature oC:	82

Elapsed Time Min	Dial Gauge Reading Div	Change In Height mm	Elapsed Time Min	Dial Gauge Reading Div	Change In Height mm	Elapsed Time Min	Dial Gauge Reading Div	Change In Height mm
0	0	0.00	210	7	0.07	5760	8	0.08
5	1	0.00	240	7	0.07	6240	8	0.08
10	1	0.01	270	7	0.07	7200	8	0.08
15	1	0.01	300	7	0.07	7680	8	0.08
20	2	0.02	360	7	0.07	8640	8	0.08
25	2	0.02	420	7	0.07	9120	8	0.08
30	2	0.02	480	7	0.07	10080	8	0.08
40	2	0.02	1440	8	0.08			
50	4	0.04	1680	8	0.08			
60	4	0.04	1920	8	0.08			
75	5	0.05	2880	8	0.08			
90	5	0.05	3120	8	0.08			
105	5	0.05	3360	8	0.08			
120	5	0.05	4320	8	0.08			
150	7	0.07	4560	8	0.08			
180	7	0.07	4800	8	0.08

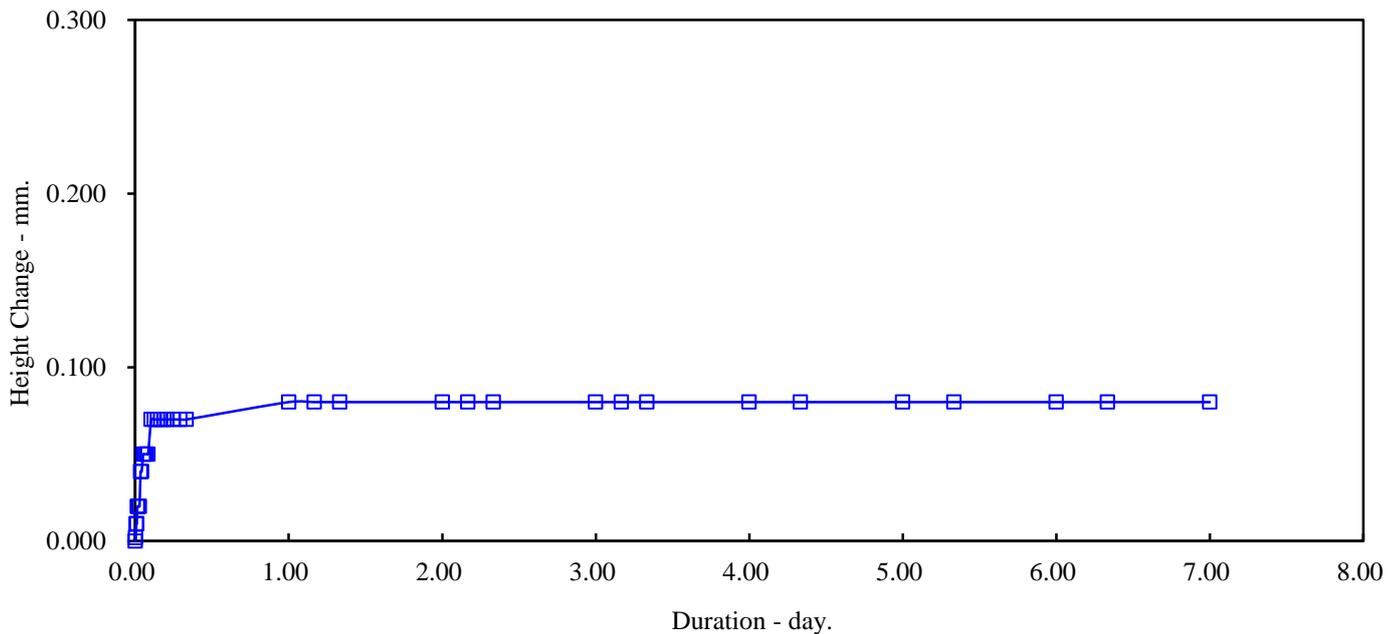
# EMERY EXPANSION TEST.

Hole Number / Depth (m):	TP102 / 4.00	Description.:	Dark grey gravel of slag.
<b>INITIAL CONDITIONS.</b>		<b>FINAL CONDITIONS.</b>	
Initial Height - mm:	127.17	Final Height - mm:	127.25
Initial Diameter - mm:	151.87	Final Mass - g:	4679.00
Initial Mass - g:	4610.00	Final Volume - cm <sup>3</sup> :	2305.11
Initial Volume - cm <sup>3</sup> :	2304.00	Dry Mass - g:	4532.00
Dry Mass - g:	4532.00	Final Moisture Content - %:	3.2
Initial Moisture Content - %:	1.7	Final Bulk Density - Mg/m <sup>3</sup> :	2.03
Initial Bulk Density - Mg/m <sup>3</sup> :	2.00	Final Dry Density - Mg/m <sup>3</sup> :	1.97
Initial Dry Density - Mg/m <sup>3</sup> :	1.97	Test Temperature oC:	82

Elapsed Time Min	Dial Gauge Reading Div	Change In Height mm	Elapsed Time Min	Dial Gauge Reading Div	Change In Height mm	Elapsed Time Min	Dial Gauge Reading Div	Change In Height mm
0	0	0.00	210	7	0.07	5760	8	0.08
5	1	0.00	240	7	0.07	6240	8	0.08
10	1	0.01	270	7	0.07	7200	8	0.08
15	1	0.01	300	7	0.07	7680	8	0.08
20	2	0.02	360	7	0.07	8640	8	0.08
25	2	0.02	420	7	0.07	9120	8	0.08
30	2	0.02	480	7	0.07	10080	8	0.08
40	2	0.02	1440	8	0.08			
50	4	0.04	1680	8	0.08			
60	4	0.04	1920	8	0.08			
75	5	0.05	2880	8	0.08			
90	5	0.05	3120	8	0.08			
105	5	0.05	3360	8	0.08			
120	5	0.05	4320	8	0.08			
150	7	0.07	4560	8	0.08			
180	7	0.07	4800	8	0.08

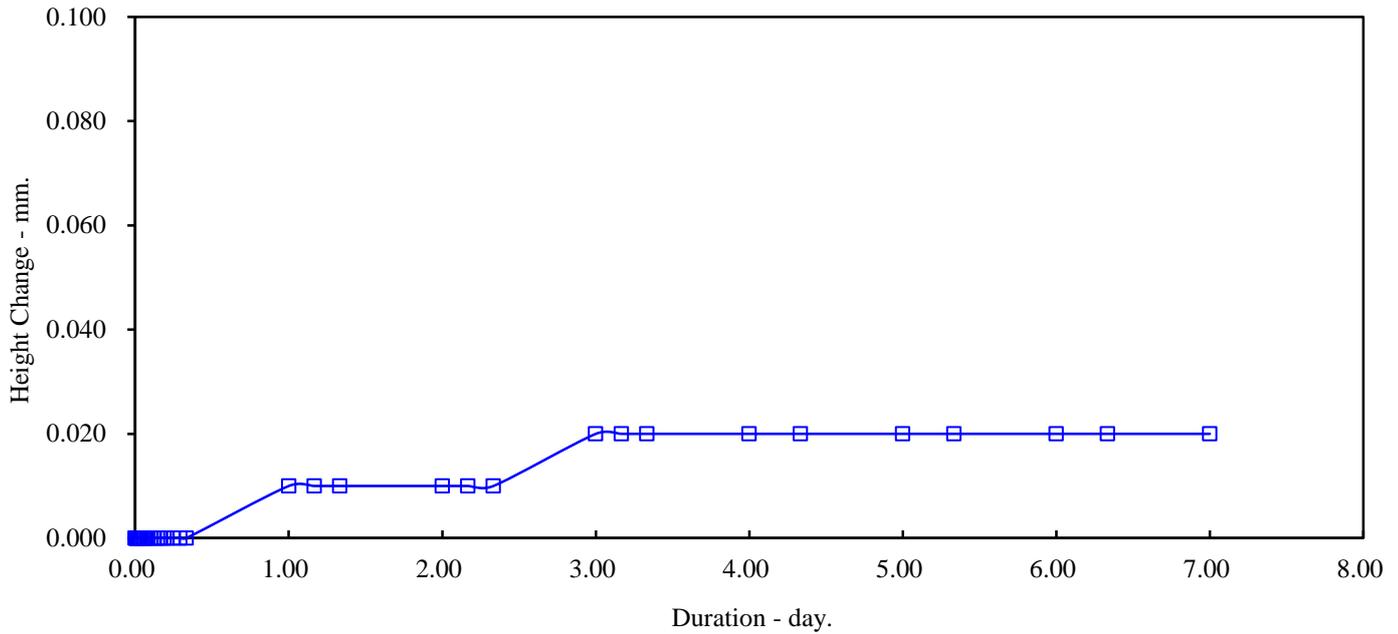
# EMERY EXPANSION TEST.

Hole Number / Depth (m):	TP103 / 1.00	Description.:	Dark grey gravel of slag.
<b>INITIAL CONDITIONS.</b>		<b>FINAL CONDITIONS.</b>	
Initial Height - mm:	127.27	Final Height - mm:	127.29
Initial Diameter - mm:	152.14	Final Mass - g:	4651.00
Initial Mass - g:	4546.00	Final Volume - cm <sup>3</sup> :	2314.04
Initial Volume - cm <sup>3</sup> :	2314.00	Dry Mass - g:	4476.00
Dry Mass - g:	4476.00	Final Moisture Content - %:	3.9
Initial Moisture Content - %:	1.6	Final Bulk Density - Mg/m <sup>3</sup> :	2.01
Initial Bulk Density - Mg/m <sup>3</sup> :	1.96	Final Dry Density - Mg/m <sup>3</sup> :	1.93
Initial Dry Density - Mg/m <sup>3</sup> :	1.93	Test Temperature oC:	82

Elapsed Time Min	Dial Gauge Reading Div	Change In Height mm	Elapsed Time Min	Dial Gauge Reading Div	Change In Height mm	Elapsed Time Min	Dial Gauge Reading Div	Change In Height mm
0	0	0.00	210	0	0.00	5760	2	0.02
5	0	0.00	240	0	0.00	6240	2	0.02
10	0	0.00	270	0	0.00	7200	2	0.02
15	0	0.00	300	0	0.00	7680	2	0.02
20	0	0.00	360	0	0.00	8640	2	0.02
25	0	0.00	420	0	0.00	9120	2	0.02
30	0	0.00	480	0	0.00	10080	2	0.02
40	0	0.00	1440	1	0.01			
50	0	0.00	1680	1	0.01			
60	0	0.00	1920	1	0.01			
75	0	0.00	2880	1	0.01			
90	0	0.00	3120	1	0.01			
105	0	0.00	3360	1	0.01			
120	0	0.00	4320	2	0.02			
150	0	0.00	4560	2	0.02			
180	0	0.00	4800	2	0.02

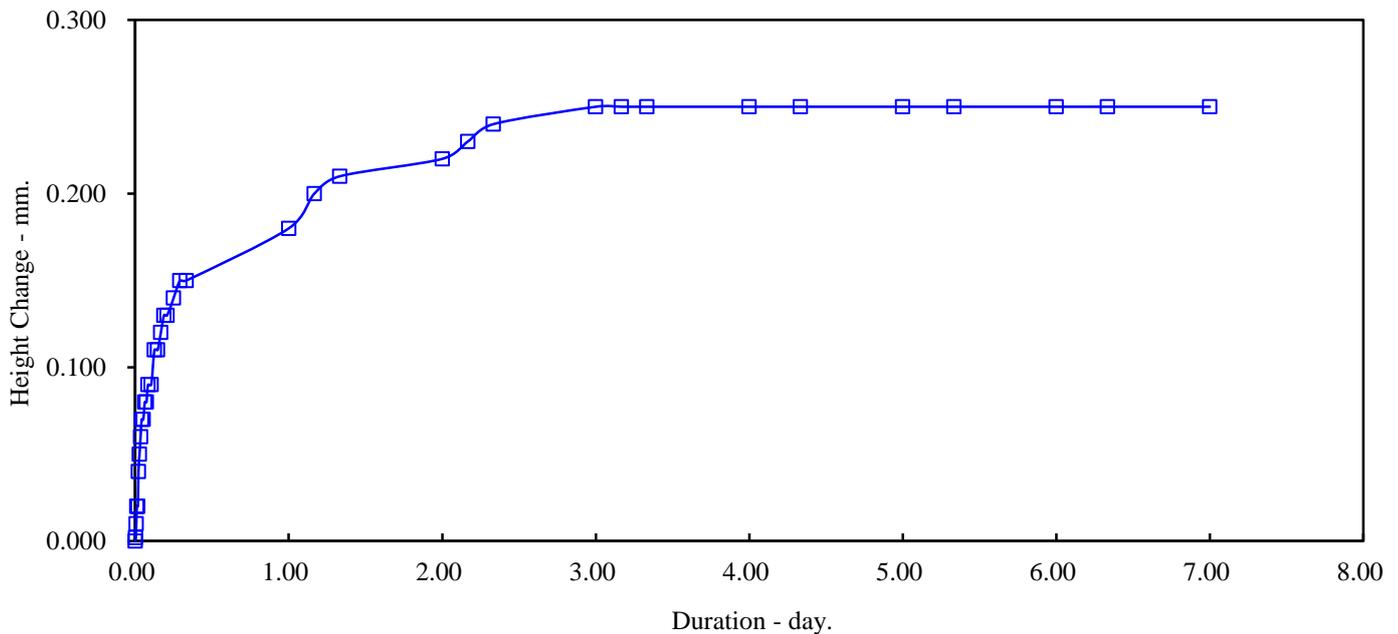
# EMERY EXPANSION TEST.

Hole Number / Depth (m):	TP104 / 1.00	Description.:	Dark grey gravel of slag.
<b>INITIAL CONDITIONS.</b>		<b>FINAL CONDITIONS.</b>	
Initial Height - mm:	126.90	Final Height - mm:	127.15
Initial Diameter - mm:	151.00	Final Mass - g:	4710.00
Initial Mass - g:	4601.00	Final Volume - cm <sup>3</sup> :	2276.98
Initial Volume - cm <sup>3</sup> :	2273.00	Dry Mass - g:	4371.00
Dry Mass - g:	4371.00	Final Moisture Content - %:	7.7
Initial Moisture Content - %:	5.3	Final Bulk Density - Mg/m <sup>3</sup> :	2.07
Initial Bulk Density - Mg/m <sup>3</sup> :	2.02	Final Dry Density - Mg/m <sup>3</sup> :	1.92
Initial Dry Density - Mg/m <sup>3</sup> :	1.92	Test Temperature oC:	82

Elapsed Time Min	Dial Gauge Reading Div	Change In Height mm	Elapsed Time Min	Dial Gauge Reading Div	Change In Height mm	Elapsed Time Min	Dial Gauge Reading Div	Change In Height mm
0	0	0.00	210	11	0.11	5760	25	0.25
5	1	0.00	240	12	0.12	6240	25	0.25
10	1	0.01	270	13	0.13	7200	25	0.25
15	2	0.02	300	13	0.13	7680	25	0.25
20	2	0.02	360	14	0.14	8640	25	0.25
25	2	0.02	420	15	0.15	9120	25	0.25
30	4	0.04	480	15	0.15	10080	25	0.25
40	5	0.05	1440	18	0.18			
50	6	0.06	1680	20	0.20			
60	7	0.07	1920	21	0.21			
75	7	0.07	2880	22	0.22			
90	8	0.08	3120	23	0.23			
105	8	0.08	3360	24	0.24			
120	9	0.09	4320	25	0.25			
150	9	0.09	4560	25	0.25			
180	11	0.11	4800	25	0.25

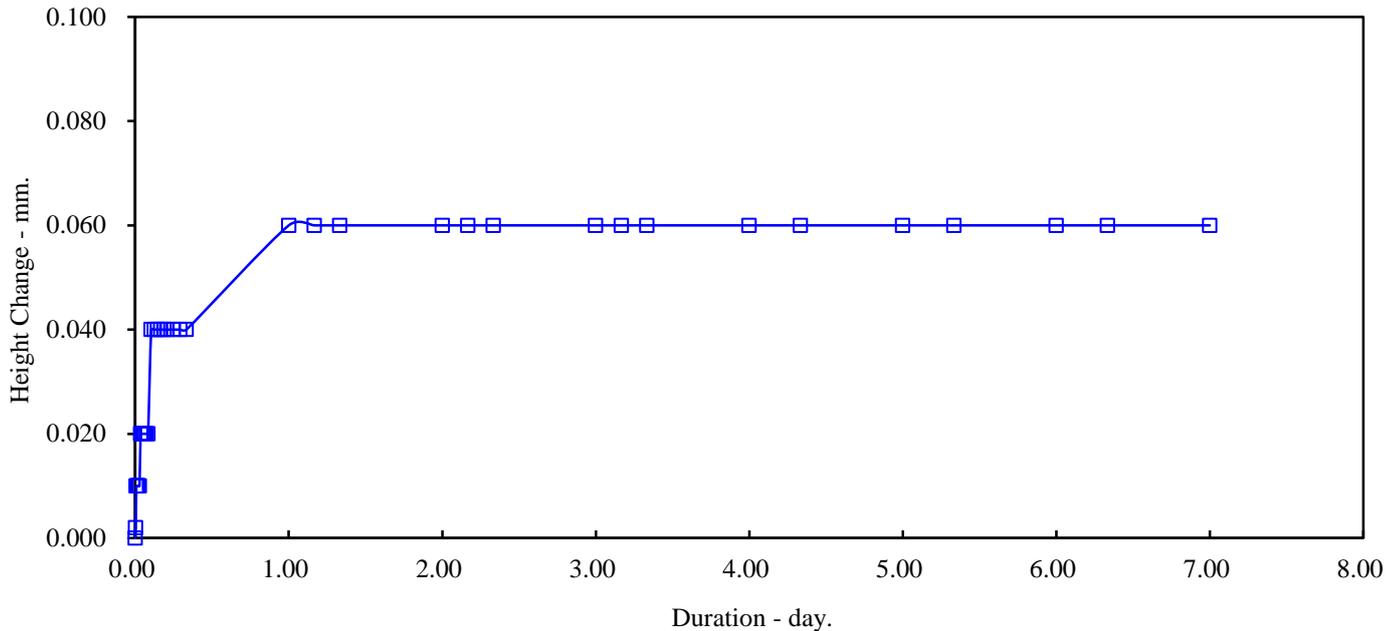
# EMERY EXPANSION TEST.

Hole Number / Depth (m):	TP106 / 1.50	Description.:	Dark grey gravel of slag.
<b>INITIAL CONDITIONS.</b>		<b>FINAL CONDITIONS.</b>	
Initial Height - mm:	127.00	Final Height - mm:	127.06
Initial Diameter - mm:	152.00	Final Mass - g:	4687.00
Initial Mass - g:	4473.00	Final Volume - cm <sup>3</sup> :	2305.61
Initial Volume - cm <sup>3</sup> :	2305.00	Dry Mass - g:	4397.00
Dry Mass - g:	4397.00	Final Moisture Content - %:	6.6
Initial Moisture Content - %:	1.7	Final Bulk Density - Mg/m <sup>3</sup> :	2.03
Initial Bulk Density - Mg/m <sup>3</sup> :	1.94	Final Dry Density - Mg/m <sup>3</sup> :	1.91
Initial Dry Density - Mg/m <sup>3</sup> :	1.91	Test Temperature oC:	82

Elapsed Time Min	Dial Gauge Reading Div	Change In Height mm	Elapsed Time Min	Dial Gauge Reading Div	Change In Height mm	Elapsed Time Min	Dial Gauge Reading Div	Change In Height mm
0	0	0.00	210	4	0.04	5760	6	0.06
5	1	0.00	240	4	0.04	6240	6	0.06
10	1	0.01	270	4	0.04	7200	6	0.06
15	1	0.01	300	4	0.04	7680	6	0.06
20	1	0.01	360	4	0.04	8640	6	0.06
25	1	0.01	420	4	0.04	9120	6	0.06
30	1	0.01	480	4	0.04	10080	6	0.06
40	1	0.01	1440	6	0.06			
50	2	0.02	1680	6	0.06			
60	2	0.02	1920	6	0.06			
75	2	0.02	2880	6	0.06			
90	2	0.02	3120	6	0.06			
105	2	0.02	3360	6	0.06			
120	2	0.02	4320	6	0.06			
150	4	0.04	4560	6	0.06			
180	4	0.04	4800	6	0.06

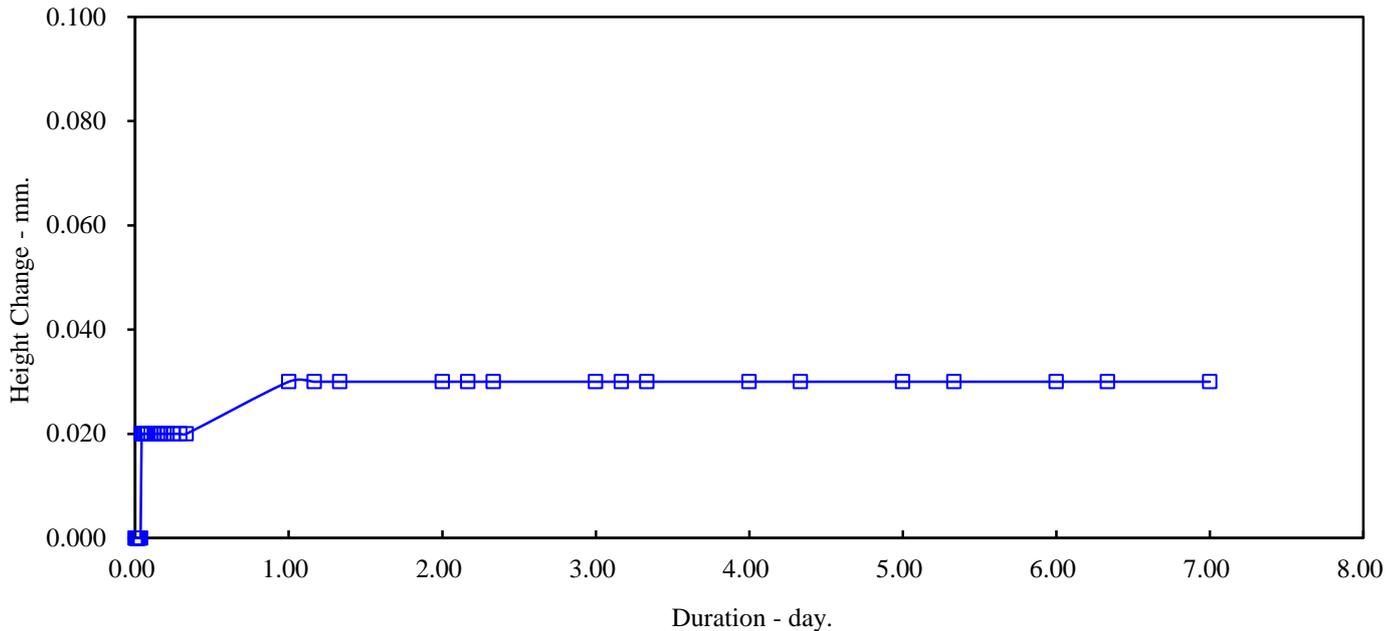
# EMERY EXPANSION TEST.

Hole Number / Depth (m):	TP109 / 2.50	Description.:	Dark grey gravel of slag.
<b>INITIAL CONDITIONS.</b>		<b>FINAL CONDITIONS.</b>	
Initial Height - mm:	126.90	Final Height - mm:	126.93
Initial Diameter - mm:	151.90	Final Mass - g:	4687.00
Initial Mass - g:	4490.00	Final Volume - cm <sup>3</sup> :	2300.22
Initial Volume - cm <sup>3</sup> :	2280.00	Dry Mass - g:	4377.00
Dry Mass - g:	4377.00	Final Moisture Content - %:	5.3
Initial Moisture Content - %:	2.6	Final Bulk Density - Mg/m <sup>3</sup> :	2.04
Initial Bulk Density - Mg/m <sup>3</sup> :	1.97	Final Dry Density - Mg/m <sup>3</sup> :	1.94
Initial Dry Density - Mg/m <sup>3</sup> :	1.92	Test Temperature oC:	82

Elapsed Time Min	Dial Gauge Reading Div	Change In Height mm	Elapsed Time Min	Dial Gauge Reading Div	Change In Height mm	Elapsed Time Min	Dial Gauge Reading Div	Change In Height mm
0	0	0.00	210	2	0.02	5760	3	0.03
5	0	0.00	240	2	0.02	6240	3	0.03
10	0	0.00	270	2	0.02	7200	3	0.03
15	0	0.00	300	2	0.02	7680	3	0.03
20	0	0.00	360	2	0.02	8640	3	0.03
25	0	0.00	420	2	0.02	9120	3	0.03
30	0	0.00	480	2	0.02	10080	3	0.03
40	0	0.00	1440	3	0.03			
50	0	0.00	1680	3	0.03			
60	2	0.02	1920	3	0.03			
75	2	0.02	2880	3	0.03			
90	2	0.02	3120	3	0.03			
105	2	0.02	3360	3	0.03			
120	2	0.02	4320	3	0.03			
150	2	0.02	4560	3	0.03			
180	2	0.02	4800	3	0.03

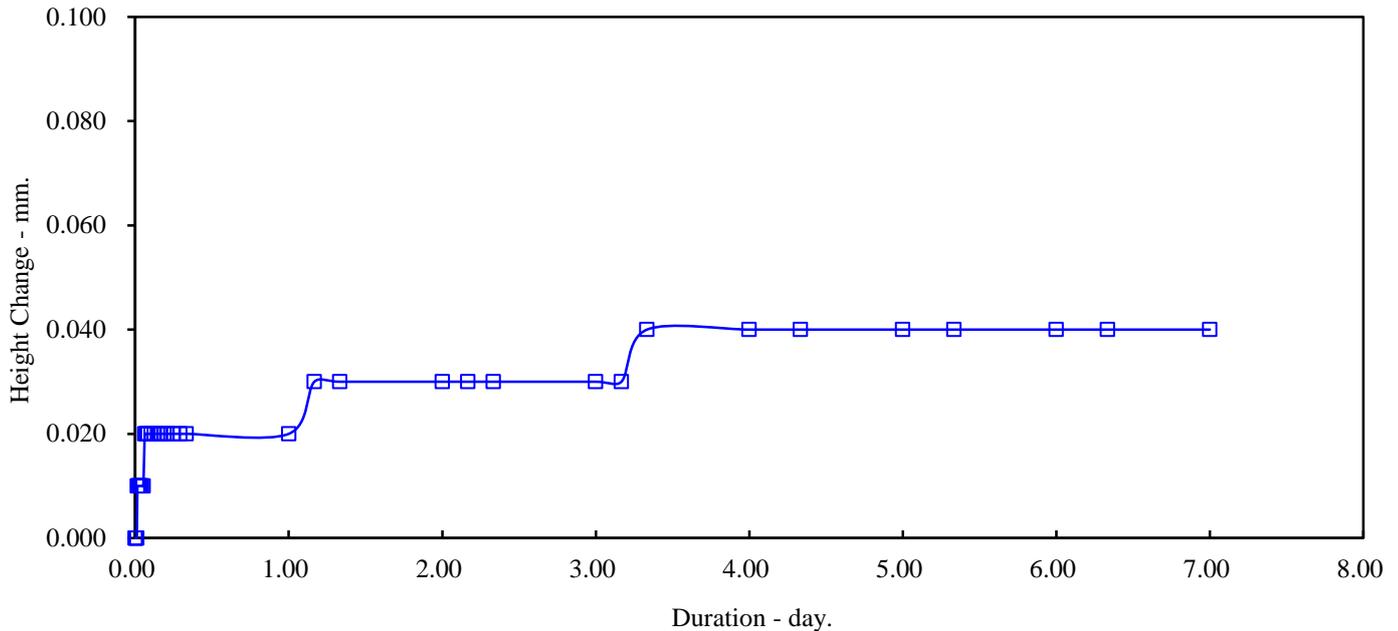
# EMERY EXPANSION TEST.

Hole Number / Depth (m):	TP111 / 3.00	Description.:	Dark grey gravel of slag.
<b>INITIAL CONDITIONS.</b>		<b>FINAL CONDITIONS.</b>	
Initial Height - mm:	127.00	Final Height - mm:	127.04
Initial Diameter - mm:	151.80	Final Mass - g:	4817.00
Initial Mass - g:	4723.00	Final Volume - cm <sup>3</sup> :	2299.18
Initial Volume - cm <sup>3</sup> :	2299.00	Dry Mass - g:	4508.00
Dry Mass - g:	4508.00	Final Moisture Content - %:	6.8
Initial Moisture Content - %:	4.8	Final Bulk Density - Mg/m <sup>3</sup> :	2.10
Initial Bulk Density - Mg/m <sup>3</sup> :	2.05	Final Dry Density - Mg/m <sup>3</sup> :	1.96
Initial Dry Density - Mg/m <sup>3</sup> :	1.96	Test Temperature oC:	82

Elapsed Time Min	Dial Gauge Reading Div	Change In Height mm	Elapsed Time Min	Dial Gauge Reading Div	Change In Height mm	Elapsed Time Min	Dial Gauge Reading Div	Change In Height mm
0	0	0.00	210	2	0.02	5760	4	0.04
5	0	0.00	240	2	0.02	6240	4	0.04
10	0	0.00	270	2	0.02	7200	4	0.04
15	0	0.00	300	2	0.02	7680	4	0.04
20	1	0.01	360	2	0.02	8640	4	0.04
25	1	0.01	420	2	0.02	9120	4	0.04
30	1	0.01	480	2	0.02	10080	4	0.04
40	1	0.01	1440	2	0.02			
50	1	0.01	1680	3	0.03			
60	1	0.01	1920	3	0.03			
75	1	0.01	2880	3	0.03			
90	2	0.02	3120	3	0.03			
105	2	0.02	3360	3	0.03			
120	2	0.02	4320	3	0.03			
150	2	0.02	4560	3	0.03			
180	2	0.02	4800	4	0.04

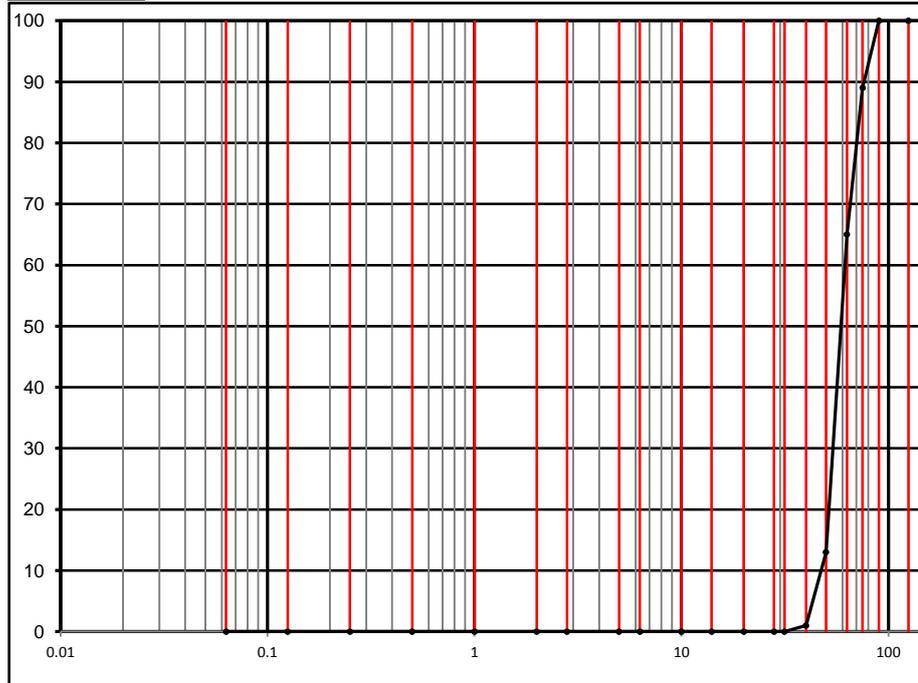
Certificate of sampling received	<b>No</b>	Name of Source:	<b>Unknown</b>
Laboratory Ref. No:	<b>S59777</b>	Method of Sampling:	<b>Unknown</b>
Client Ref. No:	<b>Recycled - 100mm Down</b>	Sampled By:	<b>Client</b>
Date and Time of Sampling:	<b>Unknown</b>		
Date of Receipt at Lab:	<b>11/08/2016</b>		
Date of Start of Test:	<b>30/08/2016</b>		
Sampling Location:	<b>Unknown</b>		
Material Description	<b>Recycled Granular - 100mm Down</b>

BS TEST SIEVE SIZE	PERCENTAGE BY MASS PASSING	SPECIFICATION LIMITS
125.0 mm	100	
90.0 mm	100	
75.0 mm	89	
63.0 mm	65	
50.0 mm	13	
40.0 mm	1	
31.5 mm	0	
28.0 mm	0	
20.0 mm	0	
14.0 mm	0	
10.0 mm	0	
6.3 mm	0	
5.0 mm	0	
2.8 mm	0	
2.0 mm	0	
1.0 mm	0	
0.500 mm	0	
0.250 mm	0	
0.125 mm	0	
0.063 mm	0
