Planning ref 23/92542- Quaker Bottom

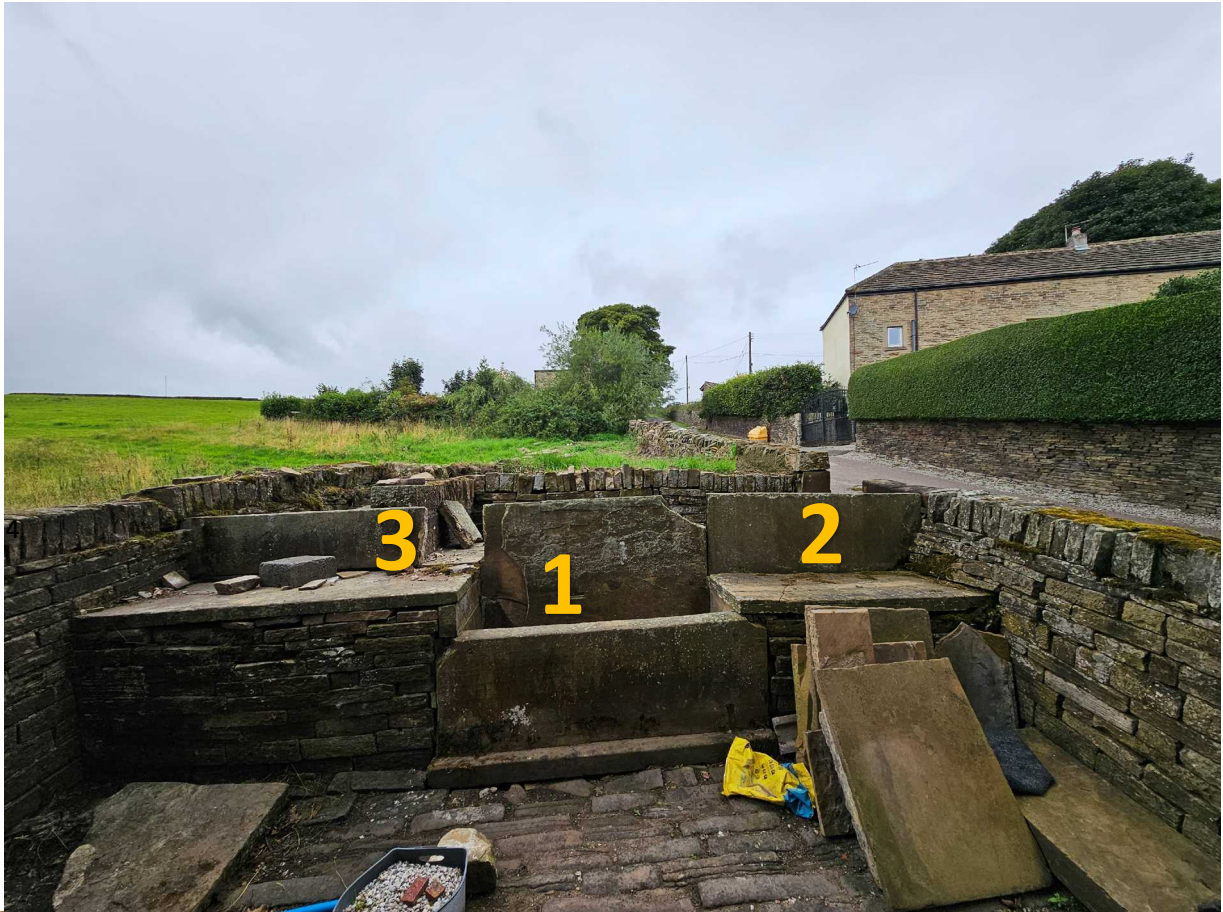
Photograph labelled number 1 shows the central dividing stone 1.2 metres by 1.5 metres. This is to be replaced with an exact matching stone.
