## Ground Investigation Report - Geotechnical

Ground Stability at Cellars Clough, Marsden

Site Ref: 6018/CCZ-G v1.0

Ground Investigation Report – Slope Stability Assessment

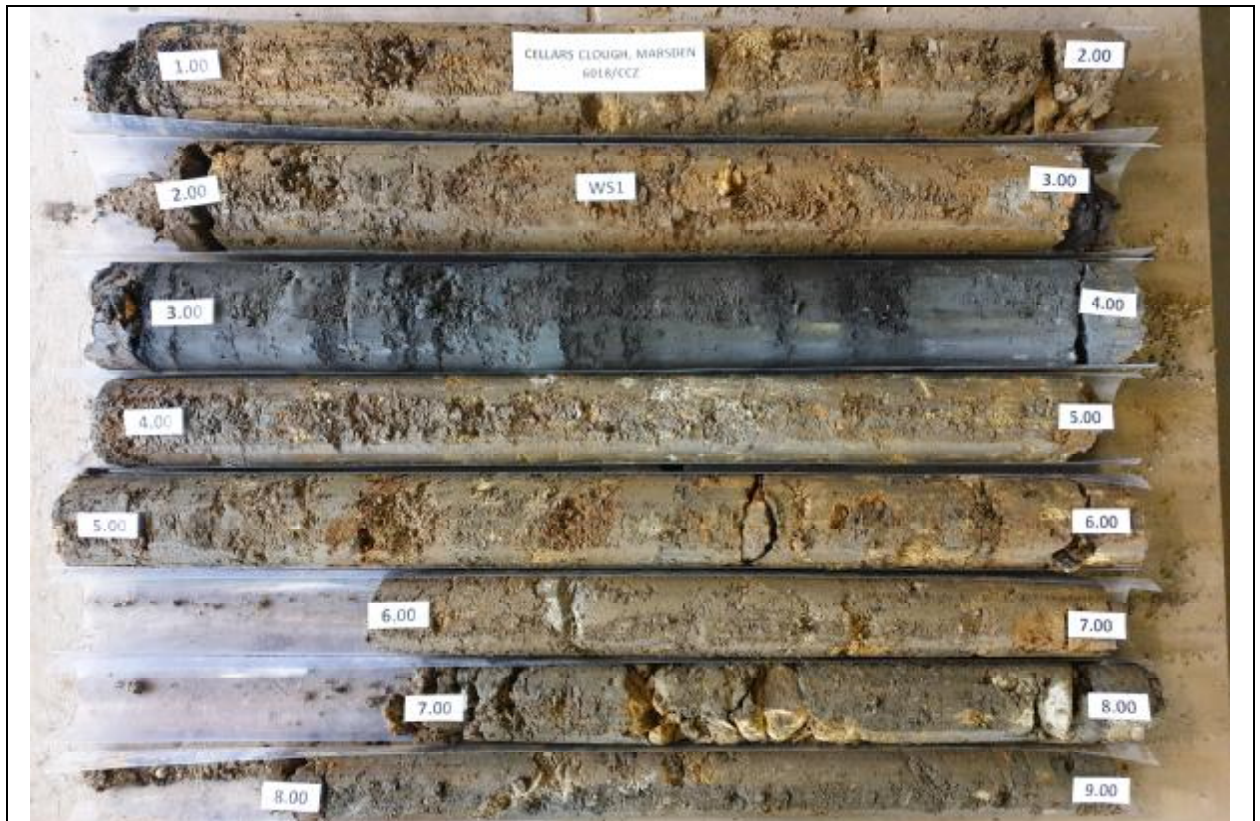
**WS1 – as recovered**

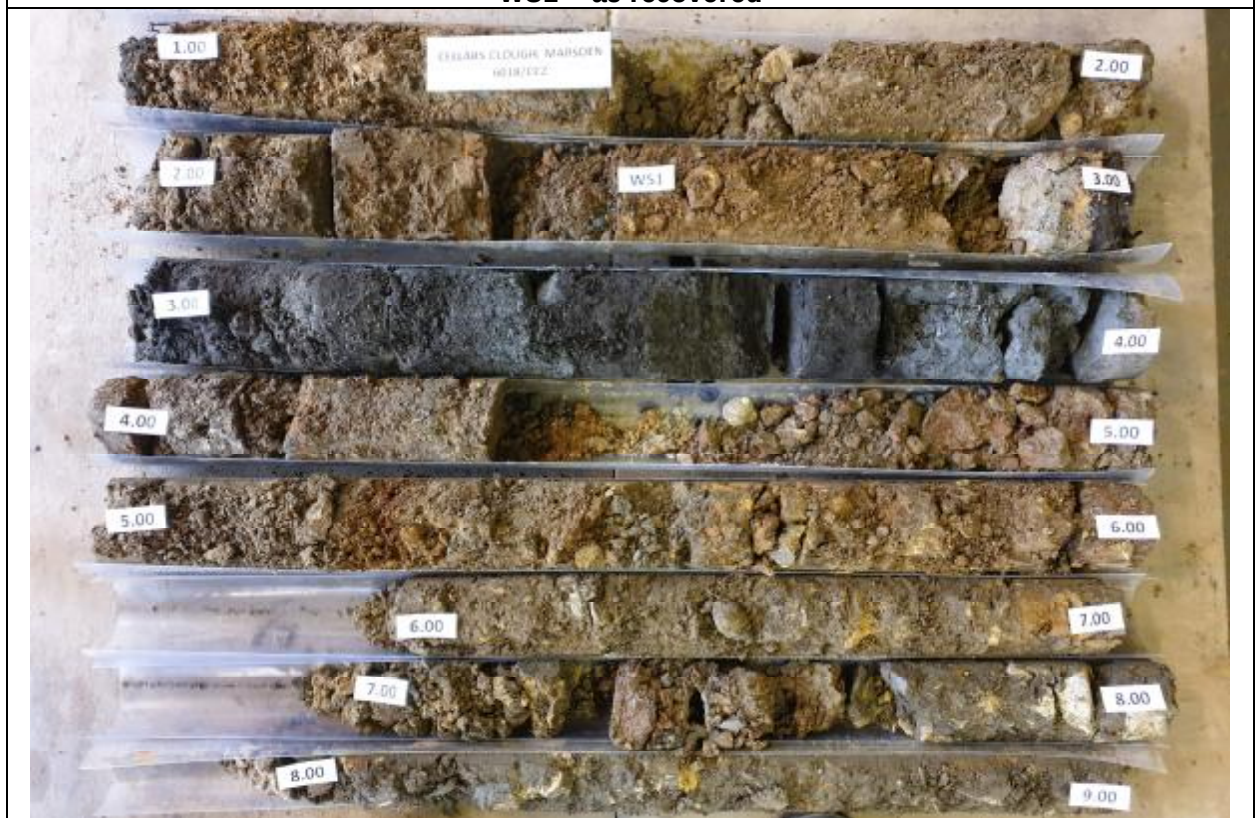
**WS1 – after sub sampling**

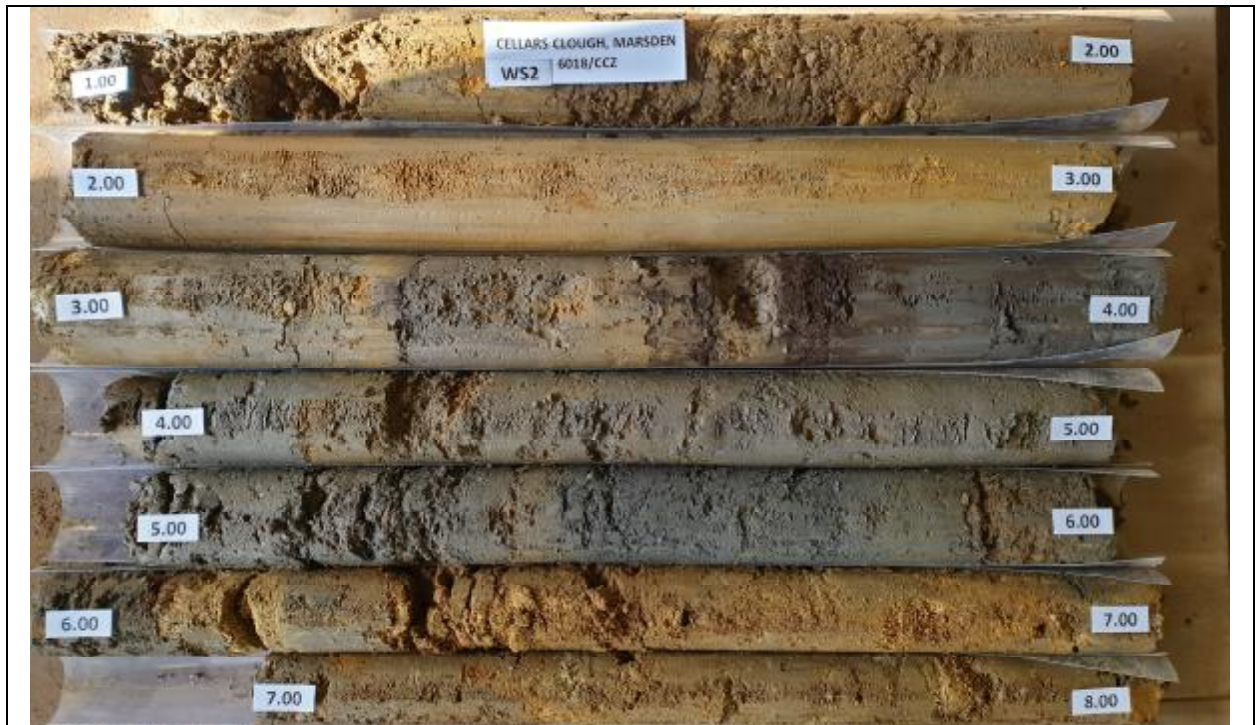
**WS2 – as recovered**

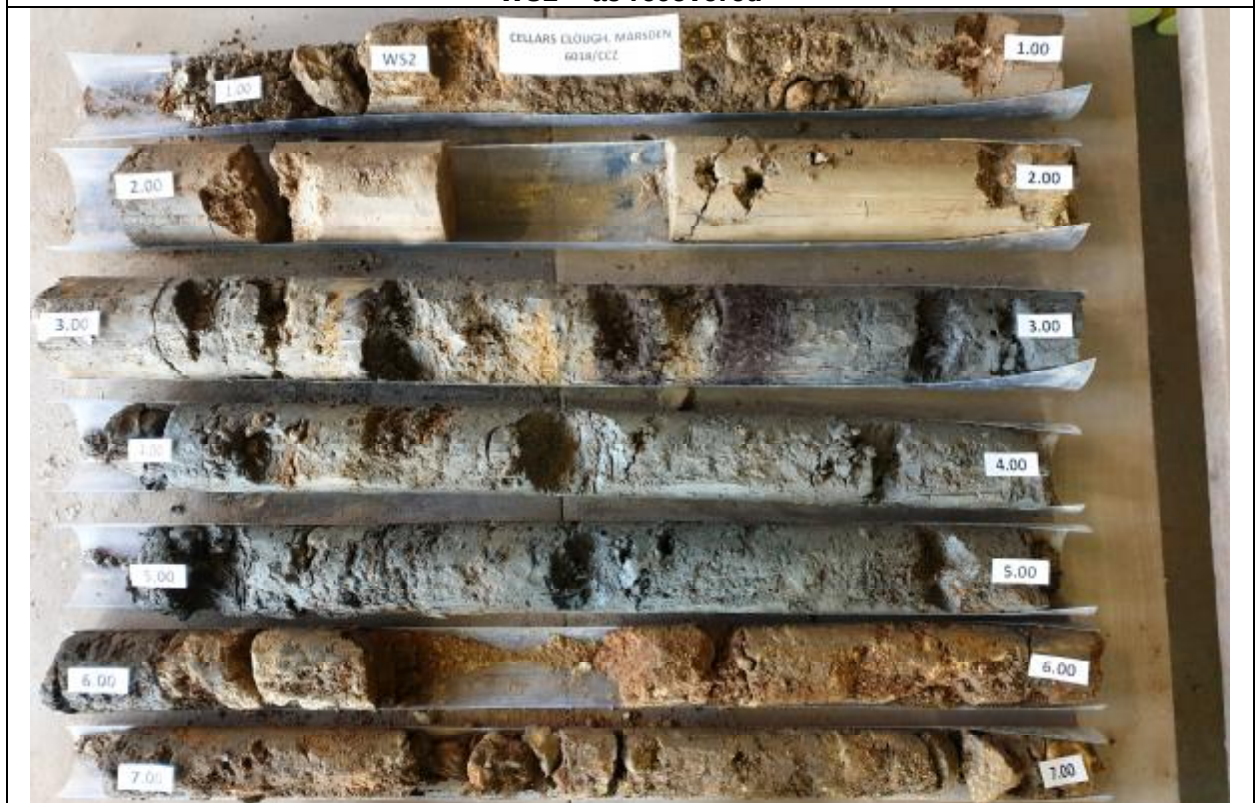
**WS2 – after sub sampling**

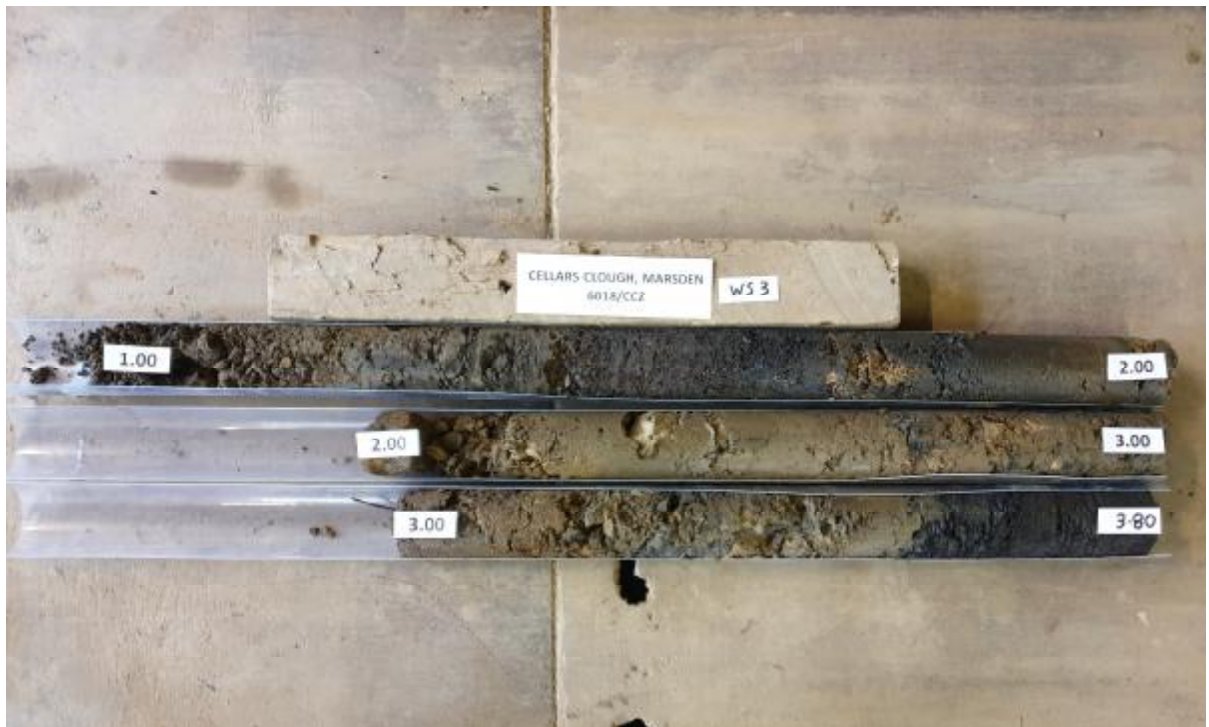
**WS3 – as recovered**

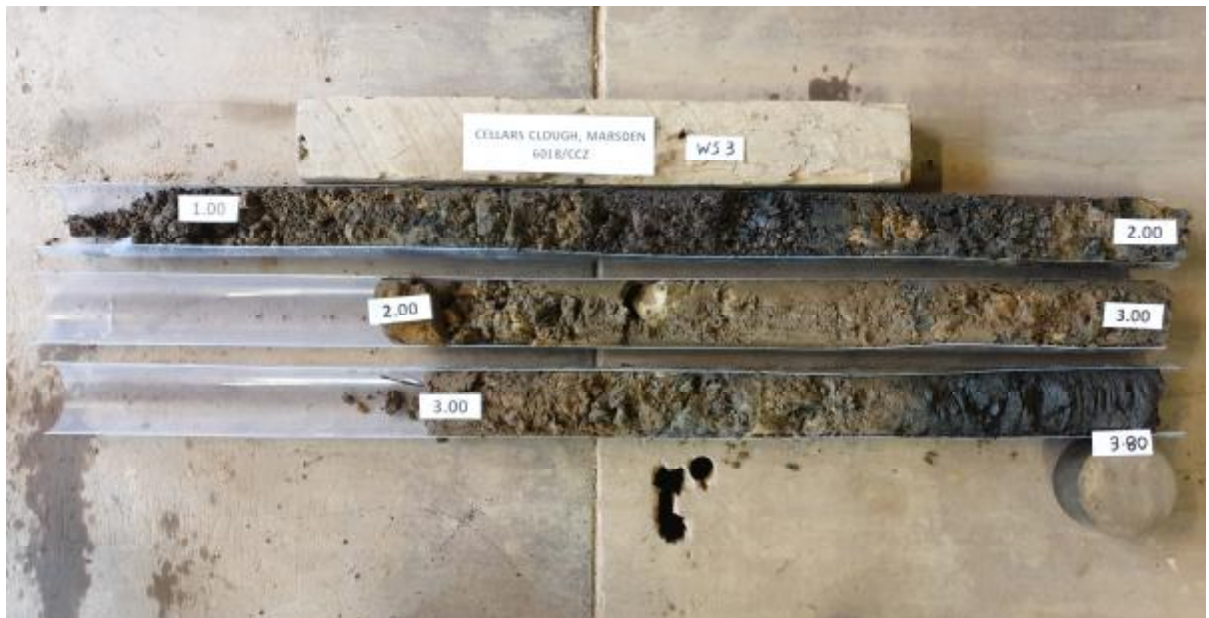
**WS3 – after sub sampling**

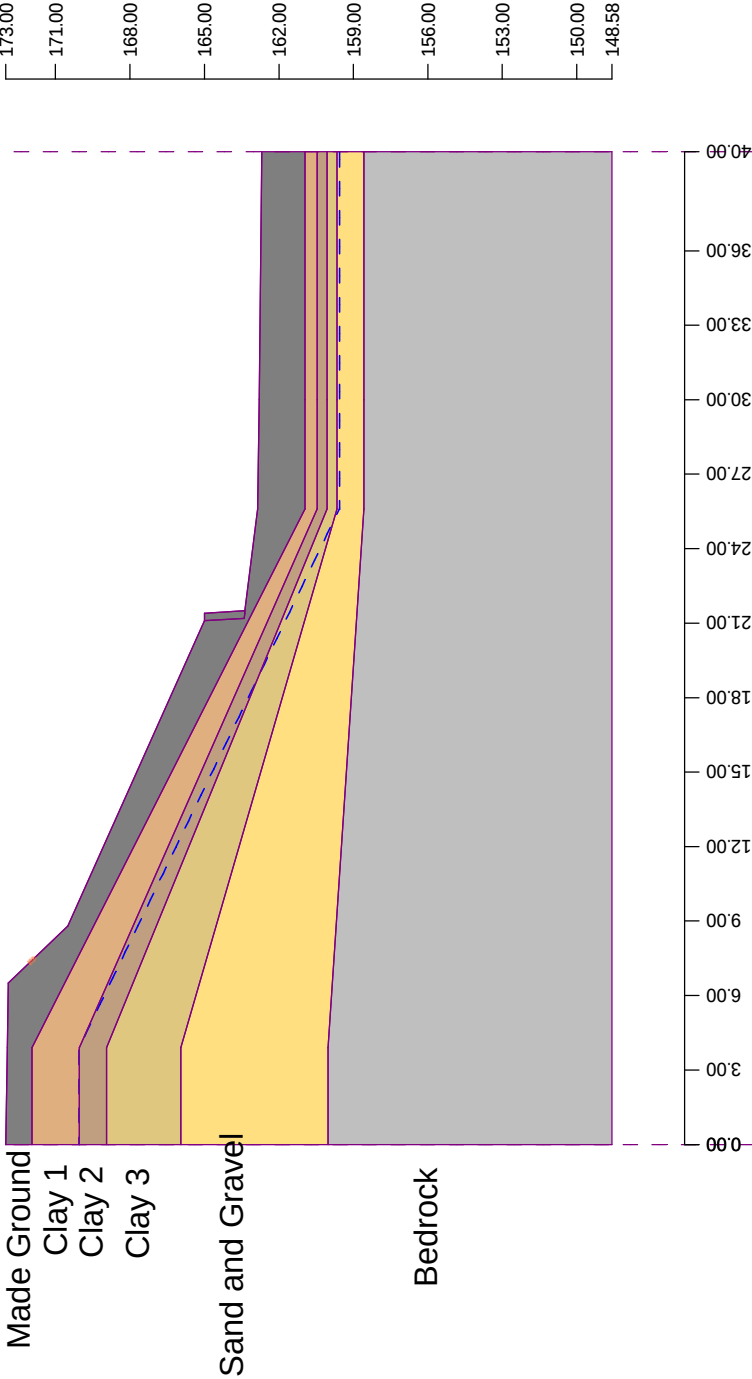
Stage - analysis : 1 - 1

The slip surface after optimization.

**Slope stability verification (Bishop)**

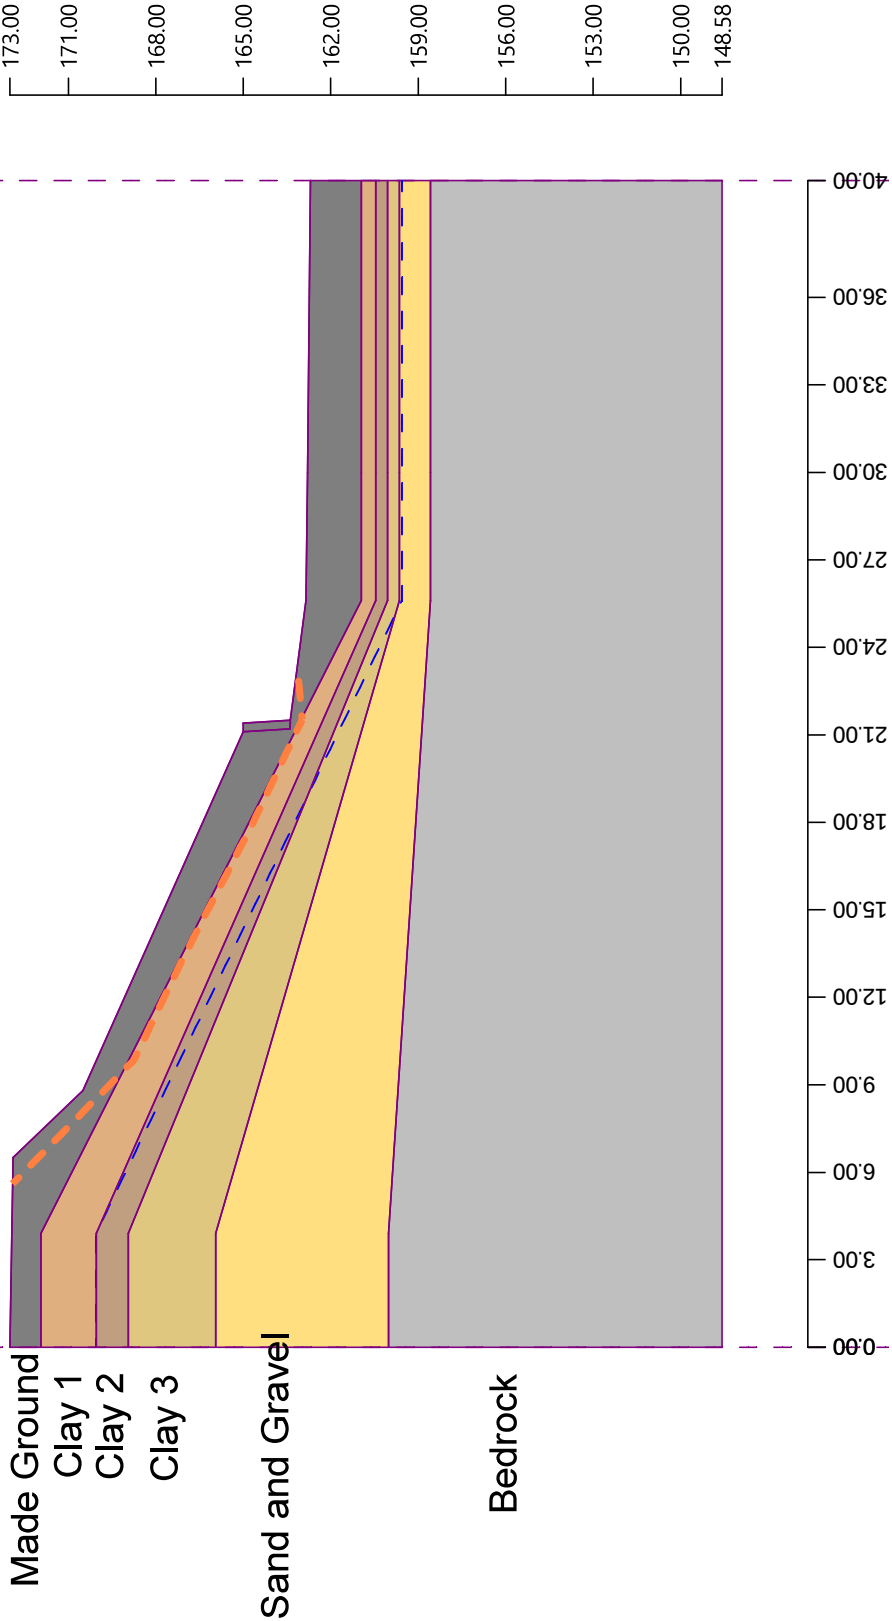
Stage - analysis : 1 - 3

The slip surface after optimization.

**Slope stability verification (Sarma)**

Factor of safety = 1.34 < 1.50

**Slope stability NOT ACCEPTABLE**
