St. Mary's School, Batley

Bat Survey Report

12/10/2023

AHR Architects Ltd.

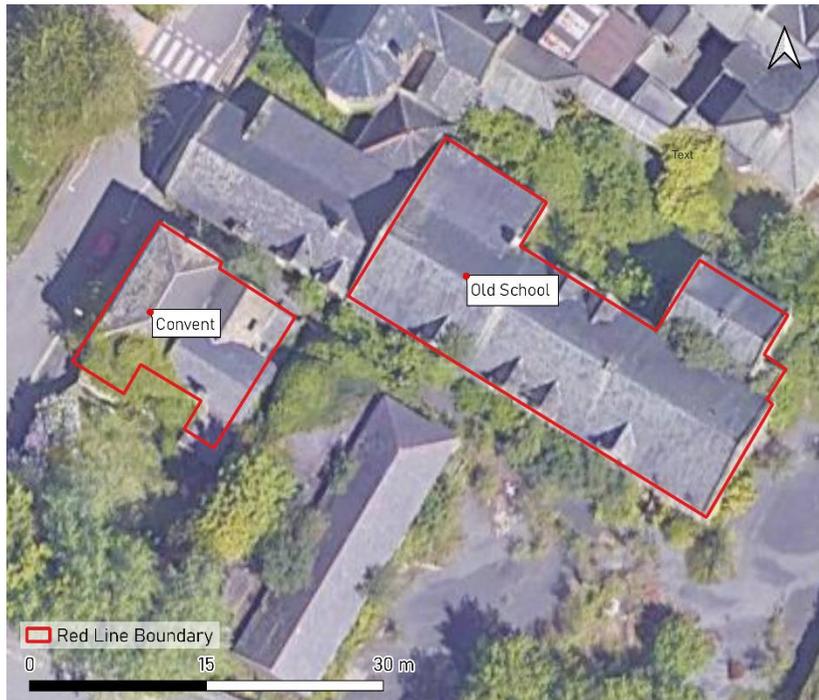
Figure 3 Location of buildings on-Site.

15. The Site comprises two buildings: an old school building, and a convent, both of which have been disused for a number of years, with the convent in particular showing signs of disrepair.
16. Neither building was accessed internally.

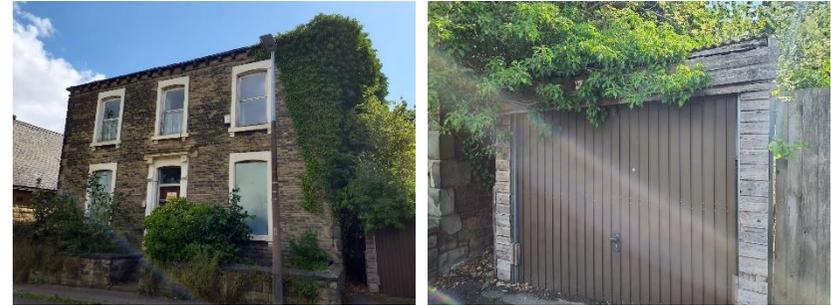
Figures 4 and 5 General view of convent (l) and garage (r).

17. The Convent comprises multiple one- and two-storey adjoining buildings, constructed of a mixture of coursed stone and brick, with a combination of hipped and gabled slate roofs. A shallow pitched extension is present to the northeast corner, and a flat roof extension to the southeastern corner. A single storey, flat roof concrete garage, with wooden cladding to one elevation, is present to the southwest corner.

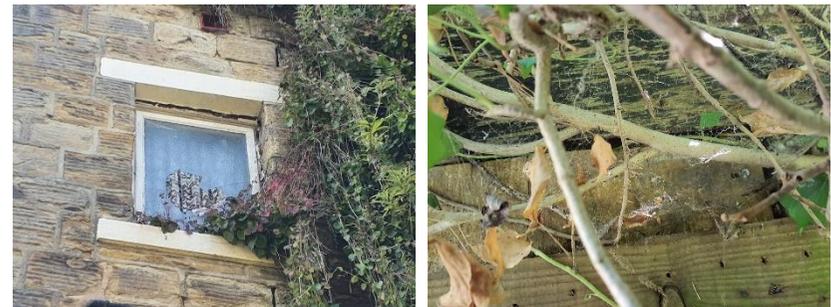
Figures 6 and 7 Showing gaps to window lintel and garage window.

19. The doors and windows of the convent are wooden framed, with concrete sills and lintels, boarded over at ground floor level with chip-board covered with aluminium. These are generally well-sealed, with the exception of one area of disrepair where the lintel has come away from the window.
20. Some gaps are present to the wooden boarding over the garage window to the southern elevation, although these are well-covered, with cobwebs evidencing a lack of recent use by bats.

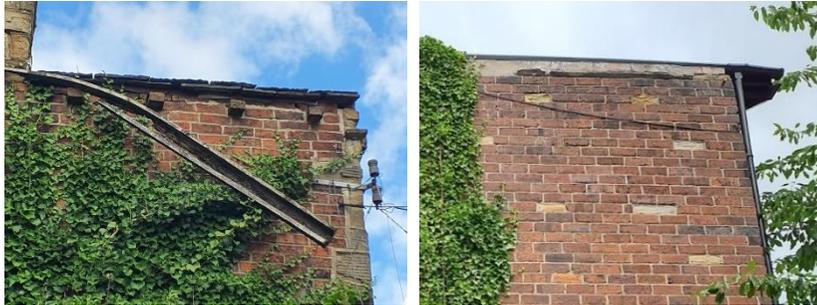
Figures 8 and 9 Disrepair at eaves, revealing gaps in brickwork.

21. The eaves and guttering are of wooden construction and mostly in good condition, with the exception of above the northeastern and southeastern corners where it has fallen away from the building, revealing gaps in masonry and below the roof edge.
22. The eaves of the extension to the southeast also appear in disrepair, allowing possible access to the wall tops and roof void.

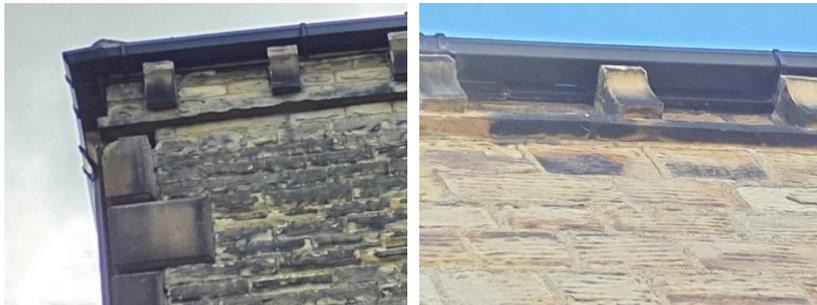
Figures 10 and 11 Missing quoin mortar (l) and gap behind eaves (r).

23. The decorative gable beam ends to the east of the building appear in decent repair, but are overgrown with ivy which could conceal gaps.
24. Some areas of missing mortar are present around the decorative quoins to the northwestern corner, along with some areas where the eaves have come away from the wall.

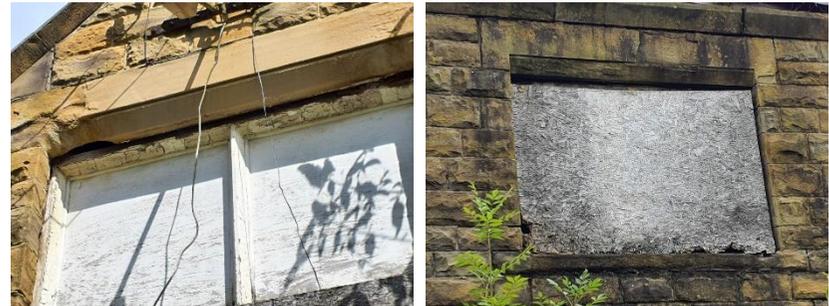
Figures 12 and 13 Gaps to window lintel (l) and around boarding (r).

27. Some gaps are present to window lintels, and to the edges of the window boarding.

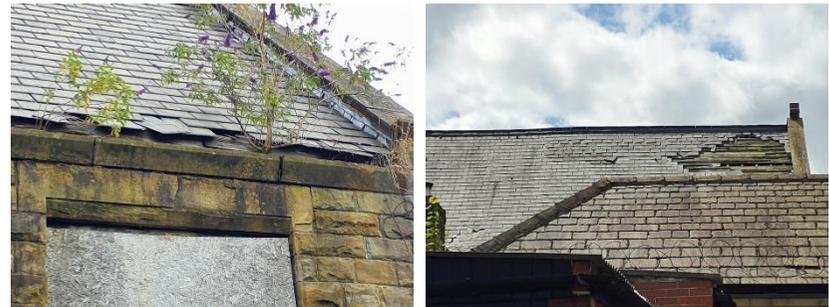
Figures 14 and 15 Damage at hidden gutter and to northern roof pitch.

28. The wall tops feature a hidden gutter, with a stone exterior cornice in good condition. Some areas of the wooden eaves above the gutter are in disrepair, however, with some gaps to roof tiles offering access into the roof void.
29. Slipped roof tiles are present throughout both pitches of the roof, with severe damage to an area of the northern elevation creating a large gap in the roof work.

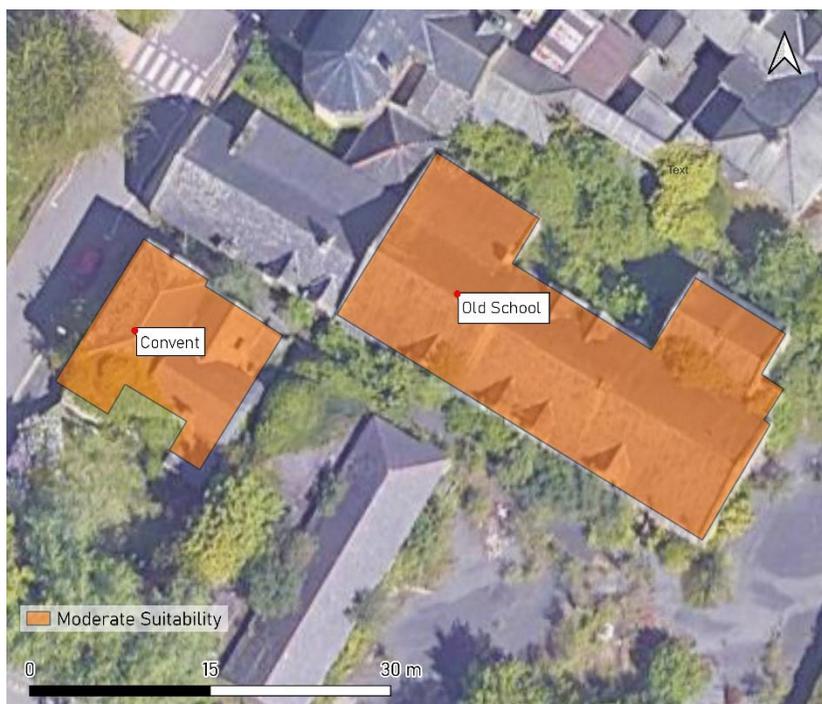
30. Based on the features present, the two buildings are assessed as having moderate suitability for supporting roosts.

Figure 16 Showing bat roost suitability of on-Site buildings.

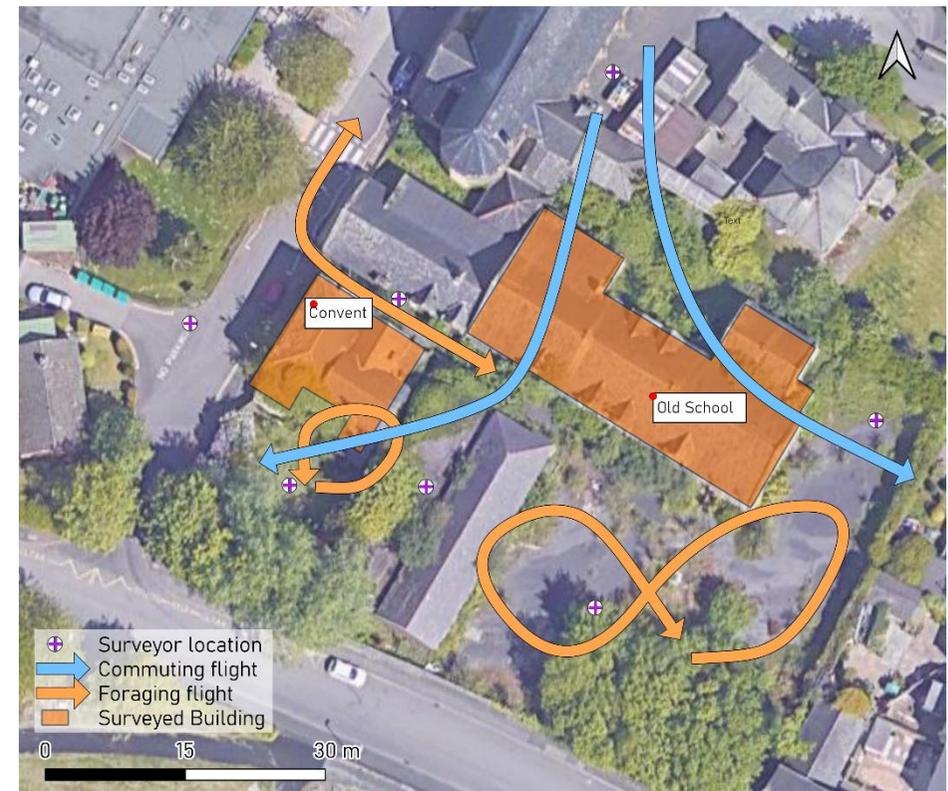
45. Intermittent foraging was observed around the eastern elevation of the Convent from 20:36 until 20:58. Interaction by individual common pipistrelles was observed at the apex of the gable at 20:45 and 20:49.

46. Common pipistrelles were heard, but not seen, in multiple locations throughout the Site from 20:54, until the last observation at 21:00.
47. No roosts were identified, or suspected, within the Old School. No emergences were observed from the Convent, but interaction by individual common pipistrelles with what was later found to be a roost feature was observed.

Figure 17 Summary of bat activity observed during emergence survey 30th Aug.

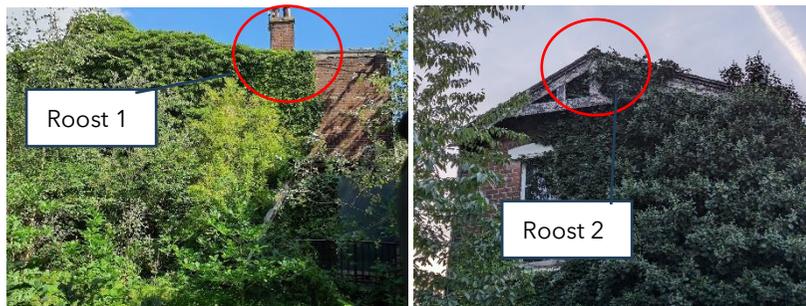
51. Two bats were observed emerging from the base of the southern chimney stack of the Convent, at 19:54 and again at 19:55. The first was also seen to forage above vegetation around the corner of this building. This has identified as Roost 1, seen in Figures 18 and 20.

52. Up to three common pipistrelles were observed foraging up and down the narrow channel between the two buildings, from 19:58 until 20:17.
53. At 20:00, a single common pipistrelle was observed emerging from the apex of the gable on the eastern elevation of the Convent, identified as Roost 2 in Figures 19 and 20.

Figures 18 and 19 Locations of emergences - southern elevation (l) and eastern elevation (r).

72. Mitigation could include integral bat boxes being incorporated into the new build. Two interim bat boxes will also be required, which would be placed in trees or on buildings around the edge of the Site allowing the introduction of new roosts at an early stage of development and prior to the loss of the identified roosts.

73. In terms of the demolition of the buildings, the following method should be agreed under licence, but should not be the subject of any condition of planning.

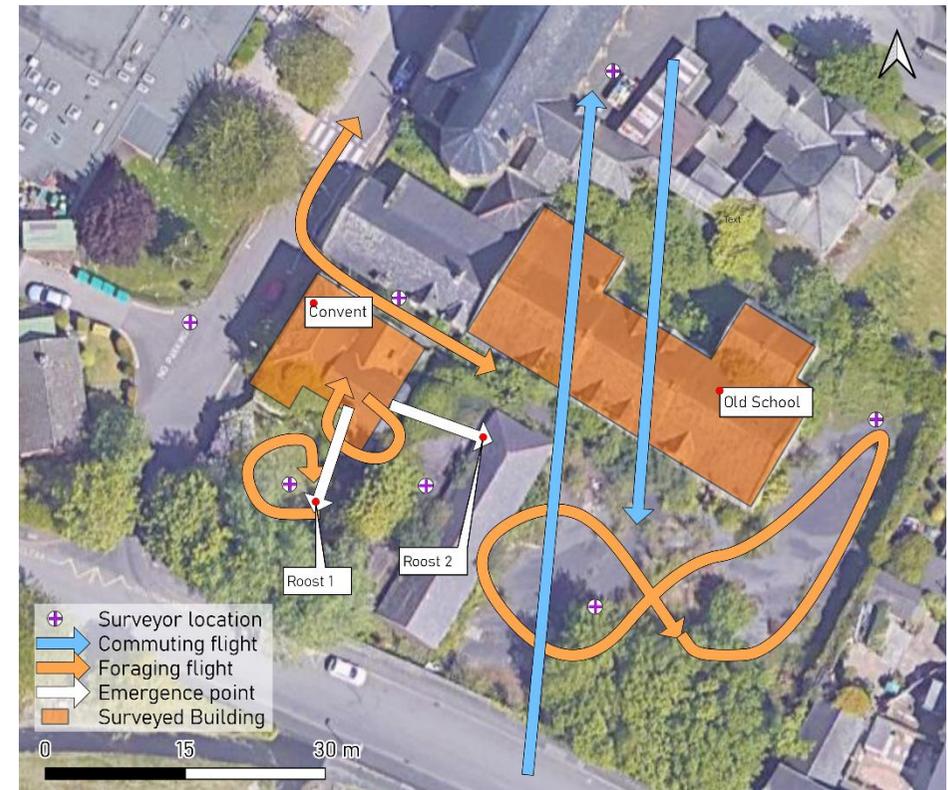
Figure 20 Summary of bat activity observed during emergence survey 13th Sept.
