Greenhead College

Remediation Verification Report

Job No: 1029739
Doc ref: NE8659-CDL-ZZ-XX-RP-GE-60202
Revision: P01
Revision date: 01 September 2023

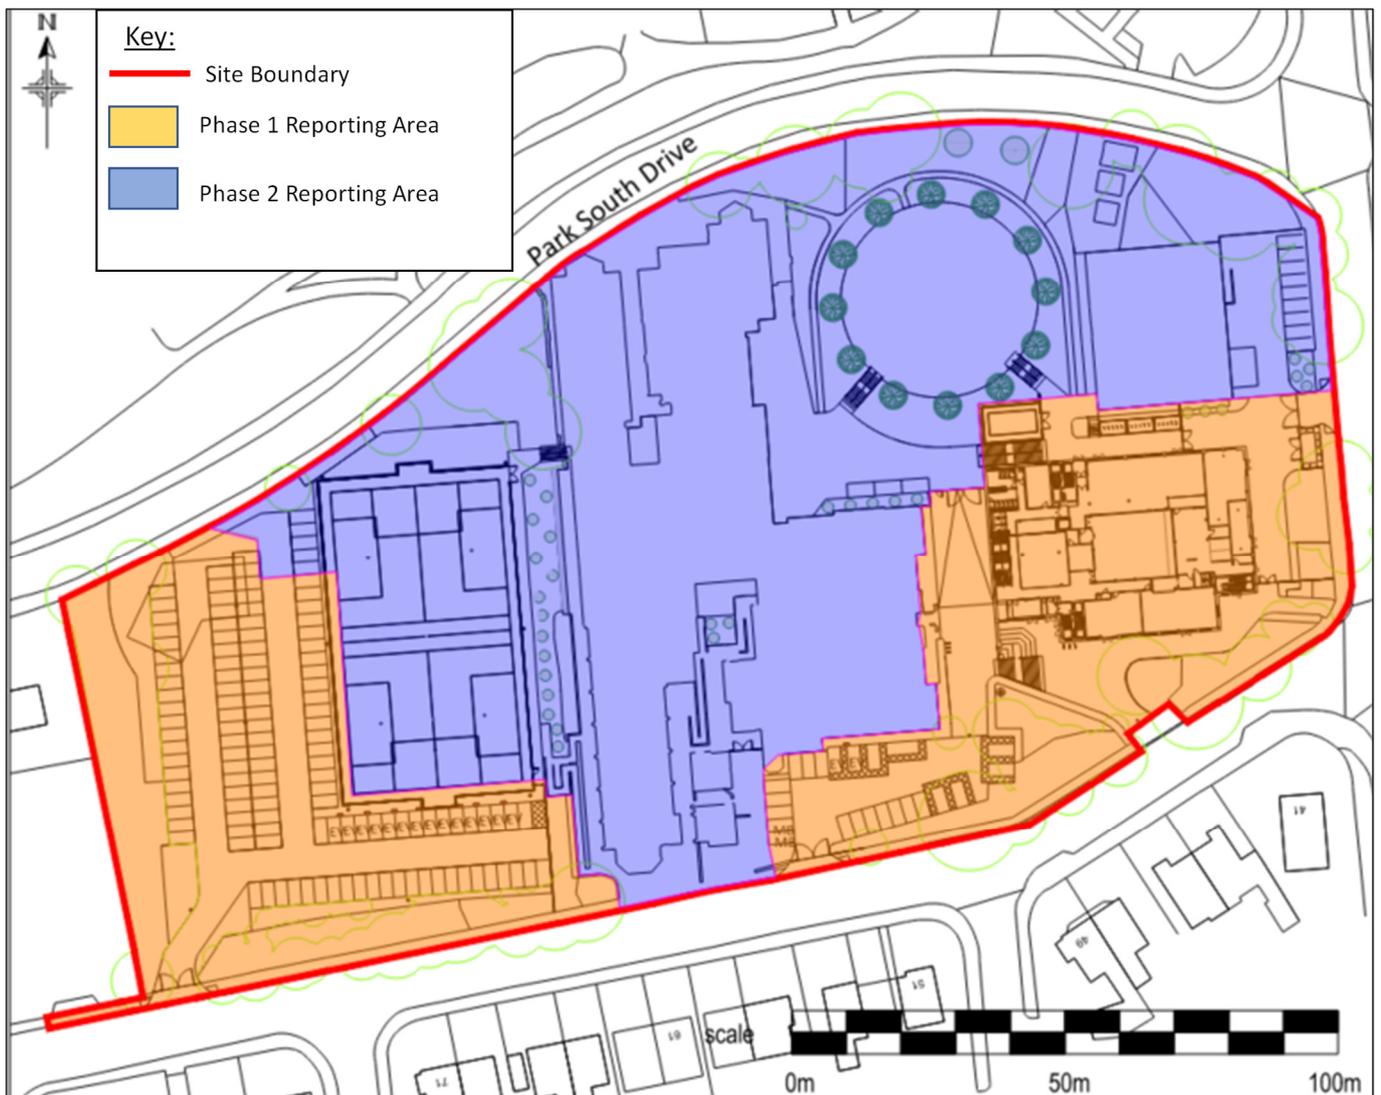
Figure 1-2: Phase 1 Remediation Verification Boundary

This Remediation Verification Report applies only to Phase 1 of the scheme as described above. Additional verification reporting is required on completion of Phase 2 of the development. The areas subject to Verification Reporting in this report is indicated in shaded orange on Figure 1-2 below.

Note that the Phase 1 boundary includes the new building in the south east, which will be referred to as the 'Main Building' herein and the car parking in the west along with the areas of hard and soft landscaping. The areas outside this verification boundary (such as the infill building and sports pitches) will not be included within this report and will be verified under separate cover.

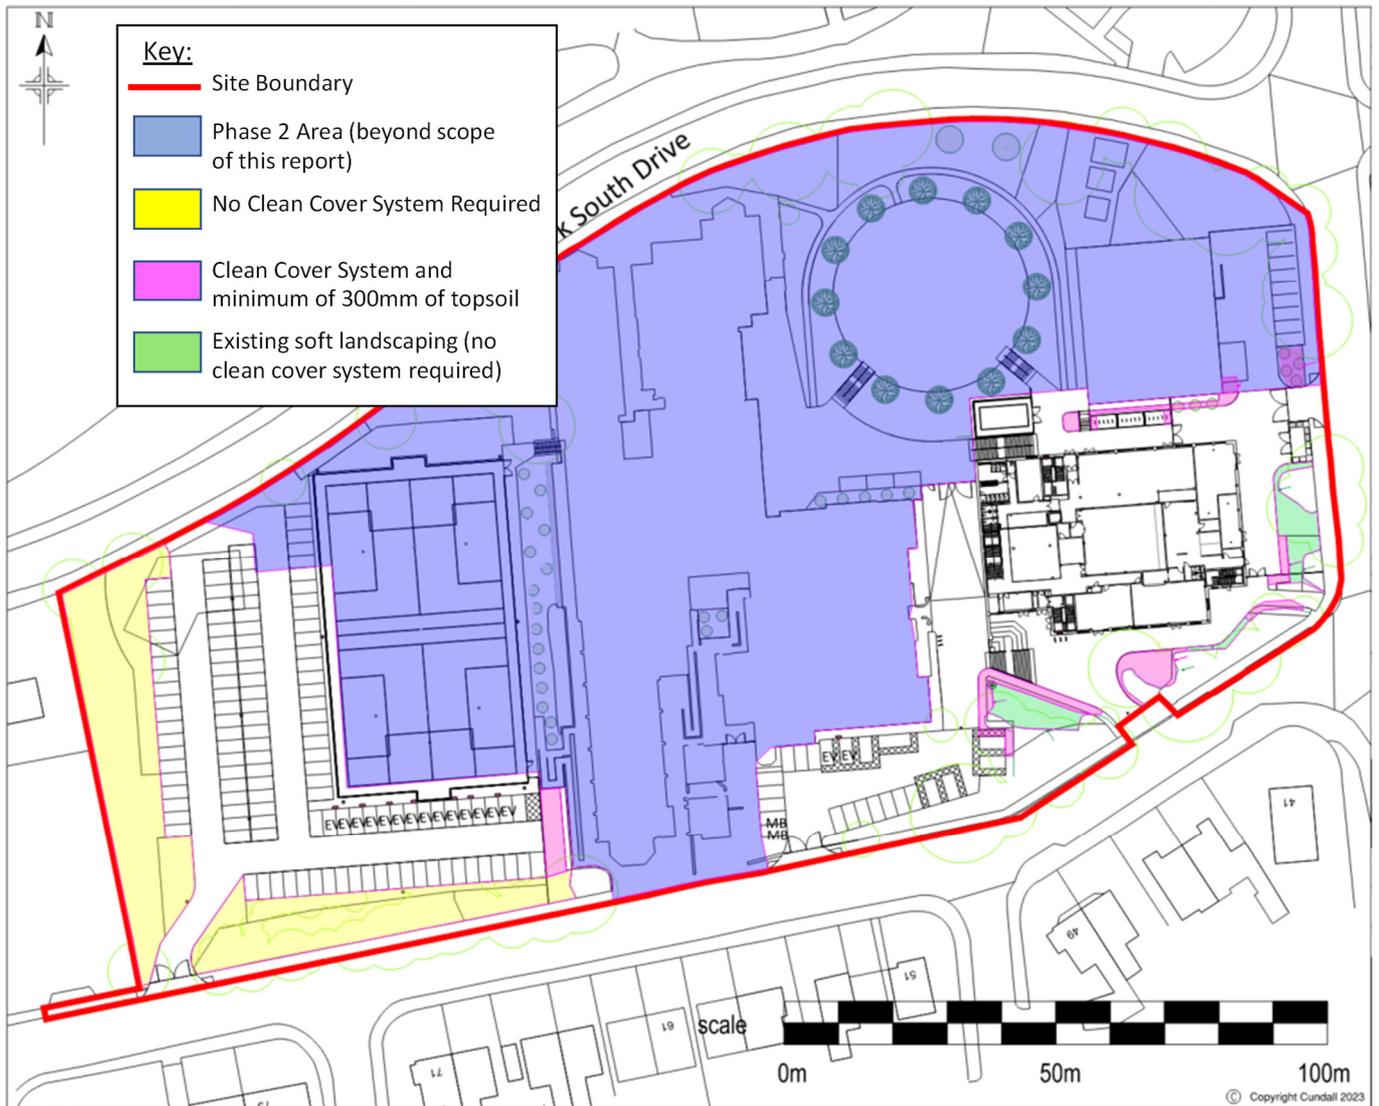
Figure 4-1: Location of Clean Cover System and where pre-existing soft landscaping is present

In areas of new soft landscaping and where made ground soils remain in situ, a clean cover system was constructed and comprised a geotextile marker layer below a minimum of 300mm of topsoil / subsoil.

In some areas, no remedial earthworks were possible to undertaken due to the presence of semi-mature, mature trees or dense vegetation (to be retained). A clean cover system was not installed within these areas.

Areas highlighted in green on Figure 4-1 are areas of pre-existing soft landscaping, no remedial earthworks were undertaken in these areas other than minor regarding and reseeded.

In areas where topsoil has been placed upon made ground soils, a geotextile separator has been used at the base of the clean cover system, followed by the placement of at least 300mm of topsoil. These areas are highlighted in pink in Figure 4-1 Further detail on the chemical suitability and testing of the imported topsoil is included in Section 4.6.

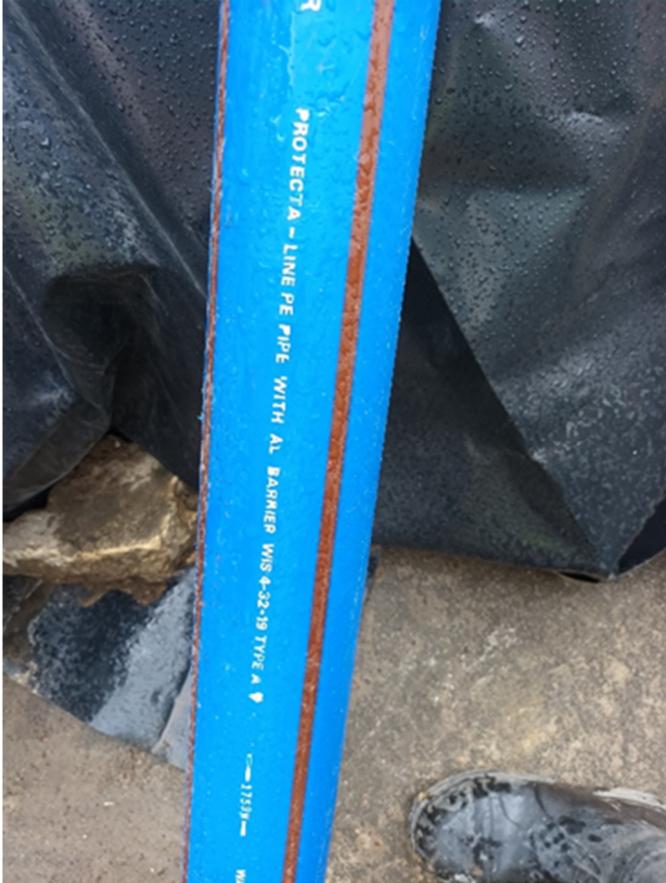
Figure 4-2: Barrier Pipe used for water supply pipes on site

The Contractor has confirmed that barrier pipe was used within the development and the relevant correspondence is presented in Appendix B. A photograph of the pipe used on site is included in Figure 4-2.

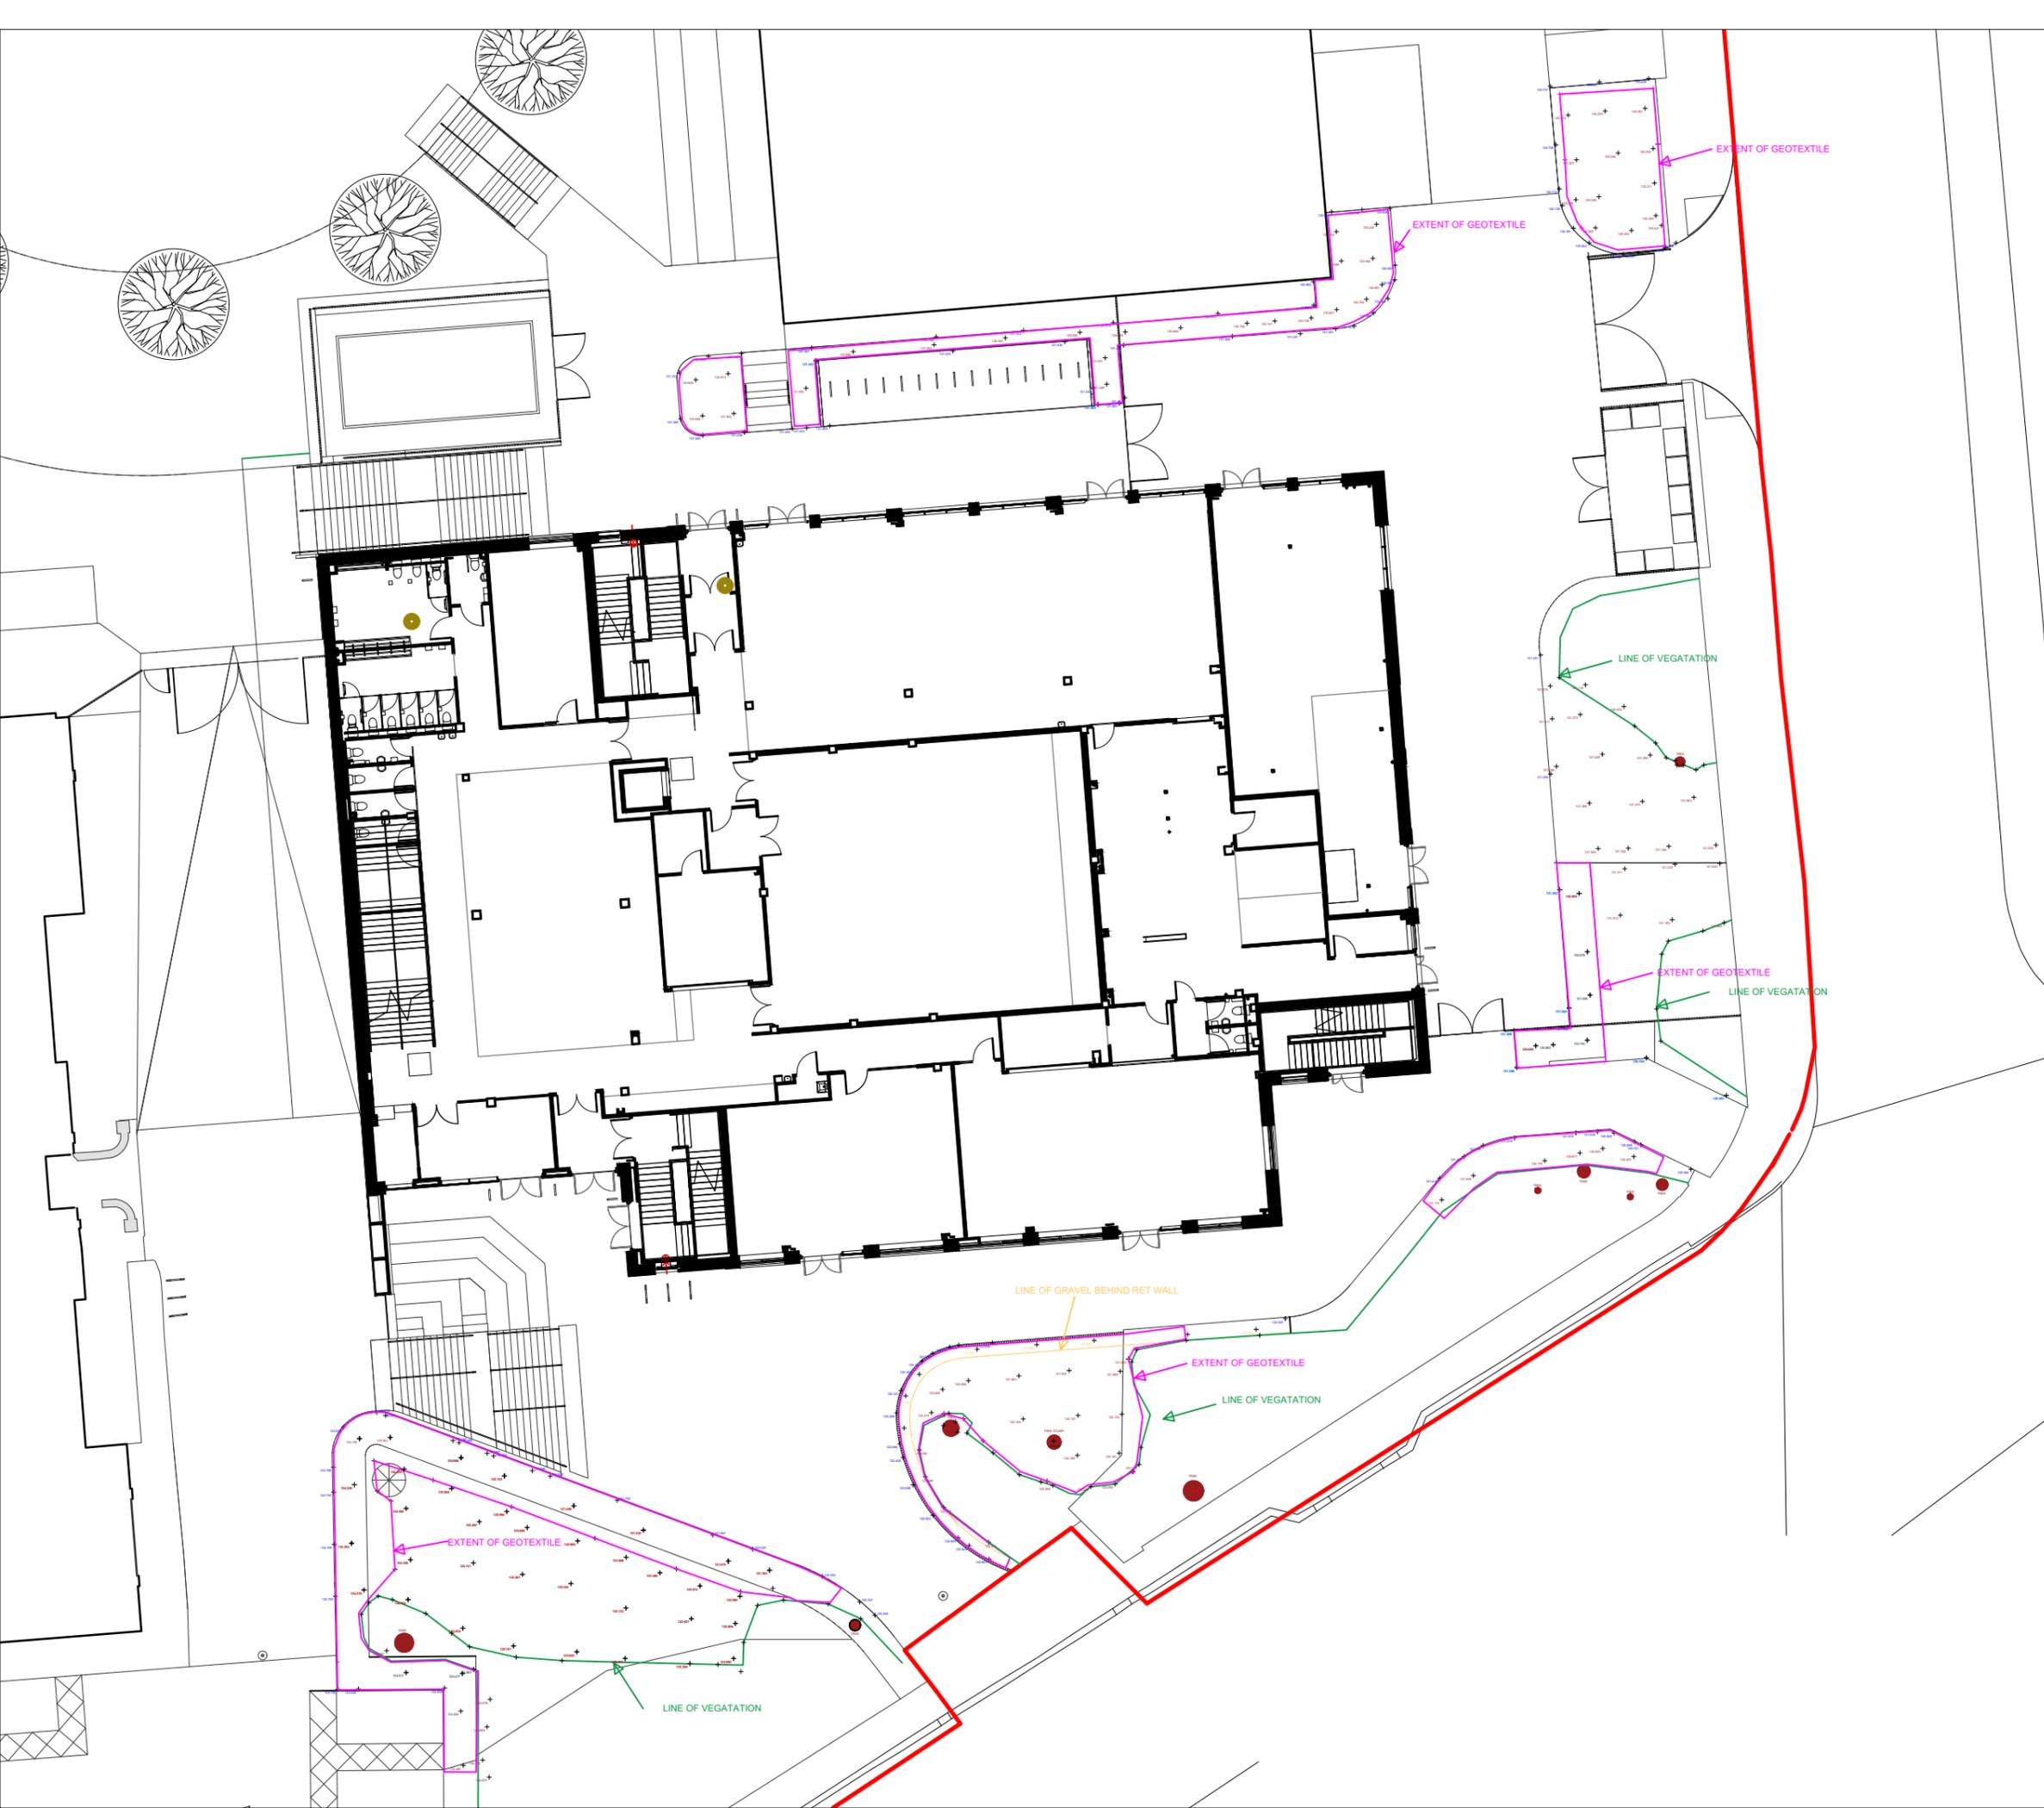
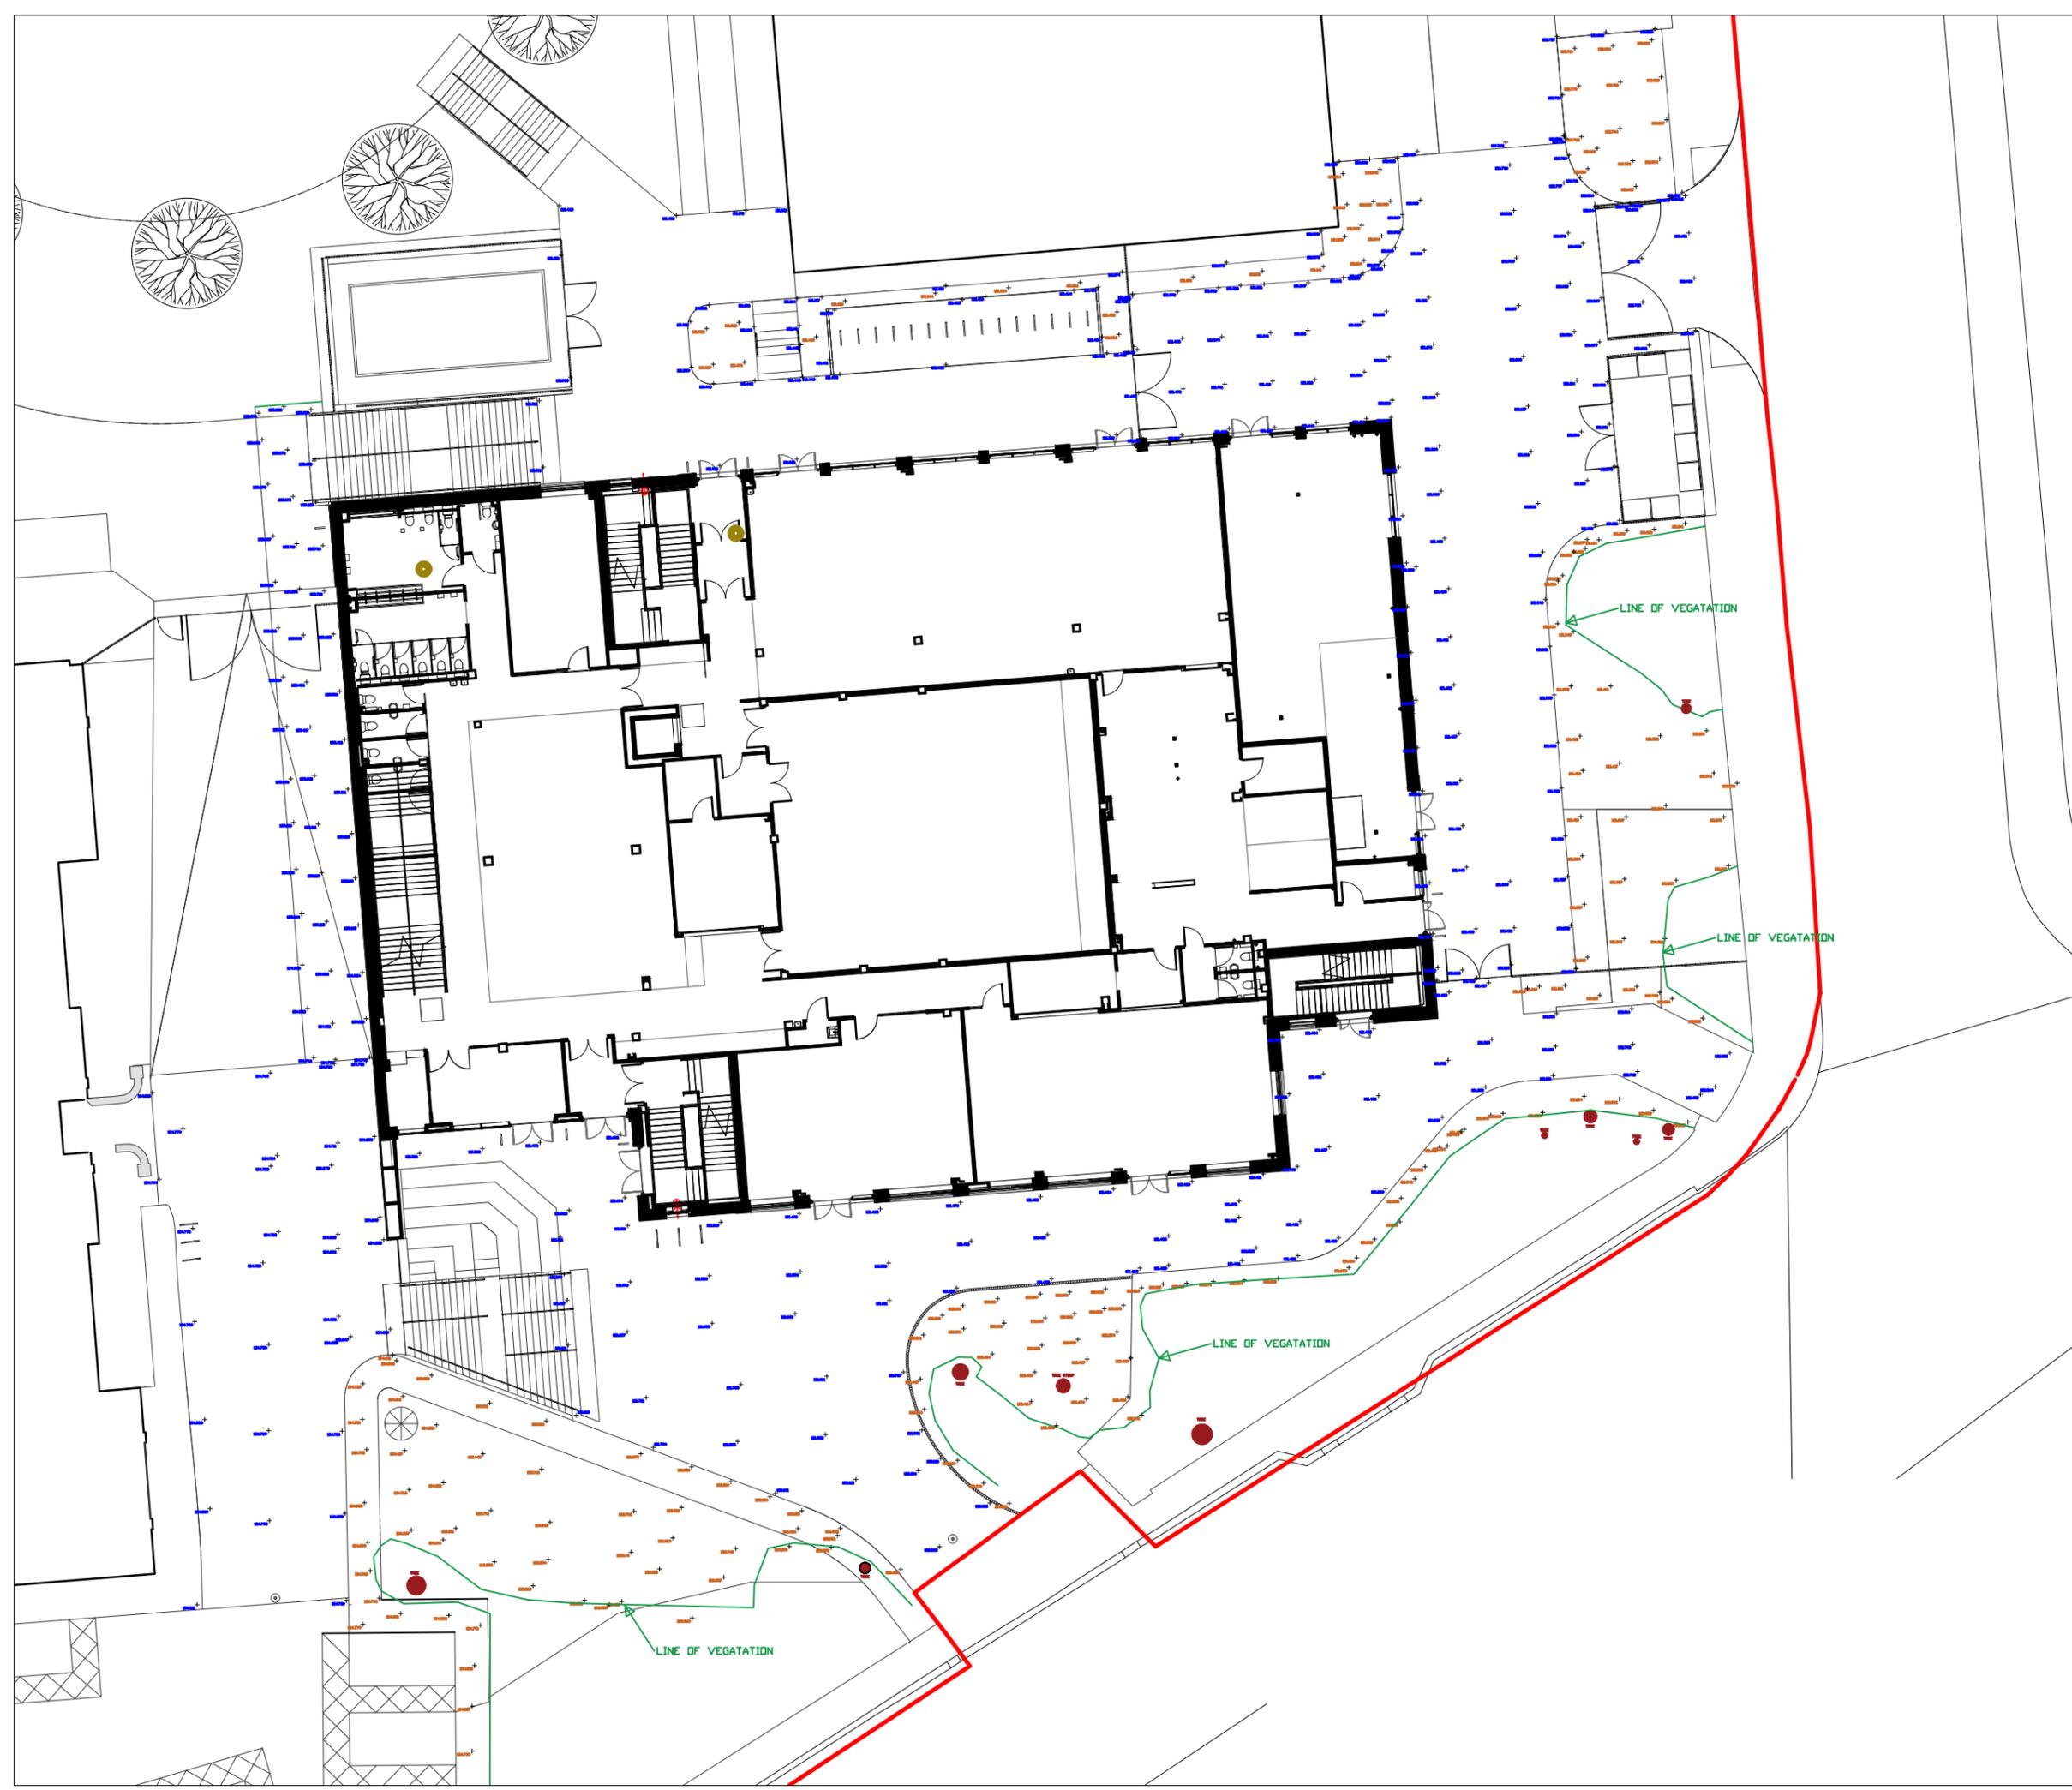
Appendix A Base of Excavation and As Built Survey

The base of excavation survey is presented in Appendix A along with an 'as built' survey following the placement and compaction of fill (where applicable) and construction of soft and hard landscaping.
