# Bat Scoping Survey to

Crown Buildings

5 Scott Hill

Clayton West

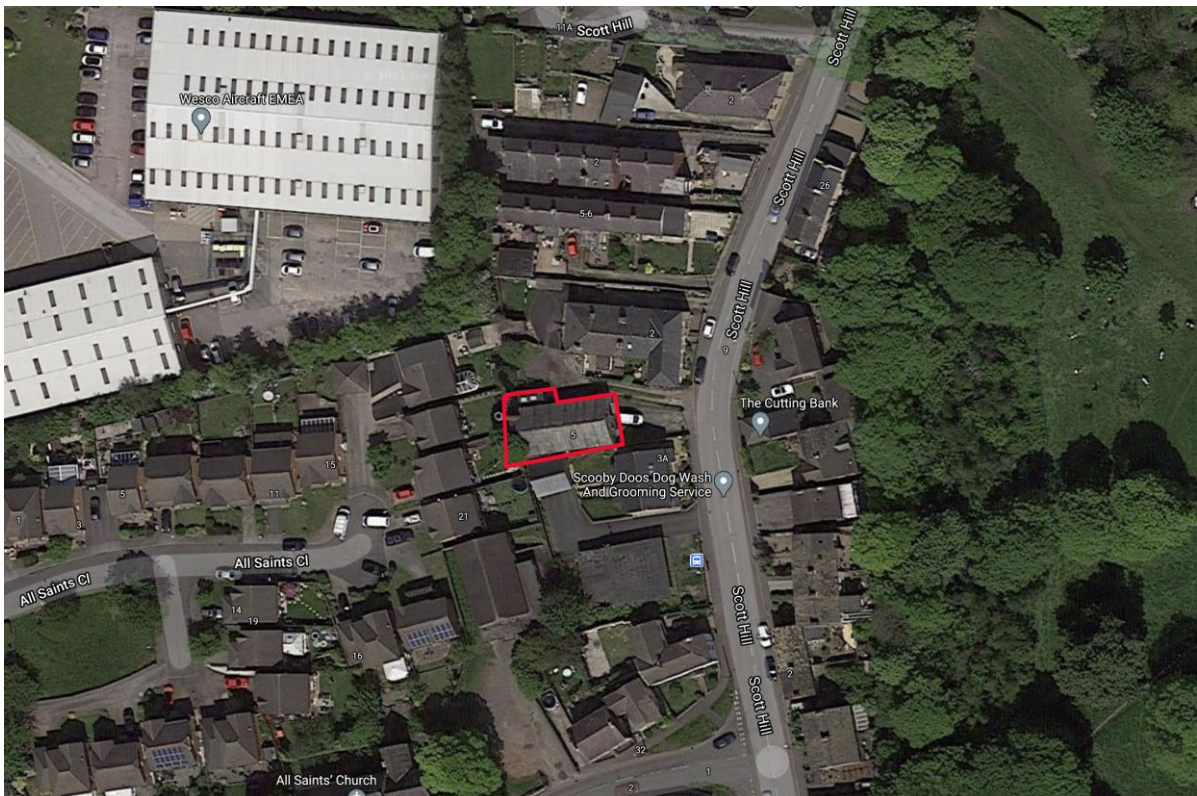
Figure 2 Aerial view of the site, surrounds and buildings surveyed

5.1 The site consists of a large workshop surrounded by hardstanding and is located on the east side of the village of Clayton West.

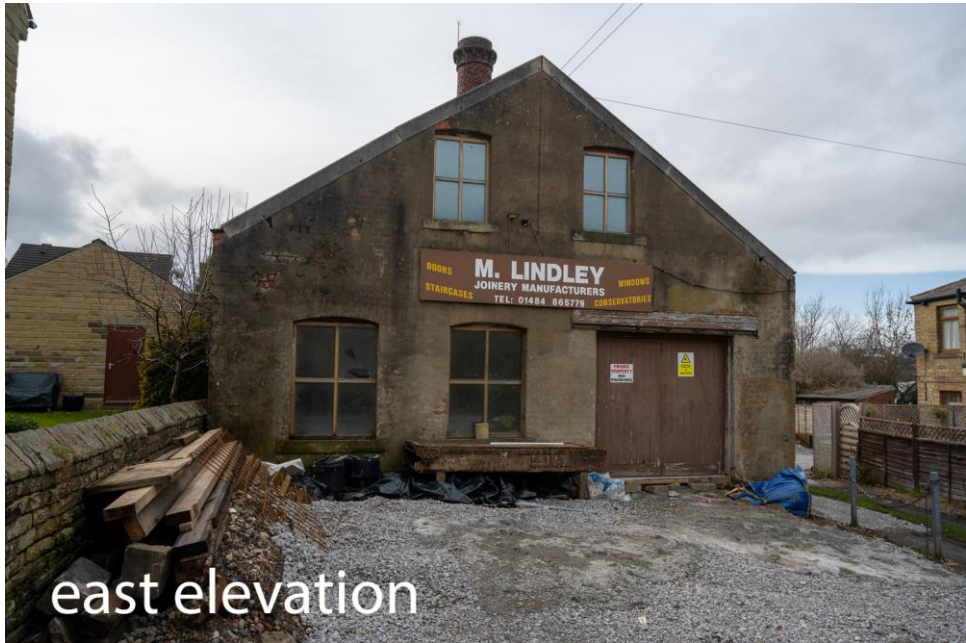
The workshop is constructed from brick and is built in English bond style and has no wall cavity. The walls appear quite sound on the south and west elevation but viewing is limited as these elevations form the boundary to private land. There are no soffits or fascia on these elevations and the gutter along the south elevation sits on the wall top and has limited potential. The east elevation has a cement render which eliminates the possibility of bats using the walls while the north elevation has been modified and altered to have large windows with a section of shiplap above each one. There are limited access points at the edges for the shiplap panels but viewing from the inside shows that these sections are open and exposed and therefore offer no potential roosting cavities.

east elevation

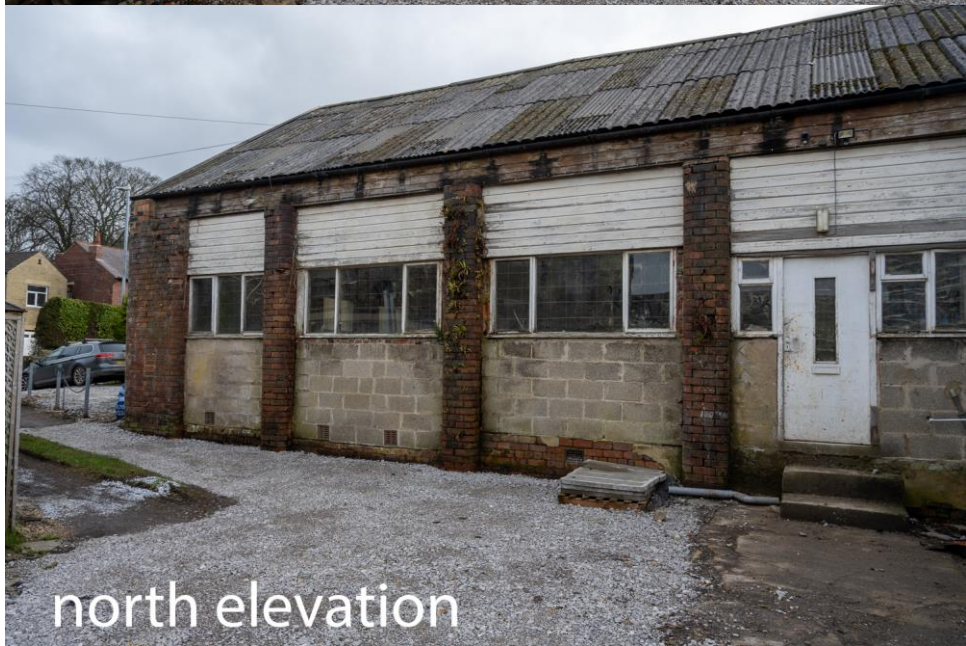
north elevation

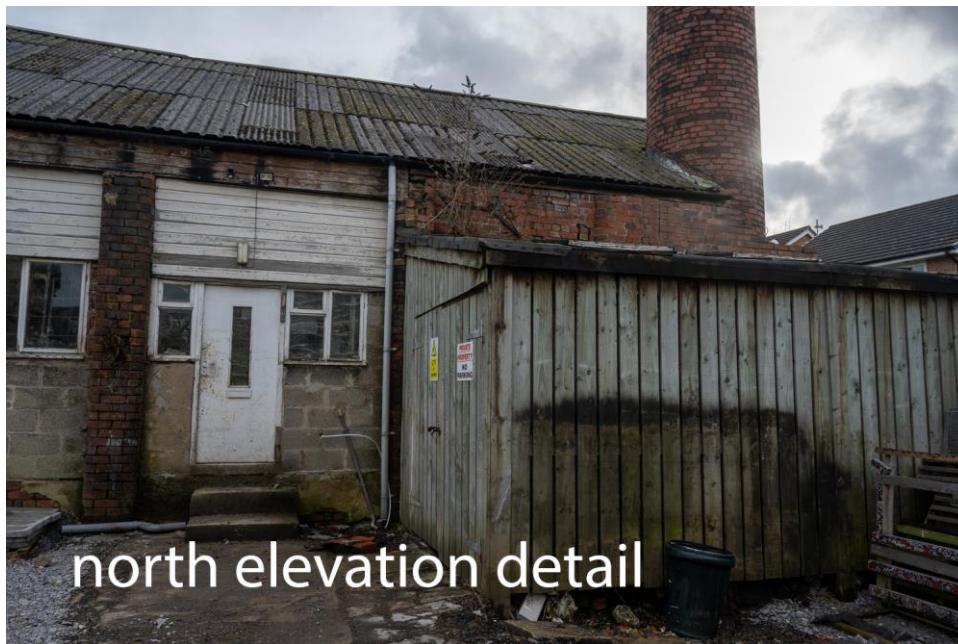
north elevation detail

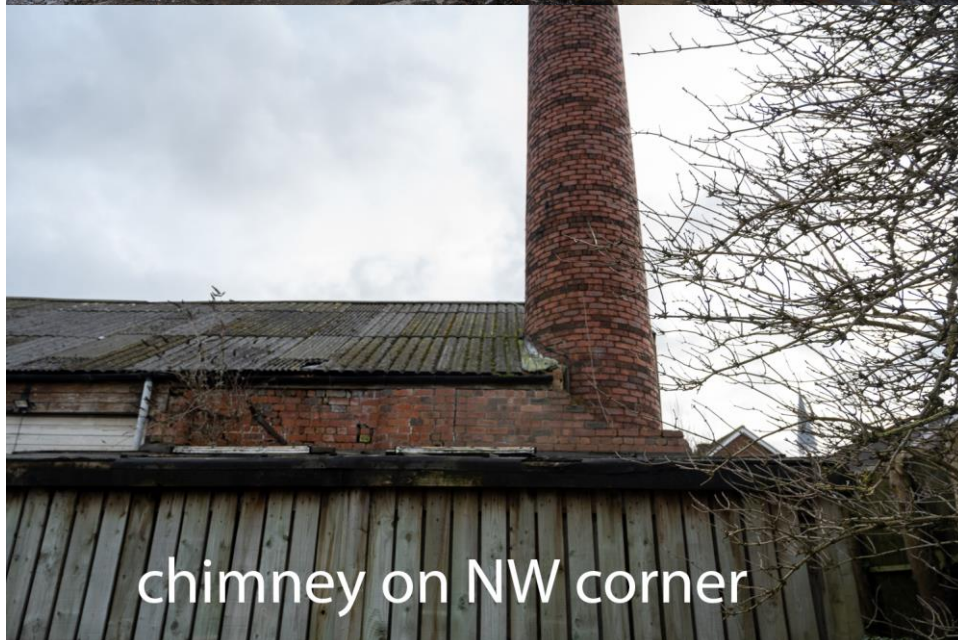
To the NW corner stands a large chimney constructed from brick and it appears to be in a sound and stable condition. There are no external features that would allow bats to roost and, until very recent change of ownership, the chimney was in use daily for burning wood scraps and sawdust via a wood burning stove which was vented into the chimney. A small lean-to outbuilding also occupies the NW corner but is of negligible interest to bats.

chimney on NW corner

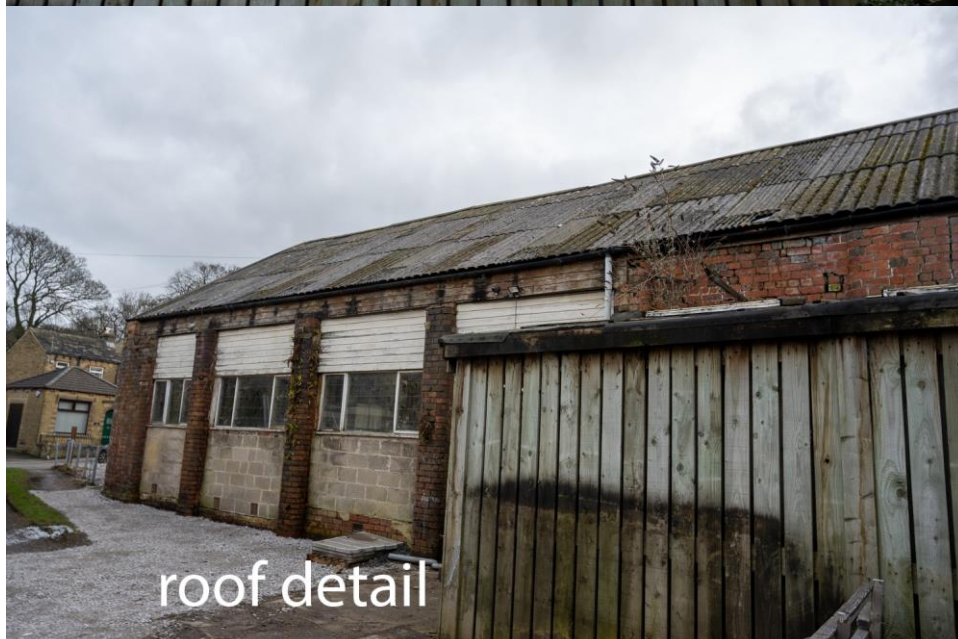
The roof is covered with interlocking cement fibre boards and has limited access potential due to the way the panels sit flat at the joints. The ridge tiles are present and do offer access to the ridge section along the undulating profile of the roof. Unusually, the interior is lined with planks or sarking and therefore there will be a gap between the wooden boards and the outer covering that may provide potential roosting sites. However, there are certain factors that might limit the suitability and these are discussed in Section 9.

The workshop itself has a limited number and diversity of potential roosting features and is assessed as being of low potential to support roosting bats, mainly along the ridge section, but experience suggests that this is unlikely as bats rarely favour the cement fibre roofing as the temperatures will fluctuate widely. The workshop has been in constant use until very recently as a joinery workshop and has been subjected to noise and a great deal of dust which permeates most of the crevices within the building and there is some evidence that the ridges are not watertight and sections are damp.

roof detail

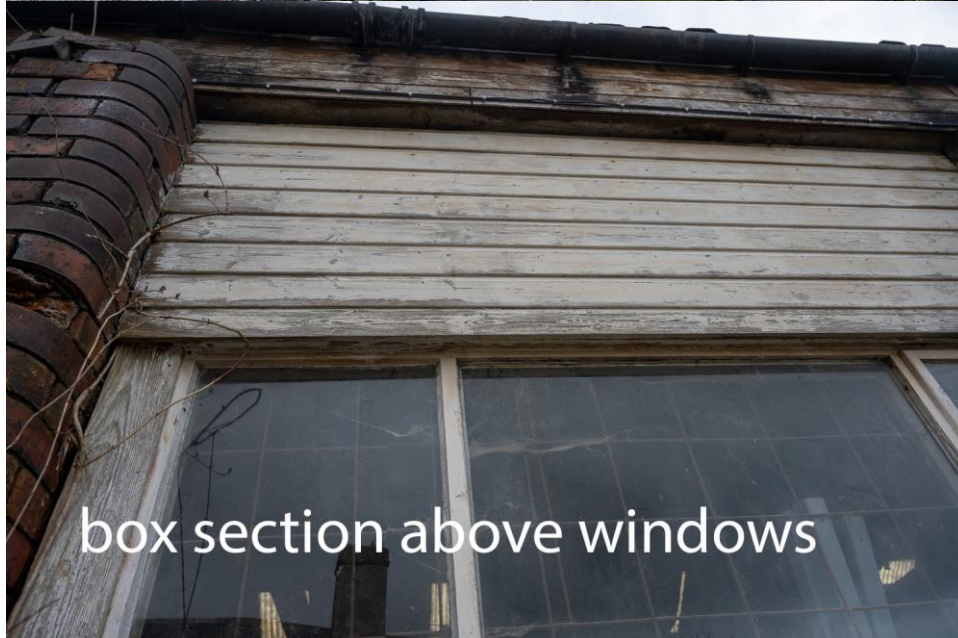
box section above windows

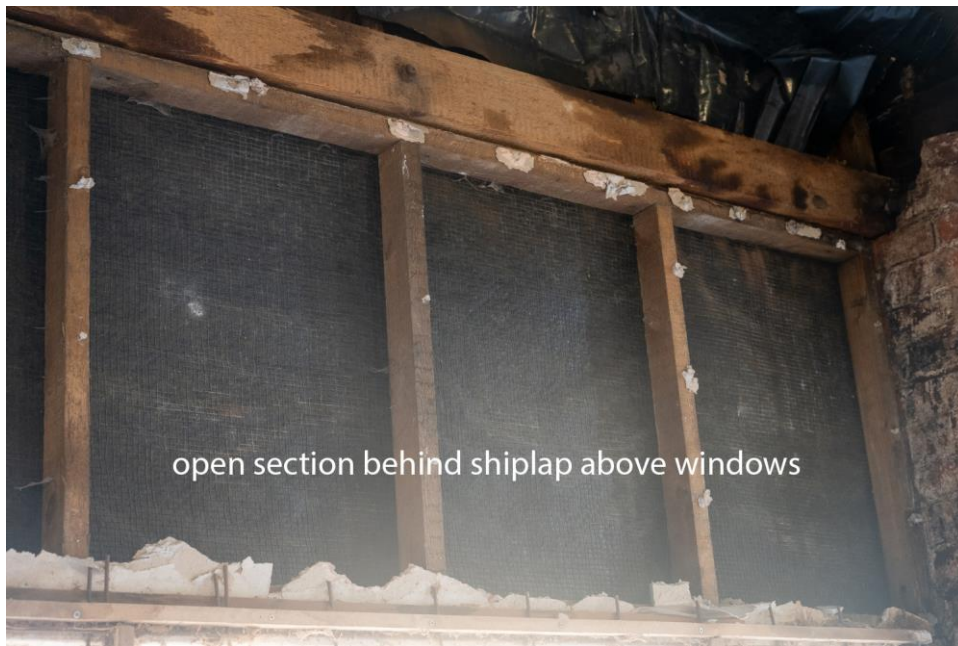
open section behind shiplap above windows

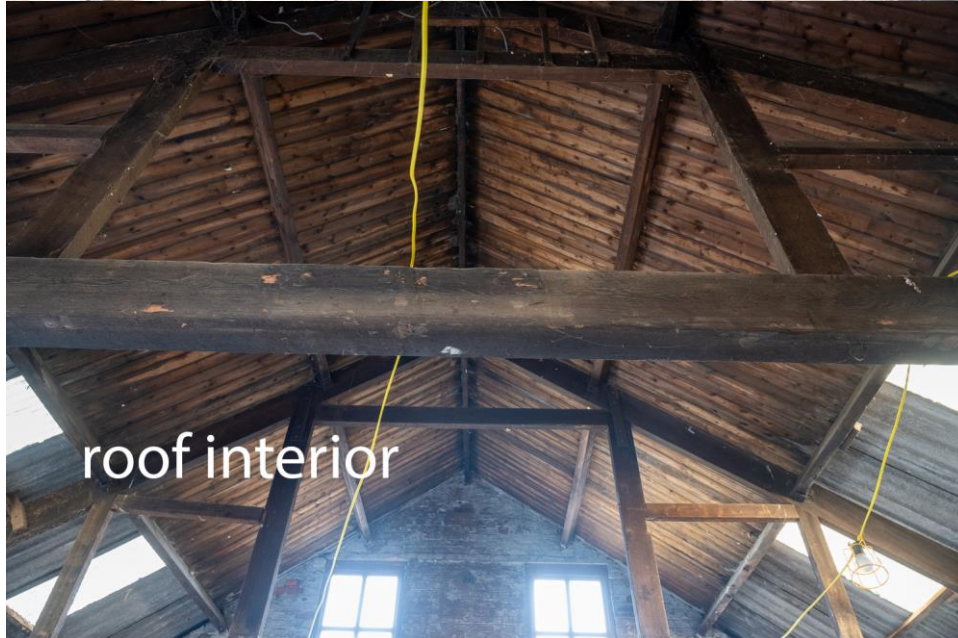
roof interior
