GROUND INVESTIGATION REPORT

Oxford Road, Dewsbury, West Yorkshire

Report: 574017-GI

Date: January 2024

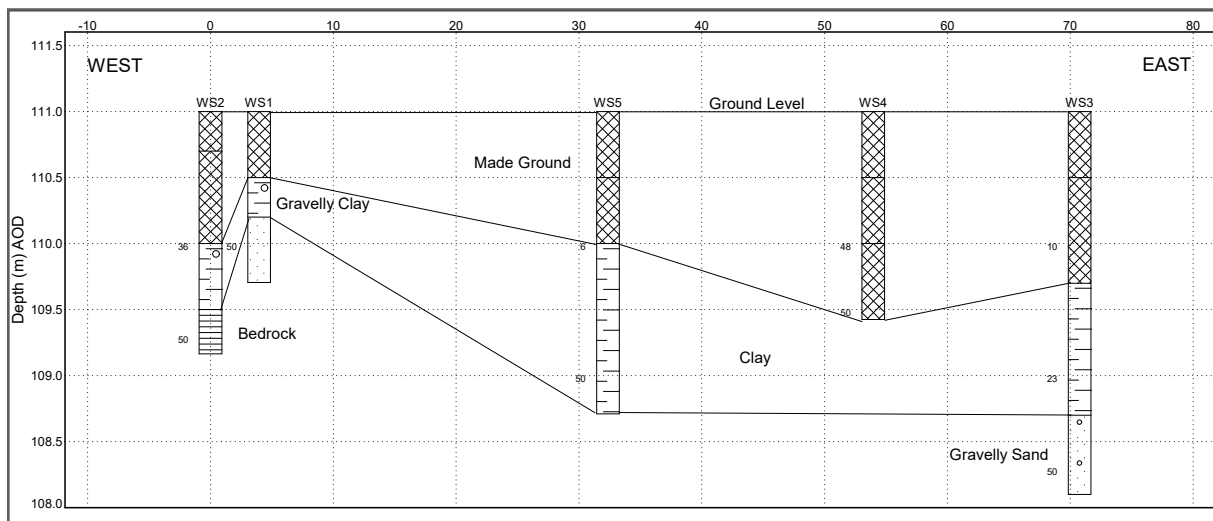
FIGURE 4 - GEOLOGICAL SECTION

The ground conditions encountered are recorded in detail in the exploratory logs appended to this report (Appendix C) and summarised on a geological section, Figure 4. Any diagram of the possible configuration of ground conditions between exploratory holes is conjectural and given for guidance purposes only. If deemed critical confirmation of intermediate ground conditions should be sought.

Made ground was found from the surface in each window sample hole, typically consisting of gravelly clay containing brick, clinker and sandstone. The made ground was found to a maximum depth of 1.61m bgl in WS4 where the window sample borehole refused, possibly on a cobble or obstruction.

Underlying the made ground was a firm to stiff brown mottled grey gravelly clay containing fragments of sandstone. This clay was found to a maximum depth of 2.30m bgl with CPT N values in the clay ranging from N6-N36, with a mean of N22. As shown on Figure 5 a general increase in N value with depth was noted through the strata profile.

Beneath the clay described above, bedrock was encountered from depths ranging between 0.80m-2.90m bgl. In WS1 and WS3, sandstone bedrock was found, while in WS2 mudstone bedrock was encountered. This is likely due to the presence of the

geological fault that is conjectured through the site. Four CPT's carried out in the bedrock all refused, with N values greater than 50.

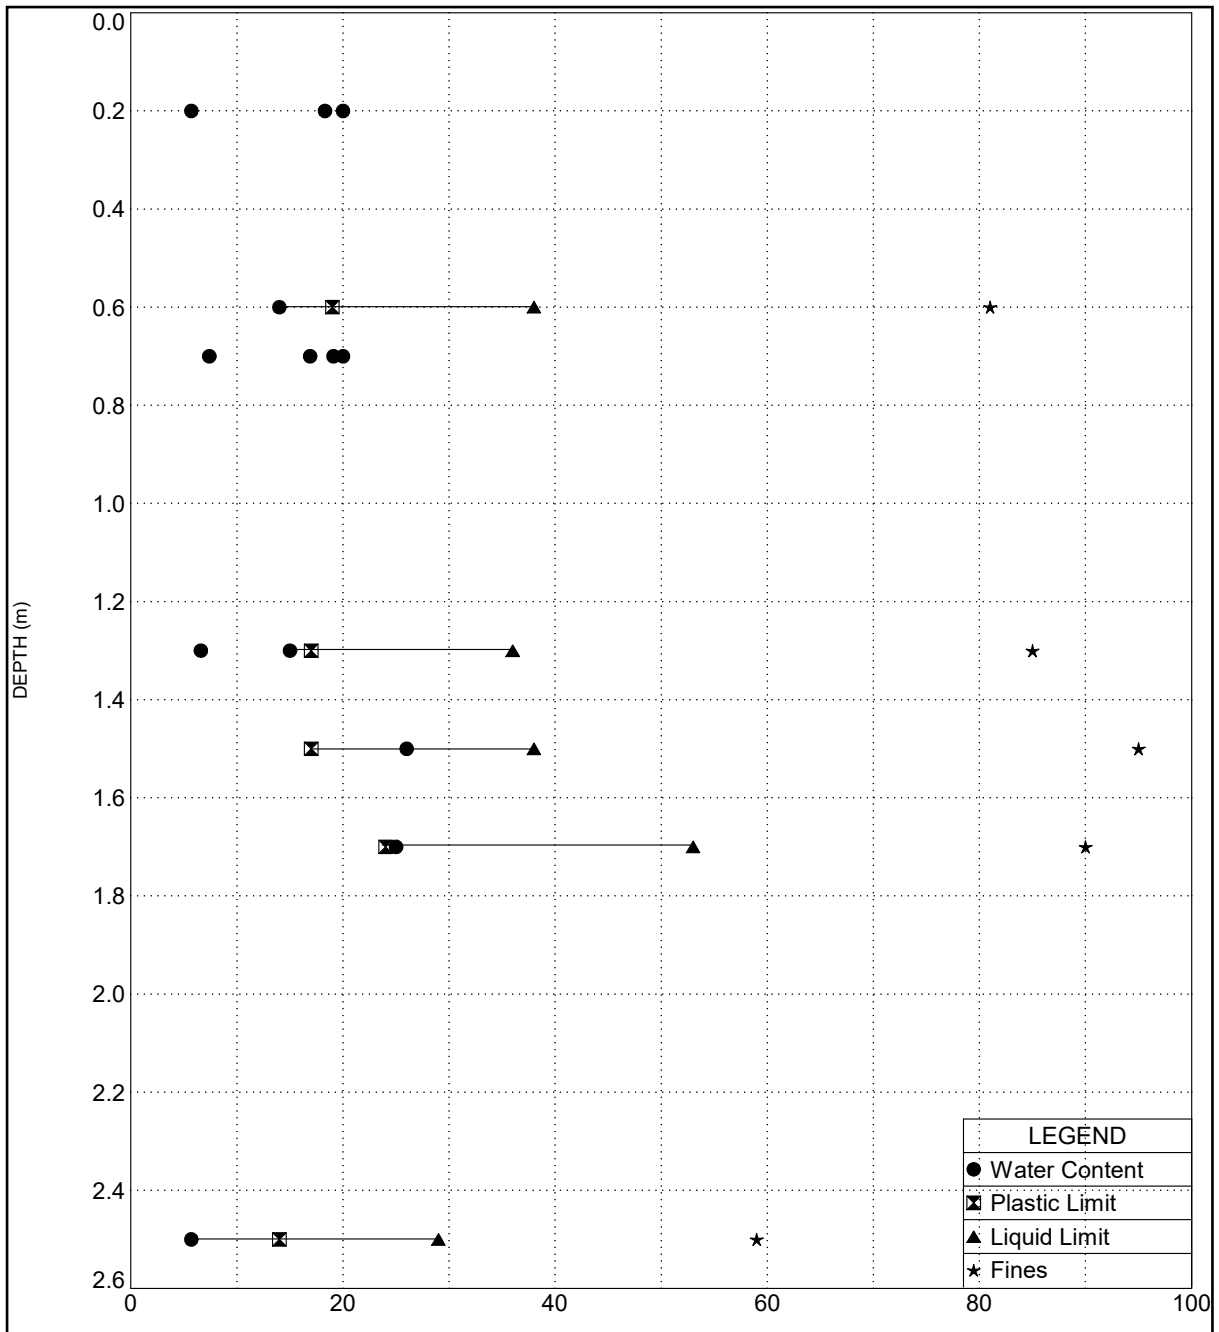
FIGURE 6 - INDEX PROPERTIES VS DEPTH GRAPH

samples of natural soils for comparison with the plasticity index results. The geotechnical testing results are summarised on Table 1 in Appendix B and also shown graphically on Figure 6.

Plasticity Index testing recorded the plastic limit of the residual soils to range from 17%-19%, with the moisture content values generally around the plastic limit values as shown on Figure 6. Calculated modified plasticity index values in accordance with

NHBC Ch.4.2 “Building near trees” ranged from 15-20%, equating to a low volume change potential when factoring the fines content of the samples.

Plasticity index testing carried out on samples of the stiff clay found the soils to be low volume change potential in accordance with NHBC Ch.4.2, with an applicable minimum founding depth of 750mm bgl.
