Bat Survey to
Spring Grove Gardens
Paul Lane
Mirfield
HD5 0PU

16th May 2023

1. Summary

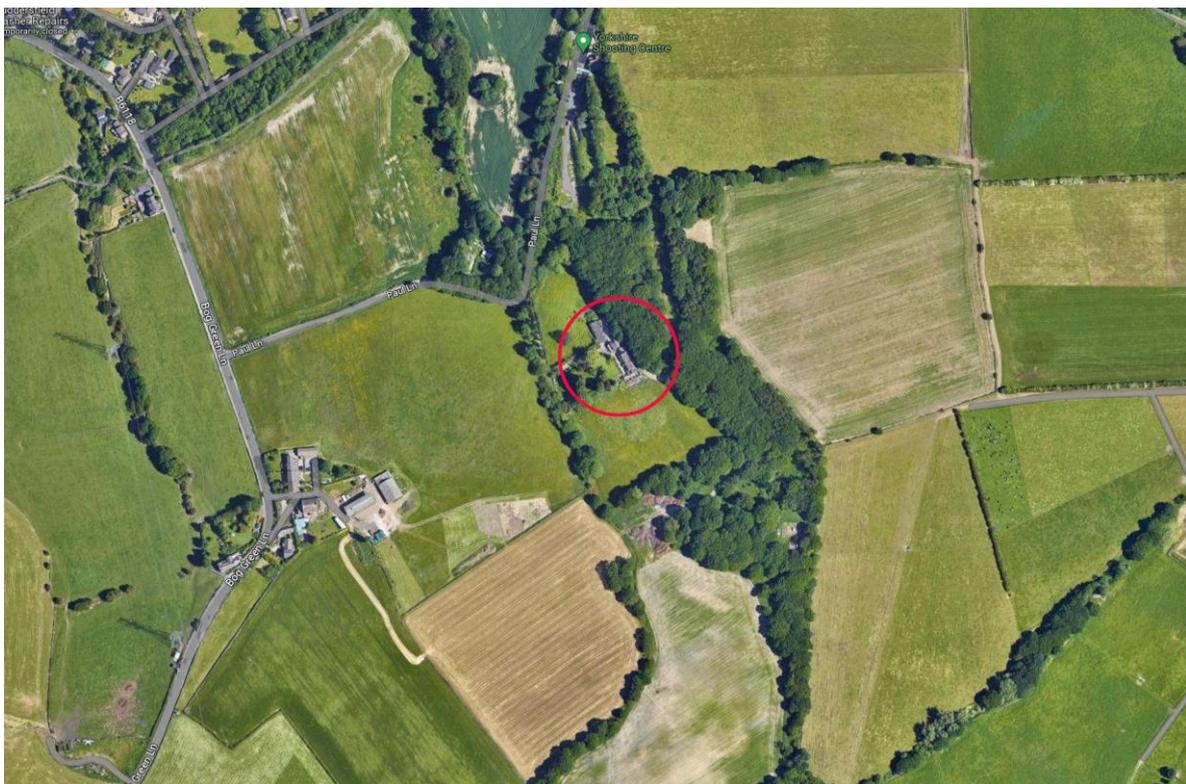
Figure 2 Aerial view of the site, surrounds and specific buildings surveyed.

The buildings surveyed are two large open-fronted storage buildings which face each other and are adjacent to the main house.

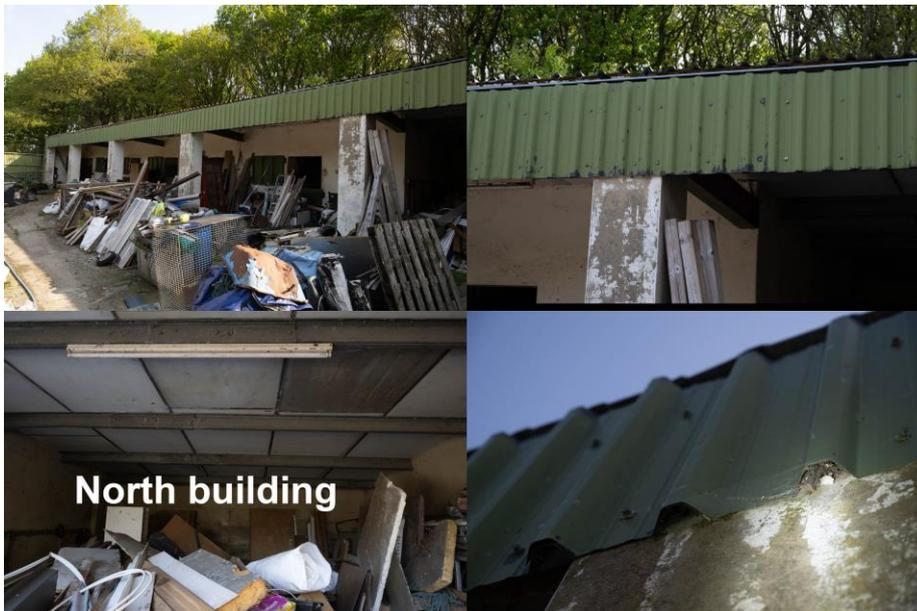
Photo 1 Showing various aspects of north range

The building on the north side of the yard is constructed from breeze block which has been entirely rendered and offers no wall cavity, structural gaps or external features that would allow bats to roost. The roof has a shallow slope and is covered with pressed steel sheeting which is single thickness and unlined and has translucent light panels. There is no attic void that is likely to support ridge dwelling species though there is a shallow suspended ceiling in this building. There was no access into the small space between the ceiling and the steel roof covering. The fascia is a skirt fabricated from the same steel sheeting as the roof and where it laps the walls, the gaps were checked and found to be virtually all covered with cobwebs. There were no droppings adhered to the walls which are pale coloured and would show droppings easily.

Both buildings have been assessed as being of negligible roosting potential.

The buildings have been assessed as being of *negligible* roosting potential and demolition works are unlikely to have any impact on bats or the local bat population. There will be no loss of existing roost sites and no loss or fragmentation of habitat caused by the development. Including permanent bat roosts or bird nesting features would increase the site's biodiversity potential.

- Inclusion of 6 Schwegler flat bat boxes 1FF should be located in the woodland to the rear of the site and located above 3m and mixed on SW and SE aspects. Alternatively, a Schwegler bat wall system 3FE could easily be incorporated into the structure on the west or south elevations to provide a discrete permanent bat roosting feature.
- Consideration should be given to a selection of bird nesting boxes in the woodland to provide a range of nest sites to hole nesting species such as titmice and starlings. Wooden bird boxes can be bought or easily made and there are plenty of plans available online or at the BTO website.

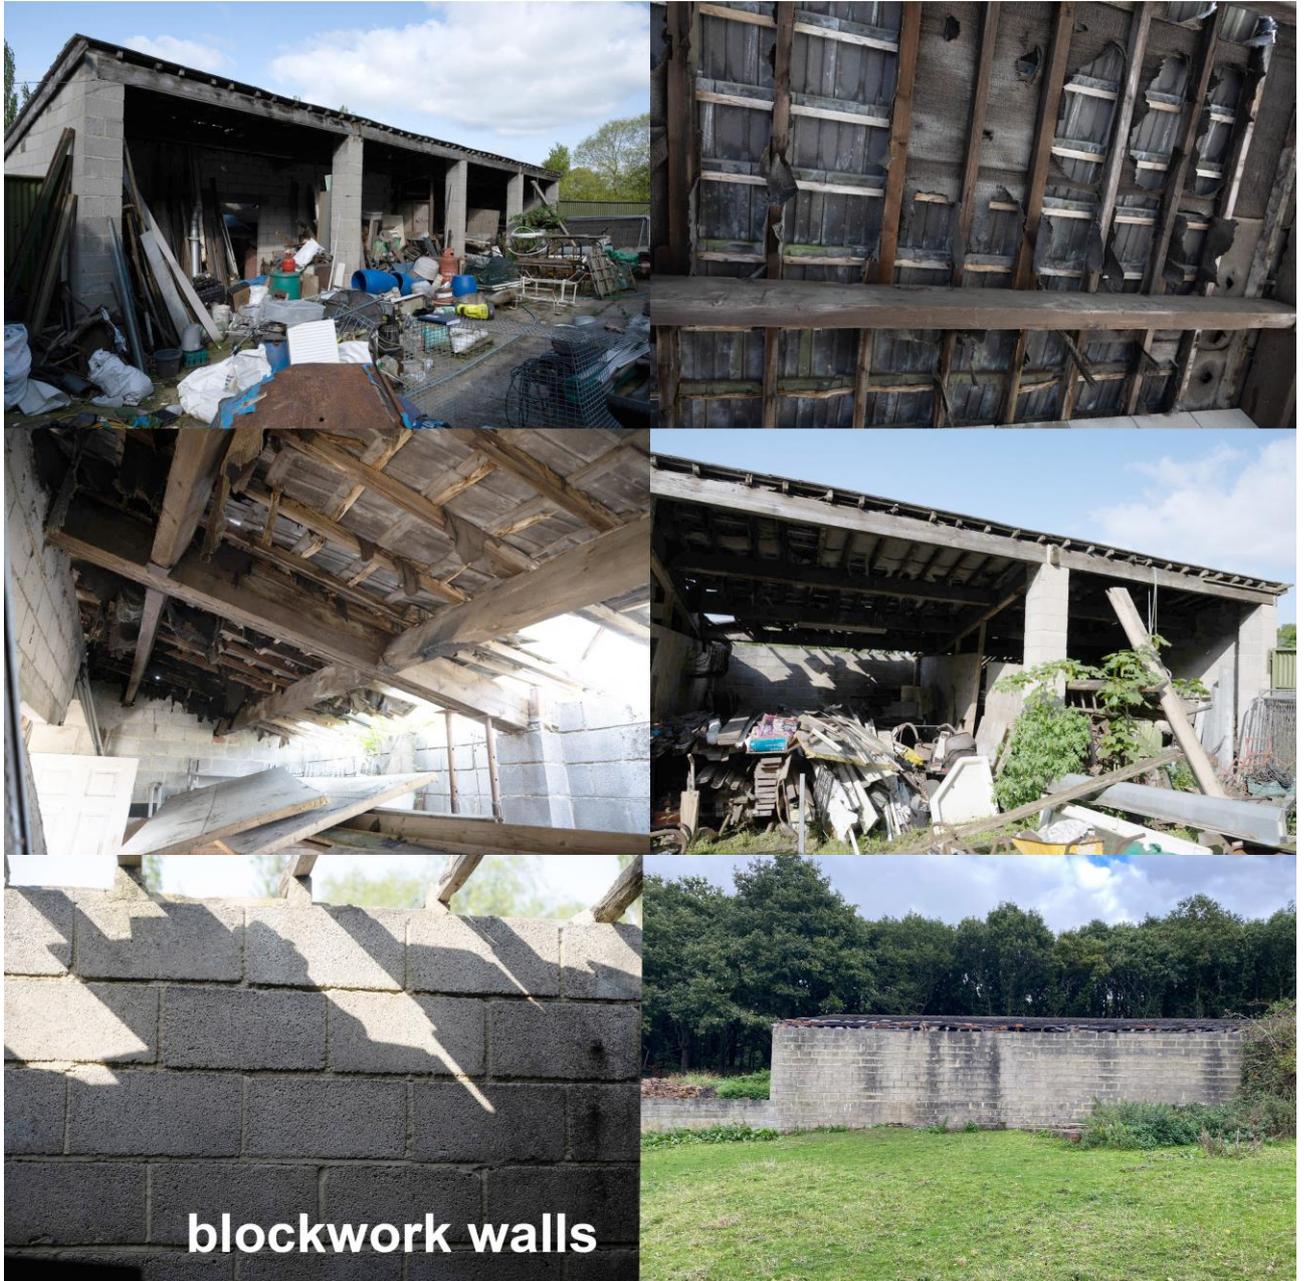
Photo 2 Showing various aspects of south range

The building on the south side of the yard is constructed from breeze blocks but is not rendered like the other but nonetheless lacks a wall cavity and has no structure cracks. There is no fascia on this building and the roof is fixed to wooden beams that offer no potential roosting sites. The shallow pitched roof is covered with a concrete tile that is tightly interlocking and offers no

access points. The tiles had a traditional felt lining and this has all but disintegrated and there is no roof void or ridge section that would support bats. The lower section of the roof has fallen away allowing light ingress into the building interior. There was no evidence of bats and no evidence of nesting birds.
