GEOENVIRONMENTAL DESK STUDY REPORT

Ferrand Lane Gomersal

MT/DS/4730.v5

December 2018

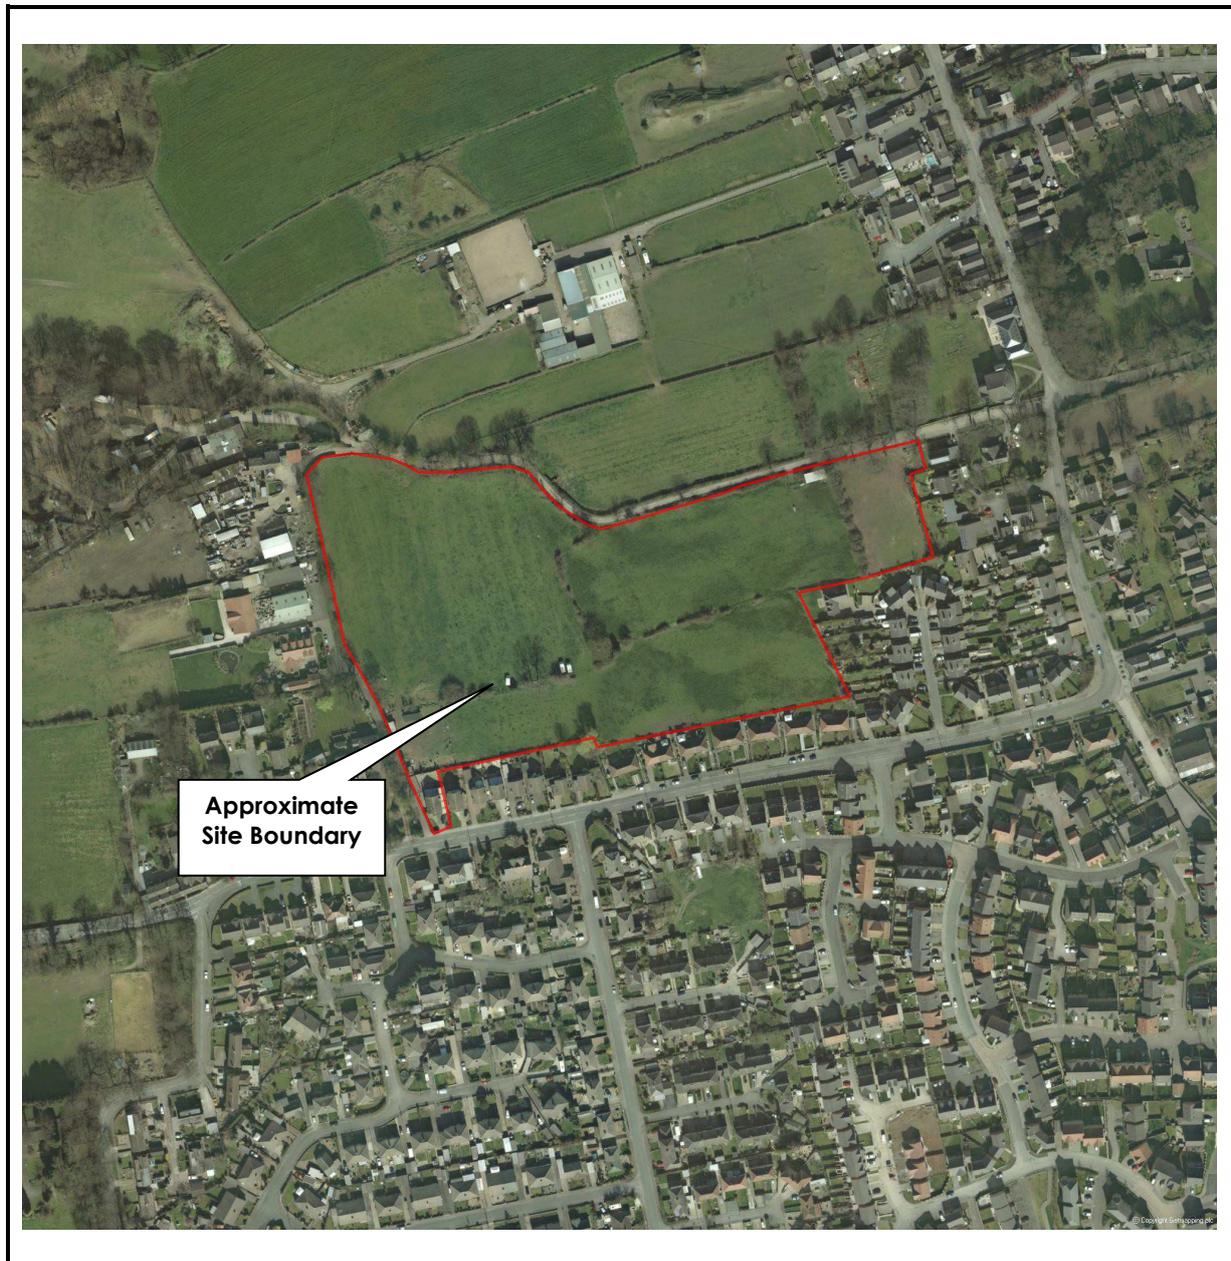
Figure 2 – Aerial Photograph	
Site	Ferrand Lane, Gomersal
Client	Quarters Gomersal Ltd
Job Number	4730
Scale	NTS

An aerial photograph of the site is presented as Figure 2 and selected photographs of the site are presented in Appendix B.

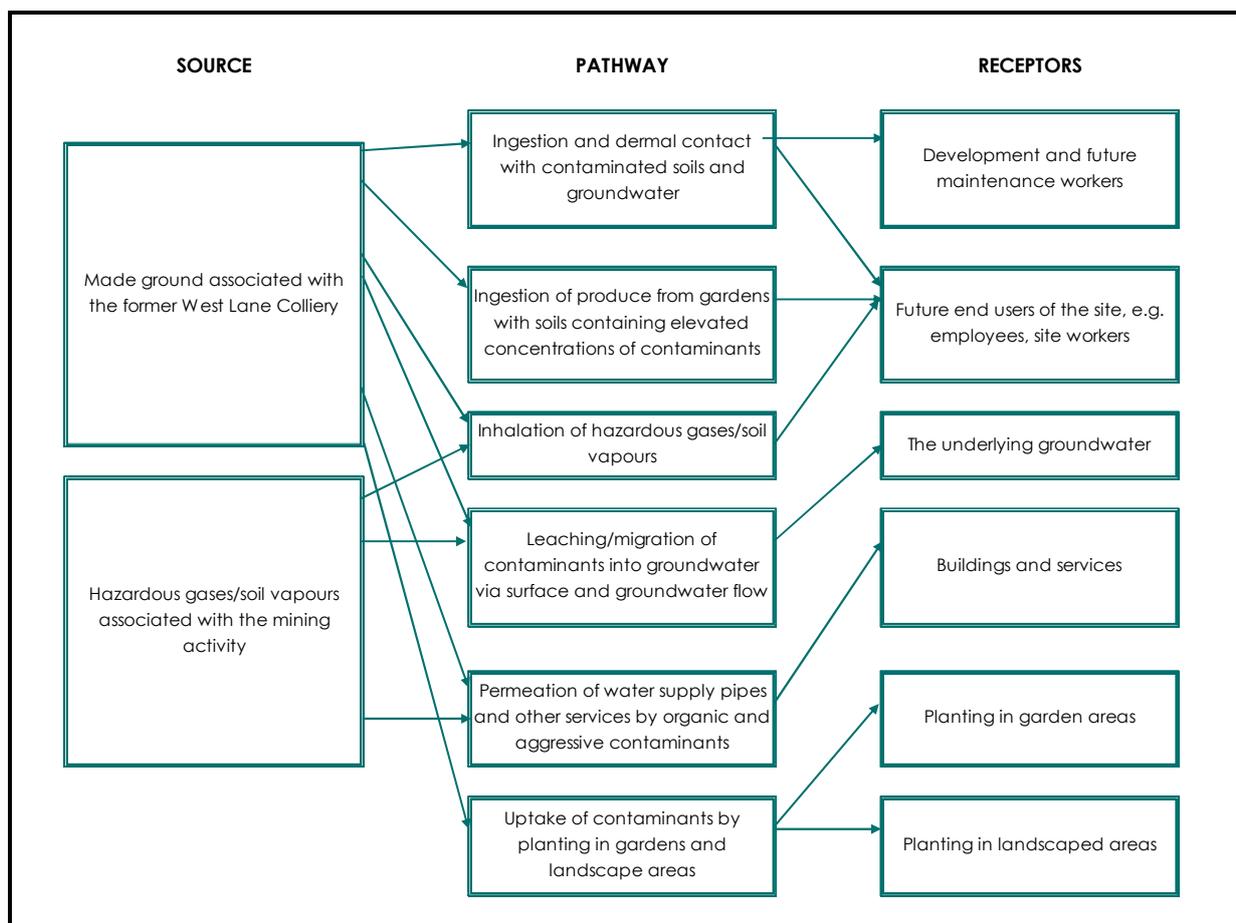
Figure 3 – Conceptual Site Model

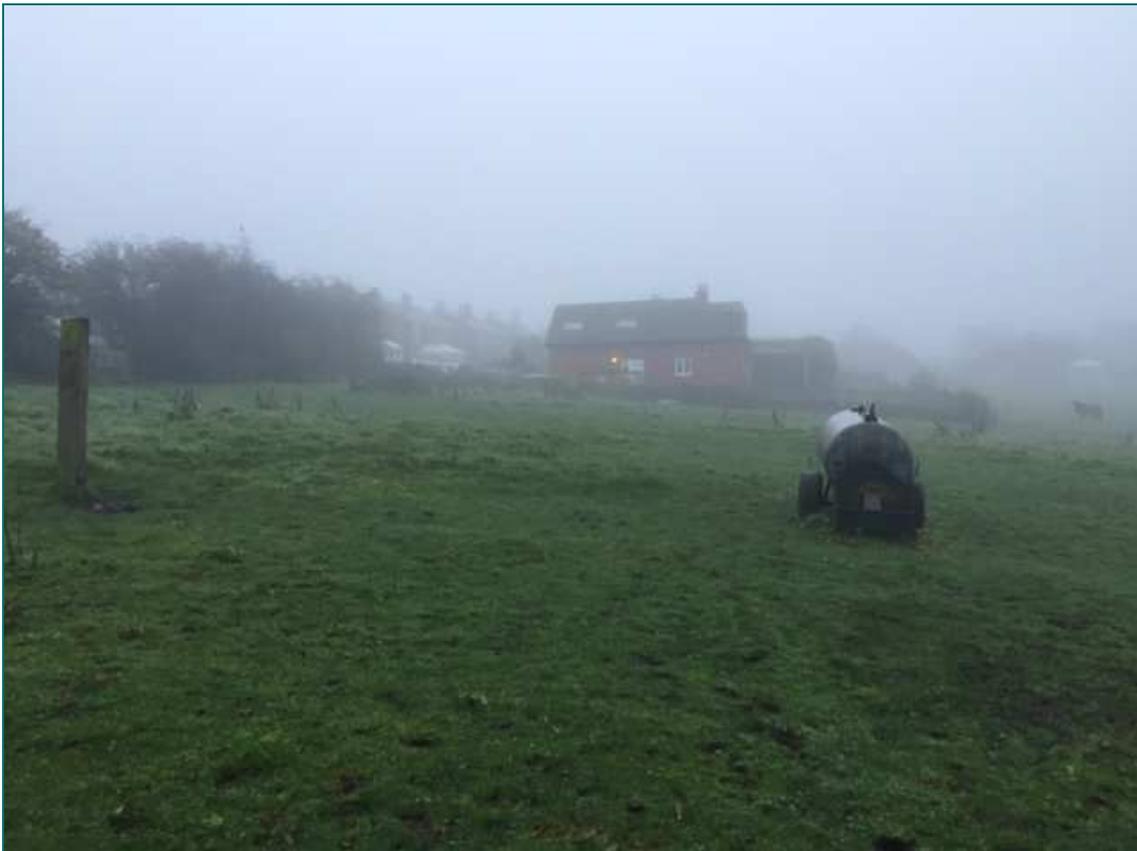
Photograph 1: View looking south at the north eastern end of the site.

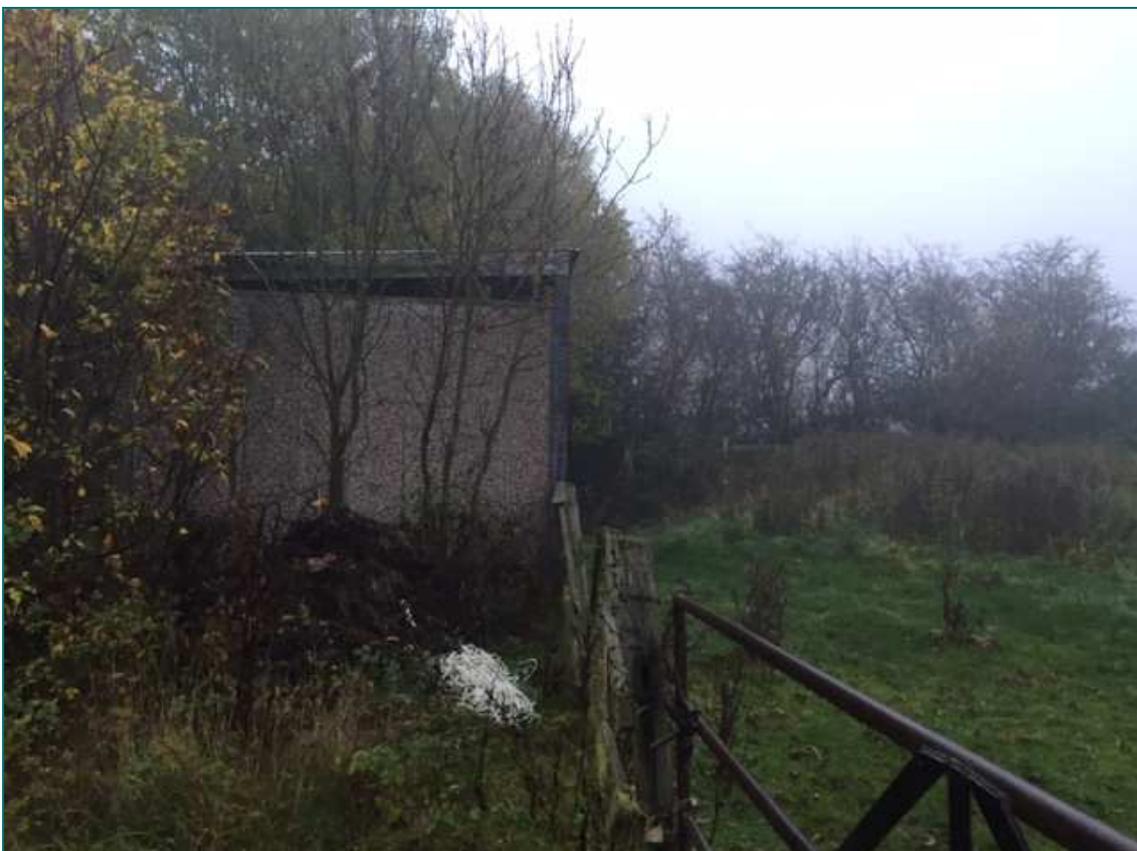
Photograph 2: View east showing outbuilding at north eastern site boundary

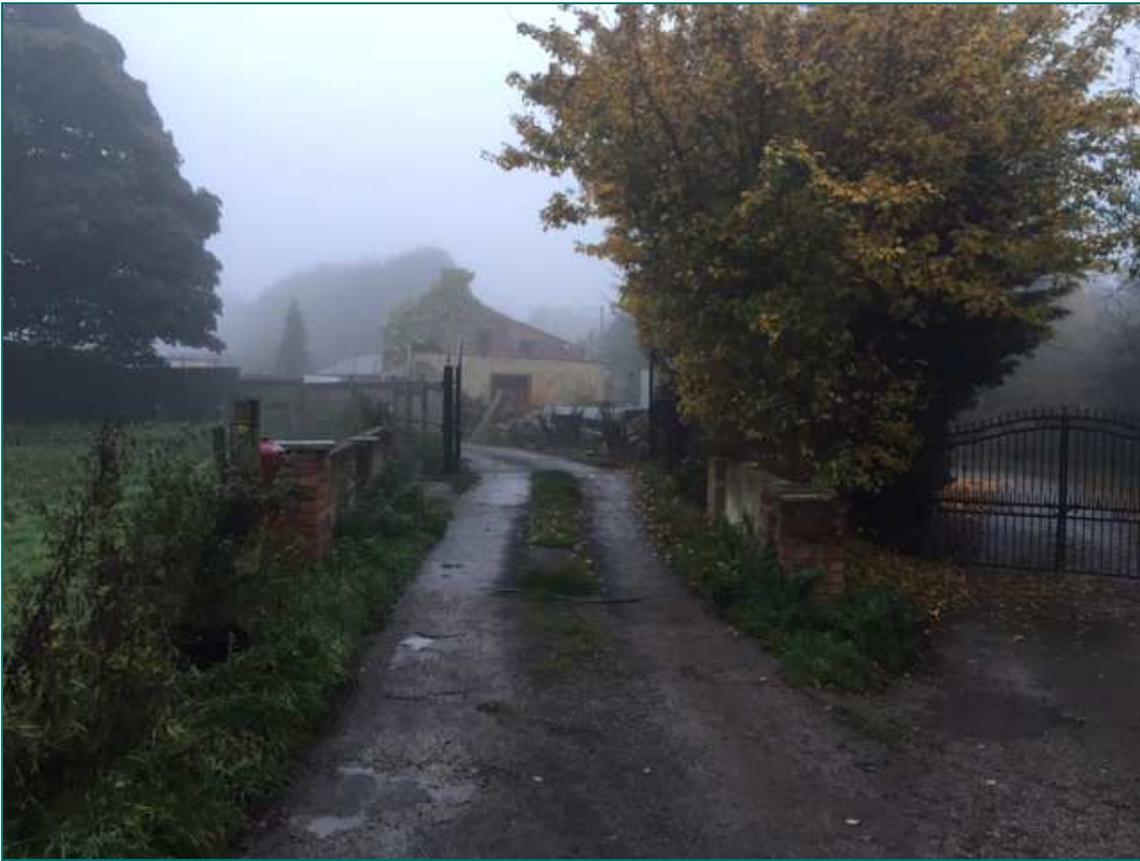
Photograph 5: View towards Throstle Nest Farm

Most of the site has a cover of short grass with mature trees and bushes along the field boundaries. Throstle Nest Farm was present at the northwest corner of the site which was utilised by commercial plant vehicles. An above ground fuel tank was noted in the field at the north western boundary, along with some agricultural equipment.

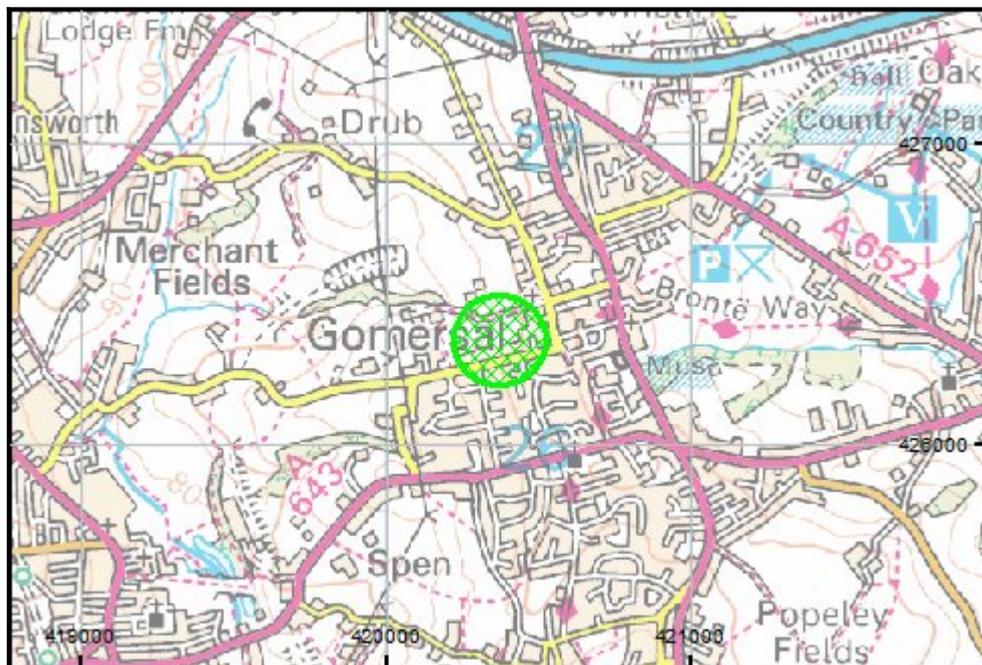
Location map

This plan shows the approximate location of the disused mine entry / entries referred to in the attached mining report. For reasons of clarity, mine entry symbols may not be drawn to the same scale as the plan.
