**67 Hall Ing Lane, Honley**

**Bat Survey Report**

**19<sup>th</sup> September 2023**

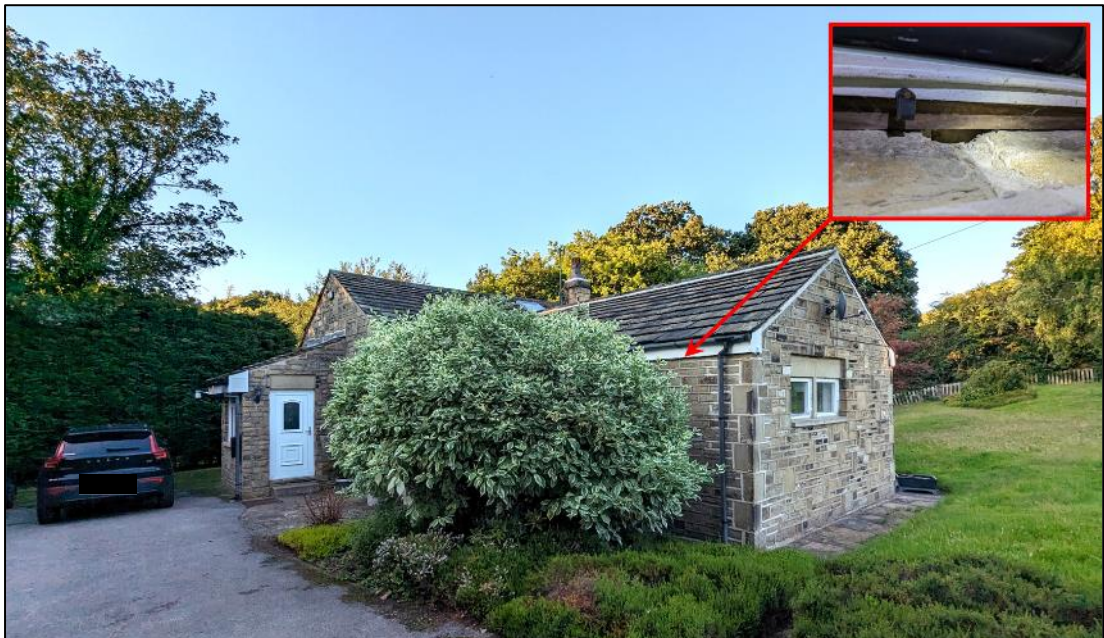
**Plate 1. South corner of dwelling, with roost location behind fascia board shown in subset image**

- 5.2.12 One bat roost location was recorded during the visual inspection, with this roost comprising a space behind the fascia board at the south end of the western elevation. The size and shape of droppings indicated pipistrelle bats, with common pipistrelle the only pipistrelle species recorded during nocturnal surveys. It is considered this roost is likely to comprise a common pipistrelle day roost. The low number of bat droppings scattered in the roof void are not considered indicative of roosting within this space.

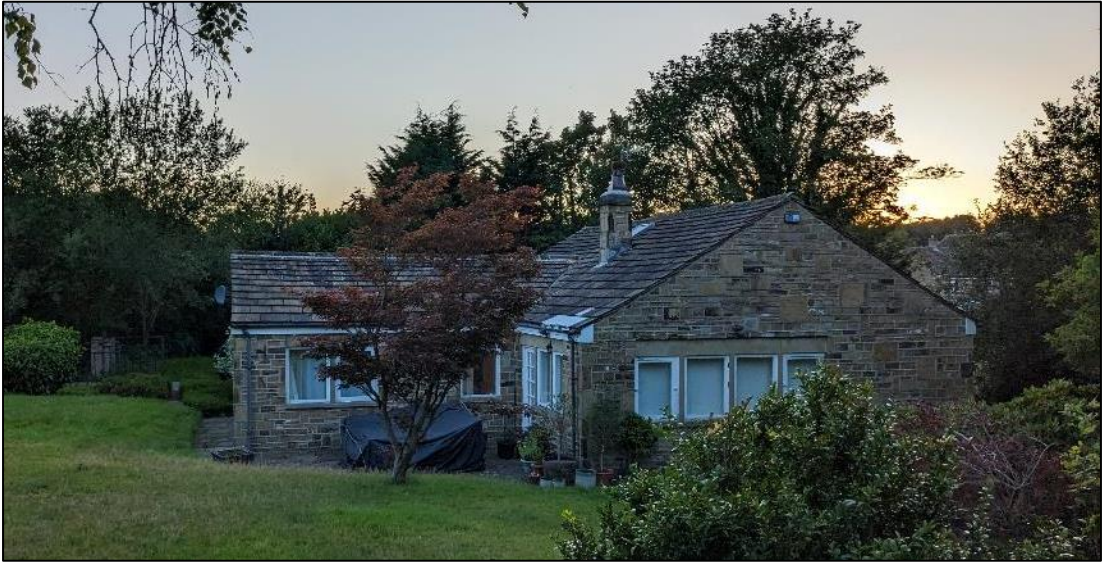
- 5.2.2 The surveyed dwelling comprised a stone-built bungalow with a multi-pitched stone-slate covered roof (Plates 1-3). The walls were expected to be of cavity construction. The building had three gables with mortar filled verges and a single-storey porch on the west elevation. A stone chimney was present. Wooden fascia boards were present with a plastic soffit on the east elevation. Single-paned wood-framed windows were present with a mix of wood and plastic doors present. Guttering was plastic.

**Plate 2. East elevation of dwelling**

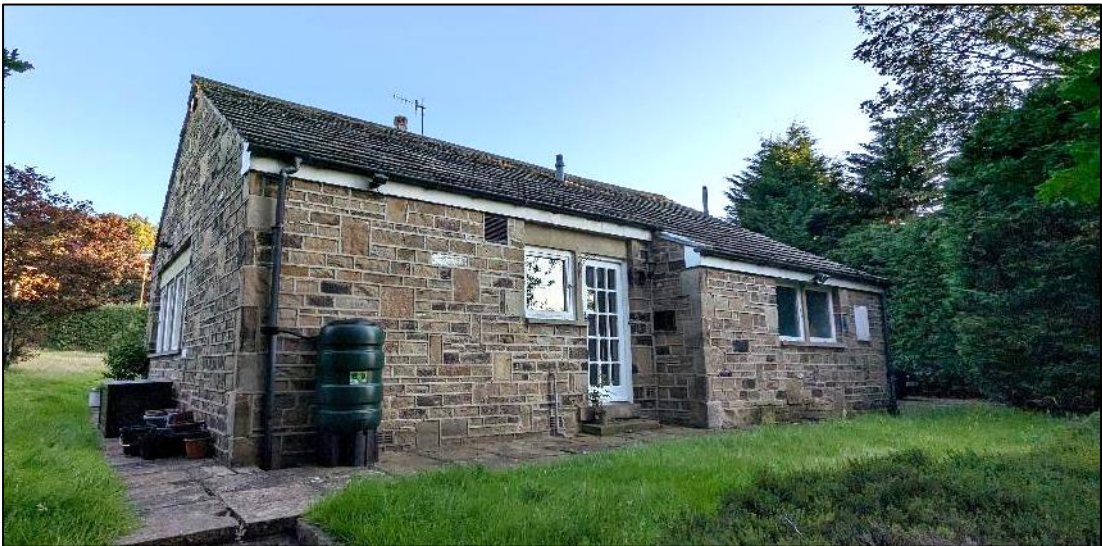
**Plate 3. North elevation of dwelling**

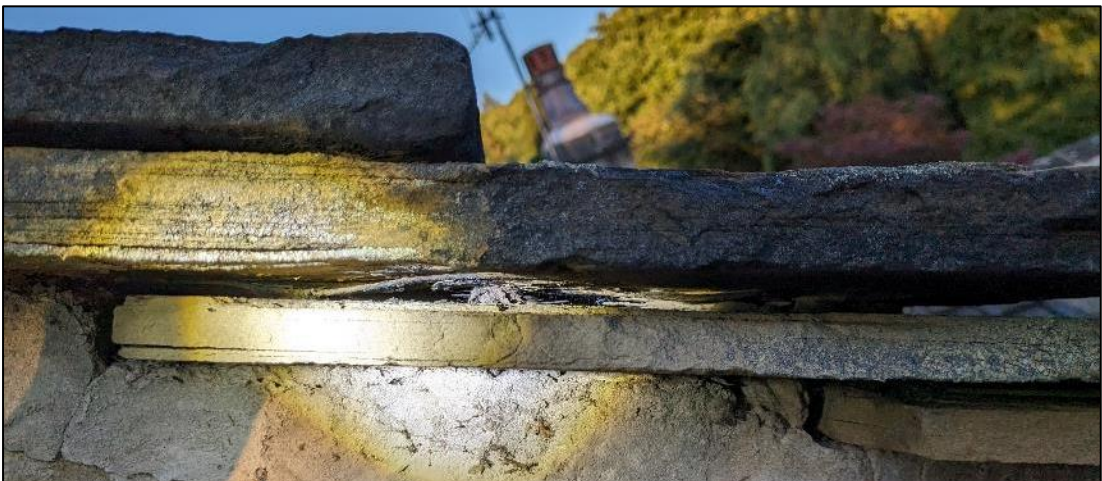
- 5.2.3 Potential roost features on the exterior of the dwelling were limited mainly to crevices present between stone roof slates (Plate 4), with such slates typically uneven in width. These gaps were particularly prominent on gable verges. Gaps were also present in places between wood fascia boards and the underlying masonry, with a cluster of three probable pipistrelle droppings recorded between a wooden fascia board and the wall on the west elevation (Plate 1). This finding of droppings behind a fascia board was considered to be evidence of a confirmed bat roost, likely a day roost.

**Plate 4. Example of gap between slates on verge**

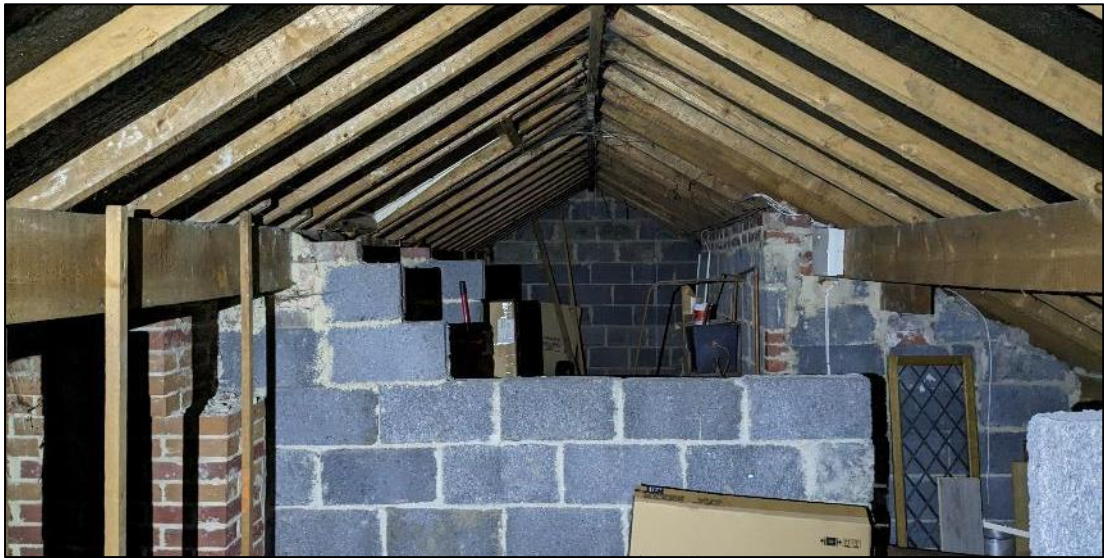
- 5.2.4 A large T-shaped roof void was present, with a maximum height of 2.2 m. The roof was mainly lined with hessian backed Type 1F bituminous felt, although some breathable roof membrane was present on the southern projection of the roof. The roof was suspended on a ridge beam, purlins, rafters and battens, with the ceiling mainly boarded out for storage but with c. 100 mm of glass-fibre insulation present elsewhere. Approximately five small (likely pipistrelle) bat droppings were recorded from within the roof void.
- 5.2.5 The surveyed building was considered to display a moderate level of bat roosting suitability. No evidence of bird nesting was recorded during the survey.

**Plate 5. Roof void interior**

- 6.3.6 Use of standard breathable roofing membranes must be avoided during building re-development. Bats have been shown to regularly become entangled and die in the component filaments of modern woven roofing membranes. When buildings are being re-developed, particularly with stone or artificial stone roof slates, it is typically impossible to completely exclude bats from the new roof. Therefore, the only acceptable types of roofing membrane to use in this instance comprise either traditional hessian-backed bituminous Type 1F felt or TLX Batsafe.

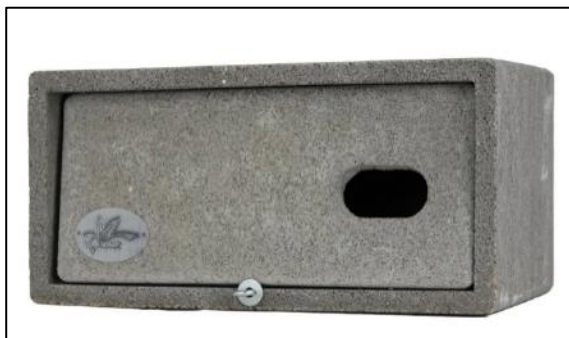
**Plate 6. Orlando Swift Brick**

- 6.3.10 Building re-development works should commence either outside the bird nesting period (March to August inclusive), or the works will need to be preceded by a nesting bird check.
- 6.3.11 In accordance with the aims of the National Planning Policy Framework, and to compensate for the loss of bird nesting habitat associated with the outbuilding, it is recommended that one integrated swift *Apus apus* box (i.e. the Orlando Swift Box (Plate 6)) be installed within the dwelling. This box should be fitted at wall top height and may be installed across any elevation. Studies have shown that swift boxes are used by other bird species that utilise buildings and consequently this measure will provide potential nesting space for house sparrows and starlings *Sturnus vulgaris*, in addition to potentially providing future nest space for swift.
