# Garage at 7 Daisy Lea Lane, Lindley

## Bat Survey Report

21<sup>st</sup> September 2023

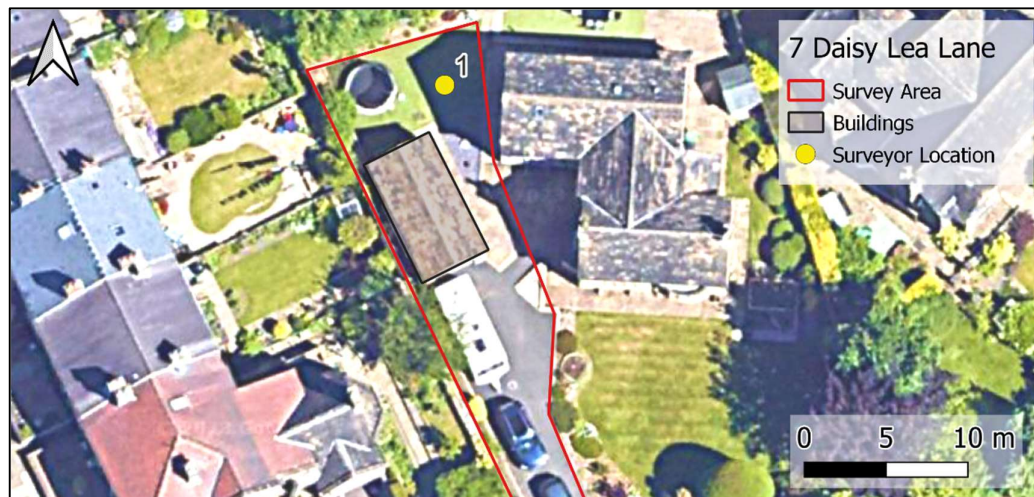
4.2.4 The nocturnal bat survey comprised a dusk emergence survey completed on 7<sup>th</sup> September 2023. The survey was conducted by John Pearse. The surveyor was equipped with a Wildlife Acoustics EM Touch bat detector and tablet recorder as well as an infrared (IR) camera and IR lighting system<sup>1</sup>. The surveyor position is shown in Figure 2.

**Figure 2. Site layout and surveyor position**

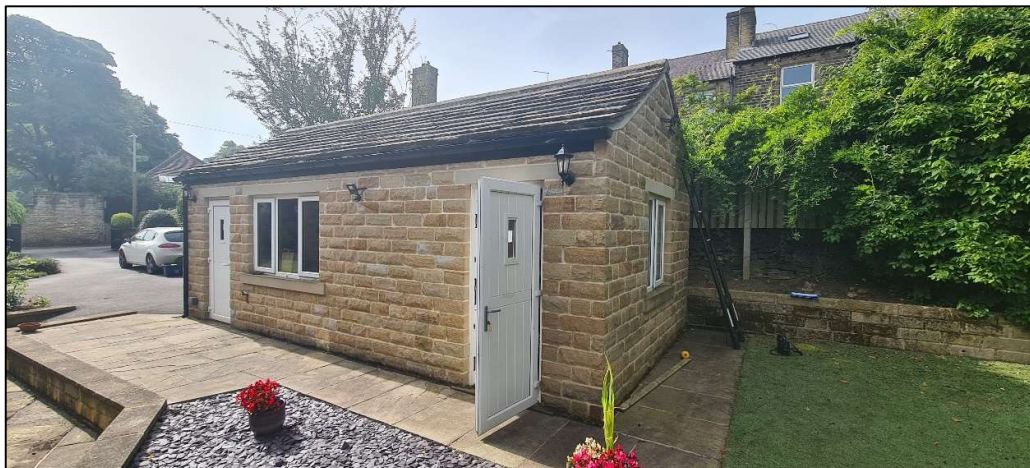
- 5.2.3 The single-storey garage was constructed from concrete blocks and stone with a two-pitched roof covered with stone slates (Plate 1).
- 5.2.4 The building had uPVC framed windows and doors and had a fascia set into the stonework. The roof verges above the two gable ends of the building were pointed with mortar.

**Plate 1. The garage viewed from the northeastern corner**

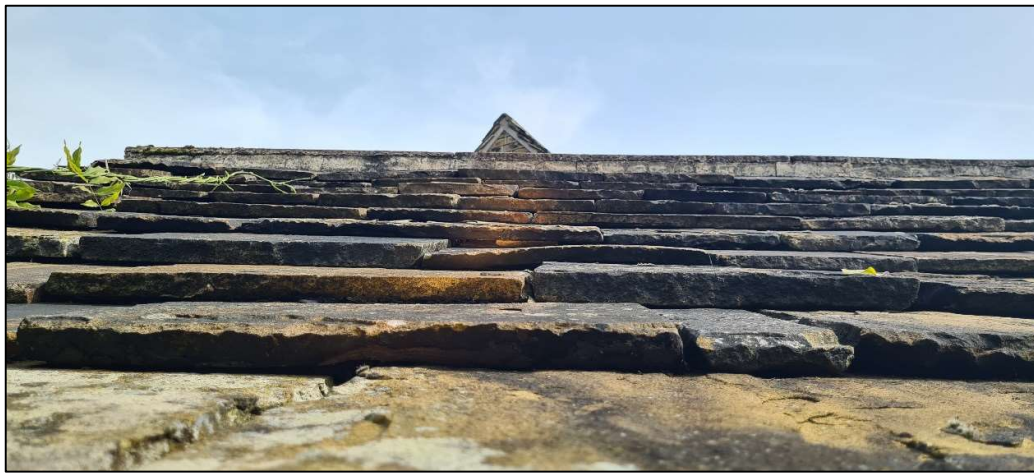
- 5.2.5 Potential bat roost features present comprised only the gaps between the stone slates shown in Plate 2 below. Due to the thickness and natural unevenness of the stone slates, the gaps were present between stone slates across the entirety of the roof pitch including at the gable ends (between stone slates but above the mortar as shown in Plate 3).
- 5.2.6 Due to the age and design of the building, no additional gaps or roosting opportunities were present.

**Plate 2. Gaps between and beneath the stone slates**

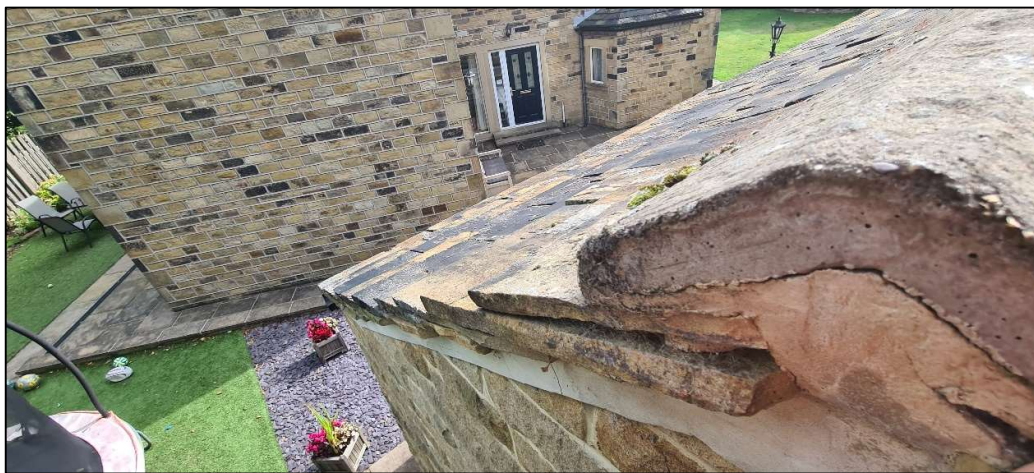
**Plate 3. Gaps between the stone slates at the northern gable end.**

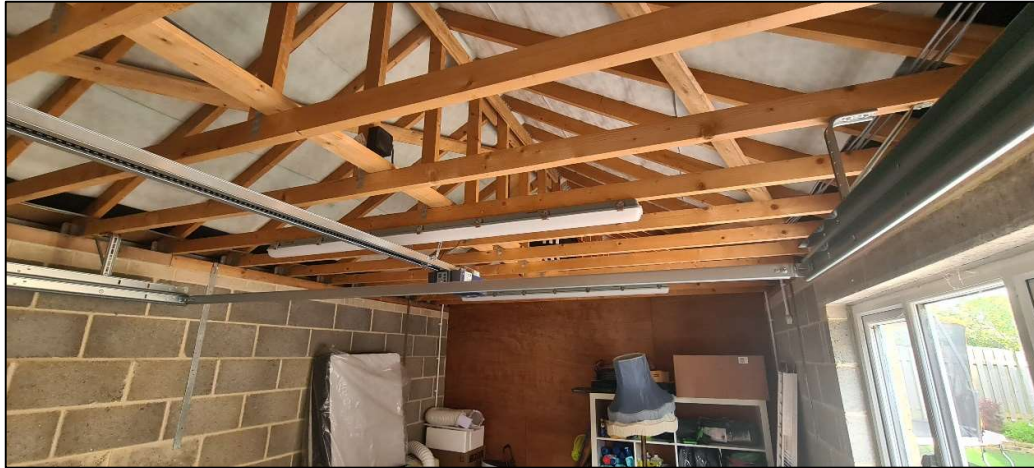
- 5.2.7 No roof void was present within the garage. The breathable roofing membrane beneath the felt was visible from the interior of the building (Plate 4). The roof was supported by modern, prefabricated wooden trusses.
- 5.2.8 The entirety of the interior of the building could be inspected. No bats, or signs of bats were present.

**Plate 4. Internal view of the roof showing the modern prefabricated roof trusses and the breathable roofing membrane**
