Land at Westgate, Cleckheaton For Strata Homes Ltd

Report no: 3043/2D

Date: July 2023

SUMMARY OF GEOENVIRONMENTAL ISSUES

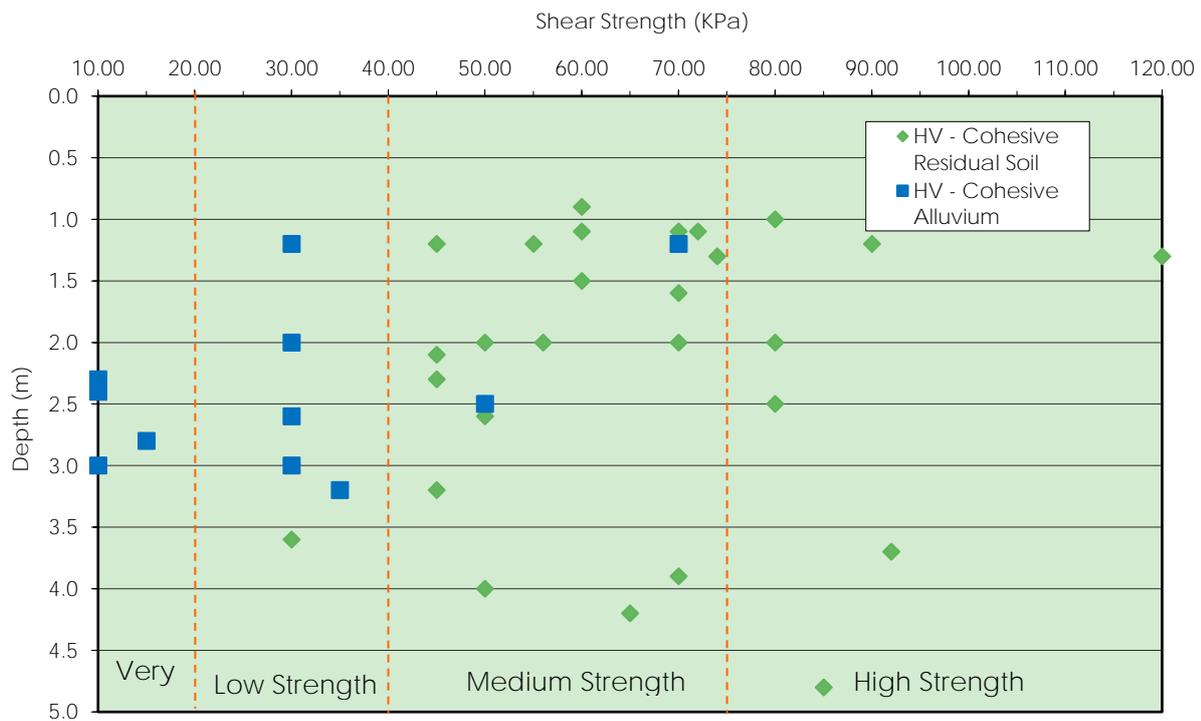
- 12.6.1 Hand shear vane testing was undertaken within trial pits in-situ to around 1.3m depth and from larger blocks of excavated clay below that depth.
- 12.6.2 The results are summarised within the plot below, within the Cohesive Alluvium deposits the results are generally very low strength to low strength.
- 12.6.3 For Cohesive Residual soils all the results are of at least medium strength except one which has fallen within the low strength category; this is likely because of a soft spot due to groundwater and/or higher sand content and is not thought to represent the true in-situ strength.
- 12.6.4 Below approximately 1.2m depth, undrained shear strength (S_u) within Cohesive Residual soils is typically greater than 50kPa.
- 12.6.5 The plot below provides a summary of undrained shear strengths:

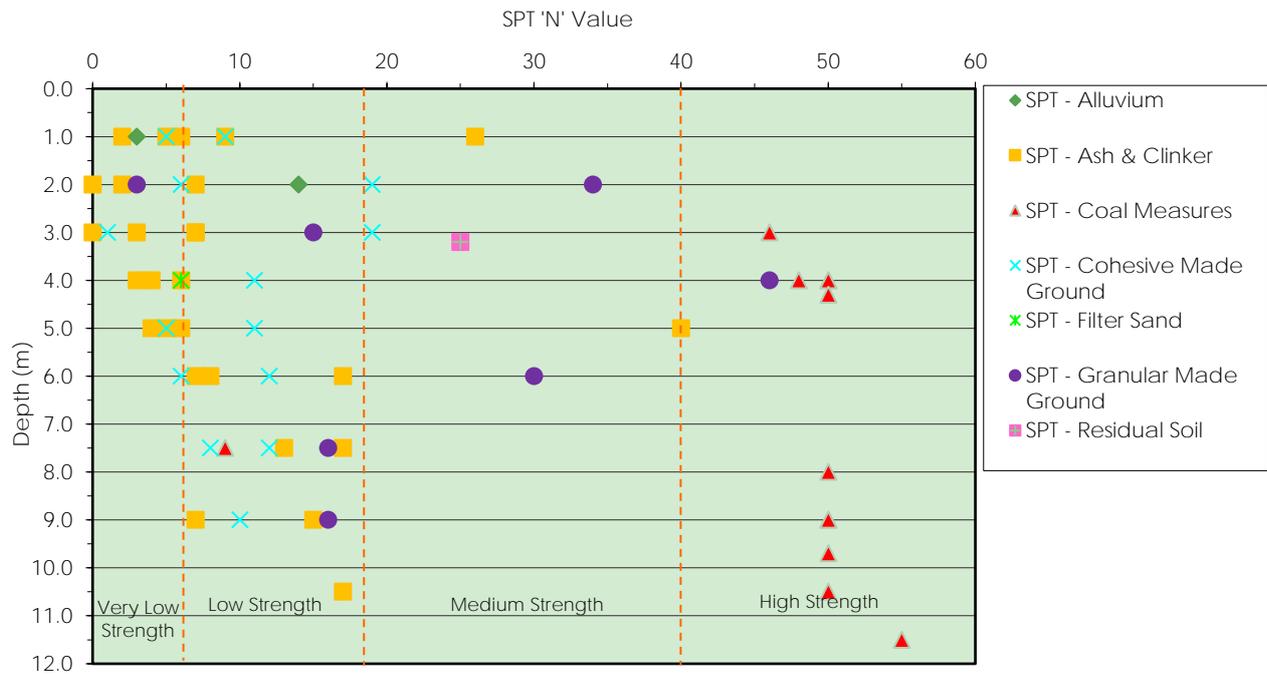
12.6.7 The SPT test results are displayed on the plot below:

12.6.8 SPT tests show that all of the made ground types tested are generally of poor and variable strength. The Alluvium (where present) is also of very low strength.

12.6.9 Residual soils are of medium strength and SPTs into bedrock (Coal Measures) typically refused after 50 blows. These readings support the descriptions given on the field logs.

12.6.6 The in-situ relative strength of both natural and made ground was established by carrying out Standard Penetration Tests (SPTs) during the drilling of the cable percussion boreholes (BHs 501 to 509).

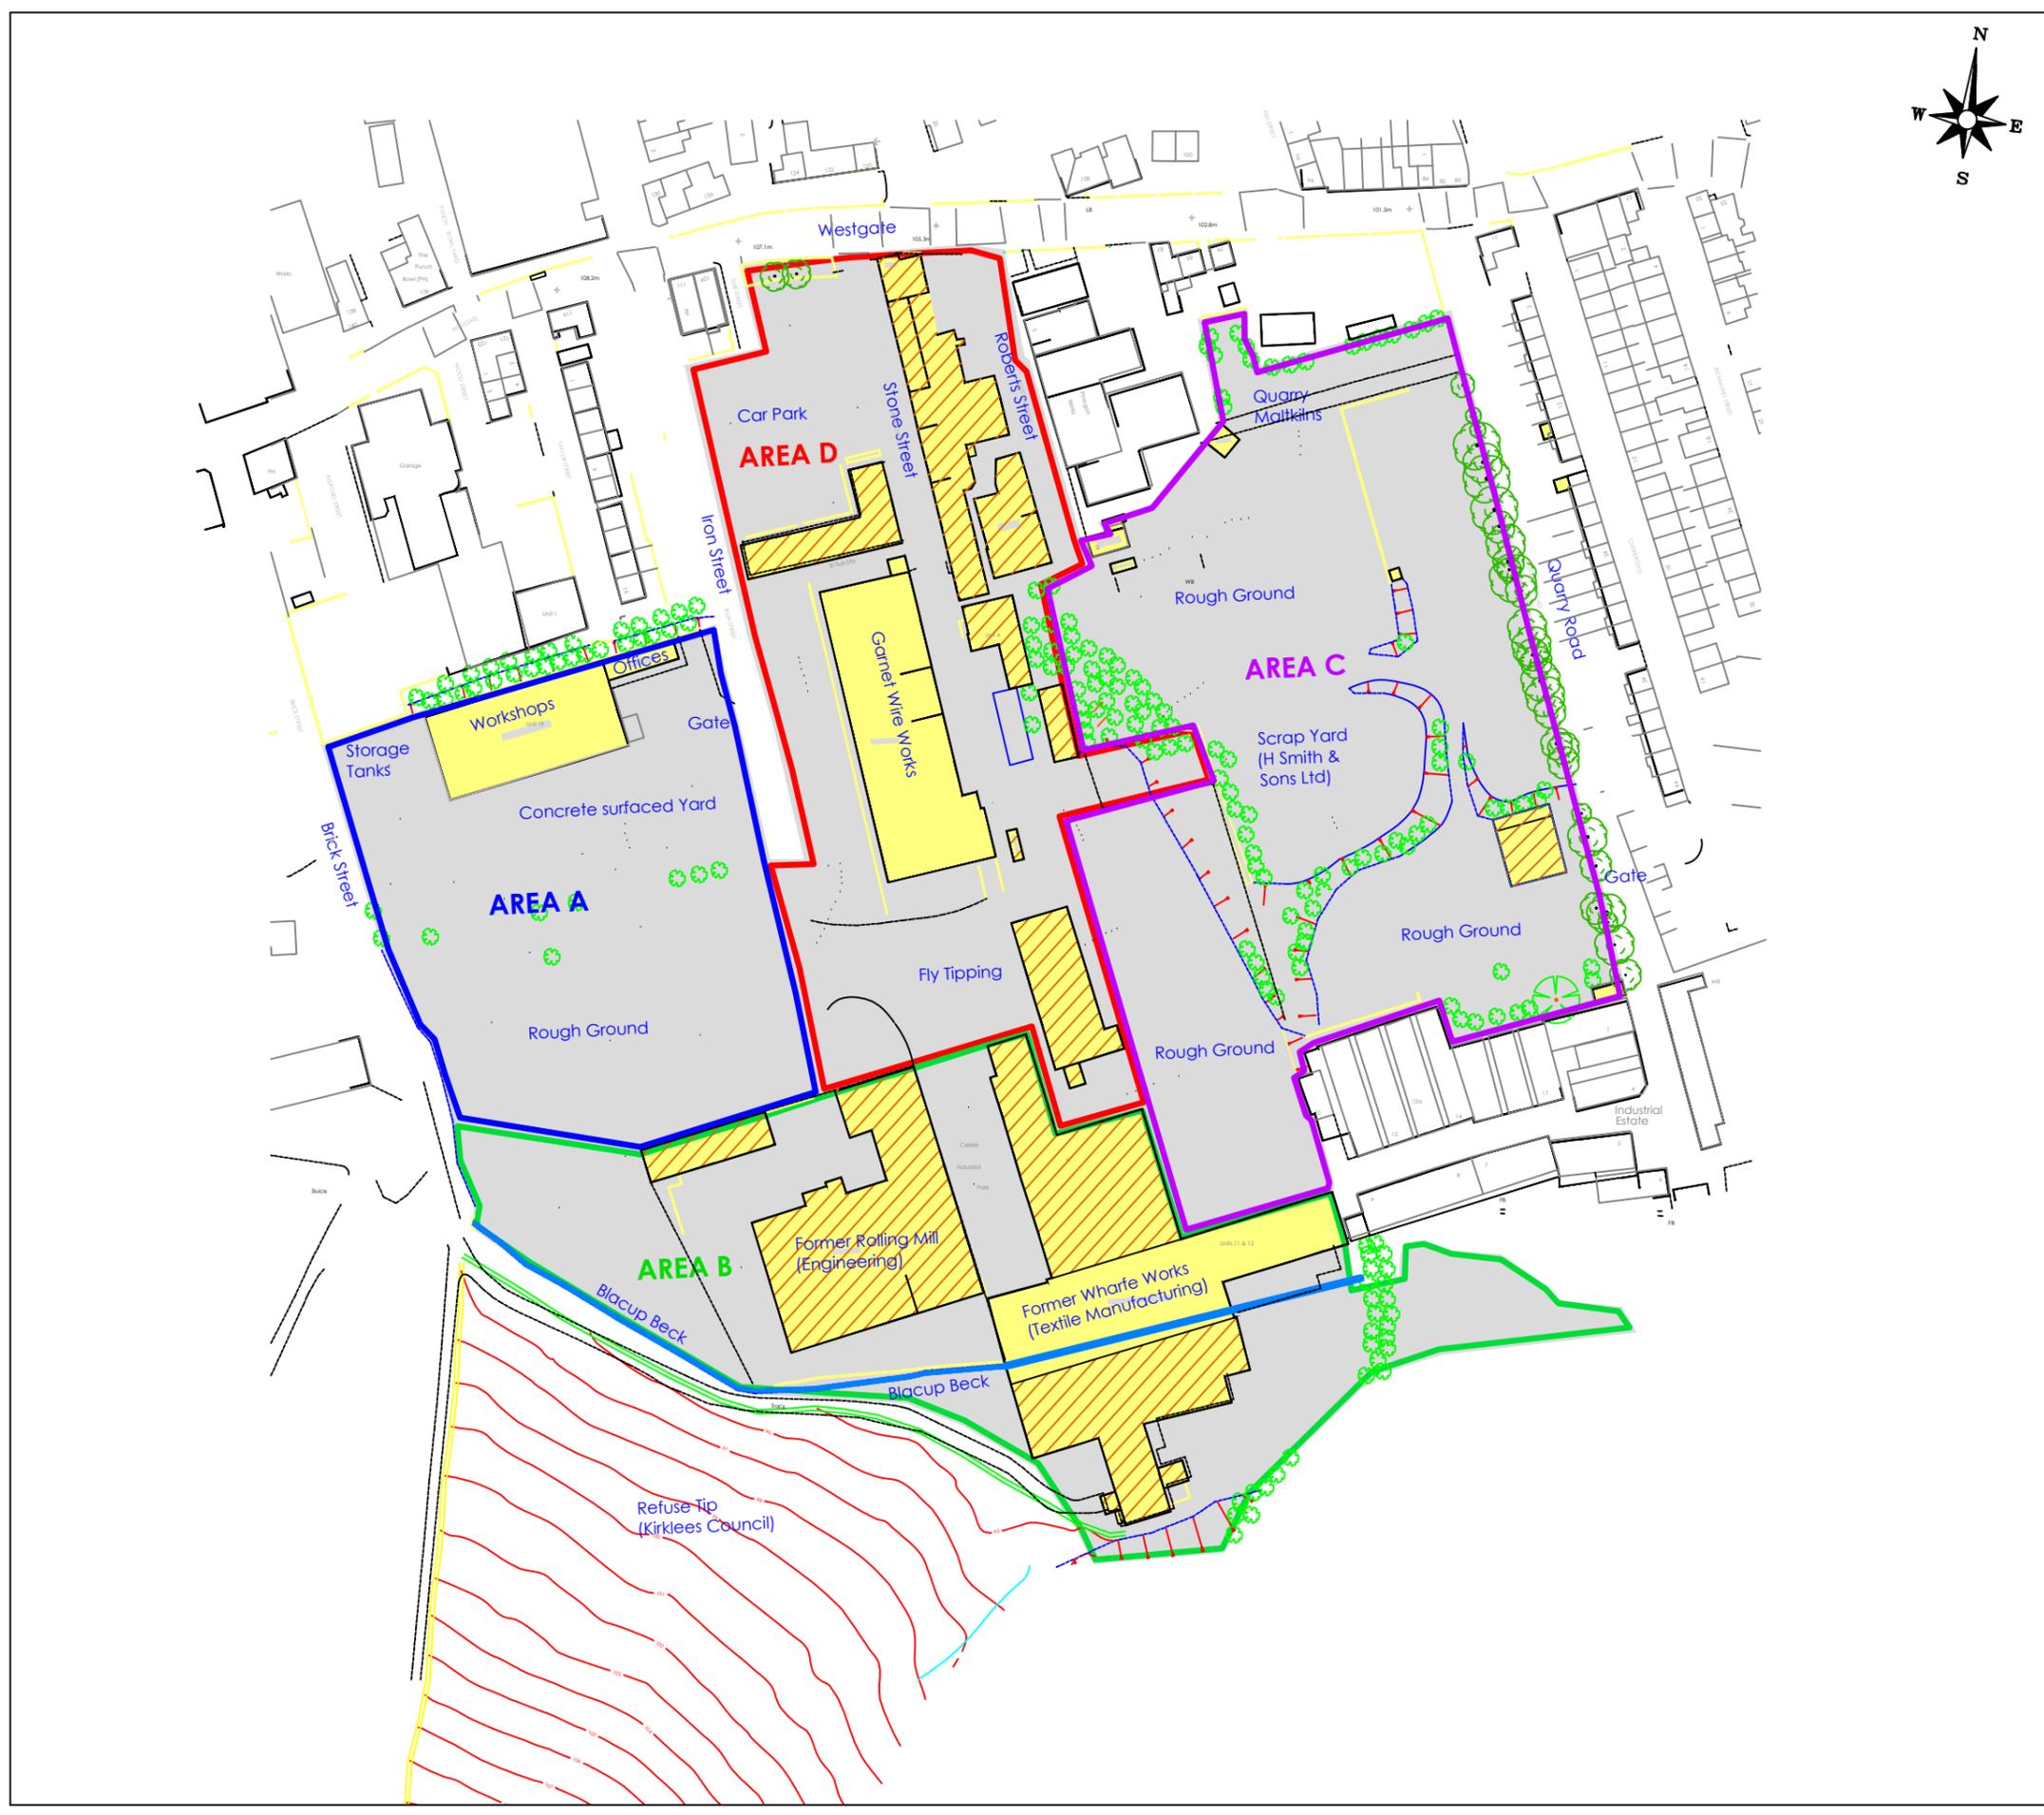
DRAWING TITLE
SITE FEATURES

- EXISTING BUILDING
- CONCRETE HARDSTAND (FORMER BUILDING FOOTPRINT)
- EXTERNAL SURFACING (CONCRETE HARDSTAND/TARMAC/ROUGH GROUND)

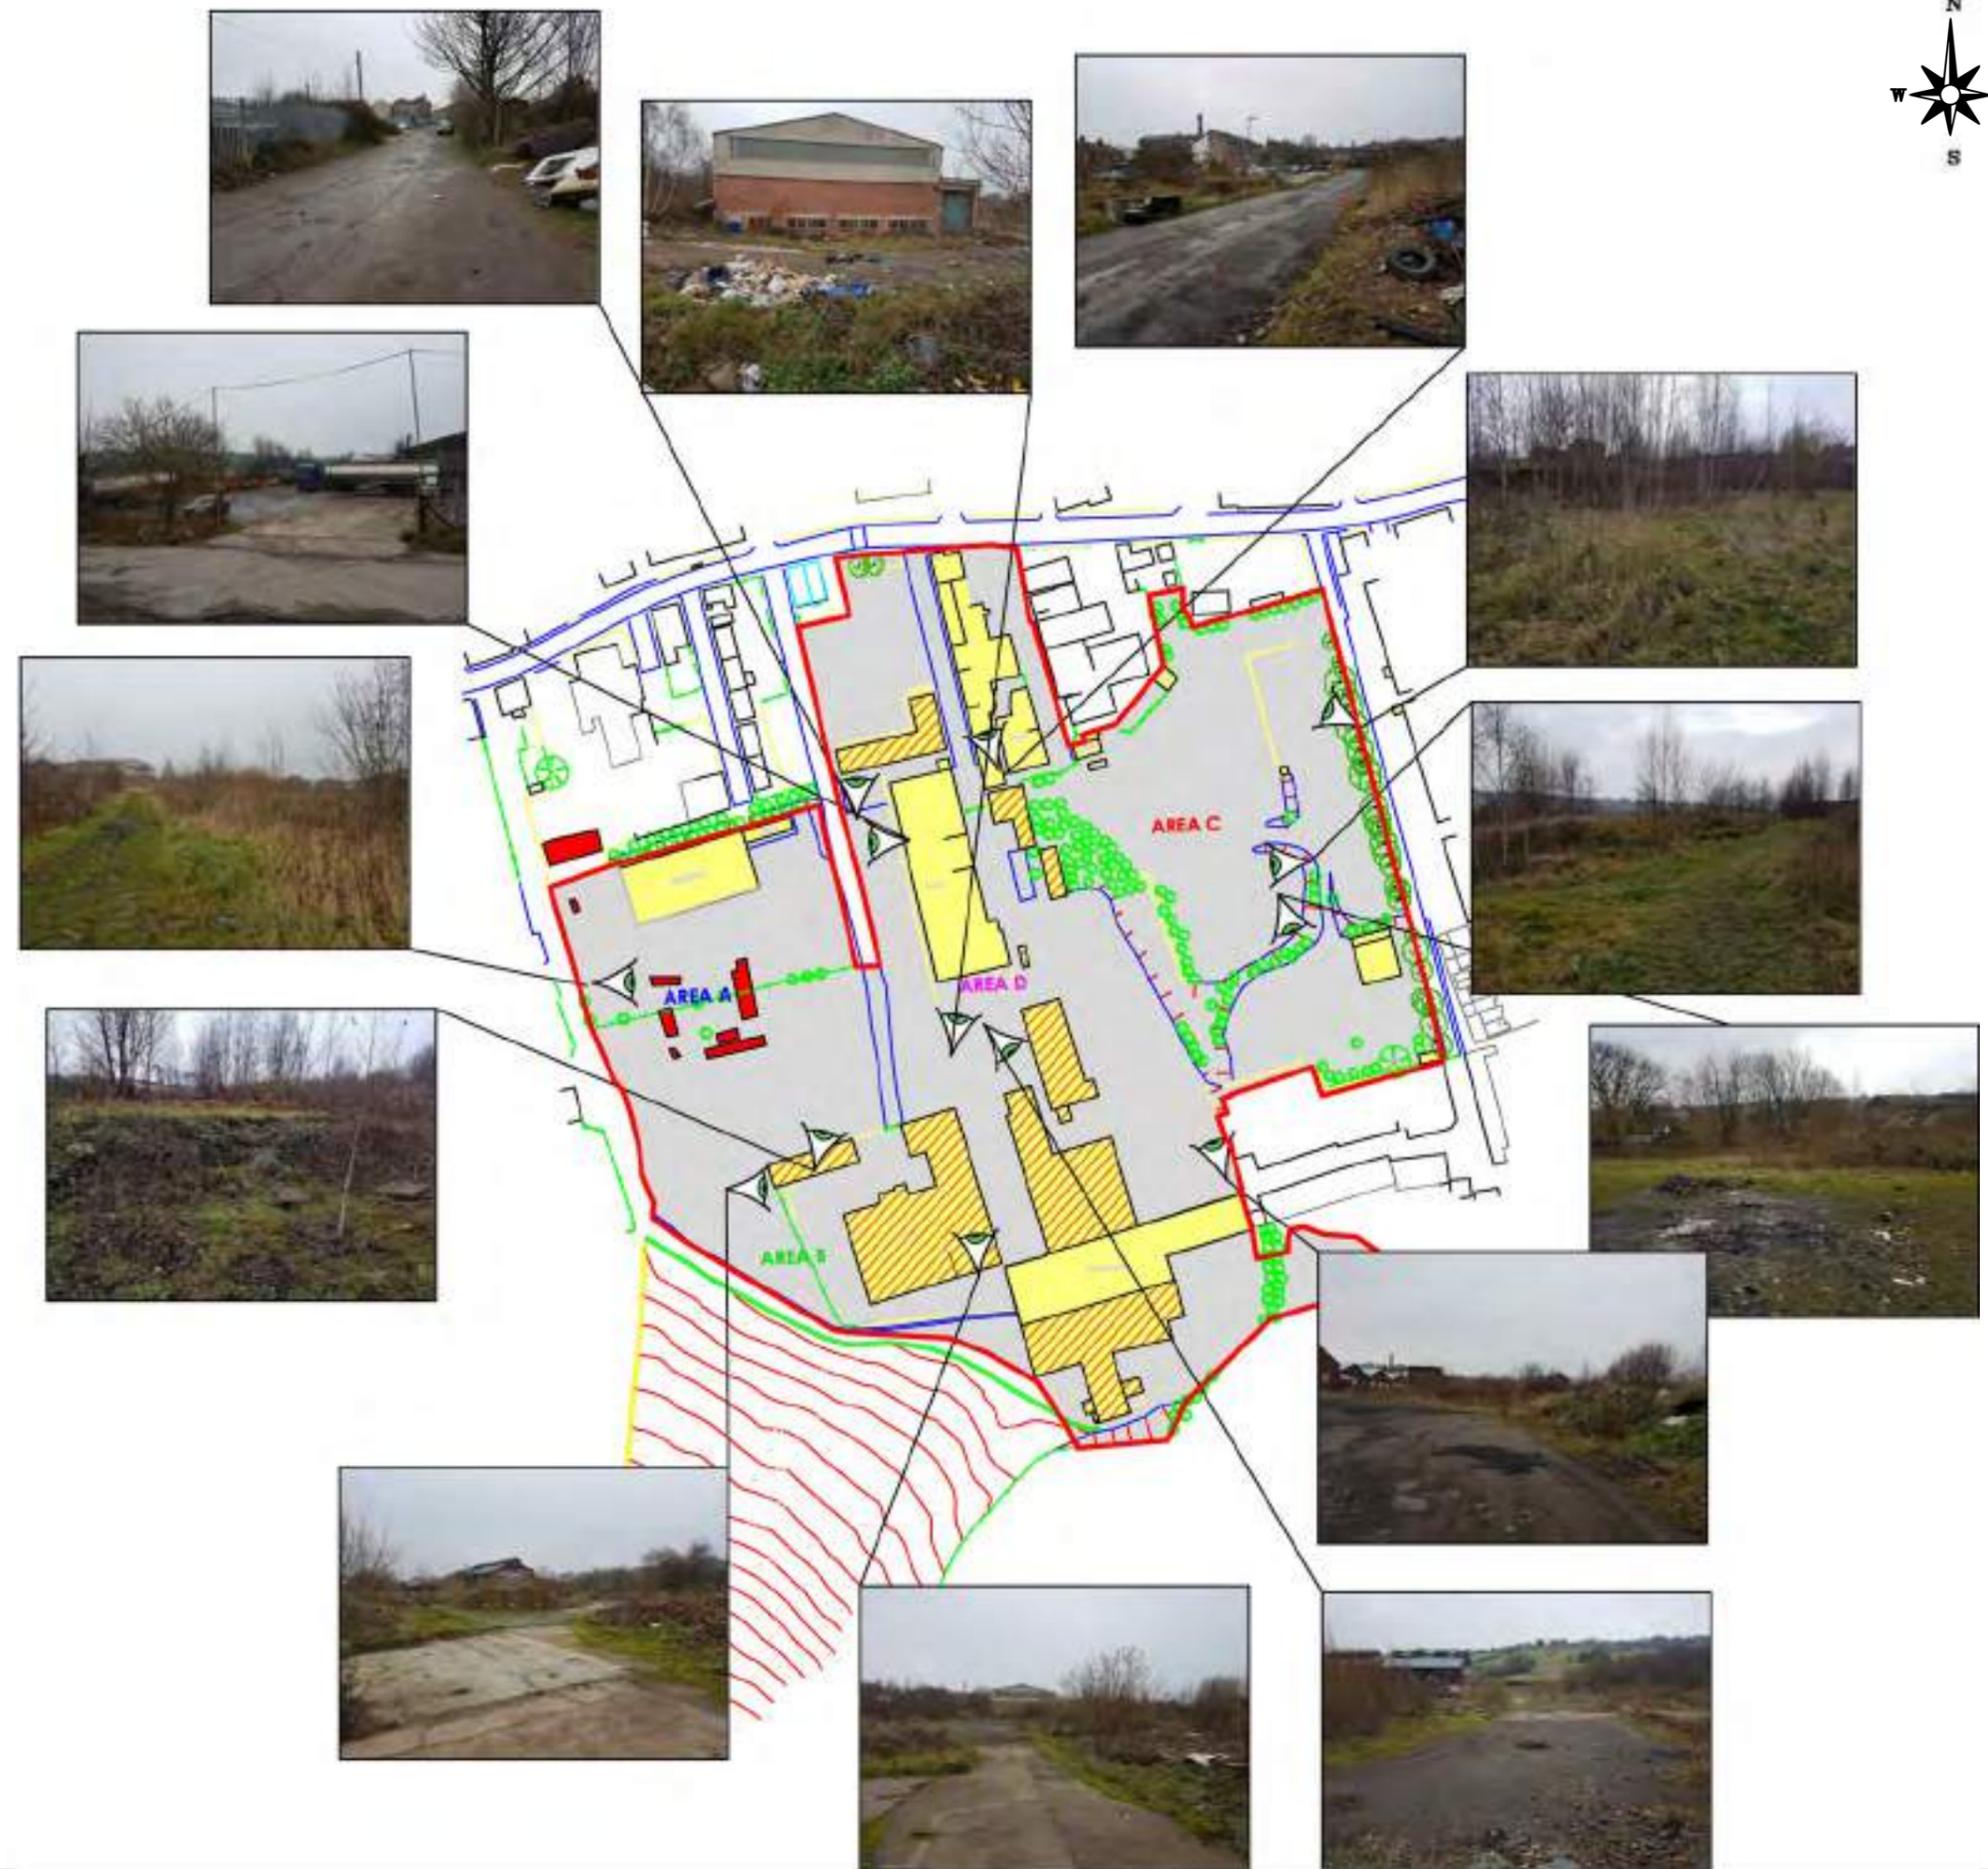
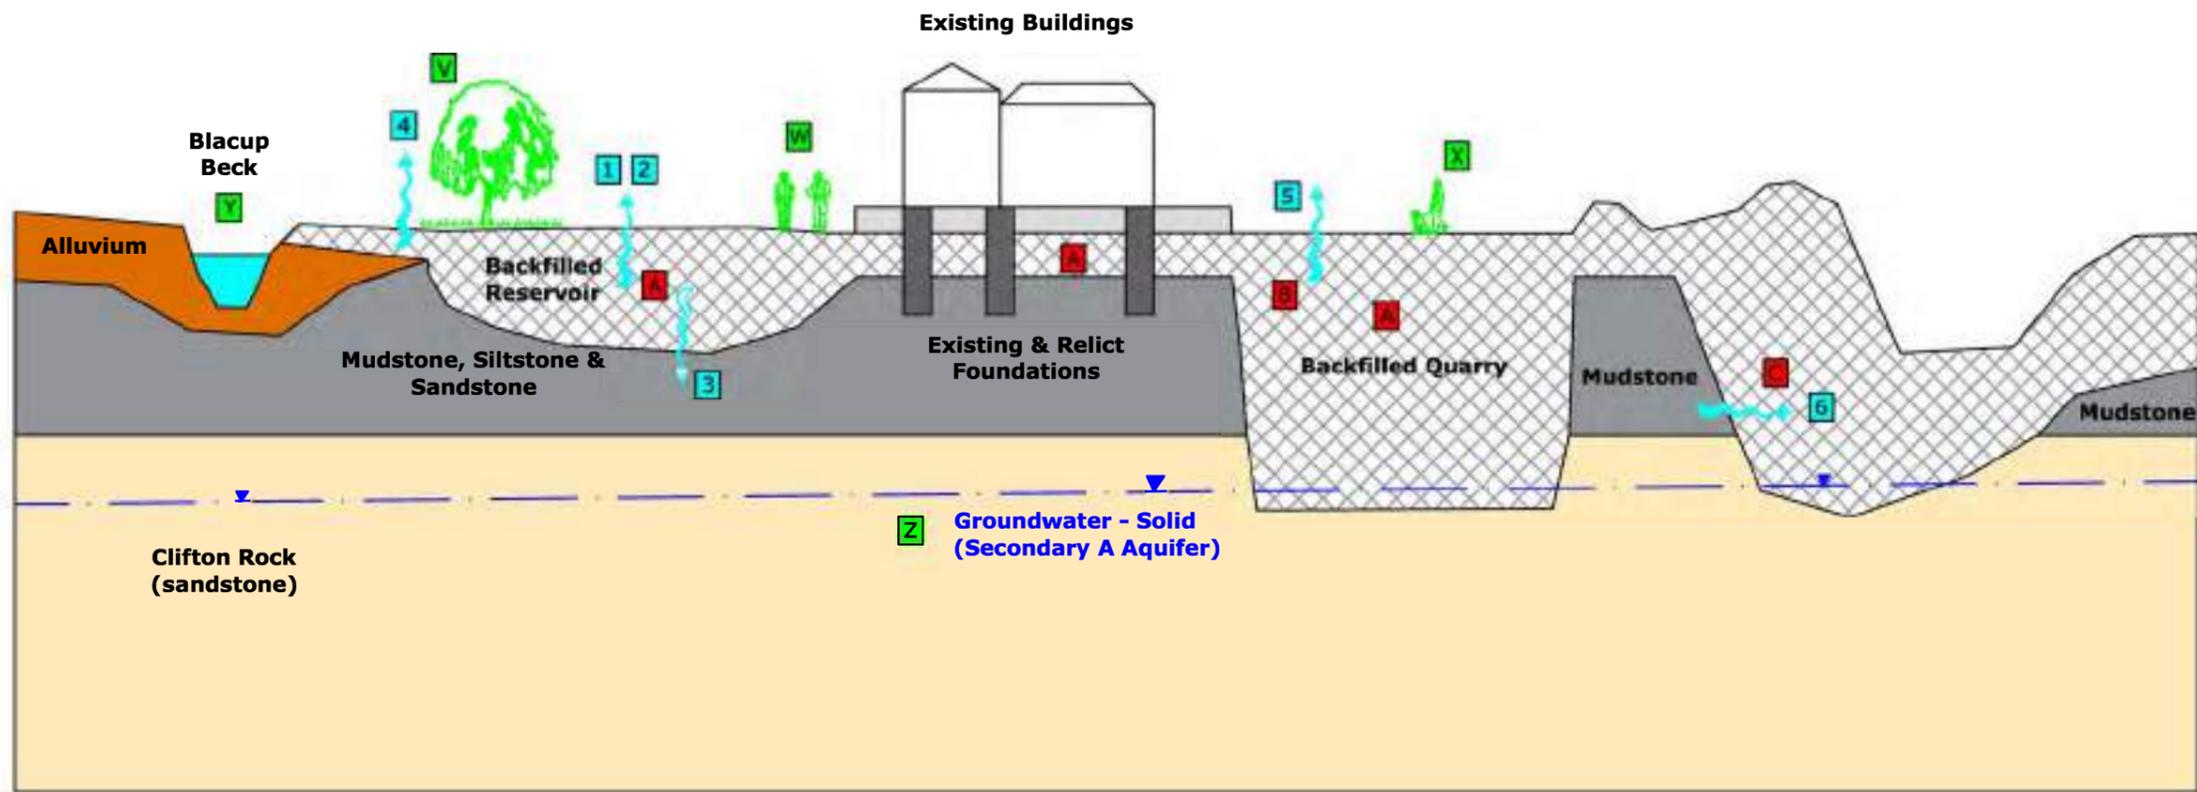
DRAWING NO. 3043/6	REVISION
-----------------------	----------

SOURCES	
■	MADE GROUND (ABESTOS & HEAVY METALS)
■	MADE GROUND (HYDROCARBONS & SOLVENTS)
■	DEEP MADE GROUND (HAZARDOUS GAS)

PATHWAYS	
1	DERMAL CONTACT
2	INGESTION/INHALATION
3	LEACHING OF CONTAMINANTS
4	UPTAKE BY PLANTS
5	VOLATILISATION
6	MIGRATION OF GAS

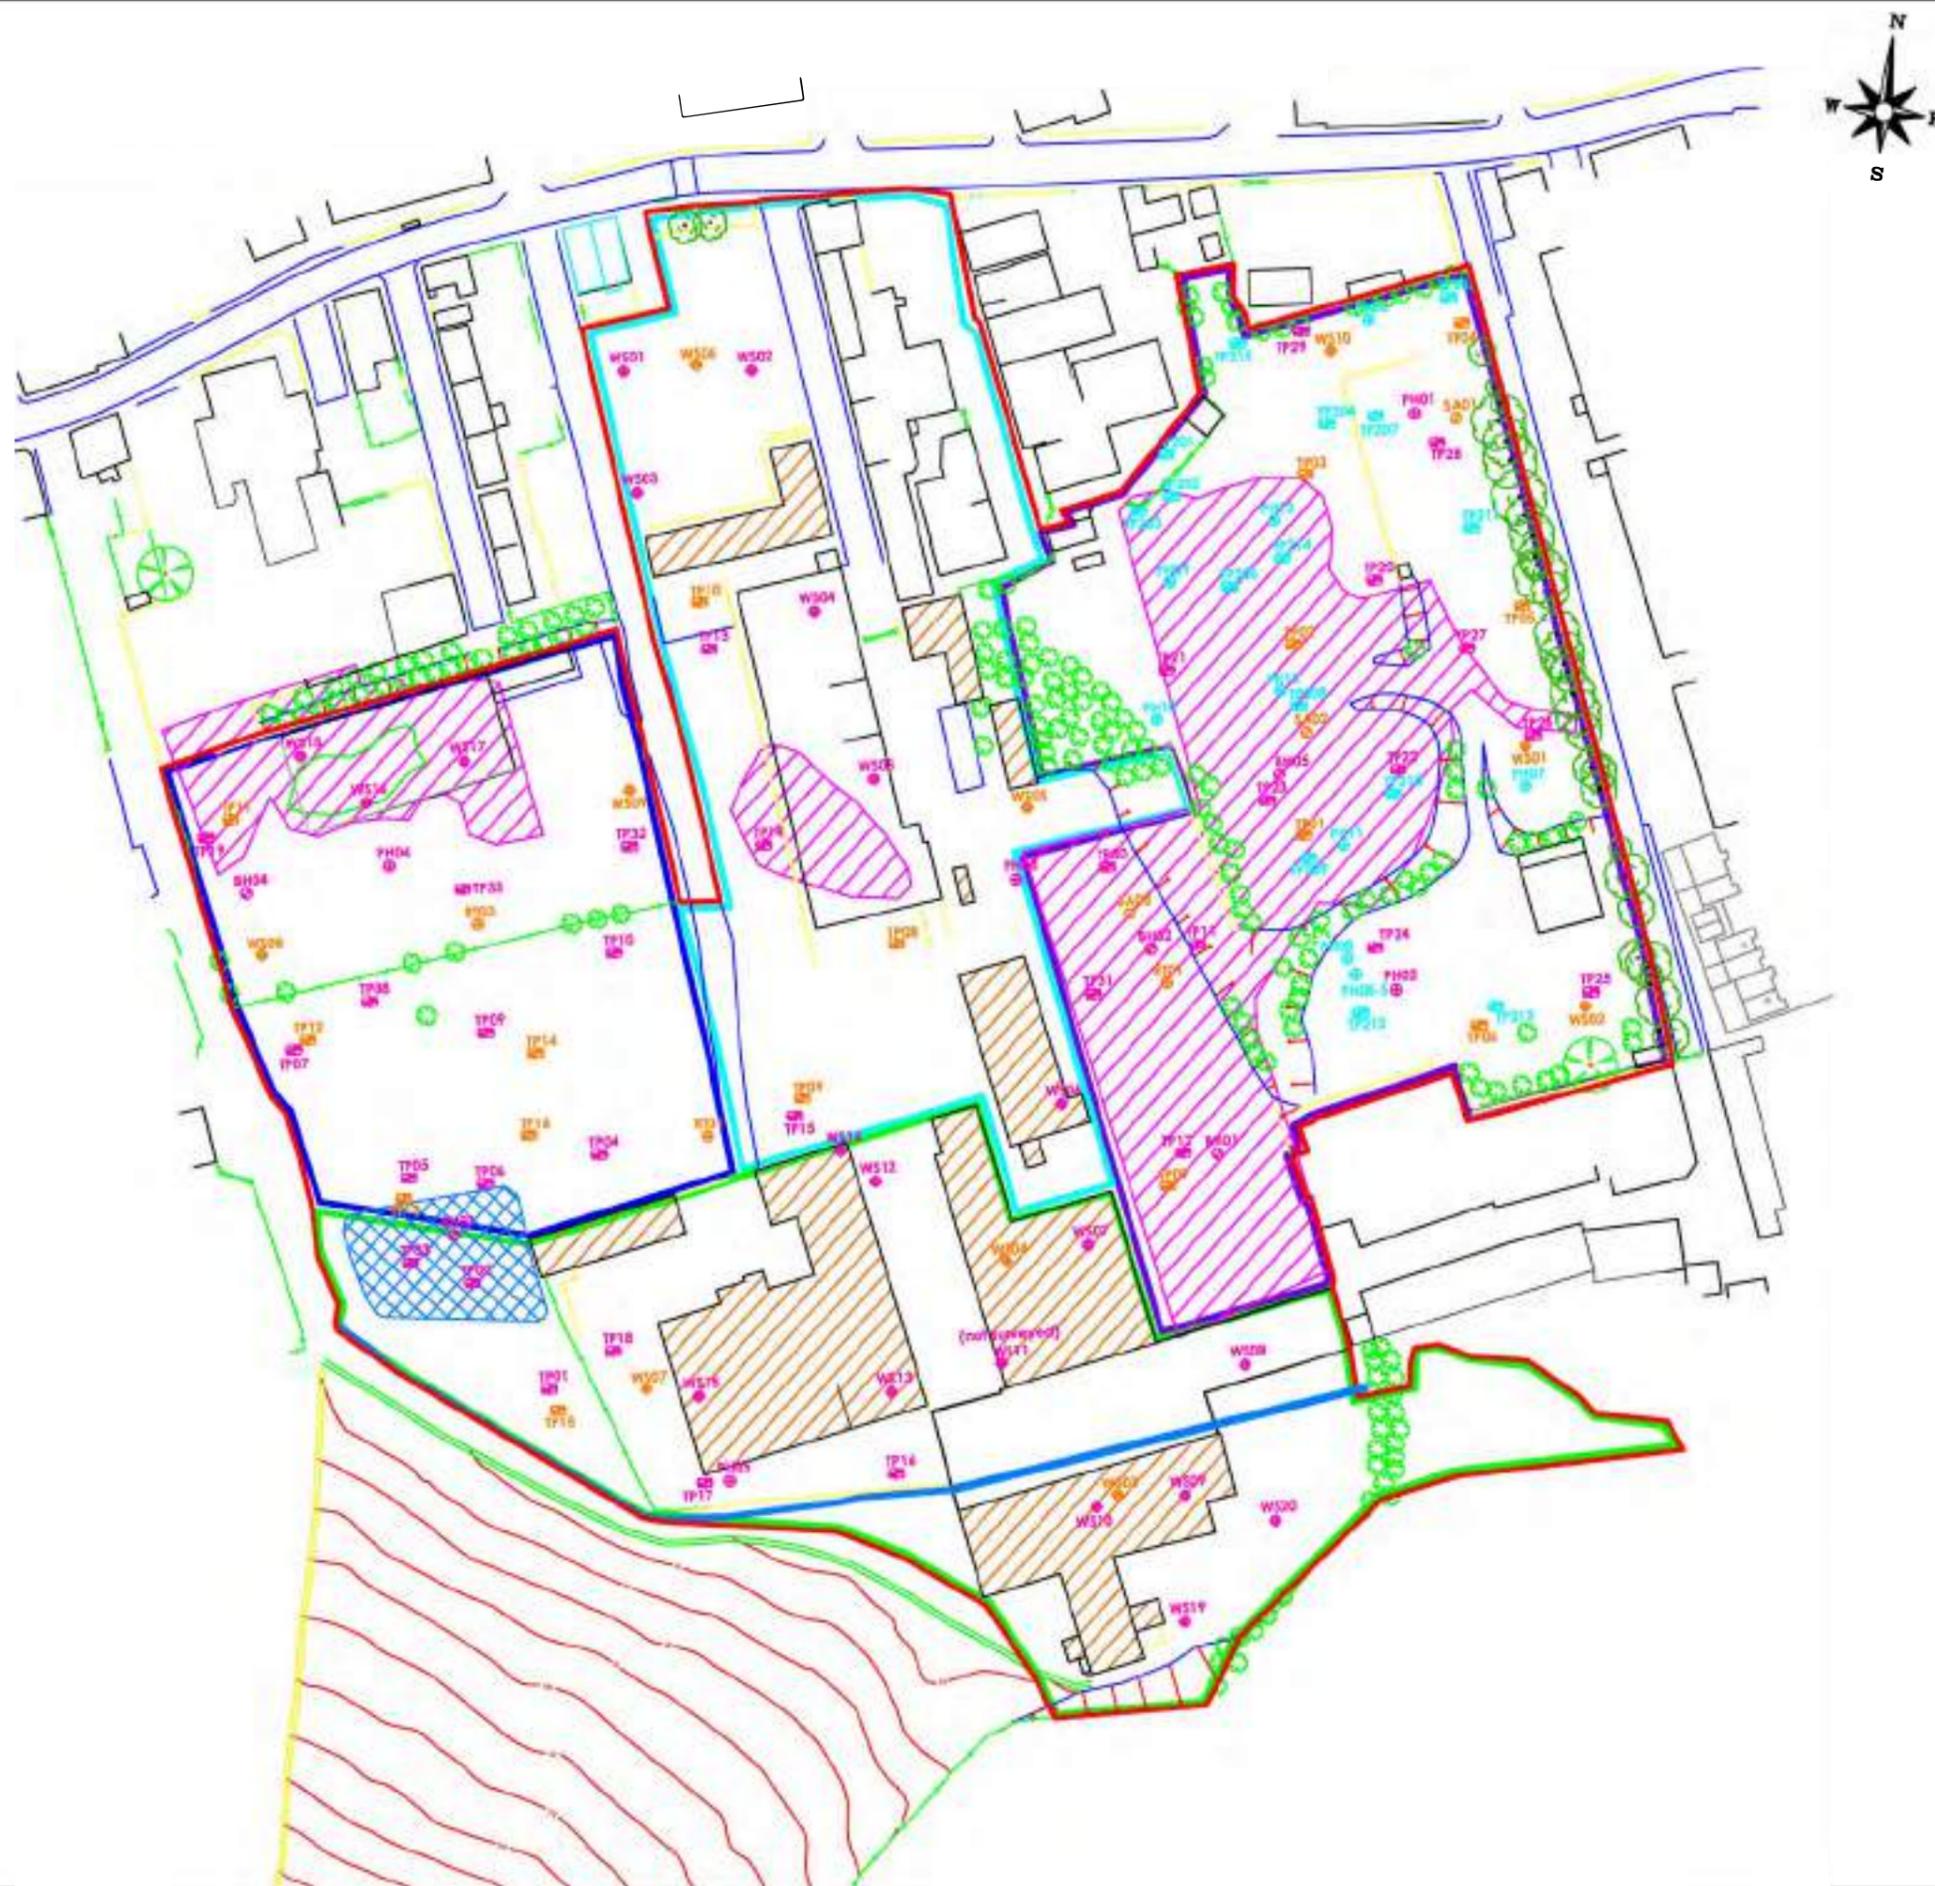
SCALE	1:1500	SHEET	A3	DRAWING NO.	3043/7	REVISION	
-------	--------	-------	----	-------------	--------	----------	--

- NOTES**
- AIG INVESTIGATION (APRIL 2001)**
- TRIAL PIT LOCATION (TPs 01 TO 33)
 - BOREHOLE LOCATION (BHs 01 TO 05)
 - PROBEHOLE LOCATION (PHs 01 TO 05)
 - WINDOW SAMPLE LOCATION (WSs 01 TO 20)
- ROGERS INVESTIGATION (2009)**
- TRIAL PIT LOCATION (TPs 01 TO 16)
 - BOREHOLE LOCATION (SAs 01 TO 03)
 - PROBEHOLE LOCATION (RTs 01 TO 03)
 - WINDOW SAMPLE LOCATION (WSs 01 TO 10)
- ENCIA INVESTIGATION (2004)**
- TRIAL PIT LOCATION (TPs 201 TO 215)
 - PROBEHOLE LOCATION (PH 6 TO 13 & 8S)
- APPROXIMATE SITE BOUNDARY

- 5.5.1 Ground conditions encountered in all previous phases of intrusive investigation are summarised in the tables in Annex I, and all exploratory locations are shown on Drawing 3043/7 in Appendix B.
- 5.5.2 The 3rd party reports include useful information to support the design of further intrusive investigations. All reports identify significant thicknesses of Made Ground in all areas, although the deepest is within the former quarry in Area C. However, many exploratory holes failed to fully penetrate made ground (often a consequence of the significant thicknesses present), in summary:

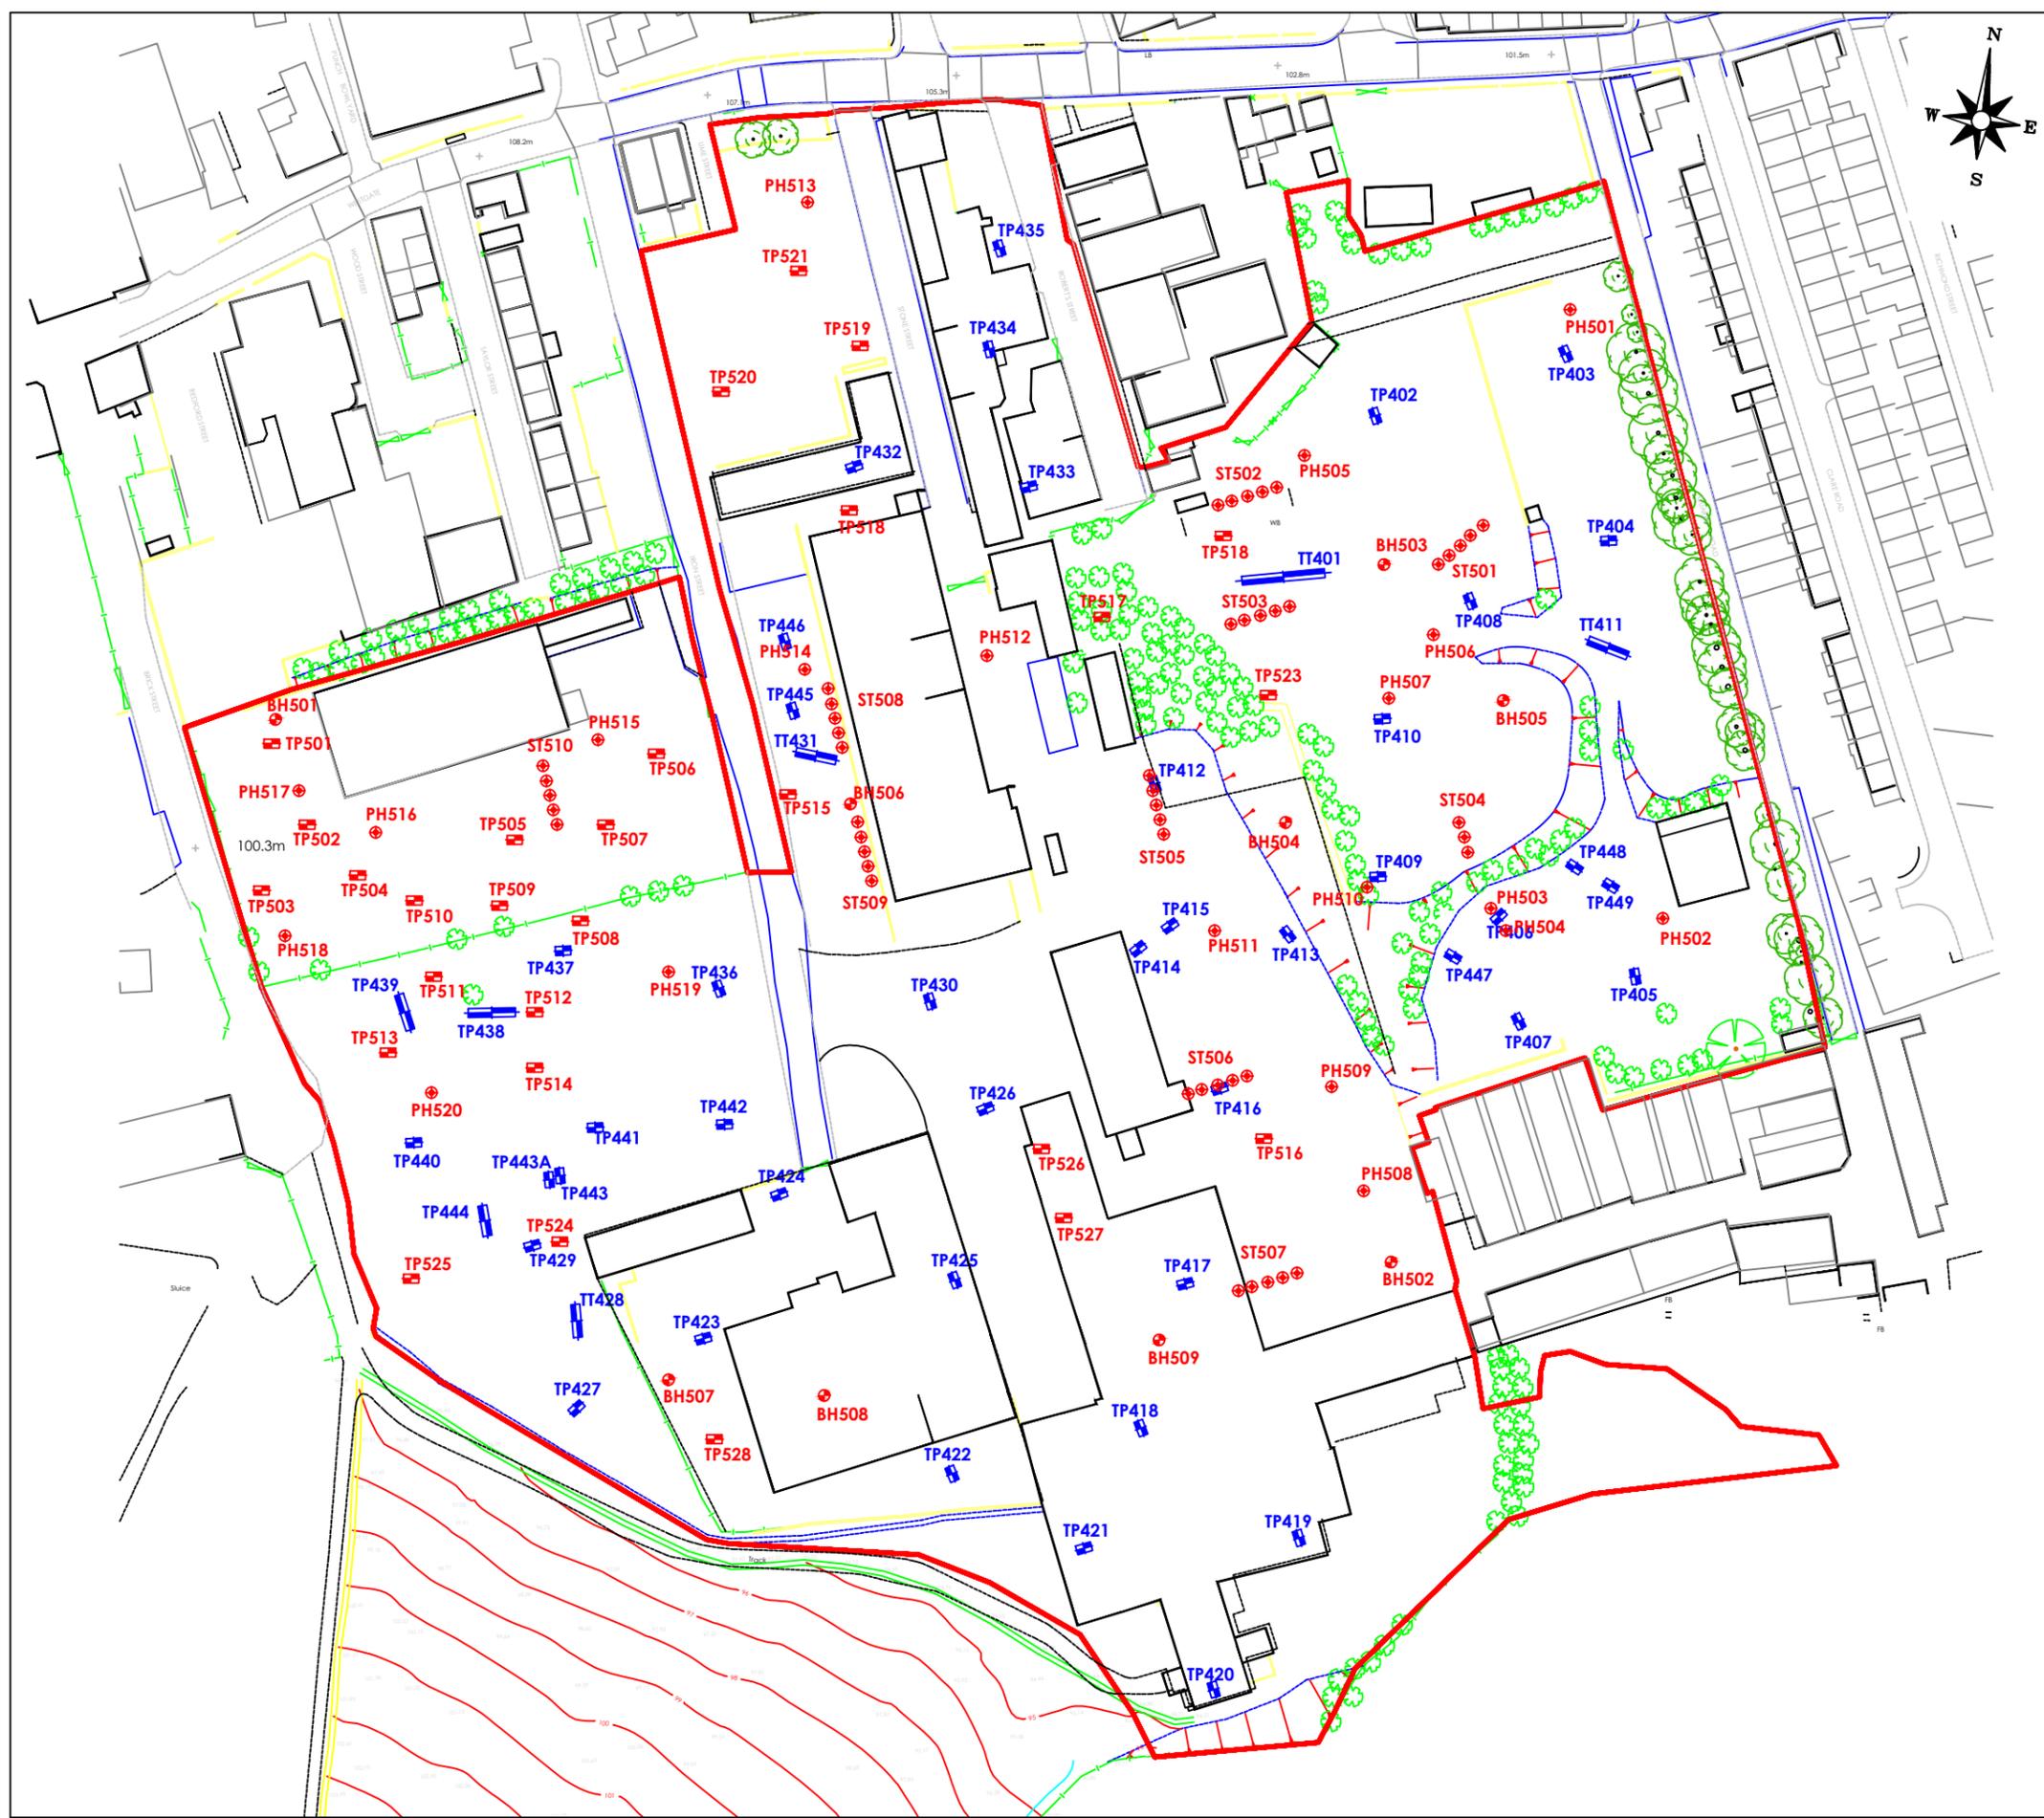
EXPLORATORY HOLE LOCATIONS

- NOTES
- TRIAL PIT LOCATION (LITHOS SEPTEMBER 2019)
 - TRIAL PIT LOCATION (LITHOS SEPTEMBER 2020)
 - CABLE PERCUSSION / ROTARY CORED BOREHOLE (LITHOS SEPTEMBER 2020)
 - PROBEHOLE / STITCH PROBEHOLE LOCATION (LITHOS SEPTEMBER 2020)
 - APPROXIMATE SITE BOUNDARY

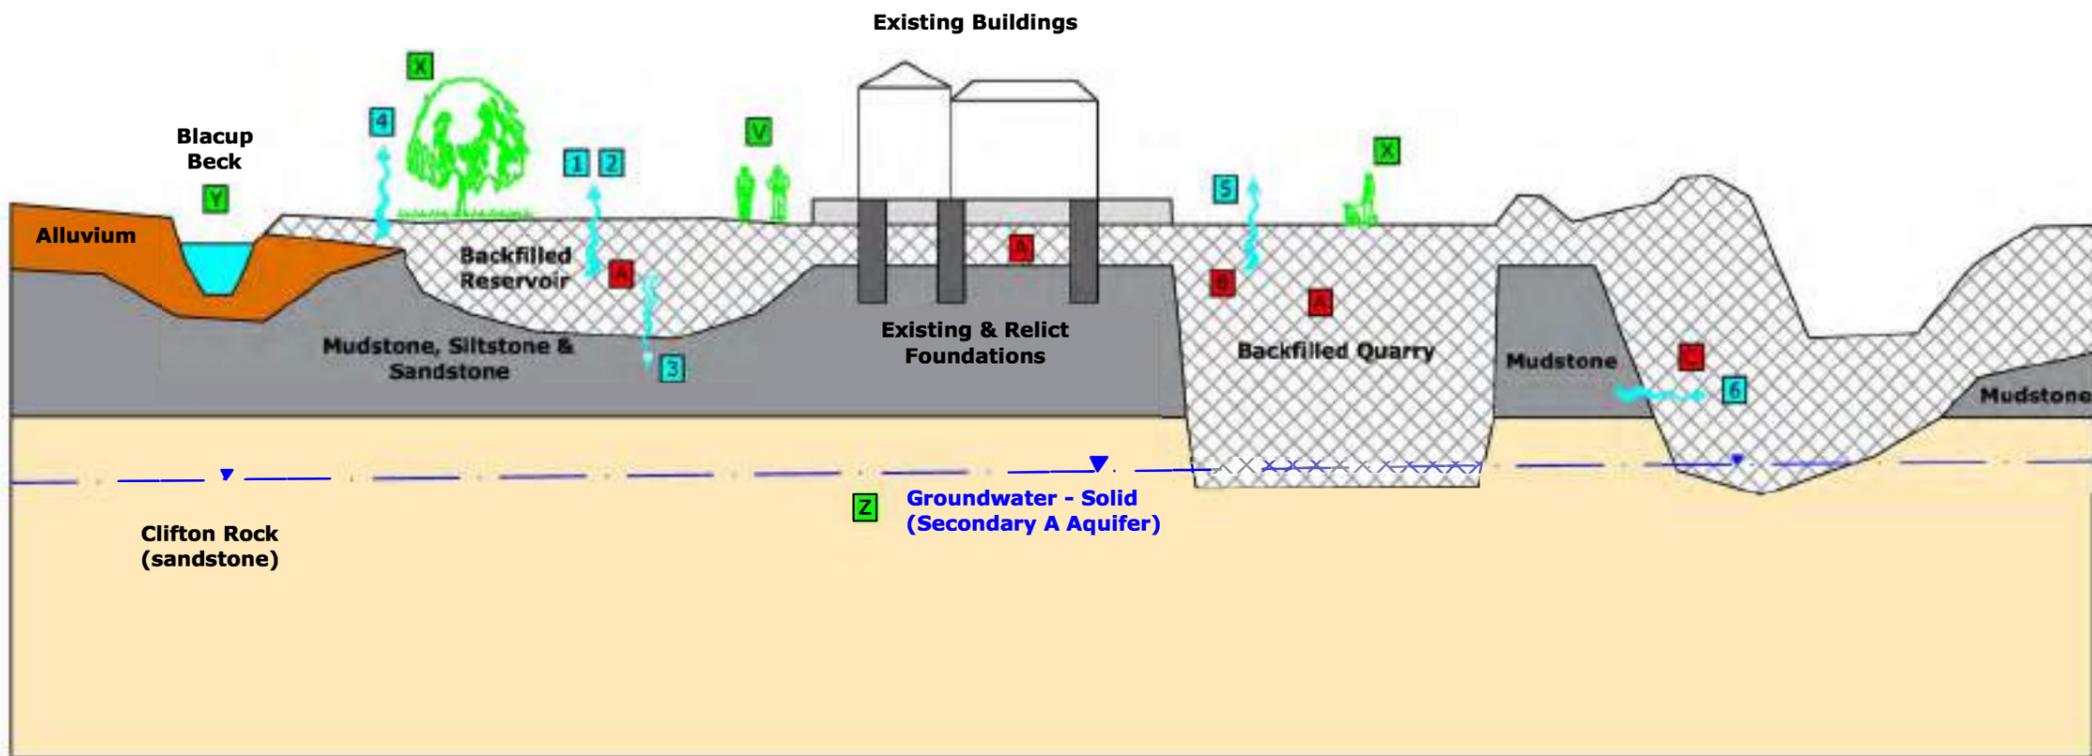
REVISED CONCEPTUAL SITE MODEL

SOURCES	
■	MADE GROUND (ABESTOS & HEAVY METALS)
■	MADE GROUND (HYDROCARBONS)
■	DEEP MADE GROUND (HAZARDOUS GAS)

PATHWAYS	
1	DERMAL CONTACT
2	INGESTION/INHALATION
3	LEACHING OF CONTAMINANTS
4	UPTAKE BY PLANTS
5	VOLATILISATION
6	MIGRATION OF GAS
