Land at Westgate, Cleckheaton For Strata Homes Ltd

Report no: 3043/2D

Date: July 2023

SUMMARY OF GEOENVIRONMENTAL ISSUES

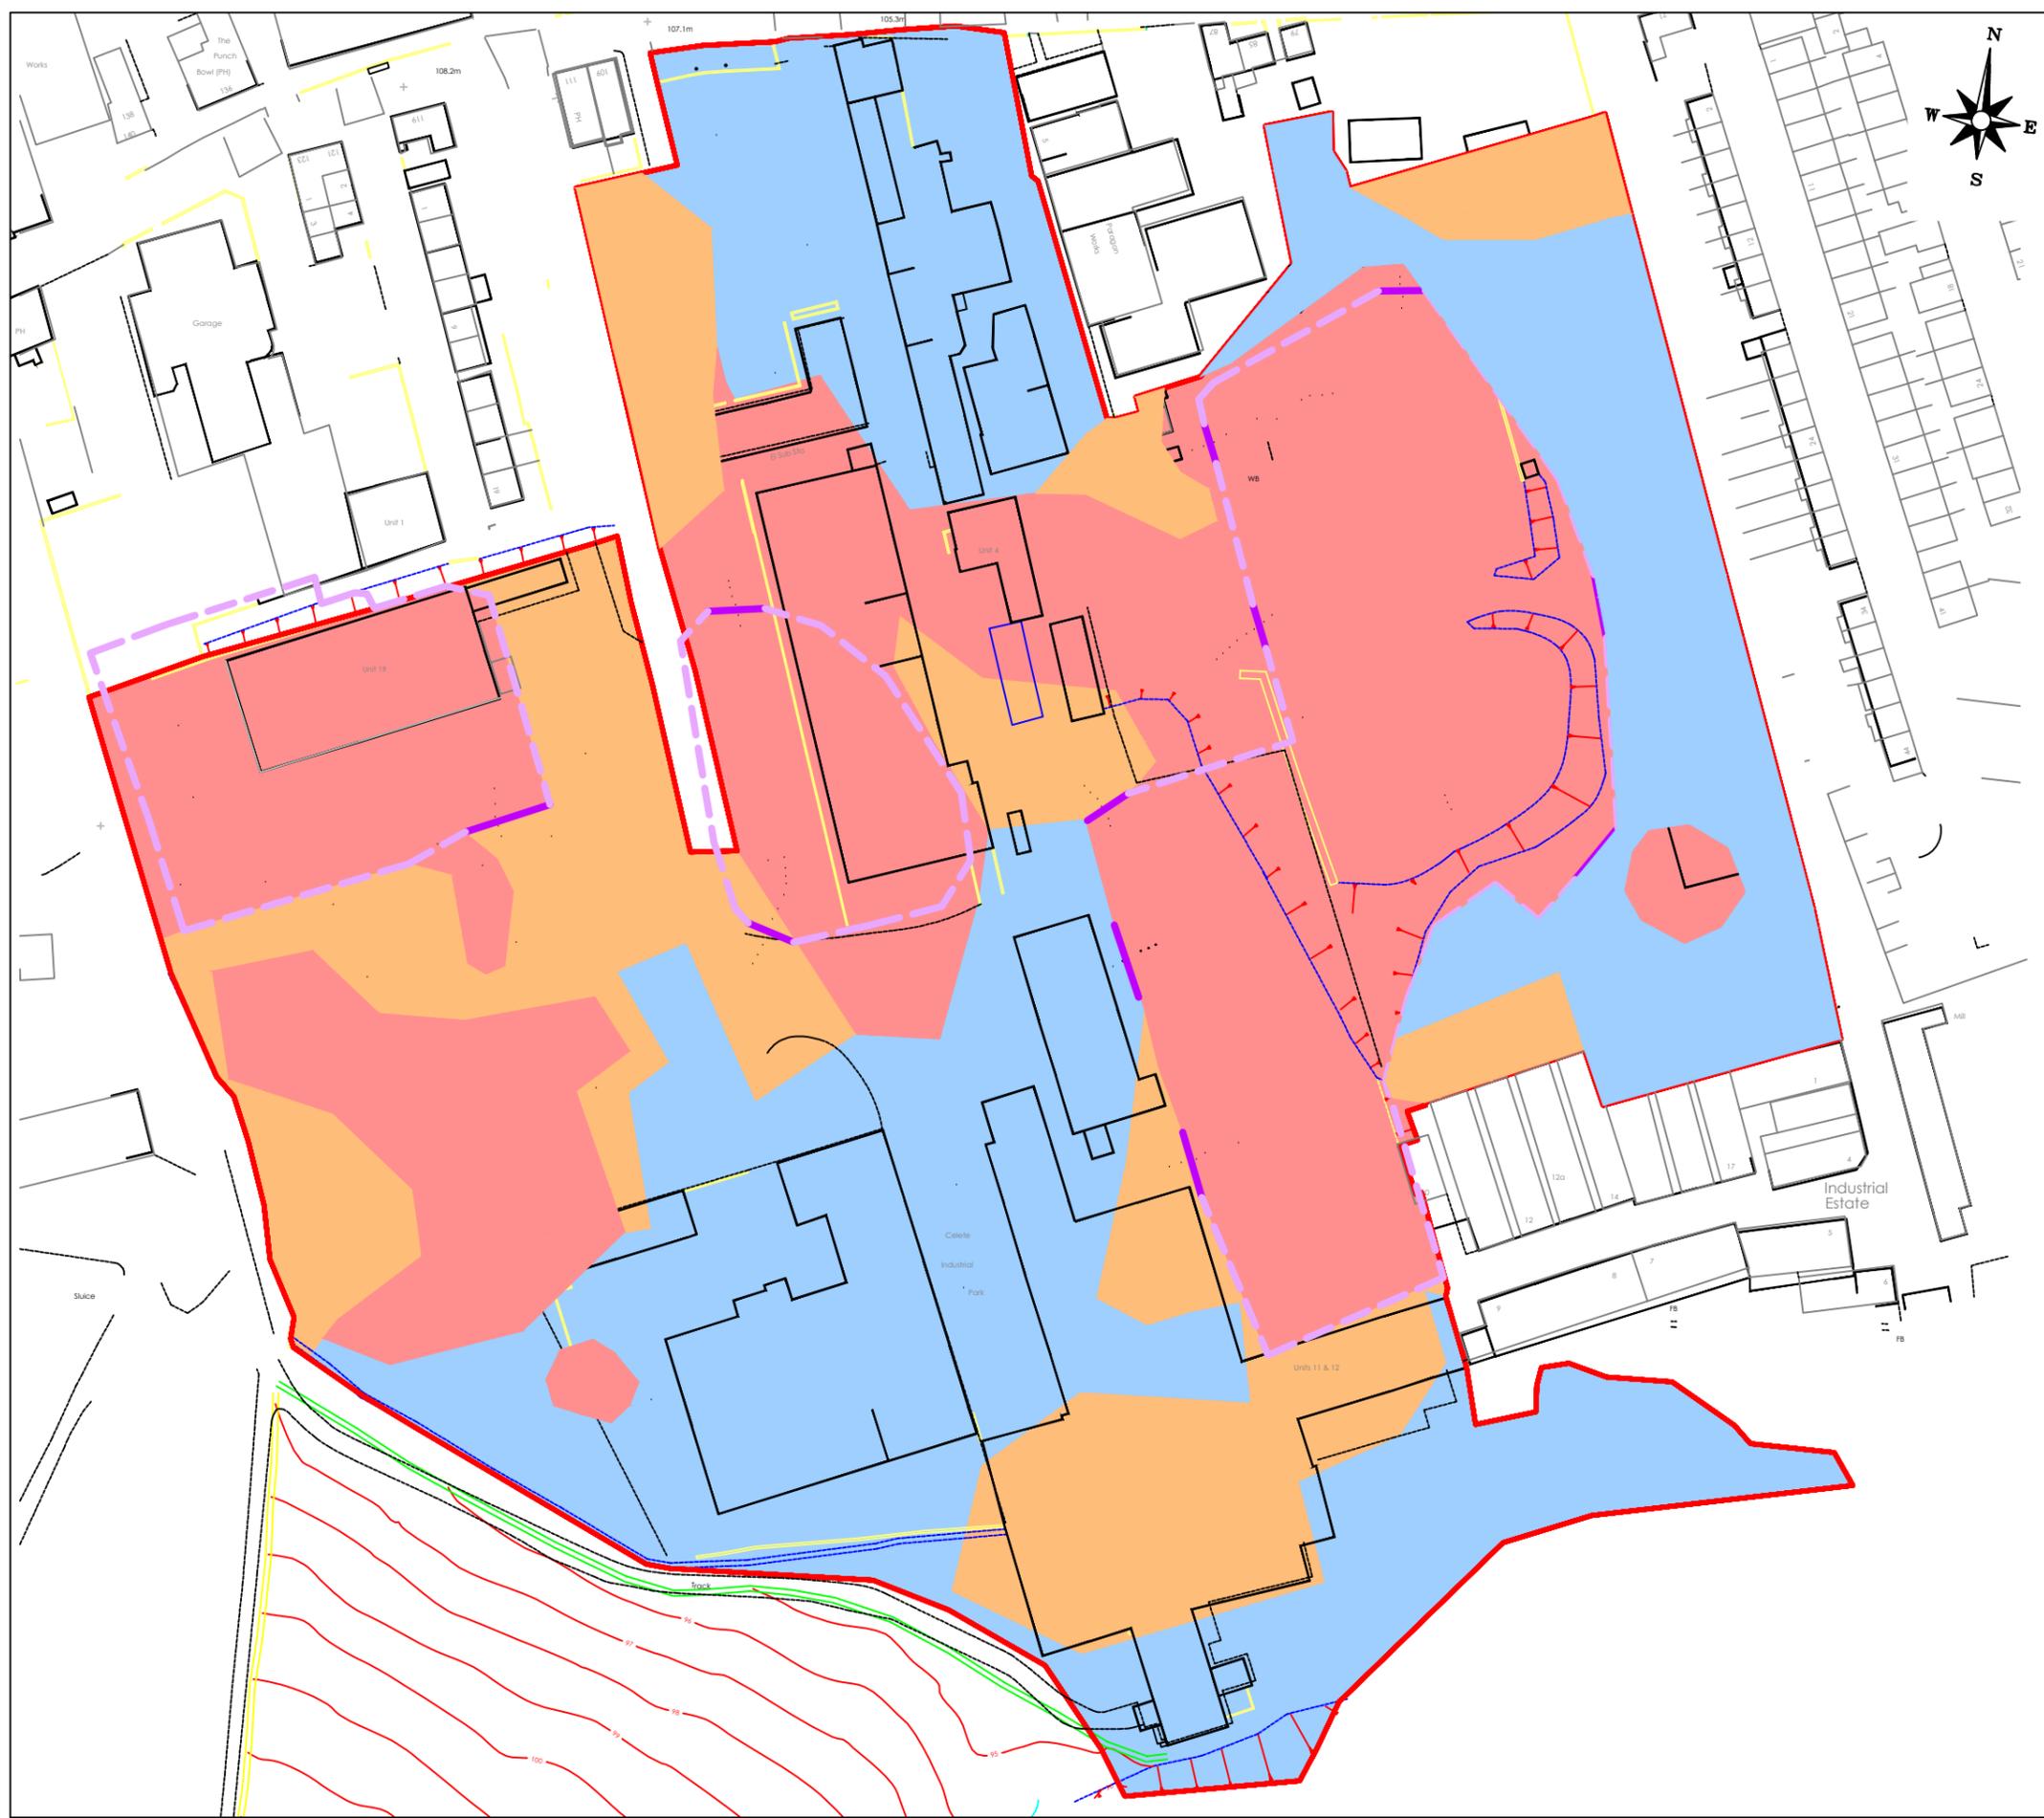
MADE GROUND & BURIED
HIGHWALL EXTENTS

- MADE GROUND <1.5m DEPTH
- MADE GROUND >1.5m DEPTH
- MADE GROUND >2.5m DEPTH
- LINE OF HIGHWALLS (KNOWN)
- LINE OF HIGHWALLS (INTERPRETED)
- APPROXIMATE SITE BOUNDARY

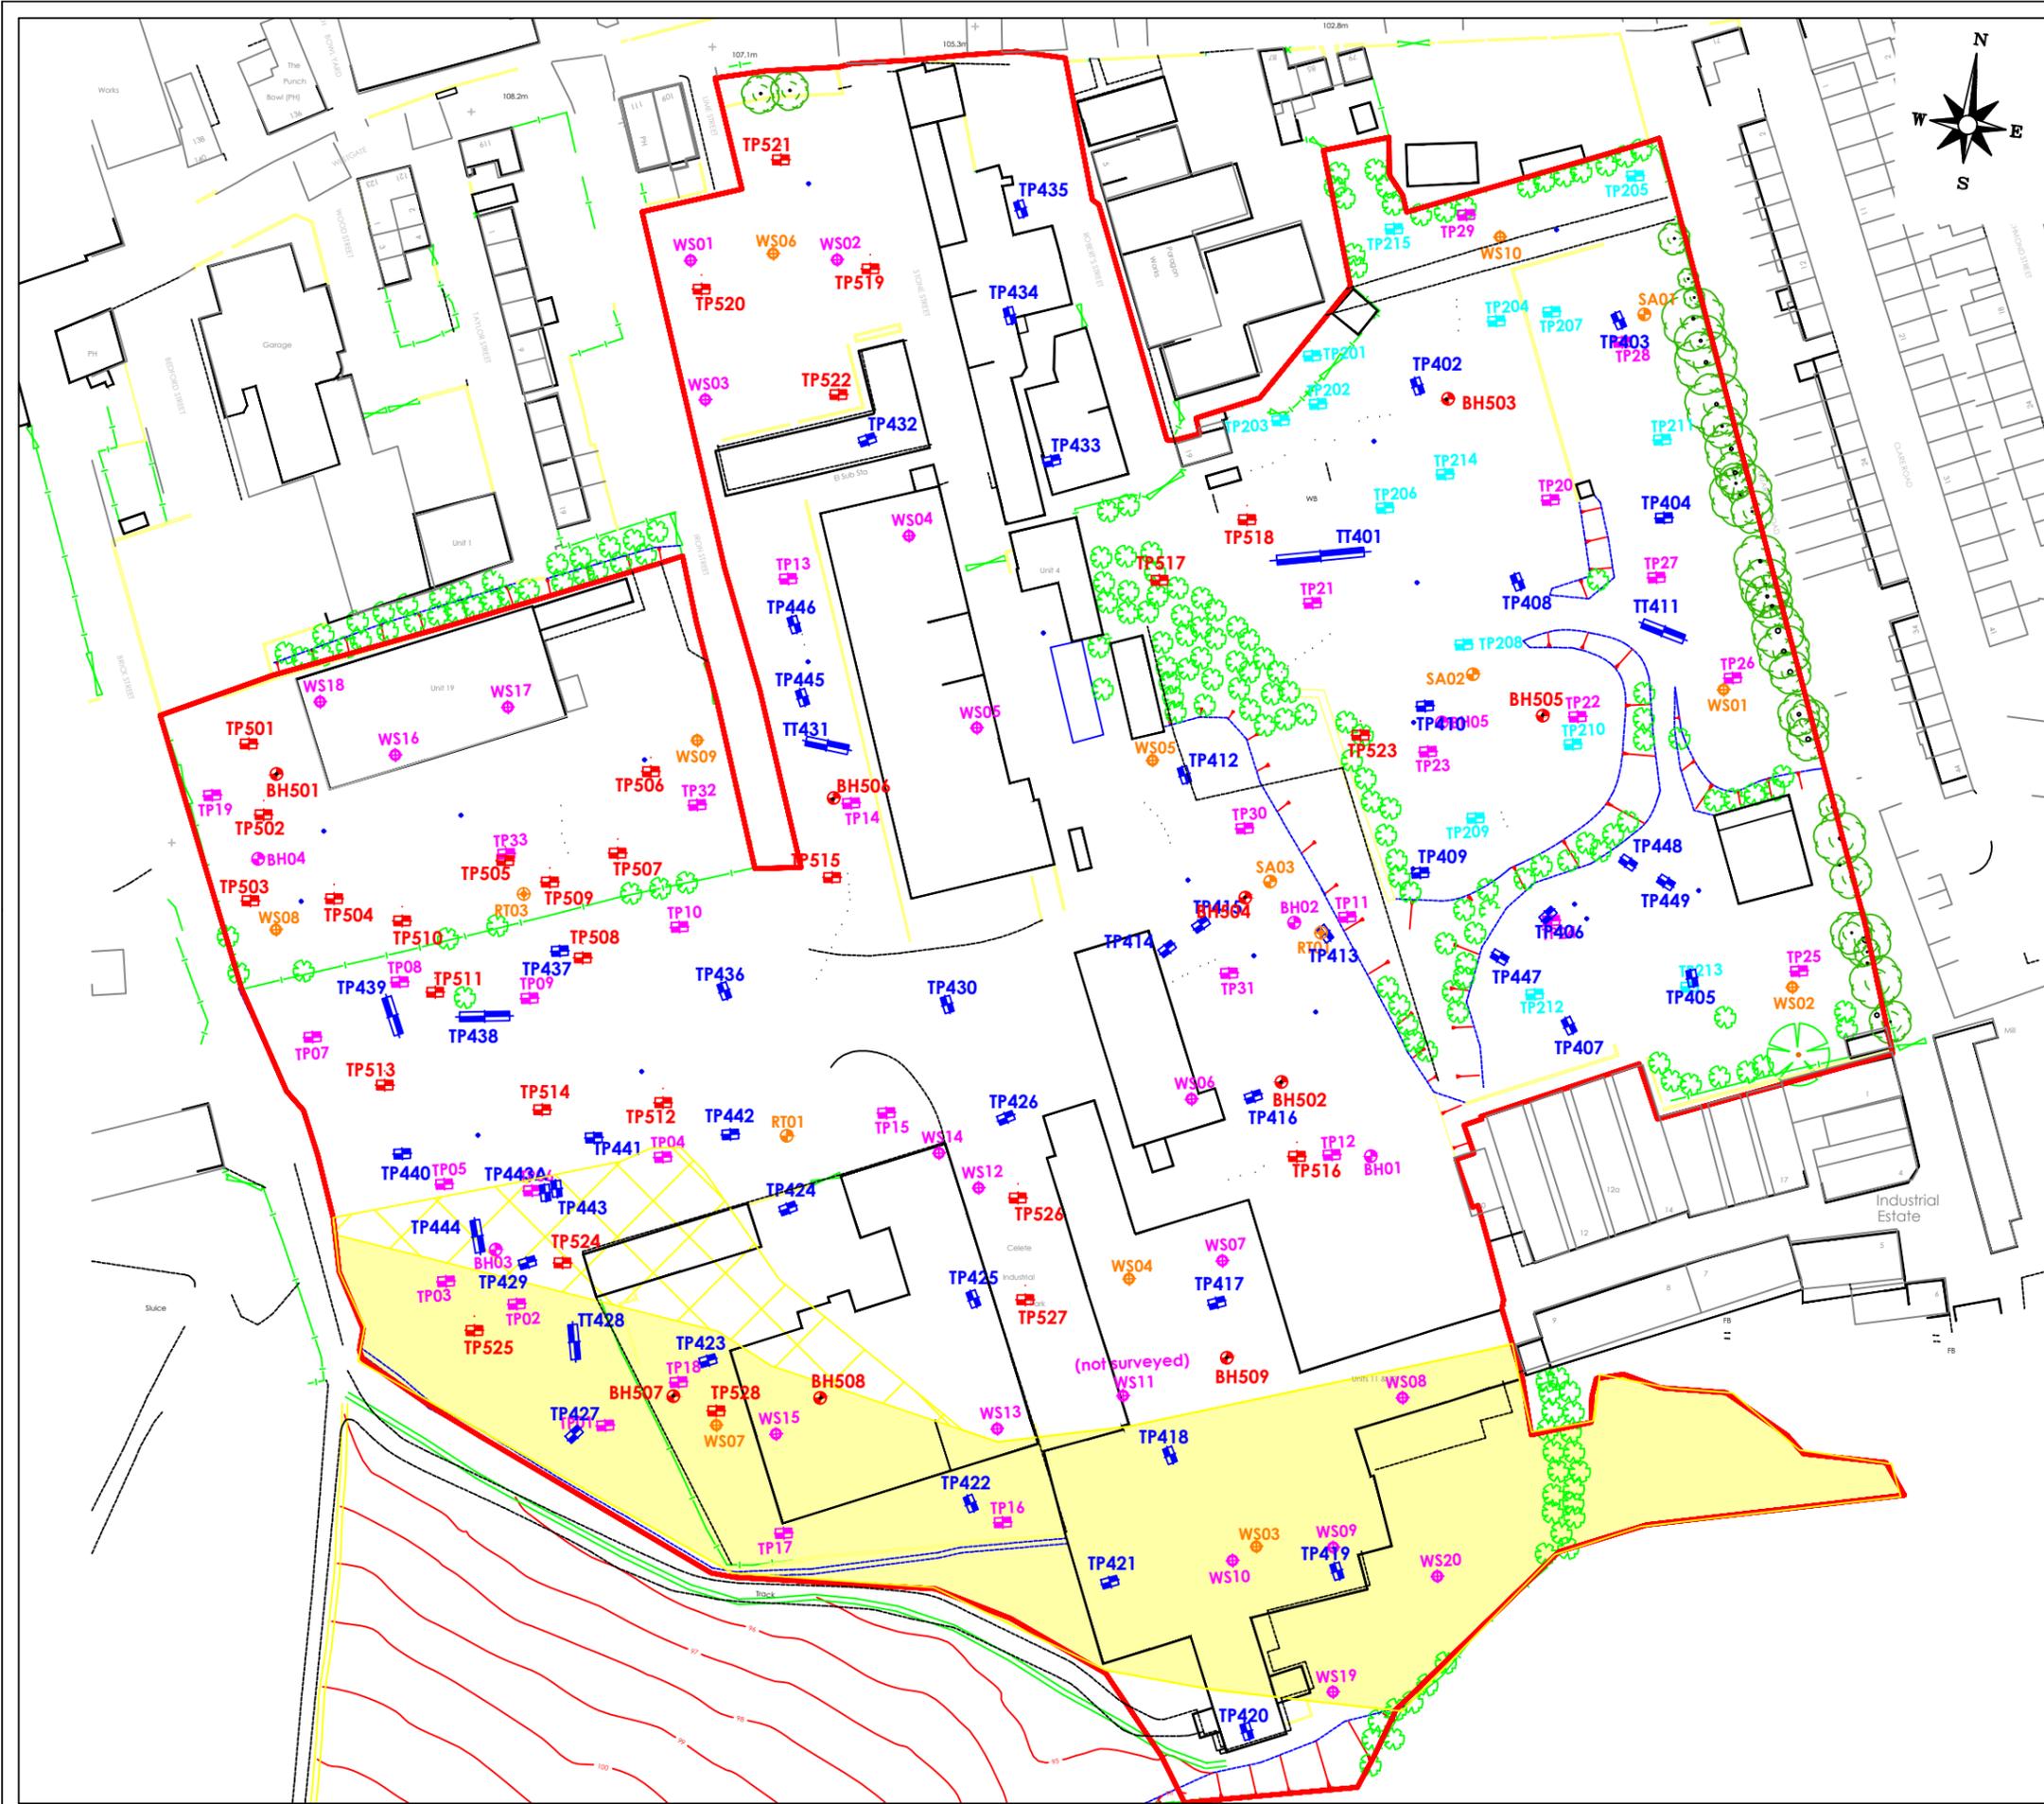
- EXTENT OF ALLUVIAL SOILS (LITHOS EXPL HOLES ONLY)
- EXTENT OF ALLUVIAL SOILS (ALL EXPL HOLES)
- APPROXIMATE SITE BOUNDARY

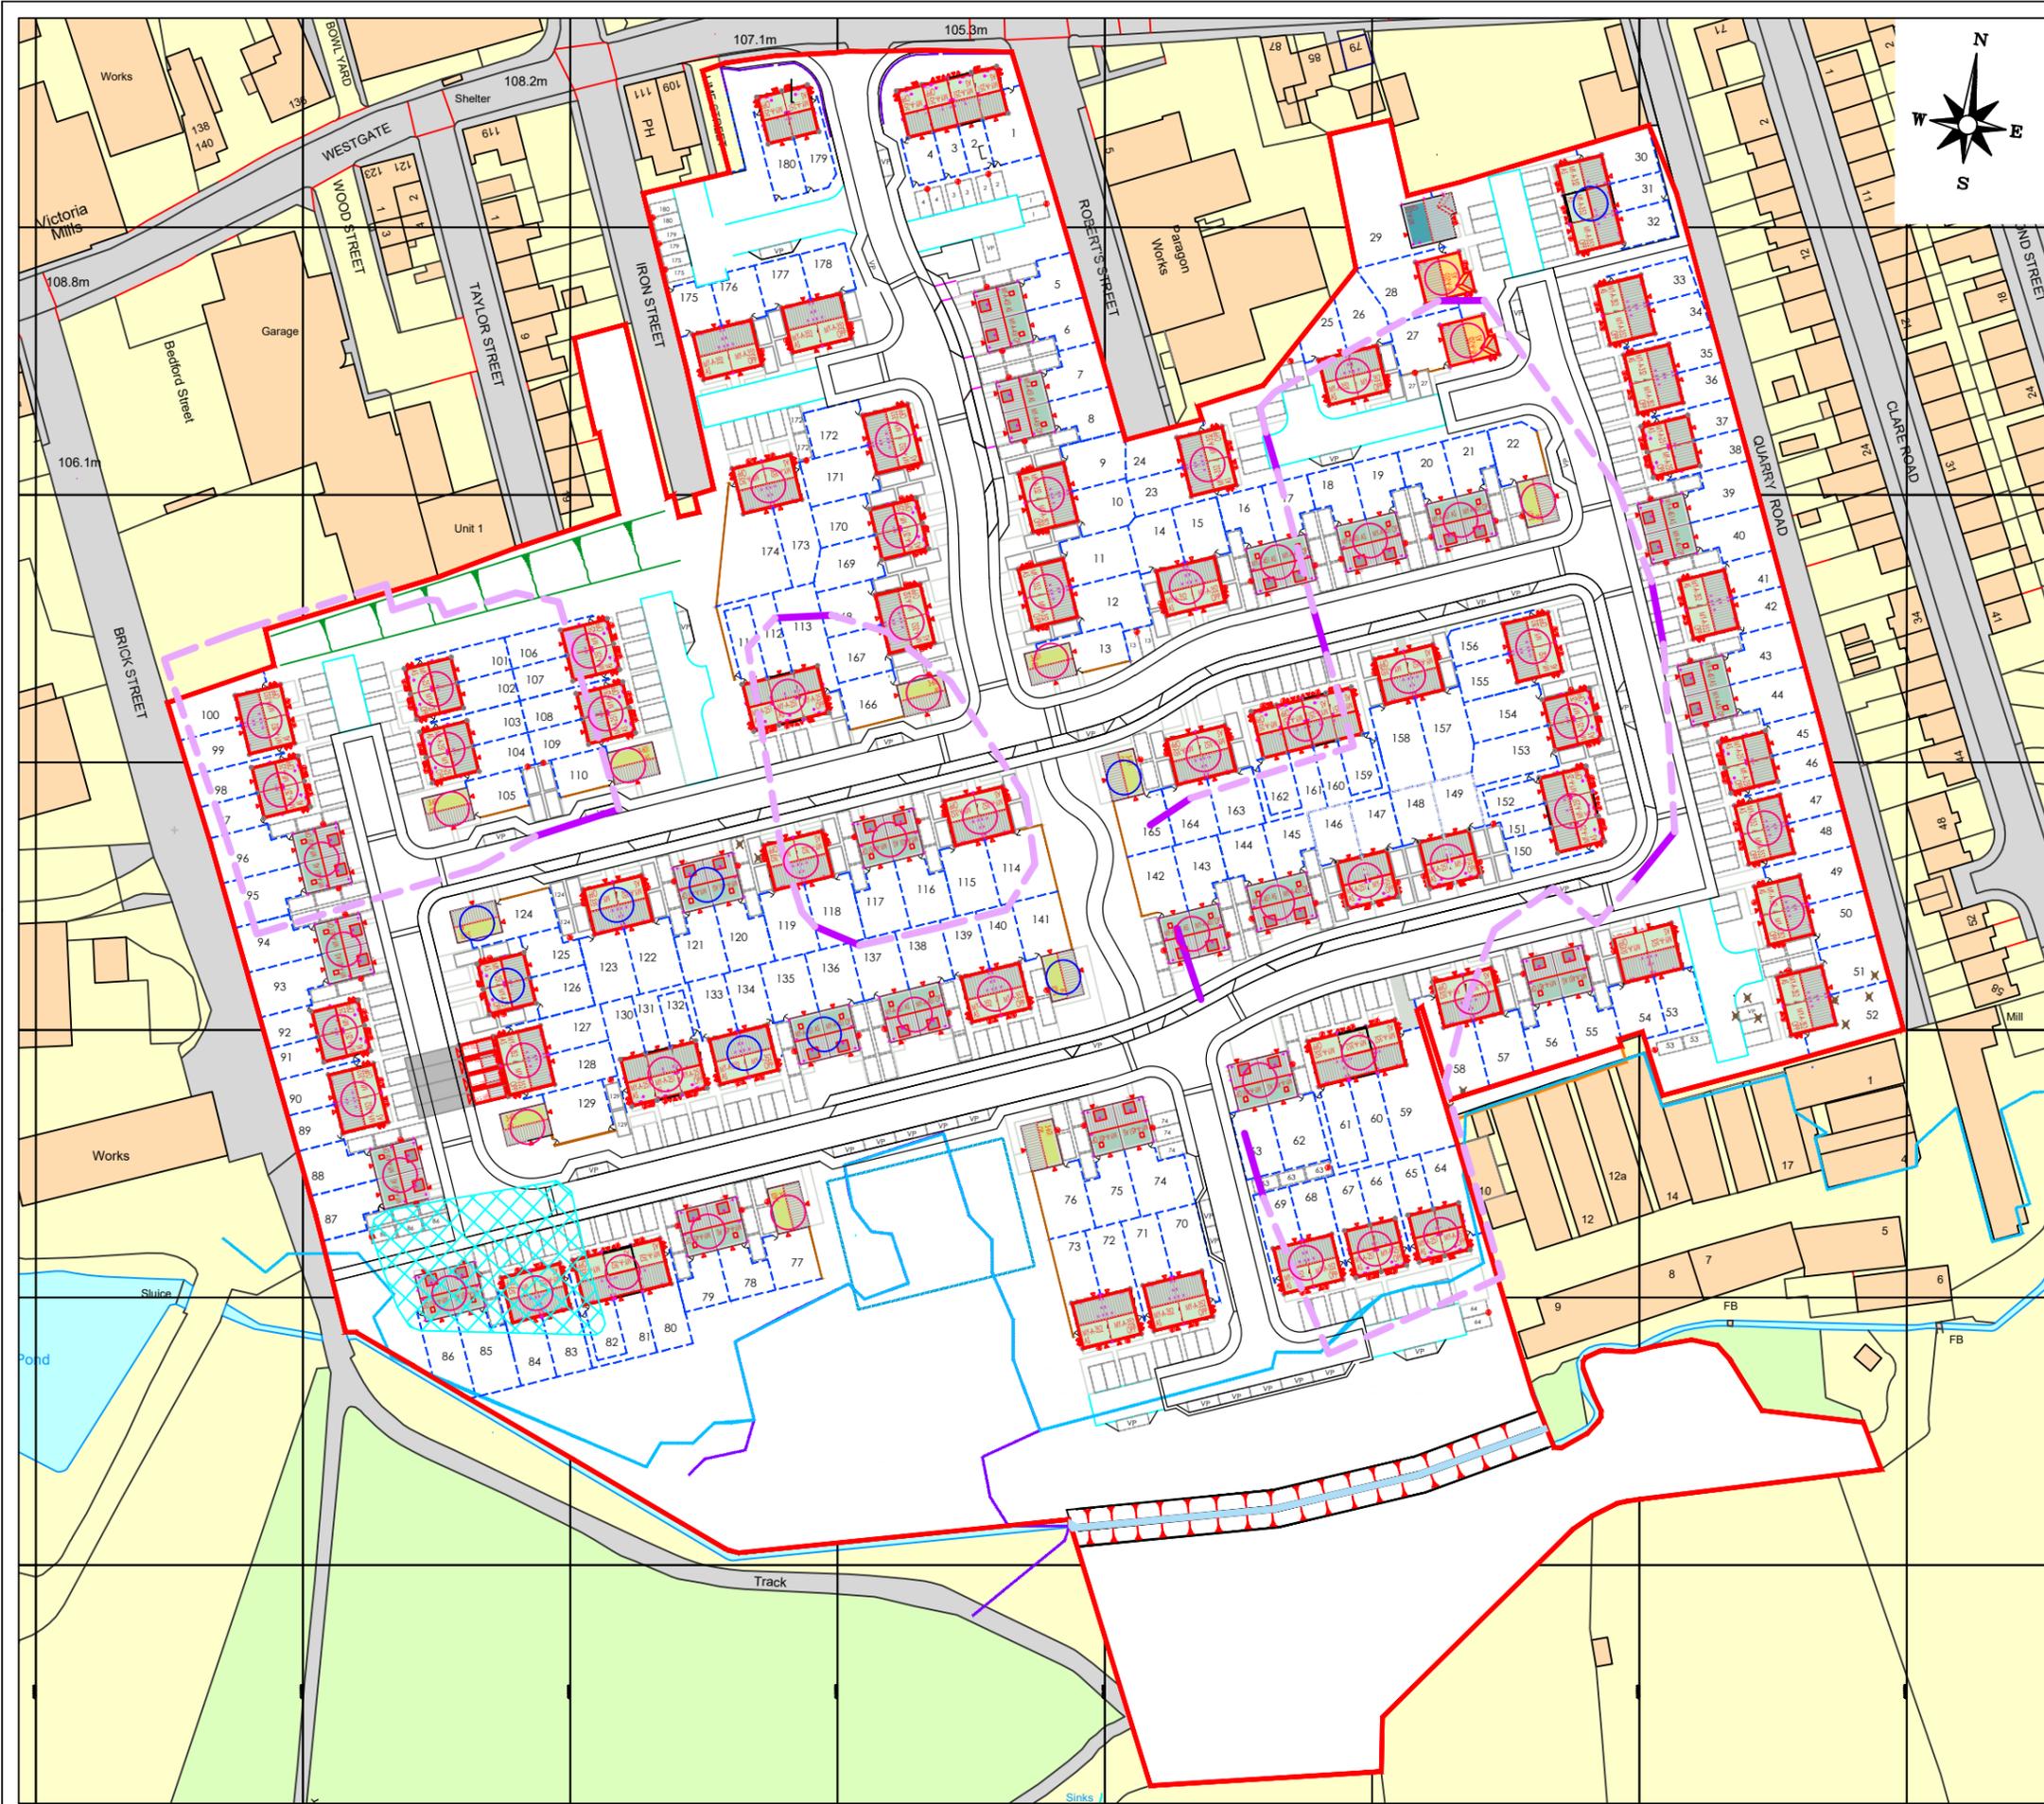
- PILED FOUNDATIONS
- DEEP TRENCH FOUNDATIONS >1.5m TO <2.5m
- STRIP FOUNDATIONS <1.5m
- LINE OF HIGHWALLS (KNOWN)
- LINE OF HIGHWALLS (INTERPRETED)
- APPROXIMATE SITE BOUNDARY

Foundations	<p>Foundation solutions here are primarily driven by thicknesses of made ground, and to a lesser extent by the presence of Alluvium in Area B.</p> <p>Shallow strip or deepened trench fill footings will be a suitable foundation solution where made ground is less than about 2m thick (c. 35% of the total site area) and underlying natural soils comprise weathered Coal Measures (not Alluvium). A piled foundation solution is likely to be required across c. 70% of the site.</p> <p>Ideally, the plot layout for this site should take account of known quarry high walls.</p> <p>The anticipated significant earthworks regrade should allow contouring of the base of made ground beyond the deep quarry backfill and this in turn should allow the preparation of a plot-specific foundation schedule.</p>
Groundwater & excavations	<p>Groundwater was encountered within the majority of exploratory holes (particularly in the south; Area B) as seepages and inflows from around 2.0m.</p> <p>Localised perched waters were encountered within backfilled features (basements, reservoir etc).</p> <p>Spalling and overbreak of excavations occurred in the majority of trial pits within the made ground. Particularly where coarse granular deposits were encountered.</p> <p>Excavations through the soft Alluvial deposits also exhibited some instability.</p> <p>However, excavations in firm/stiff clays and clayey gravels (Residual Soils) should remain stable during the construction phase in the short term.</p>
