A616 NEW MILL ROAD PARAPET  
BROCKHOLES DEVELOPMENT, LANCASTER LANE

INSPECTION AND ASSESSMENT REPORT

REPORT REF. 891010-WCL-XX-XX-RP-C-0001

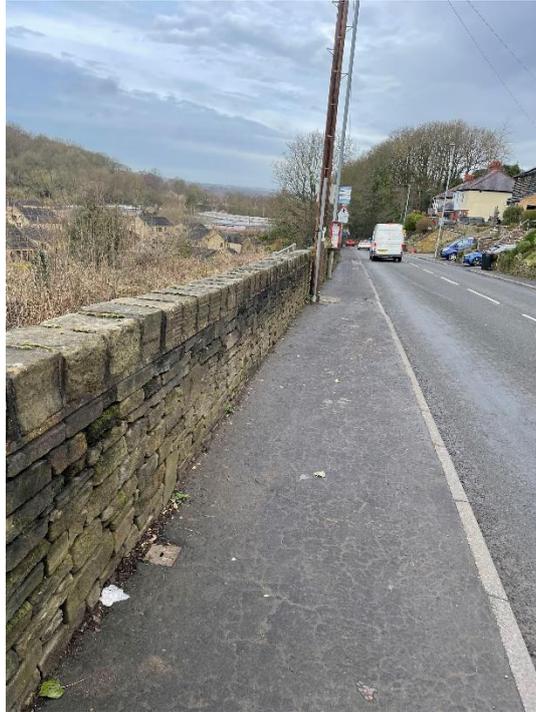
01

Parapet

View looking north along the parapet

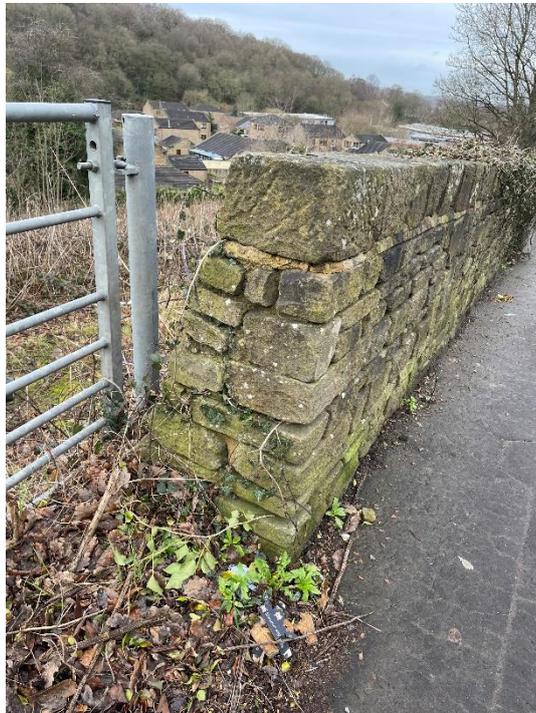
02

Parapet

Typical section through parapet wall at ch 38m

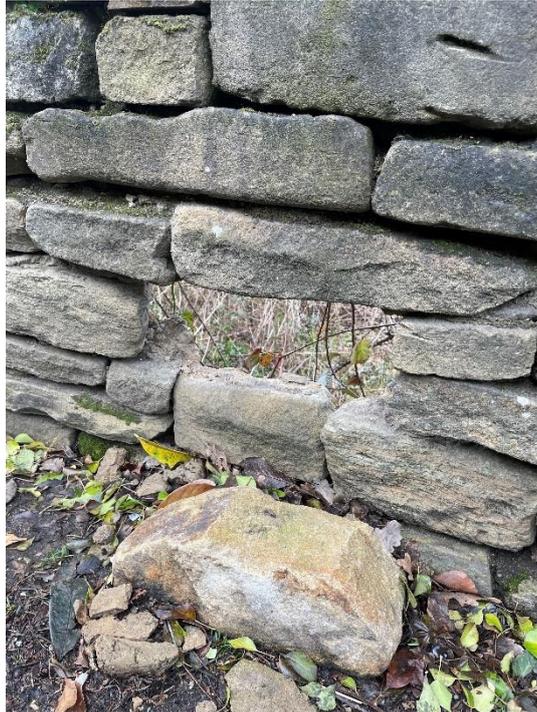
03

- 4.1 Generally, the structure was found to be in good condition with a single area of localised collapse at chainage 82m. (Photos 03,04).
- 4.2 Ivy growth was noted to the wall at the following chainages (Photo 05, typical);
- Ch 27-36m
  - Ch 51-57m
  - Ch 99-107m
- 4.3 Existing gate openings through the parapet were noted at the following chainages;
- Ch 38-41m (Photo 02)
  - Ch 60-62m
- 4.4 The following street furniture was noted on the footway adjacent to the parapet;
- Ch 31m sign post
  - Ch 55m lamp column
  - Ch 91m speed camera
- 4.5 For the purposes of the assessment, it has been assumed that the localised collapse noted at Ch 82m will be made good. No other defects which would be detrimental to the ability of the parapet to contain an errant vehicle were noted.

Parapet

Ch 82m: Localised collapse

- 6.1 Generally, the structure was found to be in good condition with a single area of localised collapse at chainage 82m which is considered to be due to localised impact. This area of collapse should be made good to ensure that the parapet is capable of providing adequate containment.
- 6.2 The assessment concludes that the parapet provides suitable containment for the traffic speed of 30mph.
- 6.3 The assessment shows a debris exit velocity of 6m/s and an extent of debris spread of 9.5m to 12m based on the proposed housing development drawings provided.

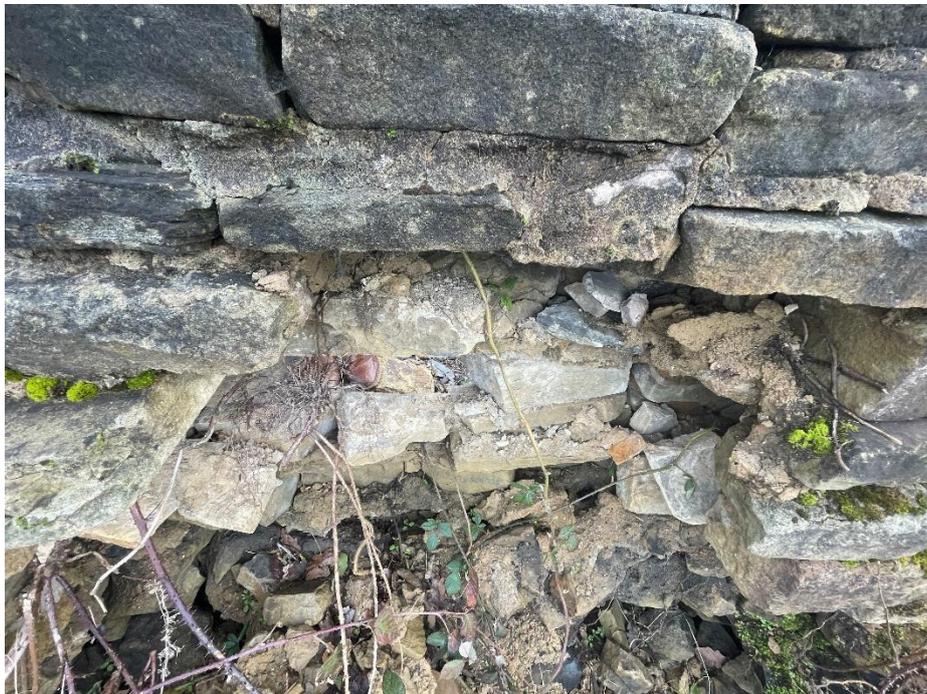
04

Parapet

Ch 82m: Non-traffic face of parapet at location of localised collapse

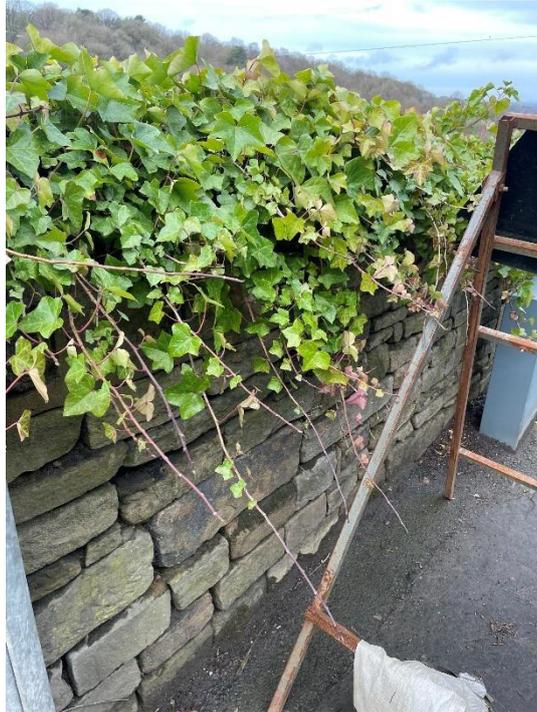
Parapet                      Ivy growth to top of parapet, typical at ch 27-36m, ch 51-57m, ch 99-103m                      05

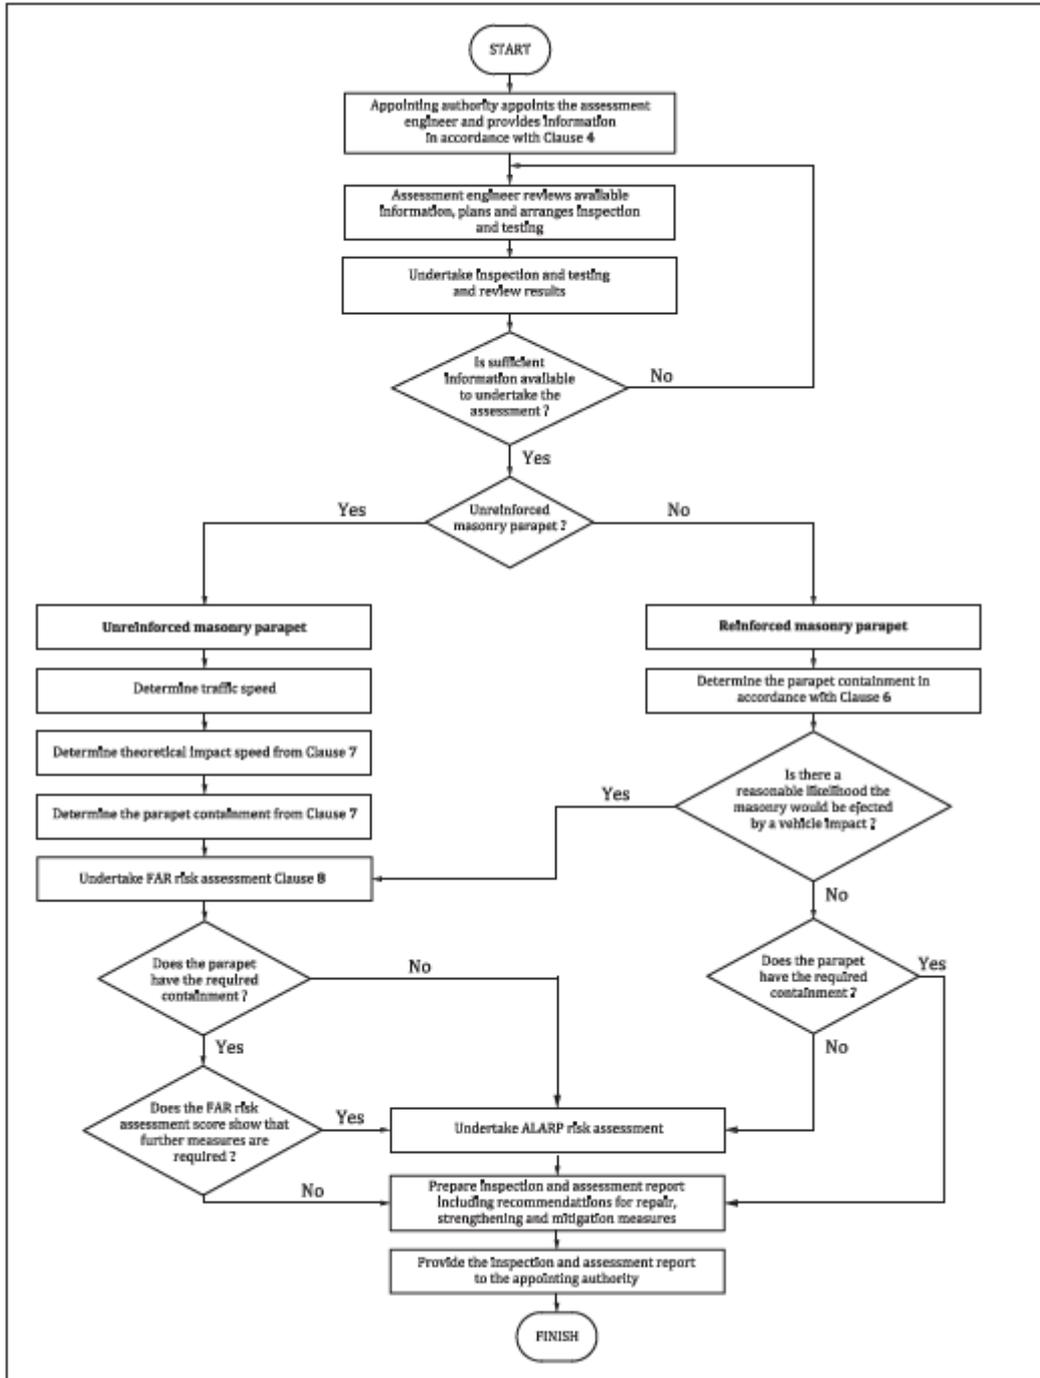
Figure 1 — Flowchart showing a suggested process for masonry parapet assessment

The parapet will be assessed in accordance with BS8770 Fig 1, see below.

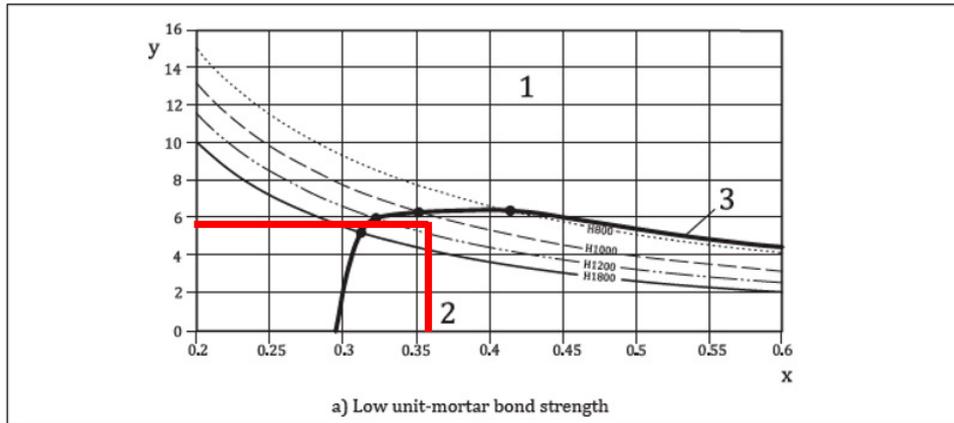
**Figure 3 — Parapet performance chart: for 80 km/h for mortared parapets of height, H (mm) (density: 2 200 kg/m<sup>3</sup>) that contain and direct cars at an impact angle of 20° or less**

Fig 3 above shows that the existing parapet, 1100mm high with 360mm av width at mid-height, provides adequate containment for and impact speed of 80kph.

The debris exit velocity is taken as 6m/s.

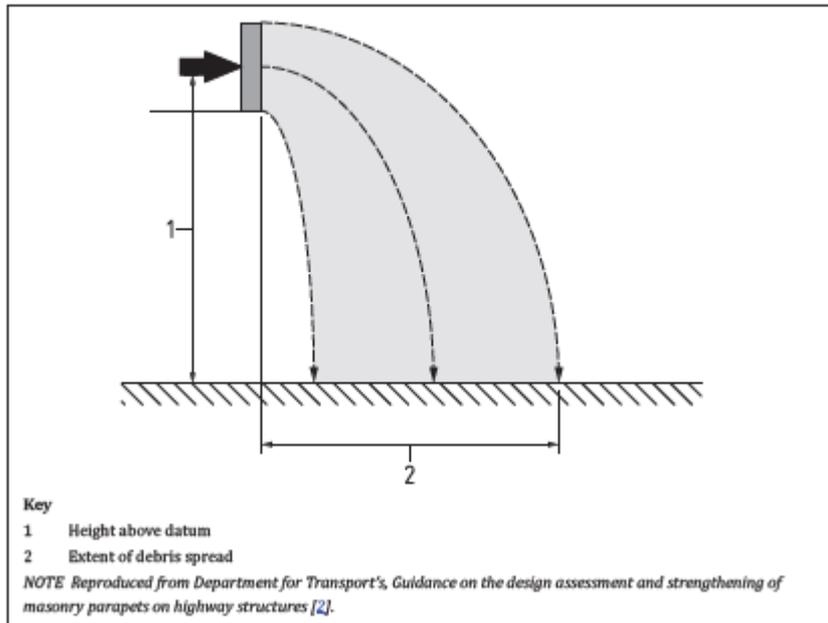
Figure 10 — Extent of debris spread: definition

The assessment shows a debris exit velocity of 6m/s and an extent of debris spread of 9.5m to 12m based on the proposed housing development drawings provided.

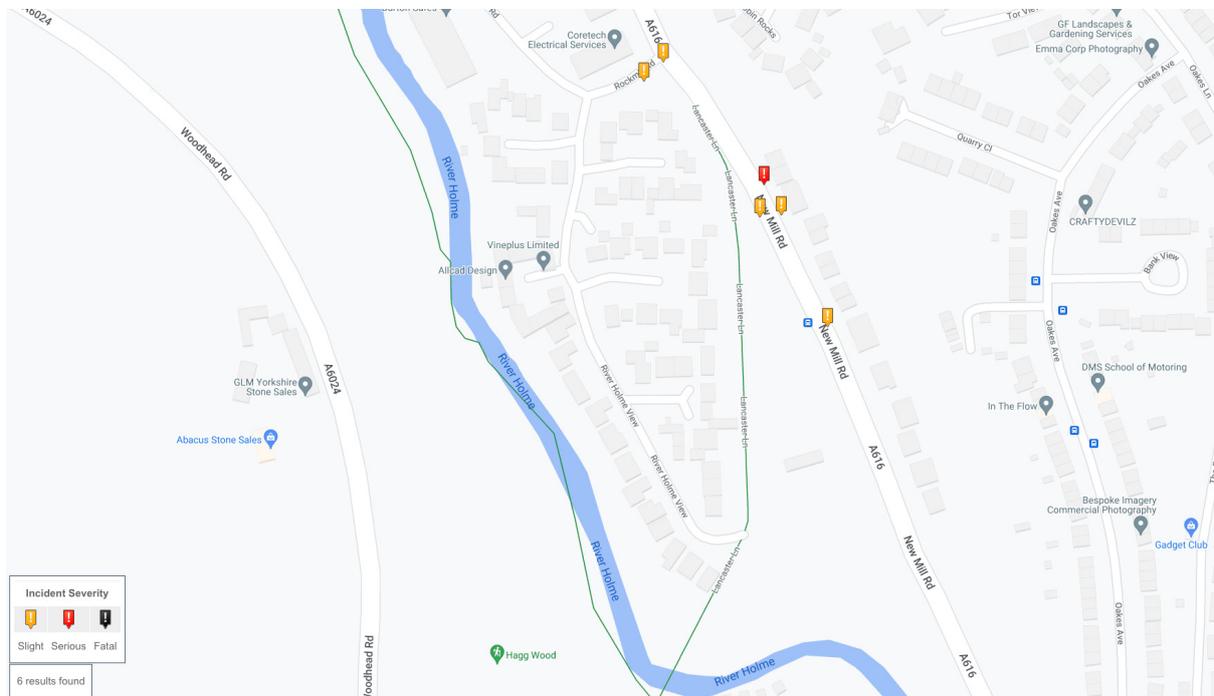
Figure 1.1 CrashMap Survey Area

- 1.1 The personal injury accident data for the last 24 years up to December 2022 within the vicinity of the site has been obtained from the CrashMap website. The data used is provided by the Department for Transport which is based upon records provided to them by local police forces. The accident data can be found at Appendix A.
- 1.2 The study area includes areas of Lancaster Lane, the A616 New Mill Road, and Rockmill Road within vicinity of the site and can be seen on the image at Figure 1.1.
