# **Moss View, Holmfirth**

## **Bat Survey Report**

**27<sup>th</sup> October 2023**

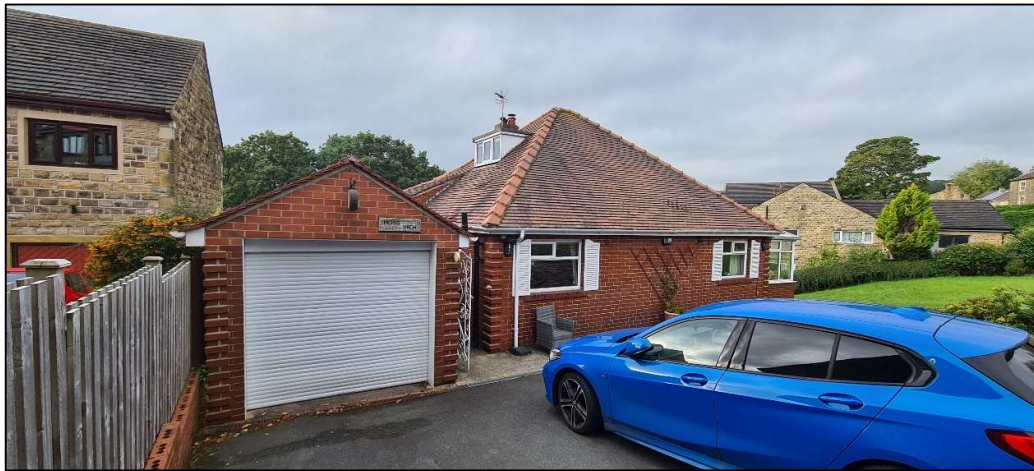
**Plate 1. The garage and dwelling viewed from the north**

- 5.2.2 The brick-built bungalow comprised the main living accommodation on the ground floor. A first-floor bedroom with a dormer window was present, as well as a lower-ground floor room (accessed separately from outside, beneath the southern part of the house), used as a utility room.
- 5.2.3 The roof across the main part of the dwelling had four pitches, hipped across the entirety of the main building creating a broadly pyramid-shaped roof. This resulted in four relatively steep pitches with a small catslide section present on the eastern aspect. The southern aspect of the building comprised a converted sunroom with a flat roof covered with a rubberised membrane. A small conservatory was present on the western aspect of the building.
- 5.2.4 The building had uPVC framed windows, soffits (on the north, east and west aspects) and fascias on the south.

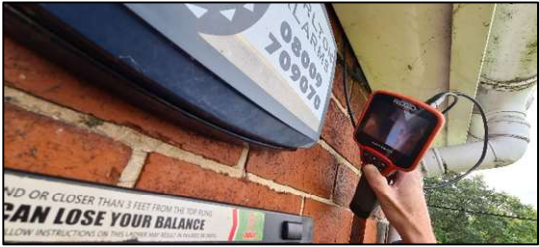
| PRF | Photo | Description |
|---|---|---|
| A | | Gap at the back of the soffit box on the western elevation. All other soffits and fascias were well sealed. |

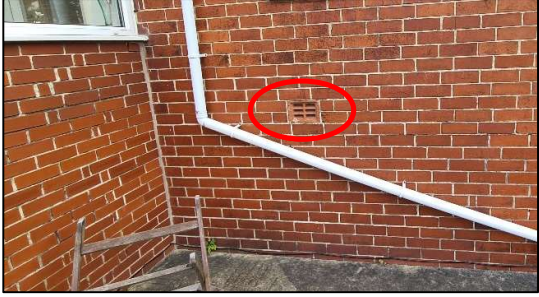
| PRF | Photo | Description |
|---|---|---|
| B | | Ventilation grills leading to the wall cavity. |

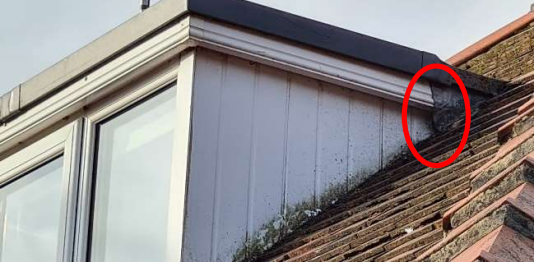
| PRF | Photo | Description |
|---|---|---|
| C | | Gap behind lead flashing next to dormer window. |

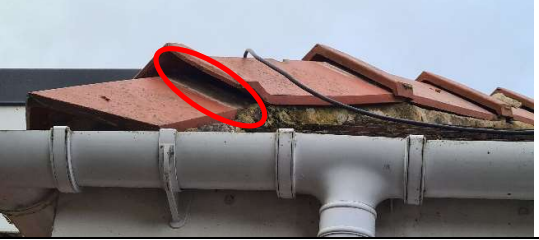
| PRF | Photo | Description |
|---|---|---|
| D | | Gaps under ridge tiles on the hips |

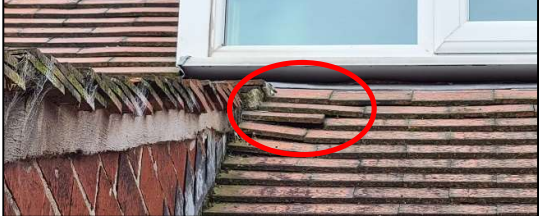
| PRF | Photo | Description |
|---|---|---|
| E | | Slightly raised tiles near the catslide roof and the base of the dormer window. |

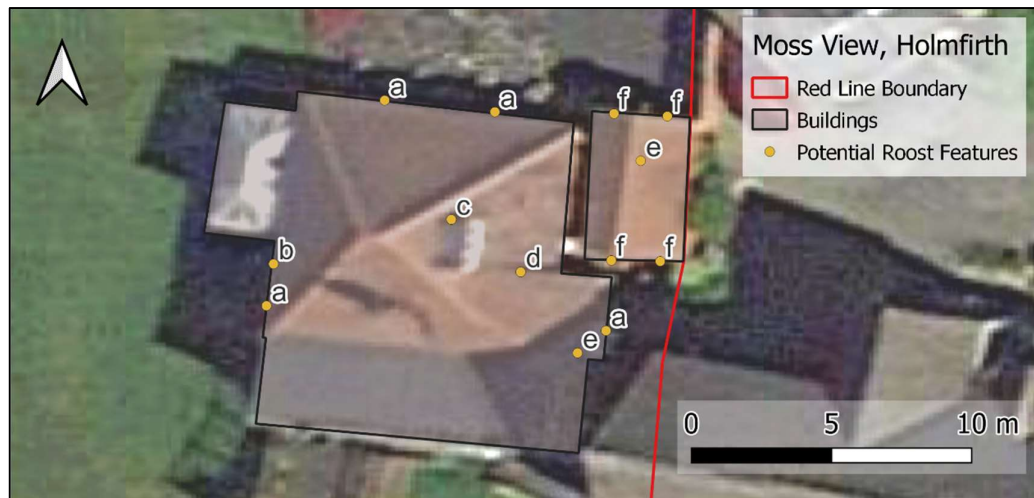
**Figure 3. PRF Locations**

- 5.2.5 Gaps with potential to be used by roosting bats comprised a gap into the soffit box, a gap behind lead flashing on the dormer window, gaps beneath ridge tiles, ventilation grills leading to the wall cavity, and gaps beneath raised tiles. The PRFs are shown in Table 3 and Figure 3 below.

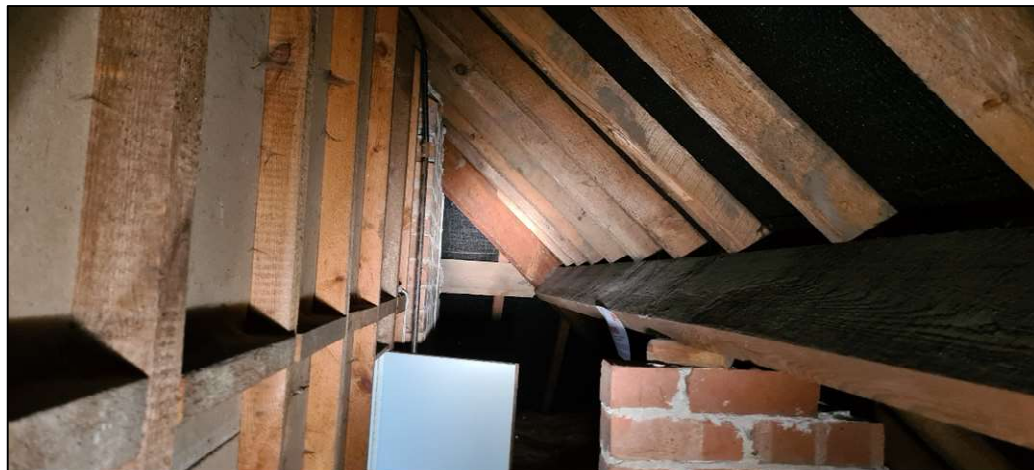
**Plate 3. Underdrawn eaves**

- 5.2.6 The roof voids within the property were limited to the underdrawn eaves and a very small loft above the bedroom. The eaves were triangular in cross section and approximately 2 m high (Plate 3).

- 5.2.7 The roof was supported by purlins resting on brick pillars / internal walls. The tiles were backed by Type 1F bitumen coated roofing felt and insulation was present between, and on top of, the joists. No signs of bats were present within the eaves space.
- 5.2.8 The small loft above the upstairs bedroom was approximately 0.6 m high (Plate 4). Additional insulation was present on top of the ceiling. No bats or signs of bats were present.

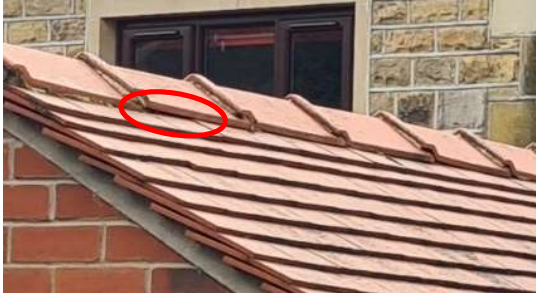
- 5.2.10 Gaps with potential to be used by roosting bats comprised a gap under a ridge tile, and gaps under tiles at the verges. The PRFs are shown in Table 4 and on Figure 3 below.

| PRF | Photo | Description |
|---|---|---|
| D | | Gap under ridge tiles |

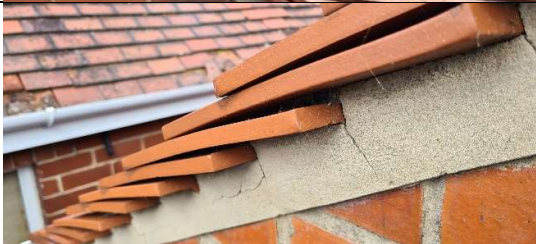
| PRF | Photo | Description |
|---|---|---|
| F | | Gaps under tiles at the north and south verges |
