## Report on Rotary Probing

Location: **Dene House**  
Kirkburton, HD8 0RW

Report No. J4323/18/E/C

Report date: August 2018

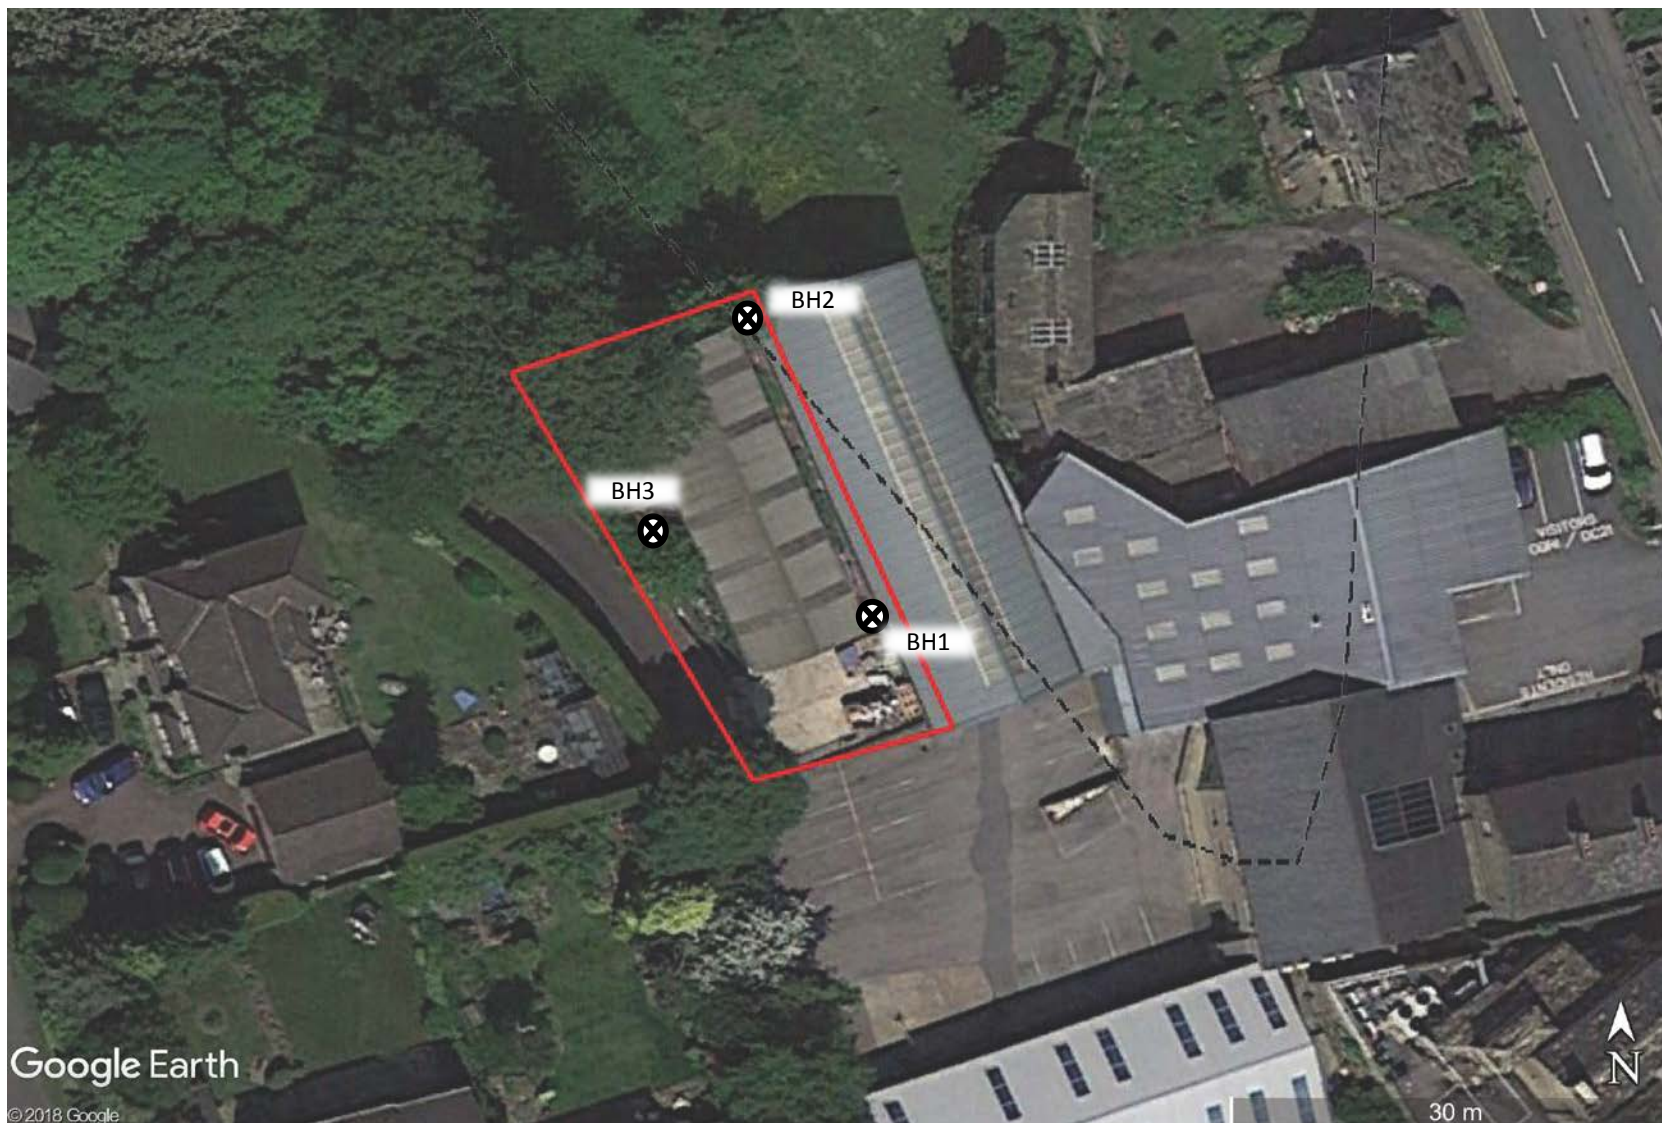
Title: **Investigation Location Plan**

Plan not to scale and investigation positions approximated from site operative's notes.

The boreholes were sunk using a Geo 205 rotary drilling rig employing rotary open-hole drilling techniques with 140mm diameter drag and tricone roller bits. Where necessary, 150mm diameter casing was temporarily installed through the overburden to support the bore. The investigation was undertaken using water flush drilling techniques in accordance with the Coal Authority and Health and Safety Executive positioning statement. Drill chippings brought to surface in the flush returns were inspected by the driller on a screen, which forms part of the re-circulation tanks. In addition, representative disturbed samples of the arisings were taken at regular depth intervals and sealed in plastic containers. These samples were returned to the laboratory for further inspection. The borehole positions are shown on the site plan, which is presented in Appendix 2 and the strata conditions are presented on the borehole records in Appendix 3.

Whilst it was necessary to ensure at least one borehole position was drilled to 30m depth, the required termination depth of the other position was reviewed during the course of the fieldworks. In this case, borehole BH1 was sunk to 30m, BH2 to 15m and BH3 was curtailed at 10m on the basis that sufficient data had been obtained.
