ARBORICULTURAL IMPACT ASSESSMENT
to BS 5837:2012
at
Ledgard Bridge Mills
Back Station Road
Mirfield
West Yorkshire
WF14 8NG

Client:
Binks Executive Homes Ltd.

JCA Ref:
16856-B/AJB

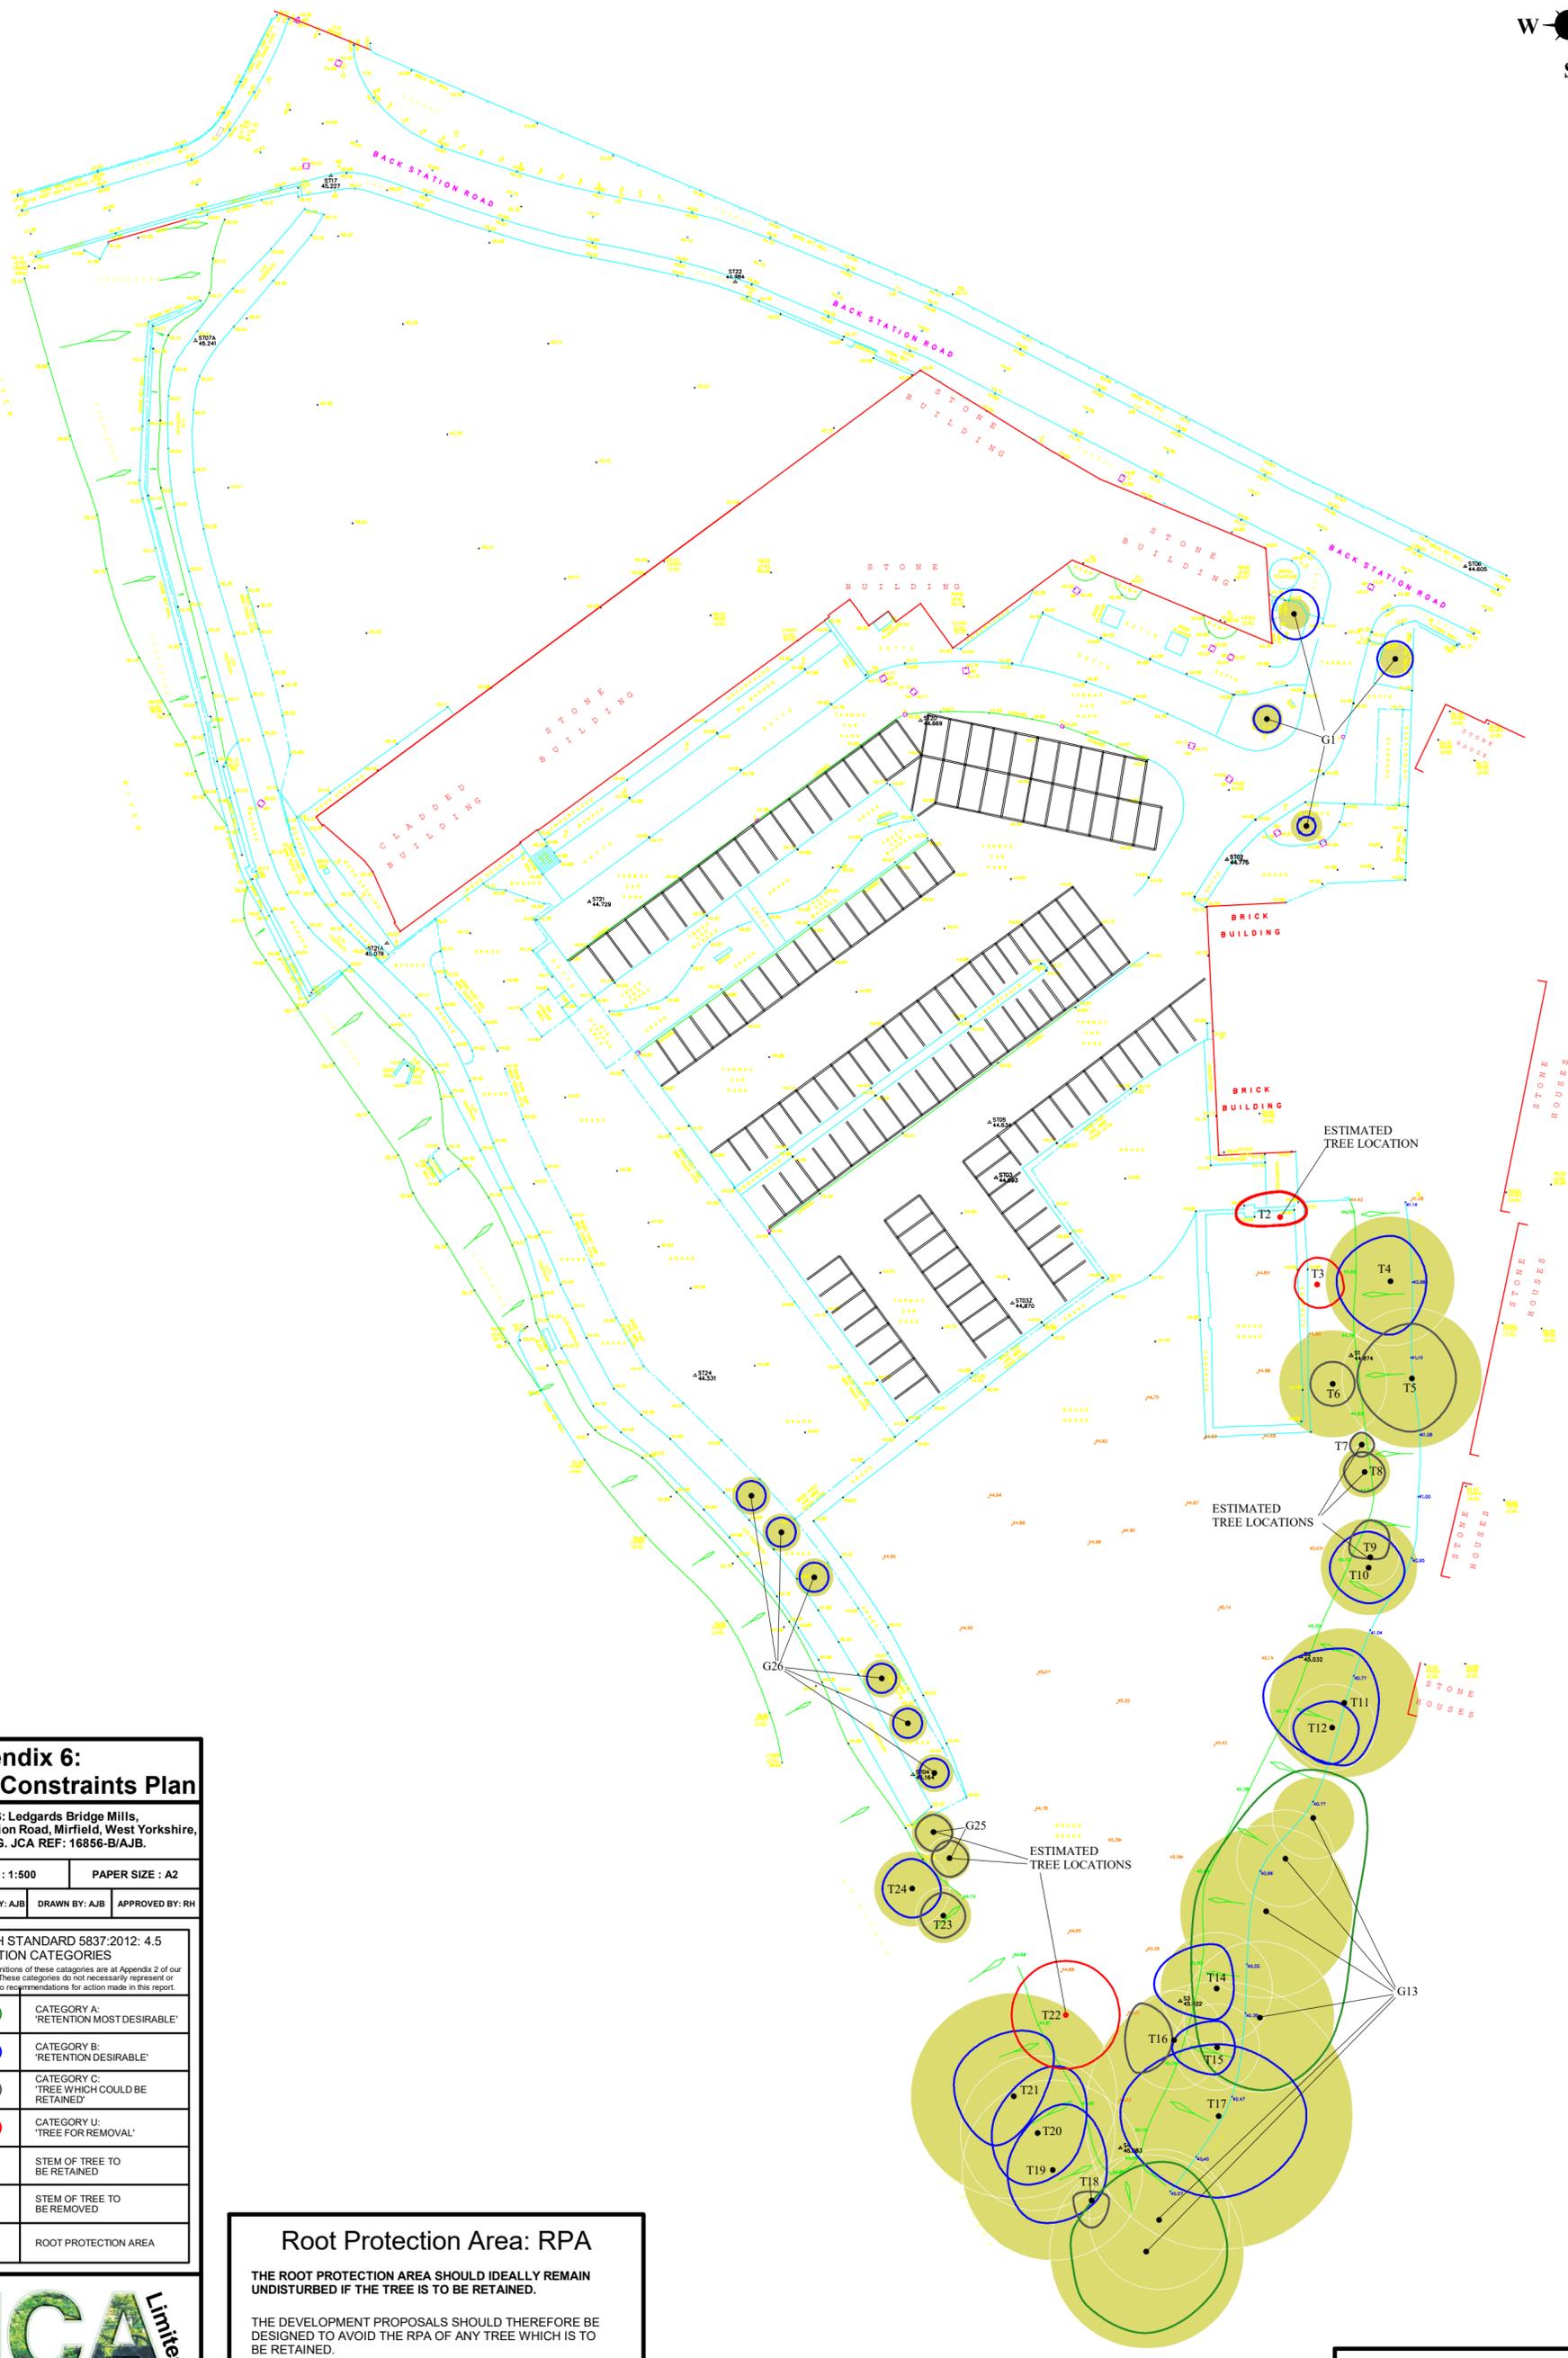
**Appendix 6:
Tree Constraints Plan**

Detailed definitions of these categories are at Appendix 2 of our report. N.B. These categories do not necessarily represent or correspond to recommendations for action made in this report.

CATEGORY A: 'RETENTION MOST DESIRABLE'
	CATEGORY B: 'RETENTION DESIRABLE'
	CATEGORY C: 'TREE WHICH COULD BE RETAINED'
	CATEGORY U: 'TREE FOR REMOVAL'
	STEM OF TREE TO BE RETAINED
	STEM OF TREE TO BE REMOVED
	ROOT PROTECTION AREA

THE ROOT PROTECTION AREA SHOULD IDEALLY REMAIN UNDISTURBED IF THE TREE IS TO BE RETAINED.

THE DEVELOPMENT PROPOSALS SHOULD THEREFORE BE DESIGNED TO AVOID THE RPA OF ANY TREE WHICH IS TO BE RETAINED.

IF IT IS NECESSARY FOR THE DEVELOPMENT TO ENCROACH INTO THE RPA OF A TREE WHICH IS TO BE RETAINED THEN SPECIALIST CONSTRUCTION TECHNIQUES AND MATERIALS MUST BE CONSIDERED.

- 2.1 The tree information recorded during the original survey is detailed in the tables at **Appendix 1**. A full explanation of the tables can be found at **Appendix 2**. Please refer also to the Tree Constraints Plan at **Appendix 5** for tree locations.

- 4.6 The protection of retained trees can be achieved by the creation of a Construction Exclusion Zone based on the Root Protection Area of a tree. The Root Protection Area of each tree or group is marked on the Tree Constraints Plan at **Appendix 5**.

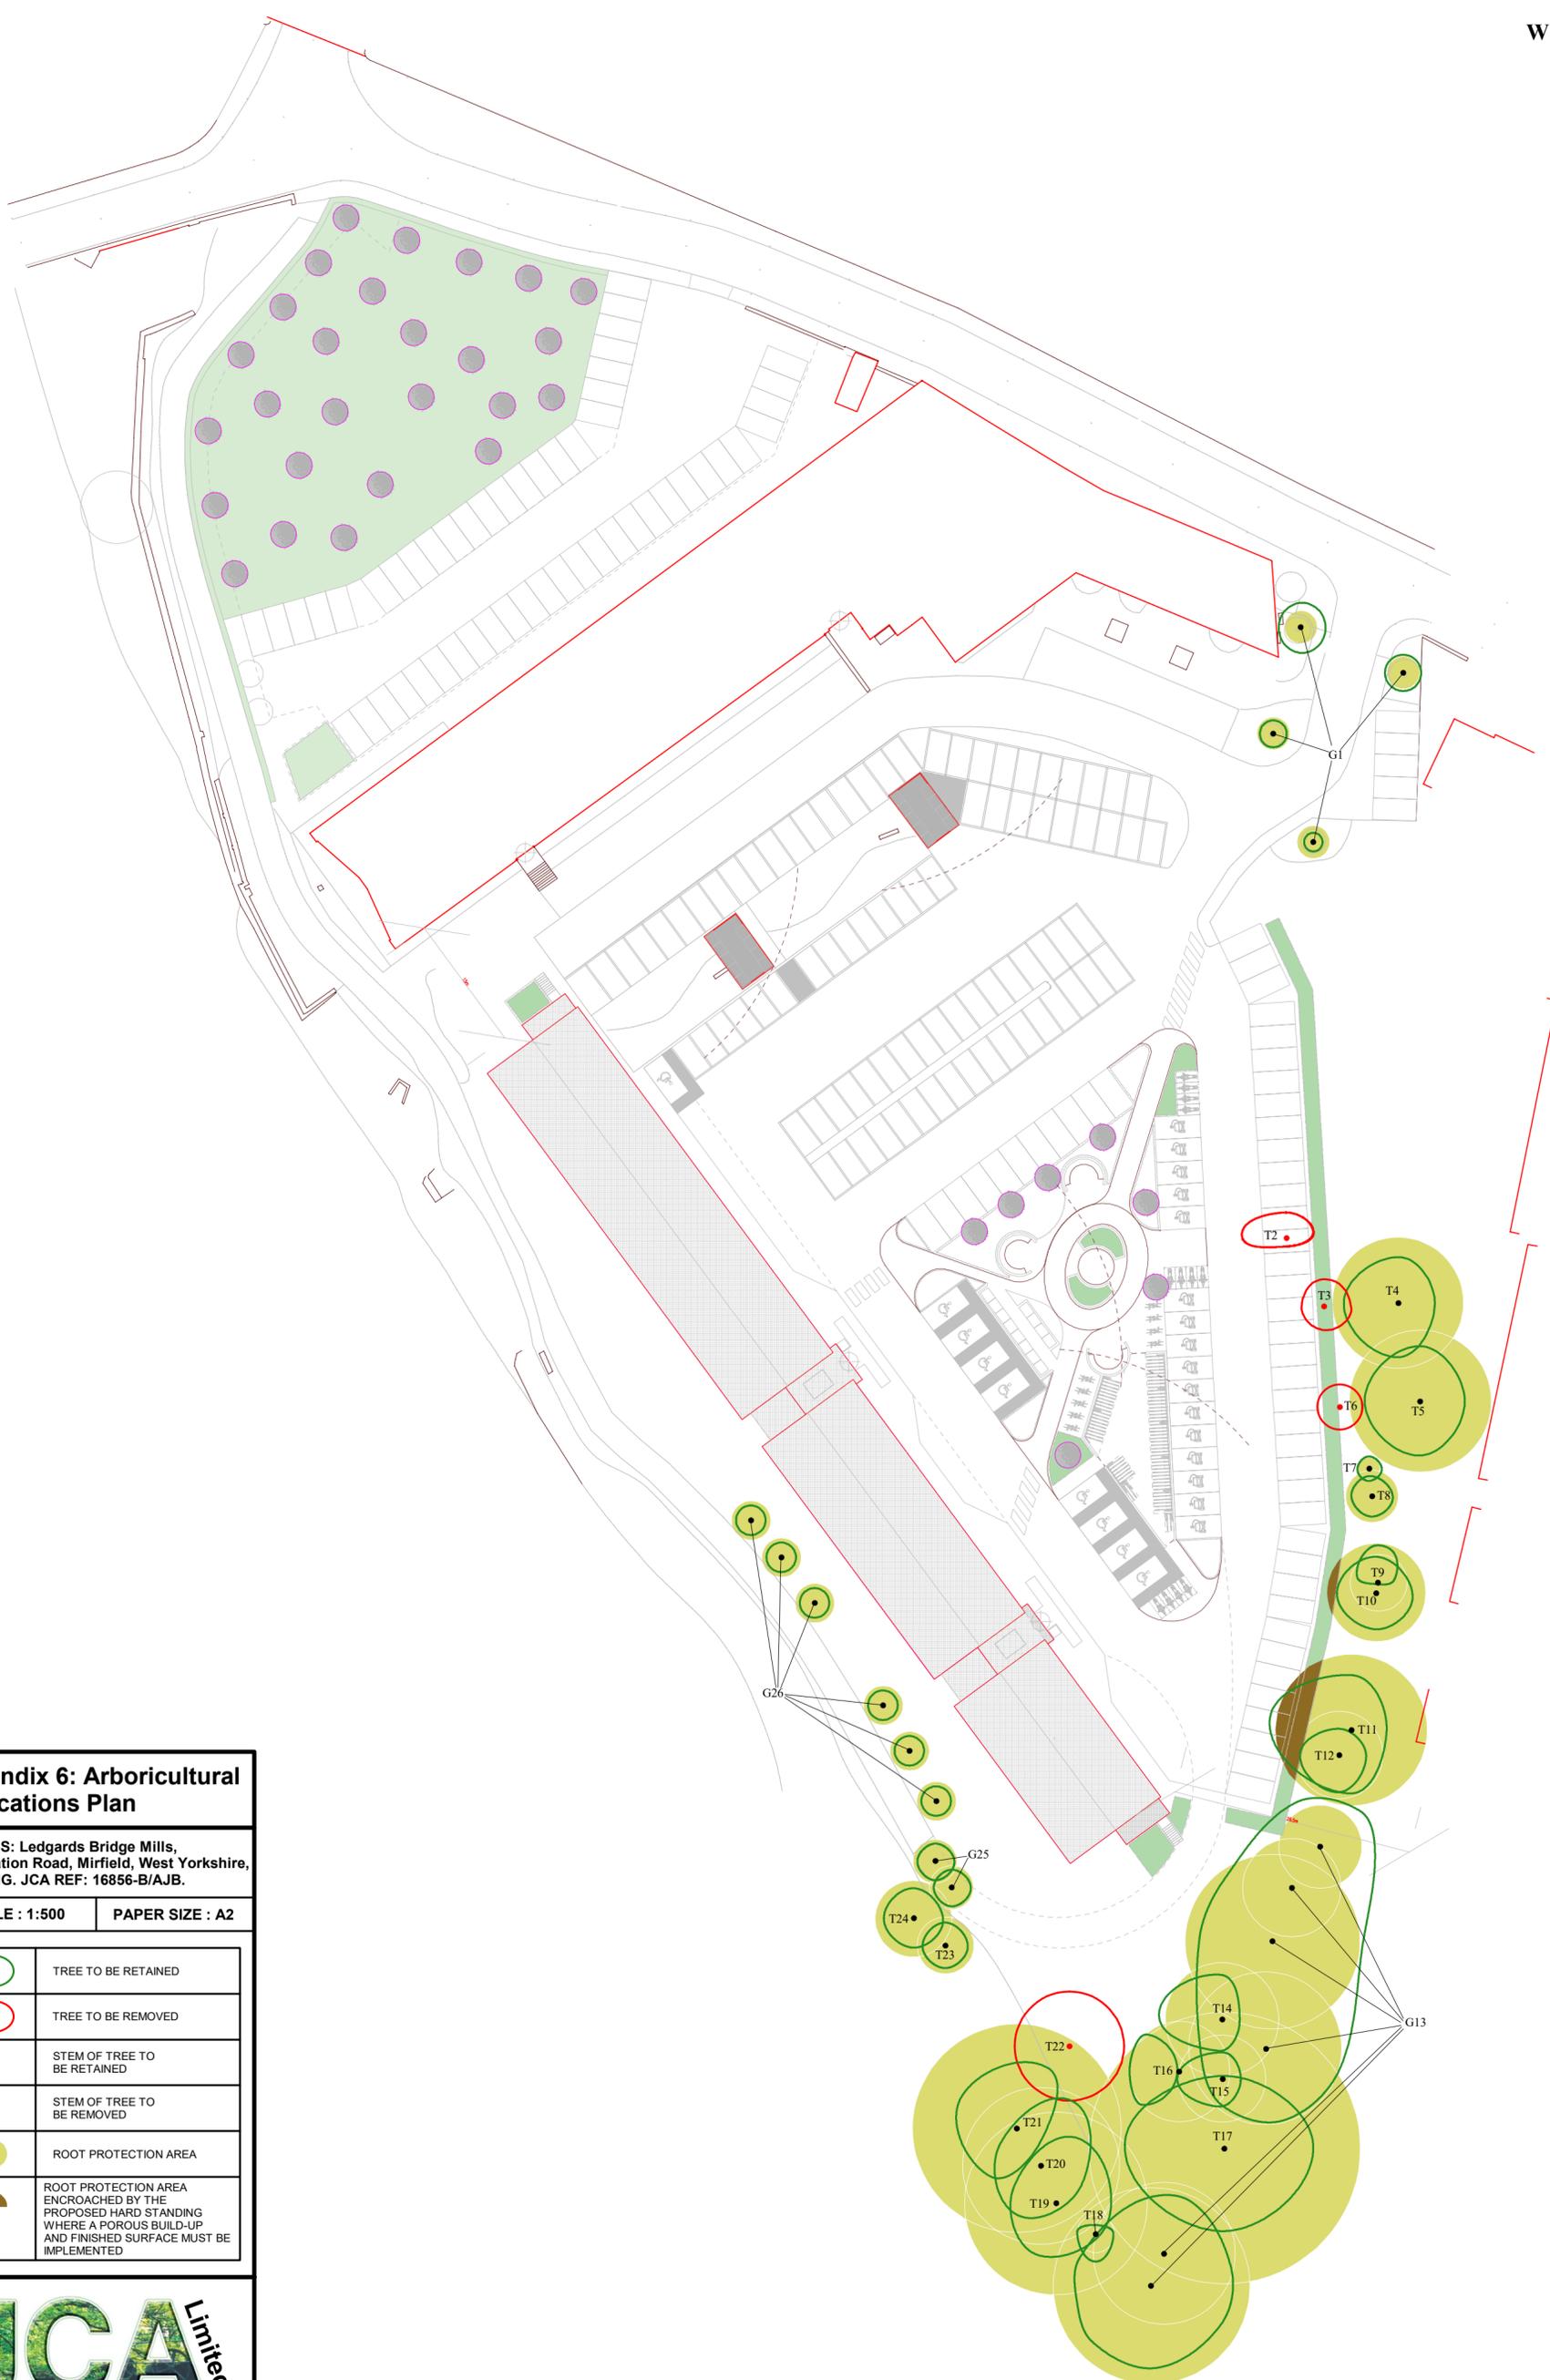
Appendix 6: Arboricultural Implications Plan

TREE TO BE RETAINED
	TREE TO BE REMOVED
	STEM OF TREE TO BE RETAINED
	STEM OF TREE TO BE REMOVED
	ROOT PROTECTION AREA
	ROOT PROTECTION AREA ENCROACHED BY THE PROPOSED HARD STANDING WHERE A POROUS BUILD-UP AND FINISHED SURFACE MUST BE IMPLEMENTED

- 3.2.1 In order to facilitate the proposed development, it will be necessary to remove **T6**, a low value tree which falls into retention category 'C' in accordance with BS5837: 2012.

- 3.5.3.1 Proposed car parking spaces and ground level build-ups are required within the rooting zones of **T10, T11 and T12** in the areas shown in brown shade on the plan at **Appendix 6**. It is recommended that the ground level build-up is comprised of a porous material such as stone gabion baskets and that the finished surface of the car park is also finished with a porous material.
- 3.5.3.2 Design principles must be confirmed by an appropriately qualified engineer and should be included in an Arboricultural Method Statement.

- 4.3 The arboricultural implications of the development have been considered and are discussed in **Section 3**.
- 4.4 **T6**, a low value tree requires removal in order to facilitate the proposed development. Tree works required to accommodate the proposals are detailed in *italics* in the tables at **Appendix 1**. Those trees requiring removal are shown in red on the Arboricultural Implications Plan at **Appendix 6**, where the proposals can also be viewed.
