## **Remediation Strategy**

103 Heckmondwike Rd  
Dewsbury Moor,  
WF13 3PG

**For Urban Future Planning Consultancy Ltd**

07 December 2023  
Report ref. 23/1149.4.1

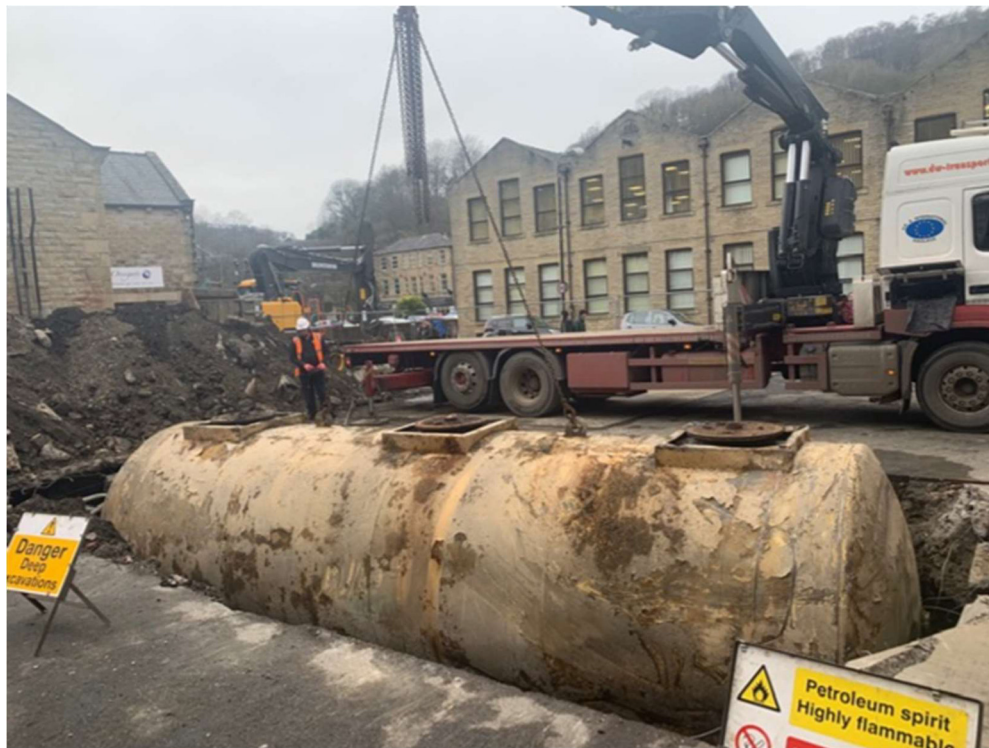
**Figure B.** The safe removal of a historic tank from the ground after excavation.

Tank removal and decommissioning processes are an environmental risk. Pipework, tanks and old infrastructure can leak in the process of decommissioning if not removed by a competent contractor.

Images showing the different sorts of tank removal processes are shown on the following page:

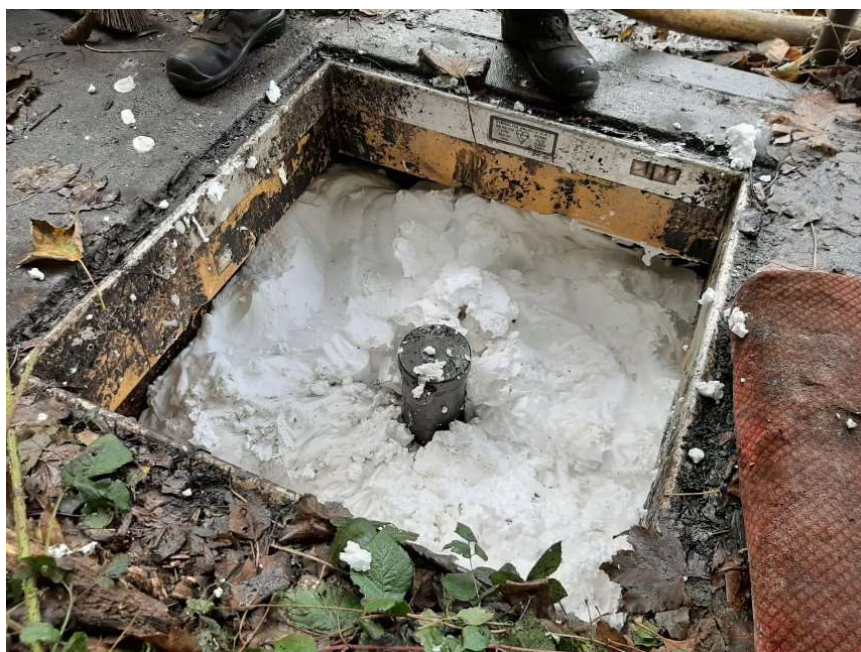
**Figure C.** A foam filled tank and chamber from the surface.

- On some sites tanks can be directly foam or concrete filled (if in locations where excavation could damage nearby structures). Other options do exist, these are found in the APEA Design, construction, modification, maintenance and decommissioning of filling stations (v4)  
<https://apea.org.uk/pages/publications/apea-publications>

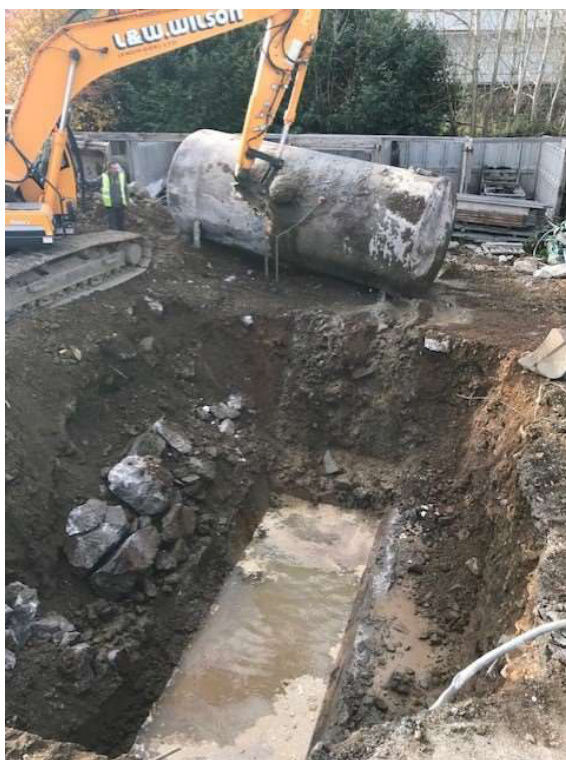
**Figure D.** Beware of bad practice! A dangerous tank removal in progress with tank contents leaking into the environment after removal.

The work should be undertaken by a specialist contractor with suitable certificates, training and experience in carrying out tank decommissioning.

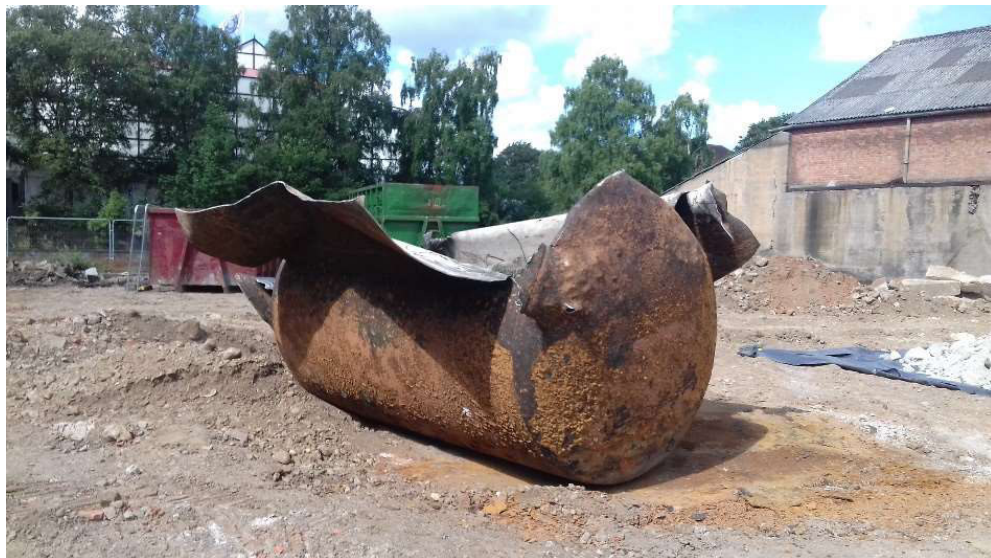
Figure E. Steel tank inspected on the surface after tank pull.

- When removed, tanks and lines should be inspected for holes and damage (pitting or heavy rusting). The locations of any holes and the conditions should be recorded.

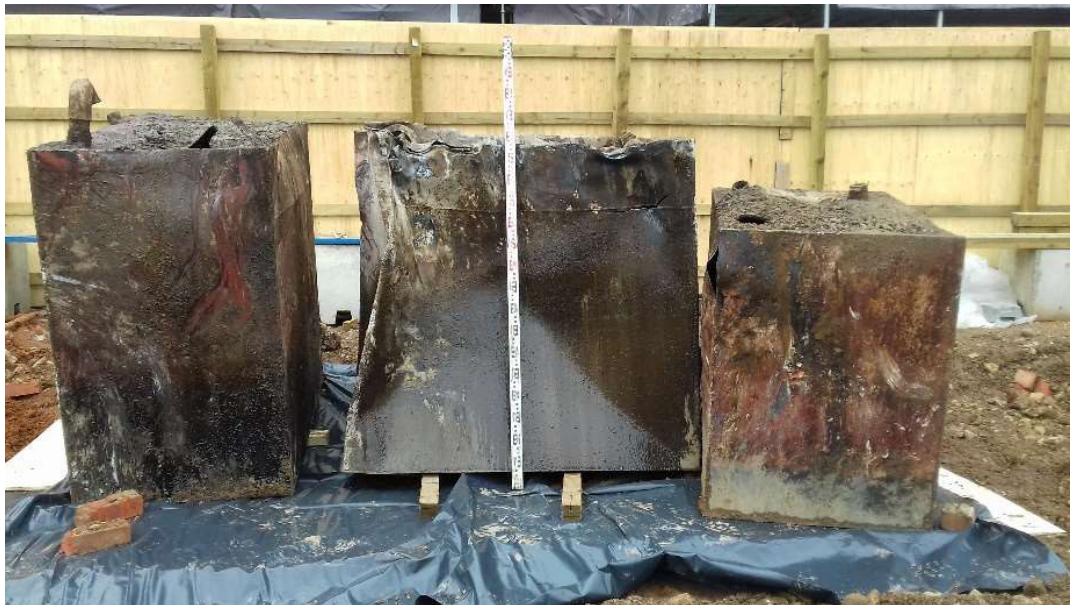
**Figure F.** Image of ASTs being inspected after a building demolition.

Any existing or historic above ground storage tanks (ASTs) may also have historic leaks from bunds or lines which could impact the underlying soils.

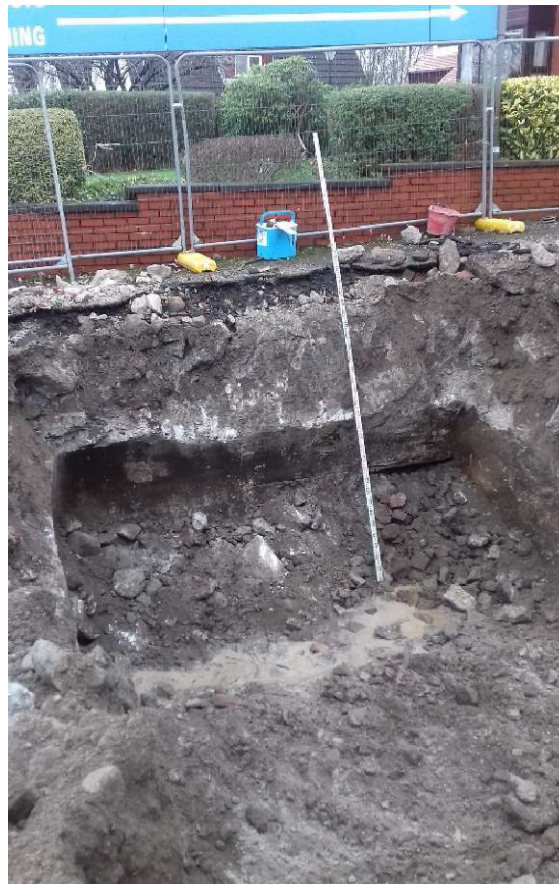
**Figure G.** Image of tank validation.

The concrete cradle has been retained for structural reasons.

- After the tank has been removed, the edges and base of the remaining hole should be excavated further, under the supervision of a Geo-environmental engineer, to remove any visual signs of contamination or odorous soils.
- Once the contamination has been sufficiently removed, soil samples should be taken from the sides and base of the excavation and sent to a laboratory where they can be analysed to see if any excessive concentrations of contamination remain.
- The number of soil samples collected for laboratory analysis varies depending on the size of the excavation. In general, a minimum of 1 sample should be taken from each side (approx. 1 per 5m<sup>2</sup> face) of the excavation and 2 samples taken from the base. Geo<sup>2</sup> can advise on the most appropriate sampling frequency.

A sample of any groundwater seeping into the base of the excavation is also to be collected for environmental chemical analysis at a suitable UKAS certified laboratory.
