# Bat Survey Update

## Storthes Hall Campus

Prepared for Ubrique Investments Ltd.

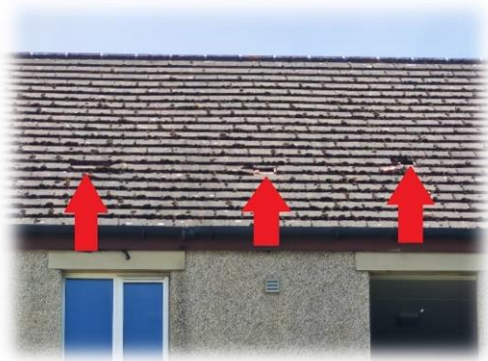
The external inspection recorded the buildings to be generally in a good condition. Several features were identified on the external of the buildings which could provide potential roosting opportunities for bats including gaps in the roof following vent removal (plate 1), gaps under fascia boards (plate 2), at wallheads (plate 3), under lead flashing (plate 4) and gaps between the wooden porches and stonework (plate 5).

Plate 1: Gaps in roof.

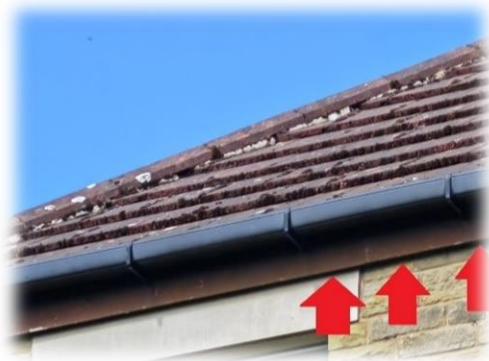
Plate 2: Gaps under fascia.

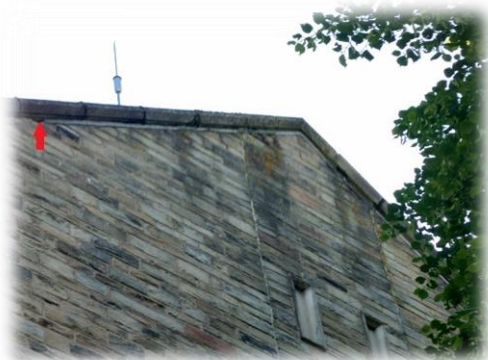
Plate 3: Gap at wallhead.

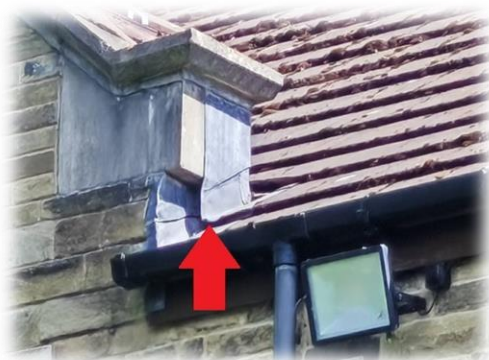
Plate 4: Gap under flashing.

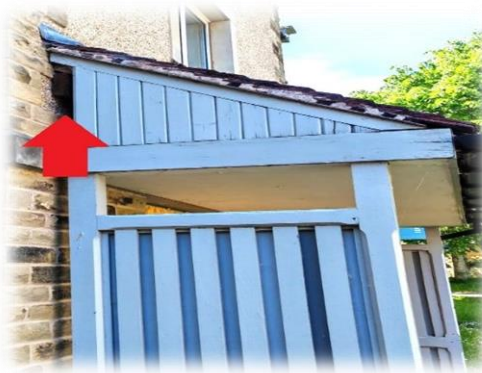
Plate 5: Gap between porch woodwork.

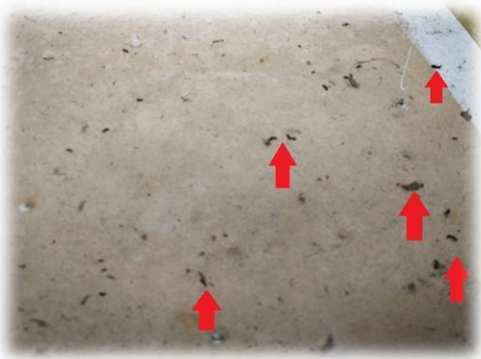
The interior of the former student accommodation blocks consisted of either three or four floors with double/single bedrooms and two kitchens on each floor. The roof voids were insulated with fibreglass ceiling insulation below 'A' frame roof structures lined with bitumen felt. Bat droppings were recorded within the roof spaces of Buildings 19 and 20. A scattering of approximately 30 bat droppings were recorded on the floor at the southern extent of the roof void of Building 19 (plate 6). The size and composition of the droppings suggest they were deposited by Brown Long-eared bats. Approximately 300 bat droppings were recorded on the insulation adjacent to an internal firewall within the roof void of Building 20 (plate 7). These droppings were found close to potential access features in the roof comprising gaps in the roof where the vents had been removed and gaps at the wallheads.

Plate 6: Bat droppings (Building 19).

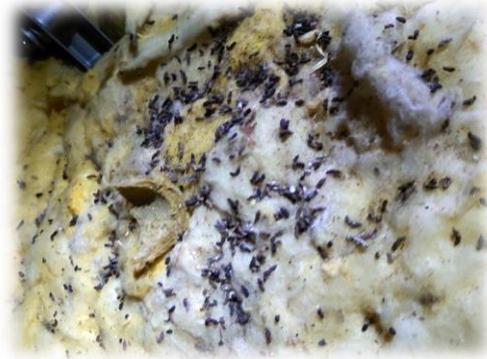
Plate 7: Bat droppings (Building 20).

during either the 2018, 2022 or 2025 activity surveys. As the property has been largely abandoned for a number of years, it is likely that the roost dynamics have changed, and this has had a negative impact on those roosts and consequently have relocated. It should be noted that the height of the buildings and increased growth of the trees on site posed some restrictions to sight lines for survey, however the level of activity recorded by Brown Long-eared bats during the surveys was low and does not correspond to the number of droppings recorded within the property, in particular building 20.

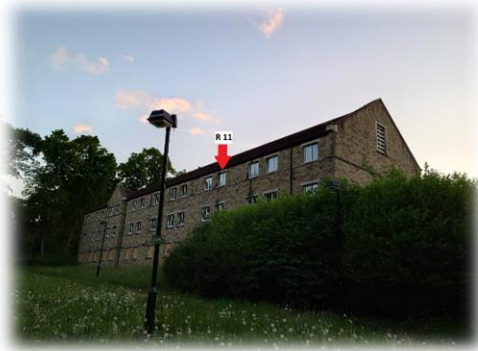
Location 8 (Building 3) – One individual bat emerged at 22.30 from under the barge board on the western aspect of the building (Roost 11, plate 8). Sound analysis of recordings taken during the survey confirm that the bat emerging from Roost 11 was Common pipistrelle. Activity was low with occasional foraging in the last 40 minutes of the survey.

Plate 8: Roost 11 (Building 3, SE. aspect).

Prior to works taking place, a detailed method statement and plan of works should be produced. Known roost locations should be exposed by hand, and a licenced bat ecologist should be present on-site during these exposures. If bats are found during the roofing works, the bat(s) will be translocated by the licenced ecologist to a 1FF bat box located on a nearby mature tree. Any scaffolding erected should be placed to avoid obstructing the bat roost entrances identified within this report.

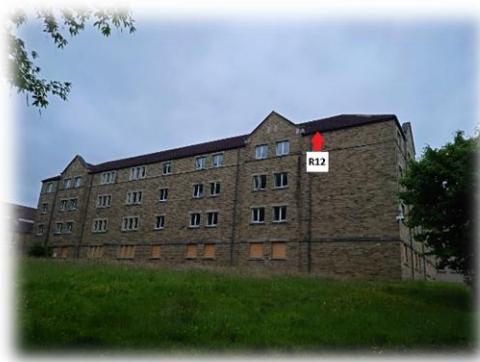
Location 34 (Building 16) – Two Common pipistrelle emergences at 21:36 and 21:41 from a gap in the fascia under the guttering (Roost 12, plate 9) with both emergences flying straight out toward the trees behind the vantage point.

*Plate 9: Roost 12 (Building 16, SE. aspect).*

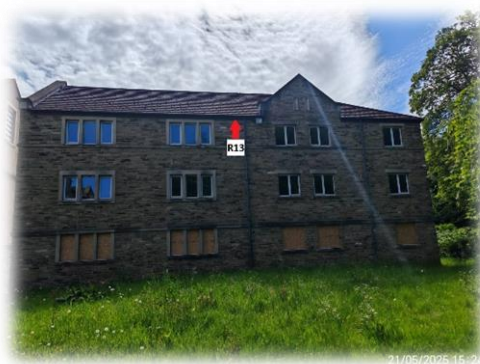
Location 22 (Building 15) One Common pipistrelle emergence from under the fascia on the eastern aspect Building 13 (Roost 13, plate 10) at 21:41.

*Plate 10: Roost 13 (Building 13, NE. aspect).*

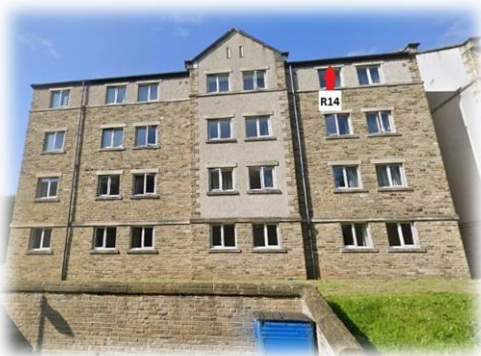
Location 38 (Building 18) – Common pipistrelle emerged from wallhead on southern aspect of Building 18 (Roost 14) at 21:28 (plate 11) with a re-entry recorded at 21:42. A second emergence from Roost 14 was recorded at 21:55, however the bat was not echolocating upon emergence. A third emergence came from a gap in the porch roof on the western aspect of Building 20 (Roost 15) at 22:15 (plate 12). Sound analysis of the recording could not confirm an exact species beyond *Myotis* sp.

Plate 11: Roost 14 (Building 18, NE. aspect).

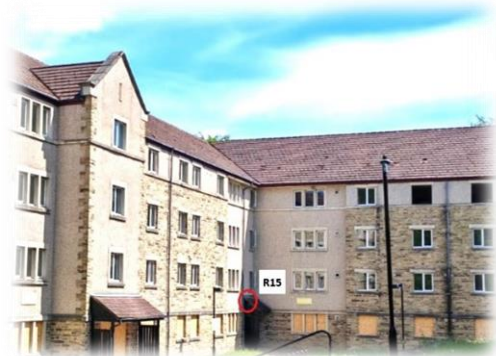
Plate 12: Roost 15 (Building 20, W. aspect).

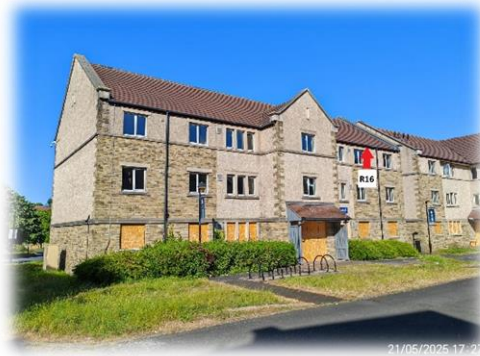
Location 17 (Buildings 6, 7 & 8) – One Common pipistrelle emergence recorded at 21:43 from below the fascia on the southwestern aspect of Building 8 (Roost 16, plate 13).

Plate 13: Roost 16 (Building 8, SW. aspect).

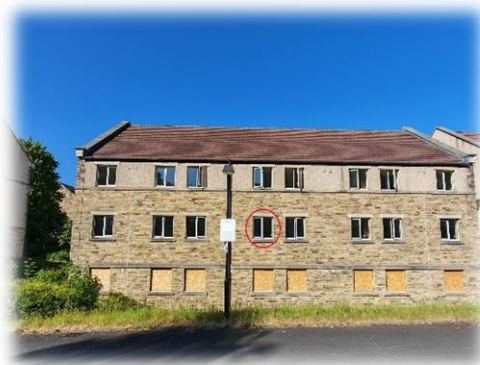
A Tawny owl was observed emerging from an open window on the southwestern aspect of Building 8 during the survey (plate 14).

Plate 14: Tawny owl emergence point (Building 8, SW. aspect).

An individual Tawny owl was observed emerging from an open window on the first floor on the southwestern aspect of Building 8. No evidence of a roost was recorded during the preliminary building assessment therefore it is possible the owl has sought shelter or was hunting within the building.

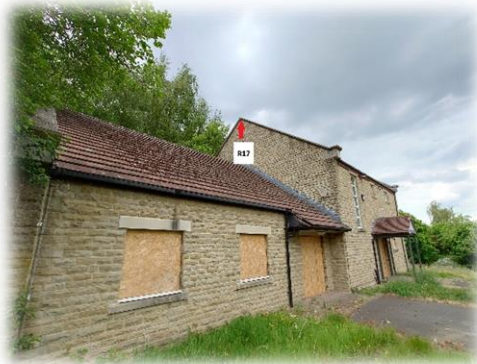
Location 5 (Building 2) – An individual bat emerged from the roof apex of the raised section of roof on the southwestern aspect at 22:12 (Roost 17, plate 15). A specific species could not be determined, however it was confirmed to be a *Myotis* sp. Moderate activity observed by Common Pipistrelle foraging and commuting around the building with occasional passes by Brown Long-eared and Natterers (*Myotis nattereri*) bats.

*Plate 15: Roost 17 (Building 2, SE. aspect).*
