# GEO-ENVIRONMENTAL REPORT

# Report on a Phase 2 Geo-environmental Investigation

Location:	<b>Crows Nest Farm</b> Crawshaw Lane, Flockton, Huddersfield, WF4 4BY	
For:	Mr & Mrs Ellis	
Consultants:	Highstone Housing Services Ltd	
Report No.	C3875/23/E/5885	Report date: December 2023

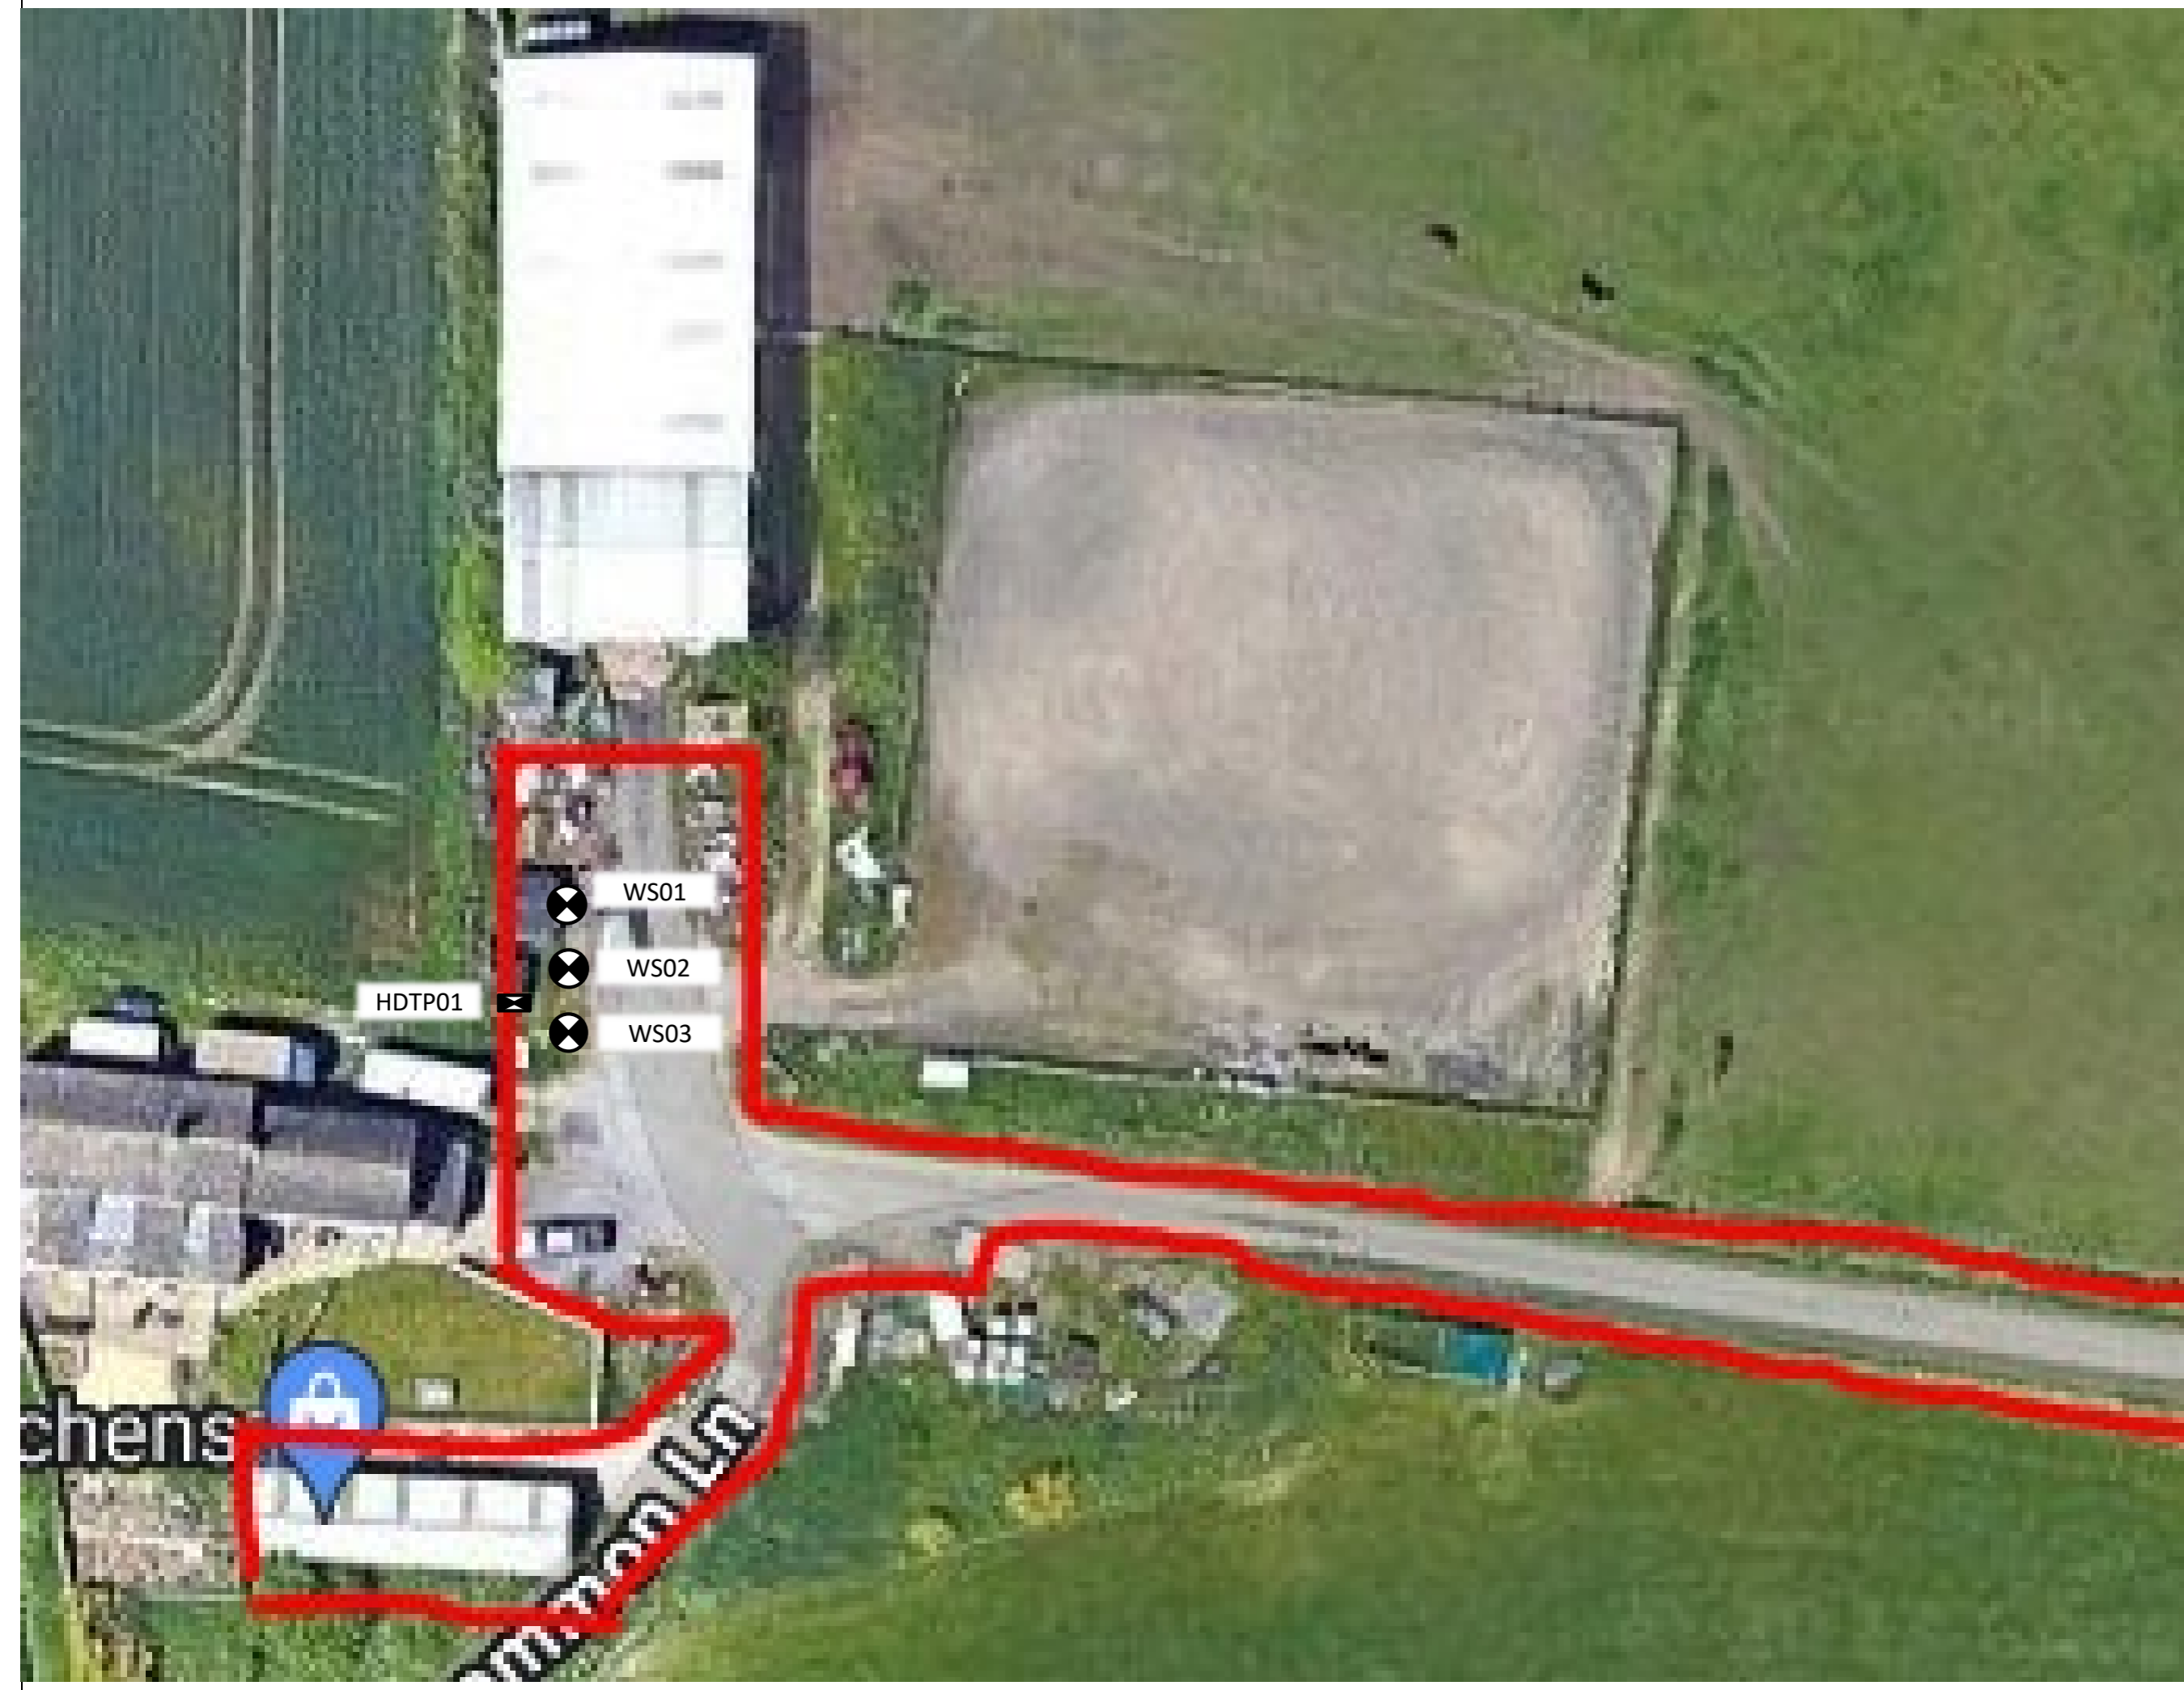
Crows Nest Farm, Crawshaw Lane, Flockton

The investigatory locations are shown on the site plan which is presented in Appendix 1 to this report.
