# Geoenvironmental Appraisal

## Land at Denby Lane, Grange Moor For Yorkshire Country Properties

Report no: 4511/1

Date: December 2022

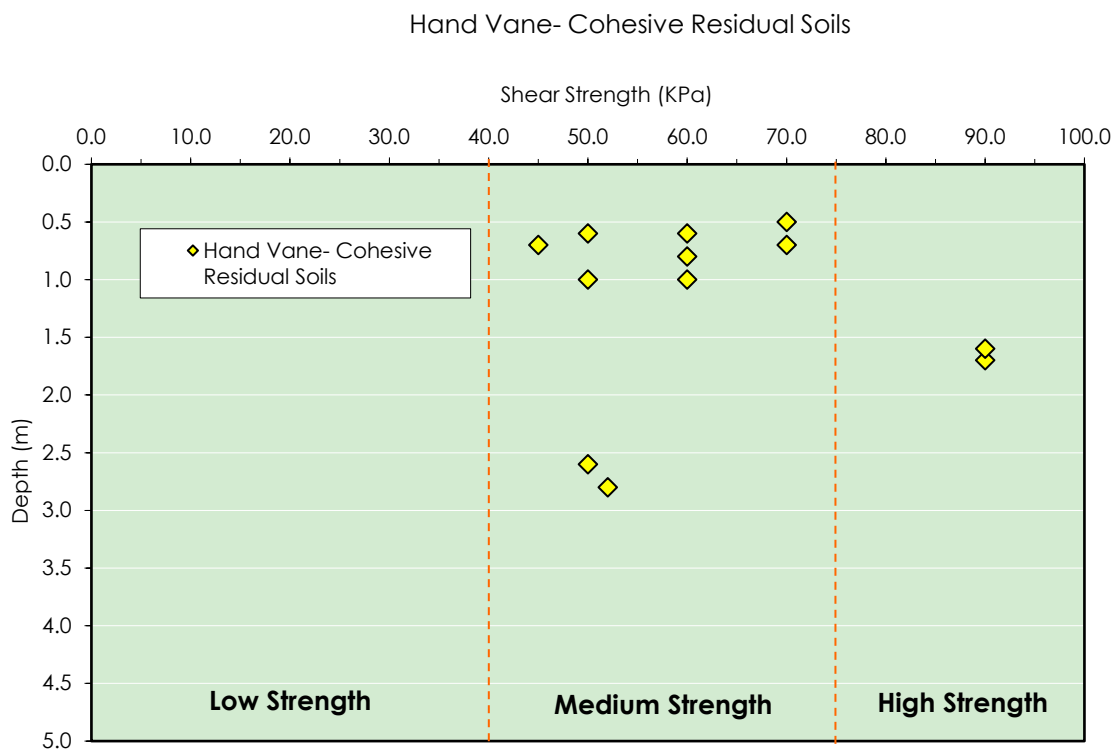
- 14.6.1 Hand shear vane testing was undertaken within trial pits in-situ to around 1.0m depth and from larger blocks of excavated clay below that depth.
- 14.6.2 The results are summarised within the plot below and illustrate that the undrained shear strength ( $S_u$ ) of Cohesive Residual Soils typically range between 45 kPa (medium strength) to 90kPa (high strength).
- 14.6.3 The plot below provides a summary of undrained shear strengths.

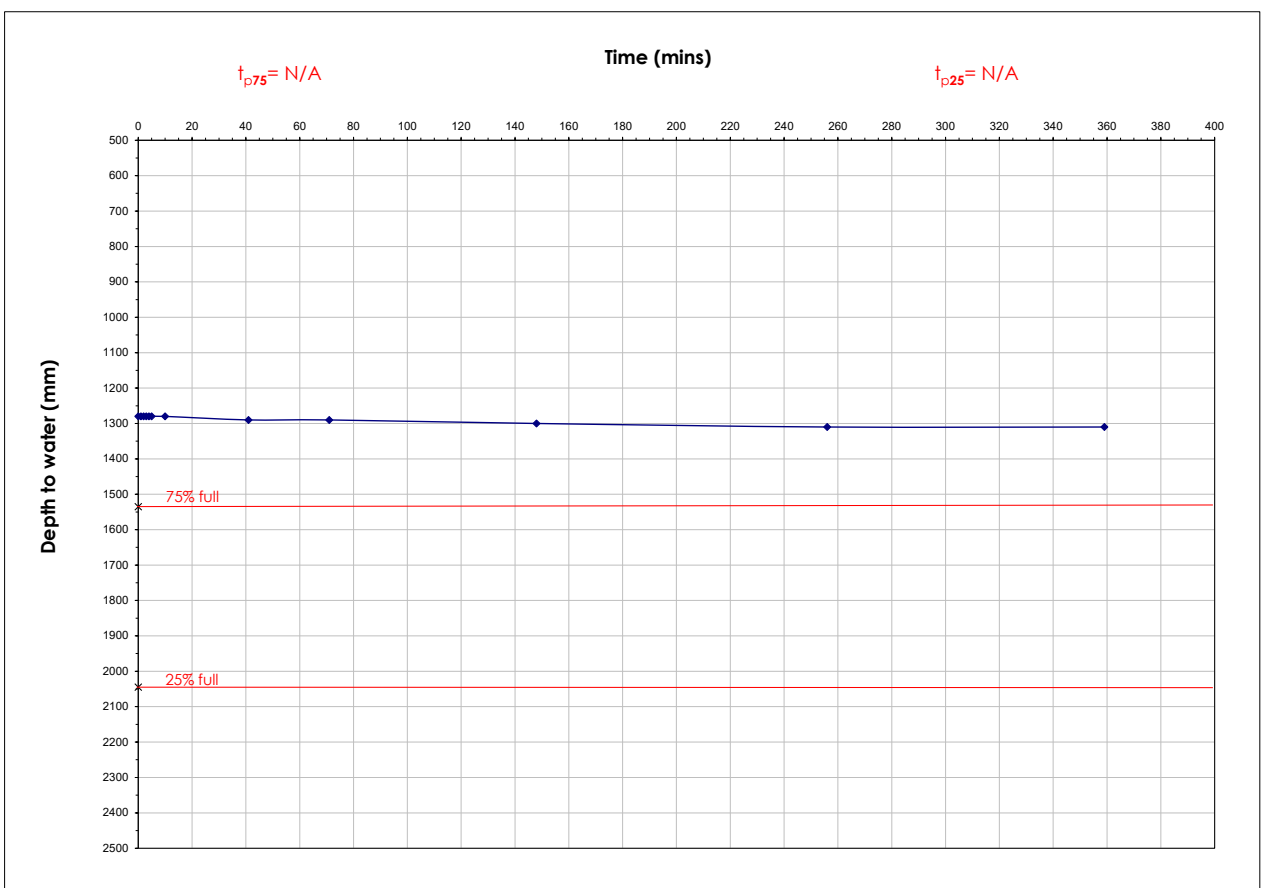
Test did not attain 25% Effective depth. Unable to calculate soil infiltration rate

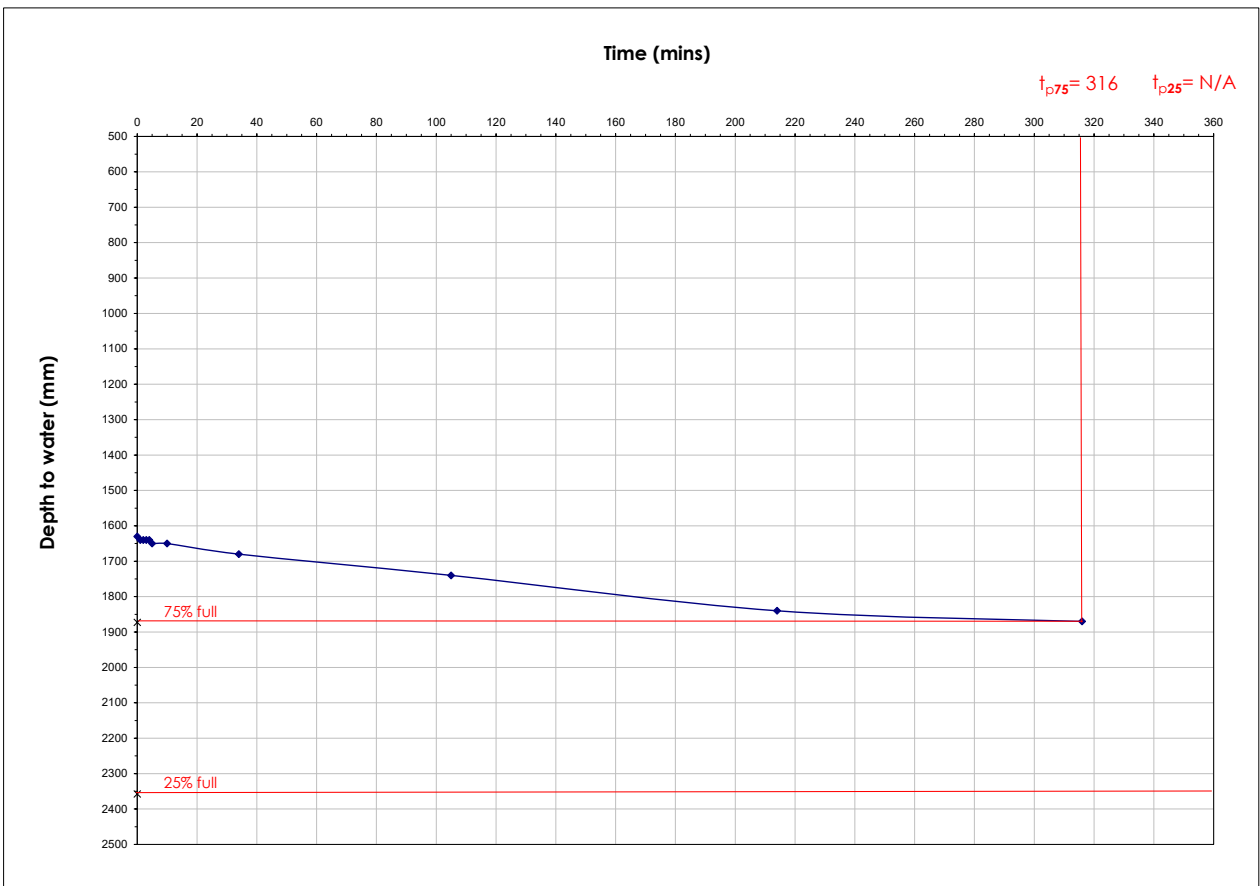
Test did not attain 25% Effective depth. Unable to calculate soil infiltration rate

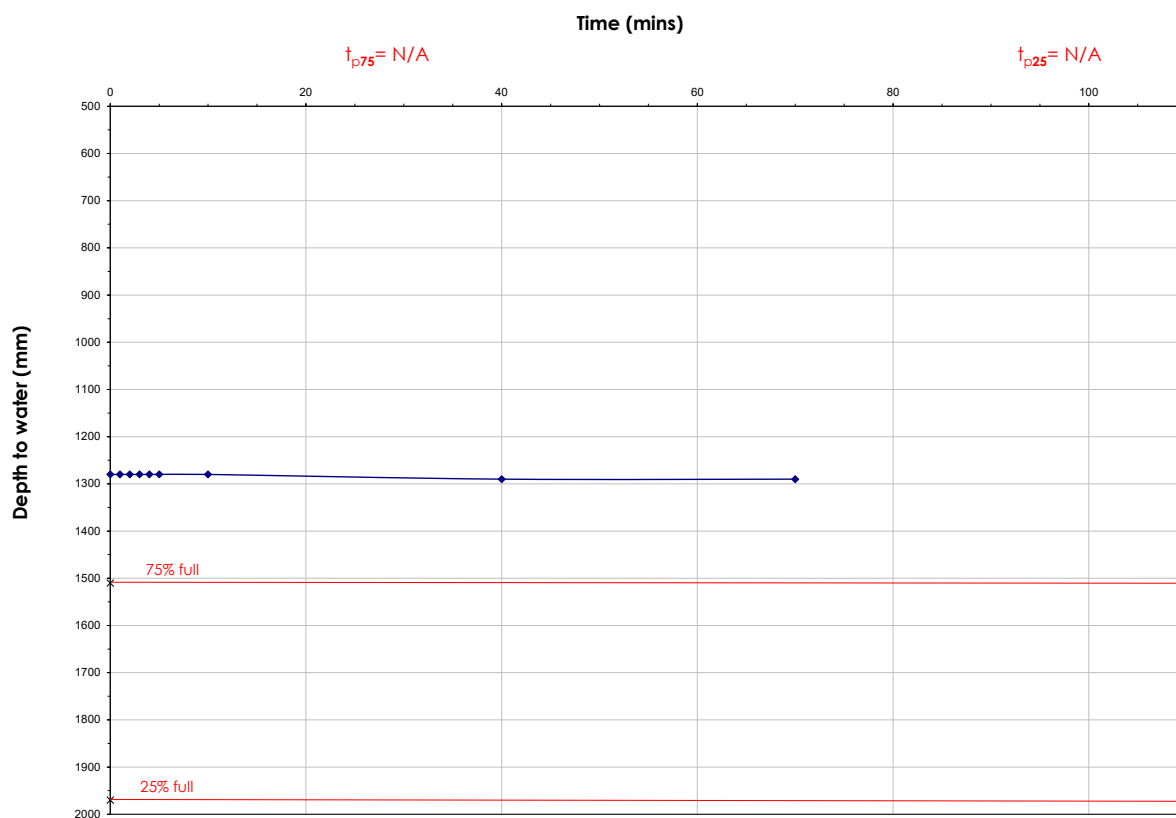
Test did not attain 25% Effective depth. Unable to calculate soil infiltration rate

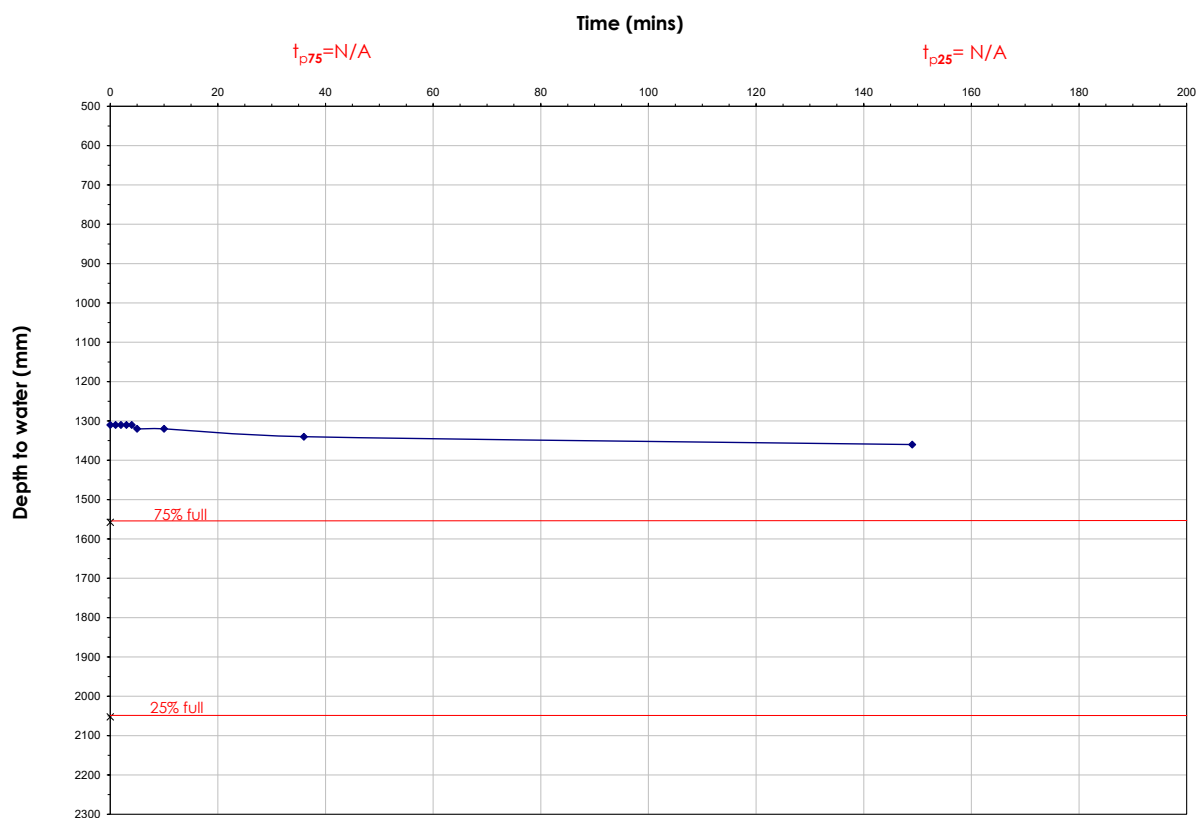
Test did not attain 25% Effective depth. Unable to calculate soil infiltration rate
