008/4511/AG/cc

### Denby Lane, Grange Moor - preliminary findings

# DENBY LANE, GRANGE MOOR - SUMMARY OF FINDINGS TO DATE

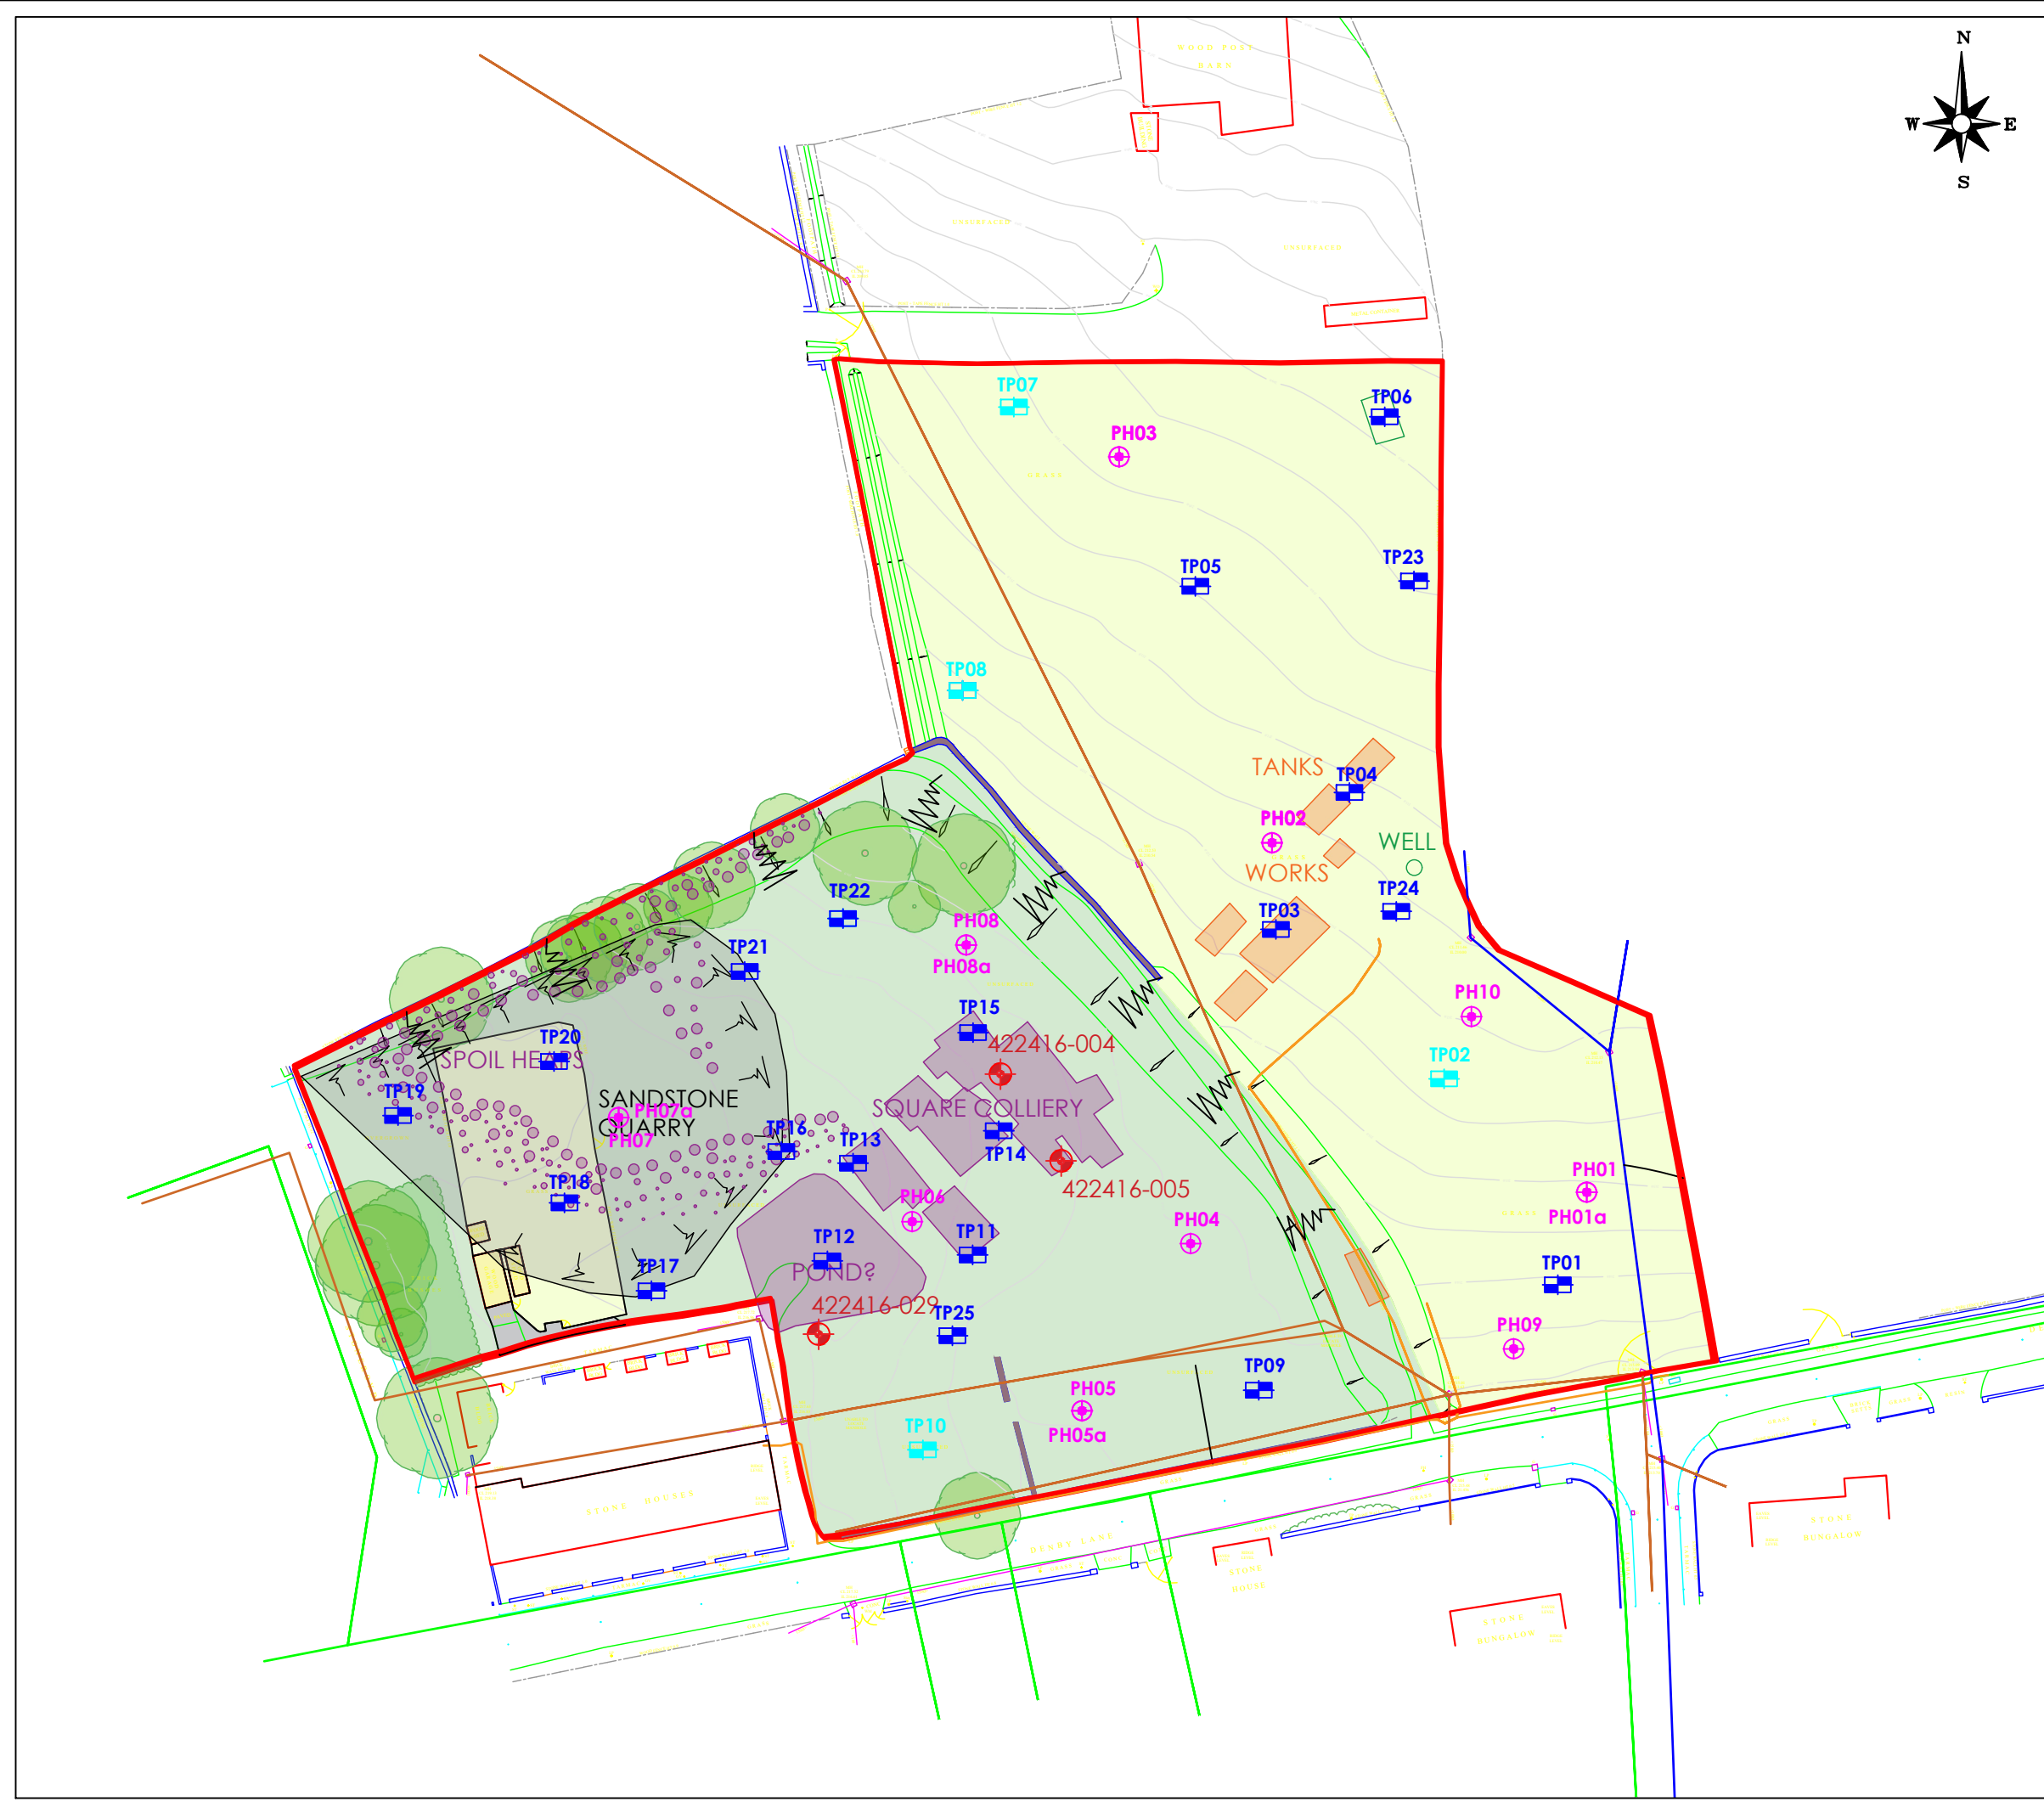
| SCALE | 1:750 | SHEET | A3 | DRAWING NO. | 4511/6 | REVISION | |

EXPLORATORY HOLE LOCATIONS HAVE BEEN SURVEYED IN (COORDINATES & GROUND LEVEL) ON COMPLETION

EXPLORATORY HOLE LOCATIONS

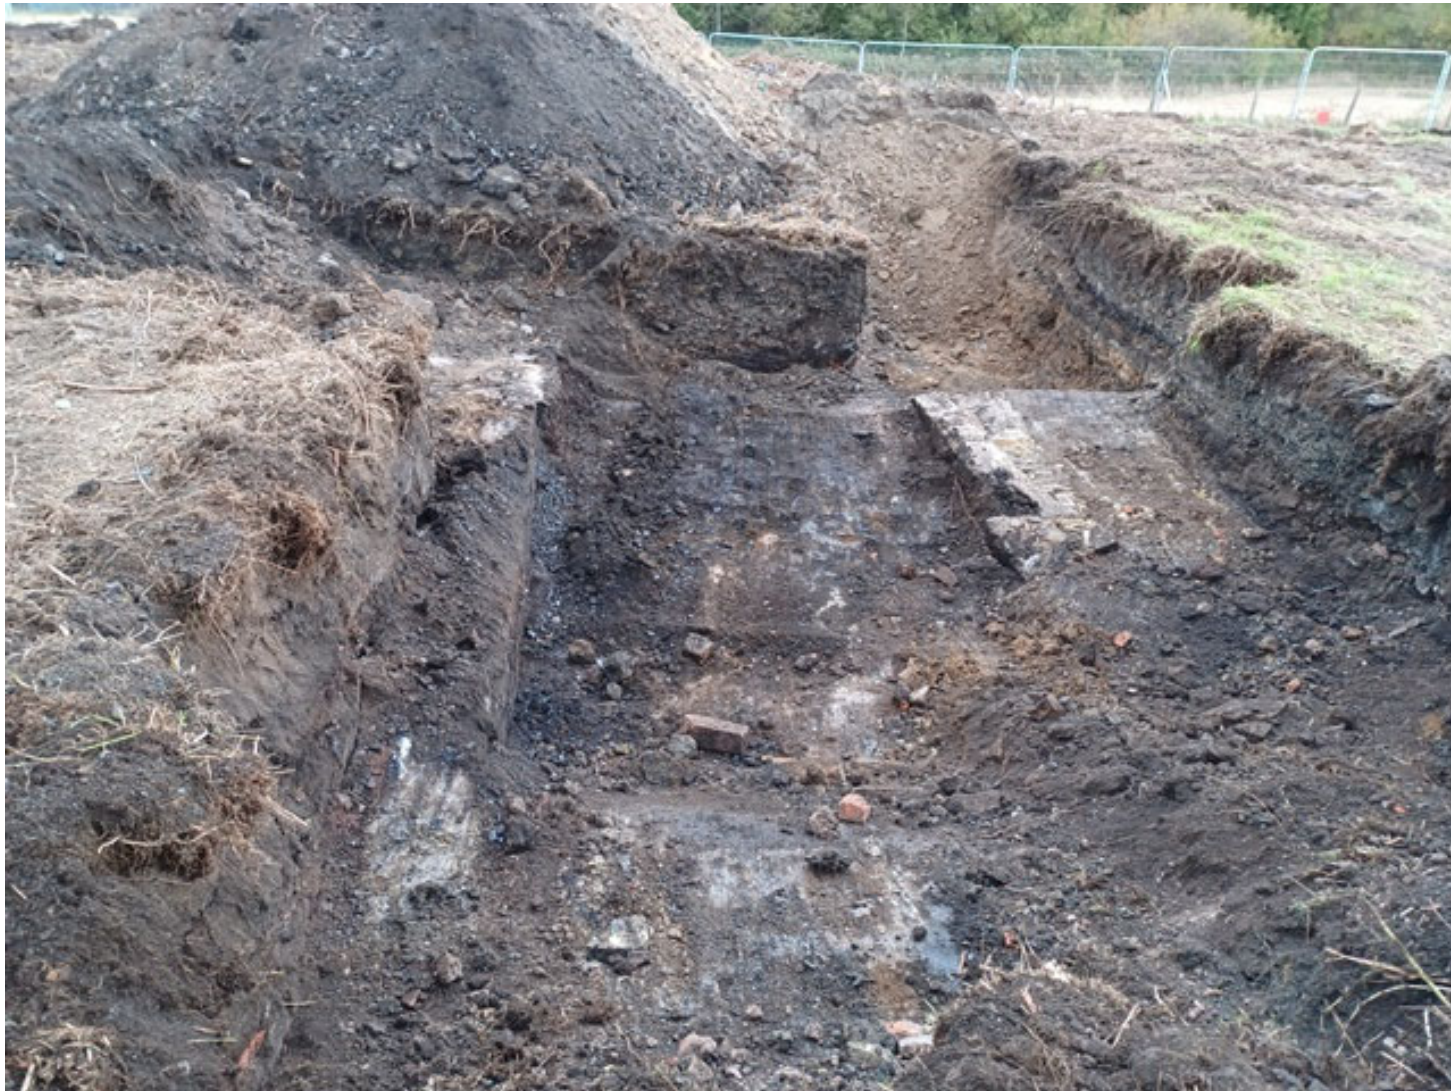
Shaft 422416-004. Located at coordinates 422335.99, 416216.01

| Hole ID | Depth to Base of | | | | | | | | | | | | Depth to Coal Measures Bedrock | Remarks |
|---|---|---|---|---|---|---|---|---|---|---|---|---|---|---|
| 422416-004 search | 1.5 | 1.5 | 0.2 | - | - | 1.5 | - | - | - | - | - | - | - | At 0.8m, square sandstone brick lined mine entry encountered. 4.0m x 2.4m in size. Backfilled with colliery spoil. |

- 3 mine entries have been located in the west of site using an excavator, shaft coordinates are included on the attached logs. Shaft 422416-029 was found to be capped with a 3.0m x 3.0m x 0.1m concrete pad. Shafts 42216-004 & 005 were uncapped, however, were backfilled with Ash & Clinker. The shaft depths should be confirmed by drilling a rotary probehole to their base.

| Issue | Remarks |
|---|---|
| Development constraints | Three recorded mine entries have been located in the western parcel of land. No development should take place over these mine entries. Foundations for plots within the vicinity of the mine entries will need to extend below a line drawn up at 45° from where the shaft cap meets rockhead. If any highways cross the mine entries, or are within the zone of influence, treatment options should be discussed with the adopting authority at an early stage. In addition, the warranty provider and the Coal Authority will need to be consulted regarding treatment proposals.<br>Whilst no evidence of workings have been encountered in the north of the eastern field, the possibility of bell pits cannot be entirely discounted. Shallow natural ground should therefore be inspected for evidence of bell pits following a topsoil strip within this area.<br>Given the difference in site levels between the eastern and western field, the site is likely to require regrading. This will require the preparation of a Materials Management Plan (MMP).<br>Shallow mineworkings have been encountered across the western field and the southern part of the eastern field. These will require remediation via drilling and grouting.<br>The underground sewer, drainage and electric utilities will require easement/diversion.<br>Due to the presence of deep made ground across the western parcel of land, the quarry highwall was only located in the far west of site (TP19). Consequently, further investigation will be required to locate the highwalls (likely rotary probing) and investigate the properties of backfilled ground (likely cable percussion drilling). |

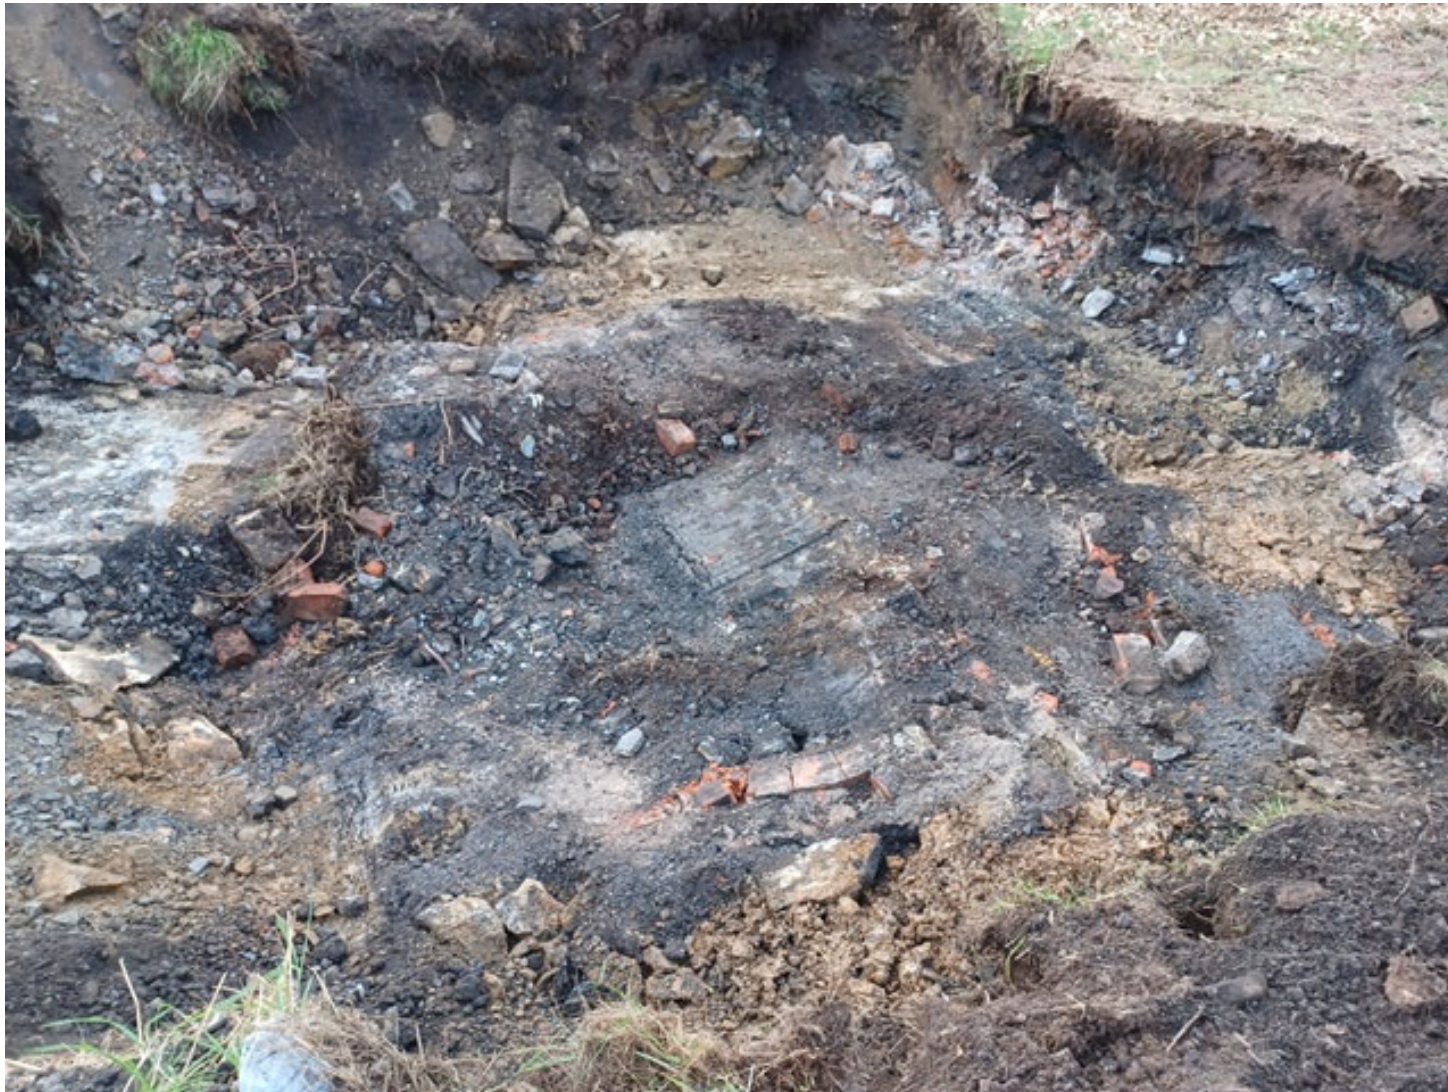
Shaft 422416-005. Located at coordinates 422342.00, 416206.01

| Hole ID | Depth to Base of | | | | | | | | | | | | Depth to Coal Measures Bedrock | Remarks |
|---|---|---|---|---|---|---|---|---|---|---|---|---|---|---|
| 422416-005 search | 1.0 | 0.8 | 0.2 | - | - | 0.8 | - | - | - | - | - | - | - | At 0.8m, double brick lined, circular mine entry encountered. C.2.6m in diameter. Backfilled with Colliery Spoil. |

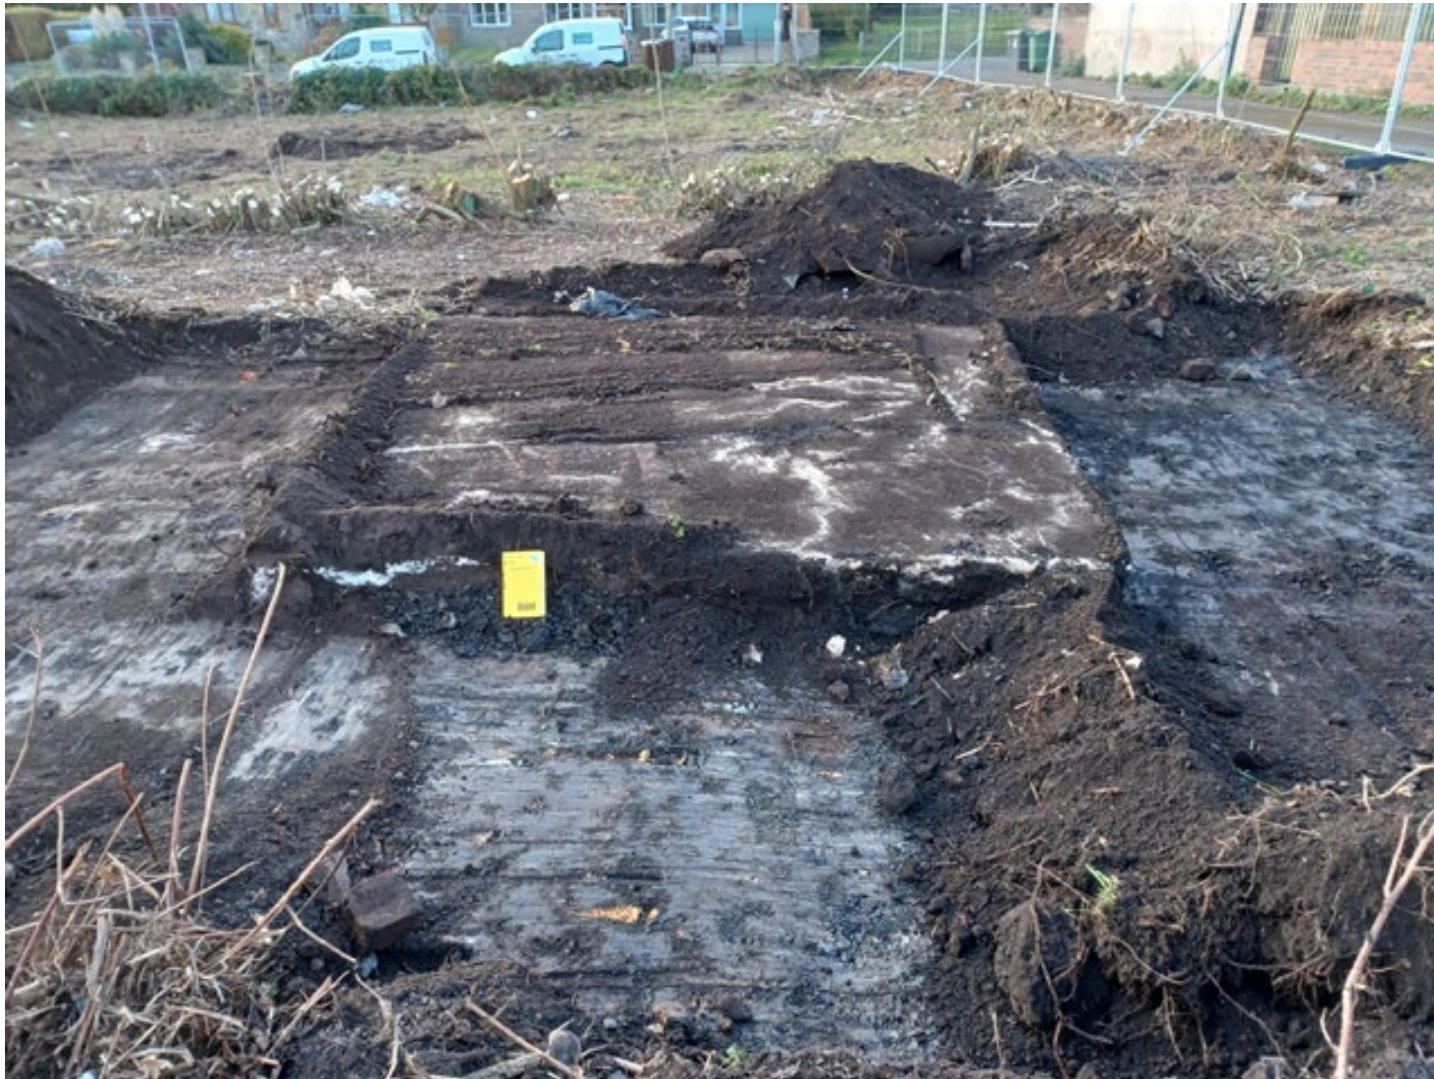
Shaft 422416-029. Located at coordinates 422315.01, 416186.03.

| Hole ID | Depth to Base of | | | | | | | | | | | | Depth to Coal Measures Bedrock | Remarks |
|---|---|---|---|---|---|---|---|---|---|---|---|---|---|---|
| 422416-029 search | 0.6 | 0.6 | - | - | - | 0.6 | - | - | - | - | - | - | - | At 0.4m, concrete square pad 3.0m x 3.0m x 0.1m encountered. Suspected shaft/well cap. |
