## **COAL MINING RISK ASSESSMENT**

### **Proposed Residential Development, Denby Lane, Grange Moor**

**KR/CMRA/G23054**

**Yorkshire Country Properties**

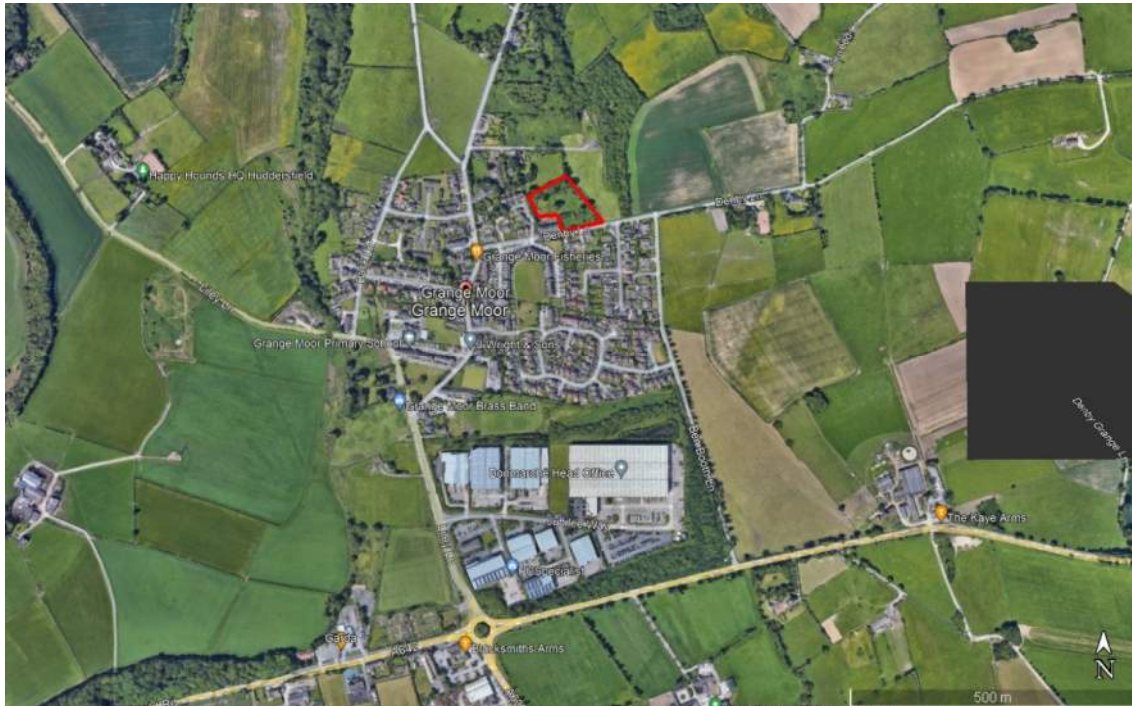
The Site Location Plan is presented Figure 1 in Appendix A to this report, however an extract is also presented below.

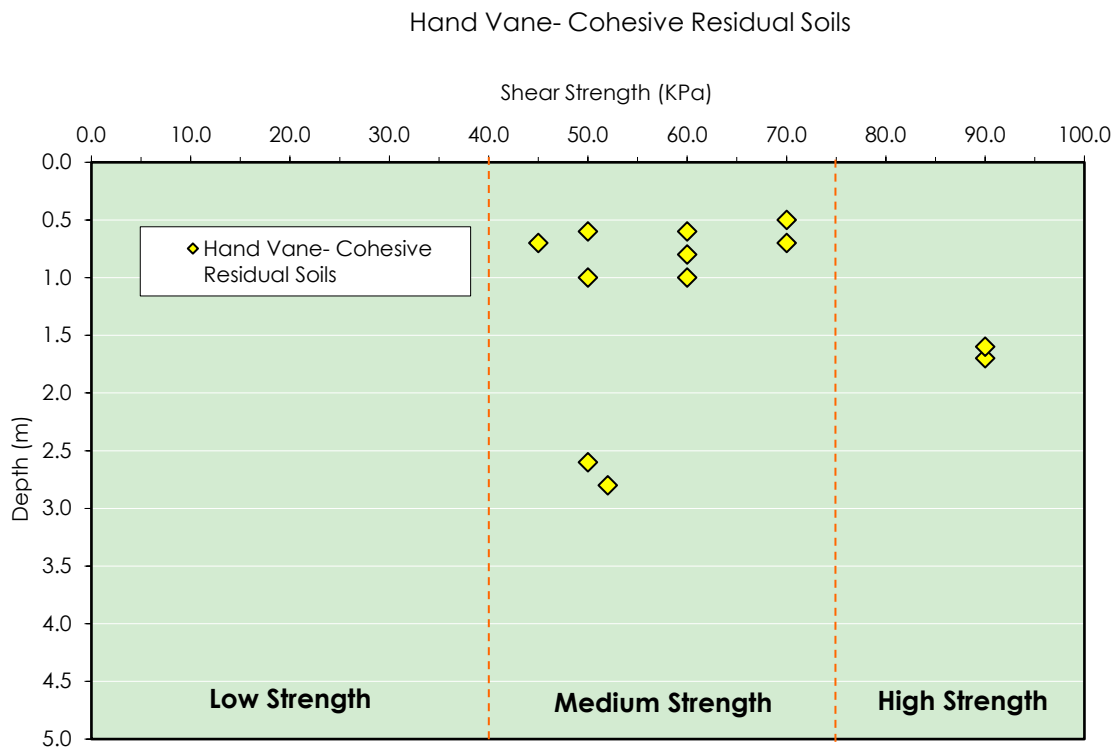
### Hand shear vane testing

- 14.6.1 Hand shear vane testing was undertaken within trial pits in-situ to around 1.0m depth and from larger blocks of excavated clay below that depth.
- 14.6.2 The results are summarised within the plot below and illustrate that the undrained shear strength ( $S_u$ ) of Cohesive Residual Soils typically range between 45 kPa (medium strength) to 90kPa (high strength).
- 14.6.3 The plot below provides a summary of undrained shear strengths.

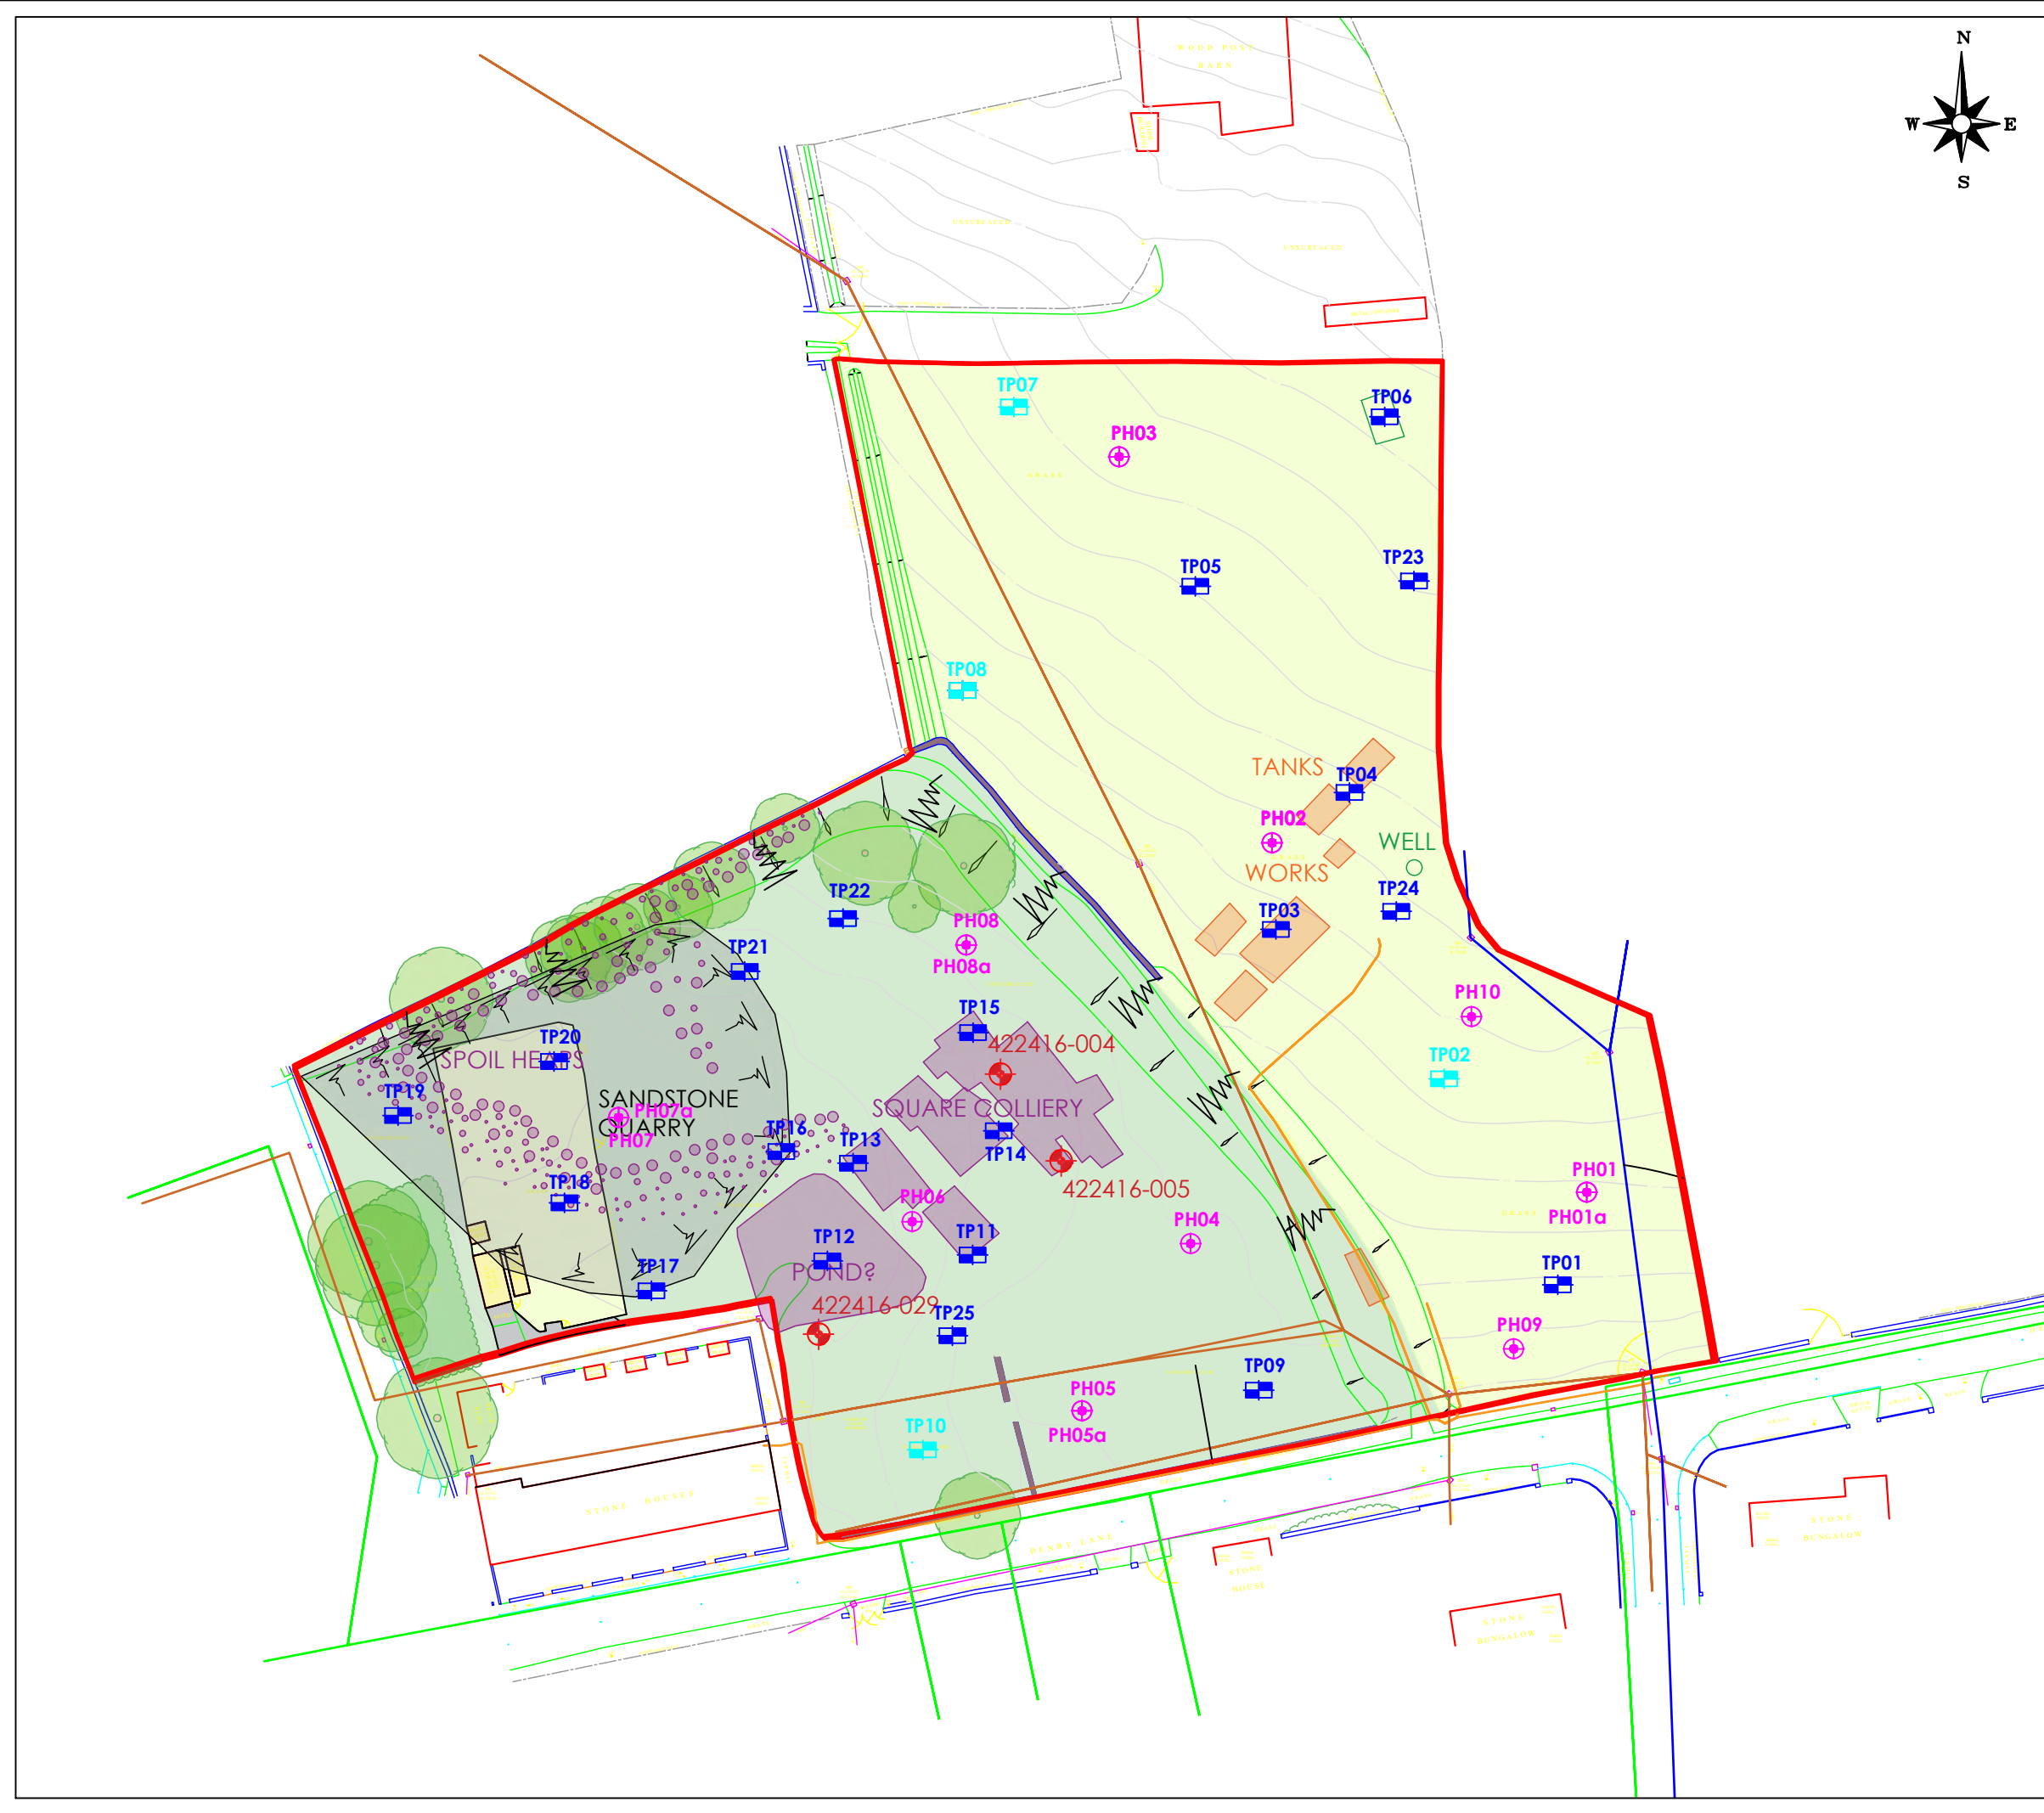
- TRIAL PIT LOCATION
- SOAKAWAY PIT LOCATION
- PROBEHOLE LOCATION
- MINE ENTRY LOCATION
- GRASS & OVERGROWN AREAS
- CROPPED FIELD
- LINE OF ELECTRICITY UTILITY
- LINE OF GAS UTILITY
- LINE OF DRAINAGE UTILITY
- LINE OF SEWER UTILITY

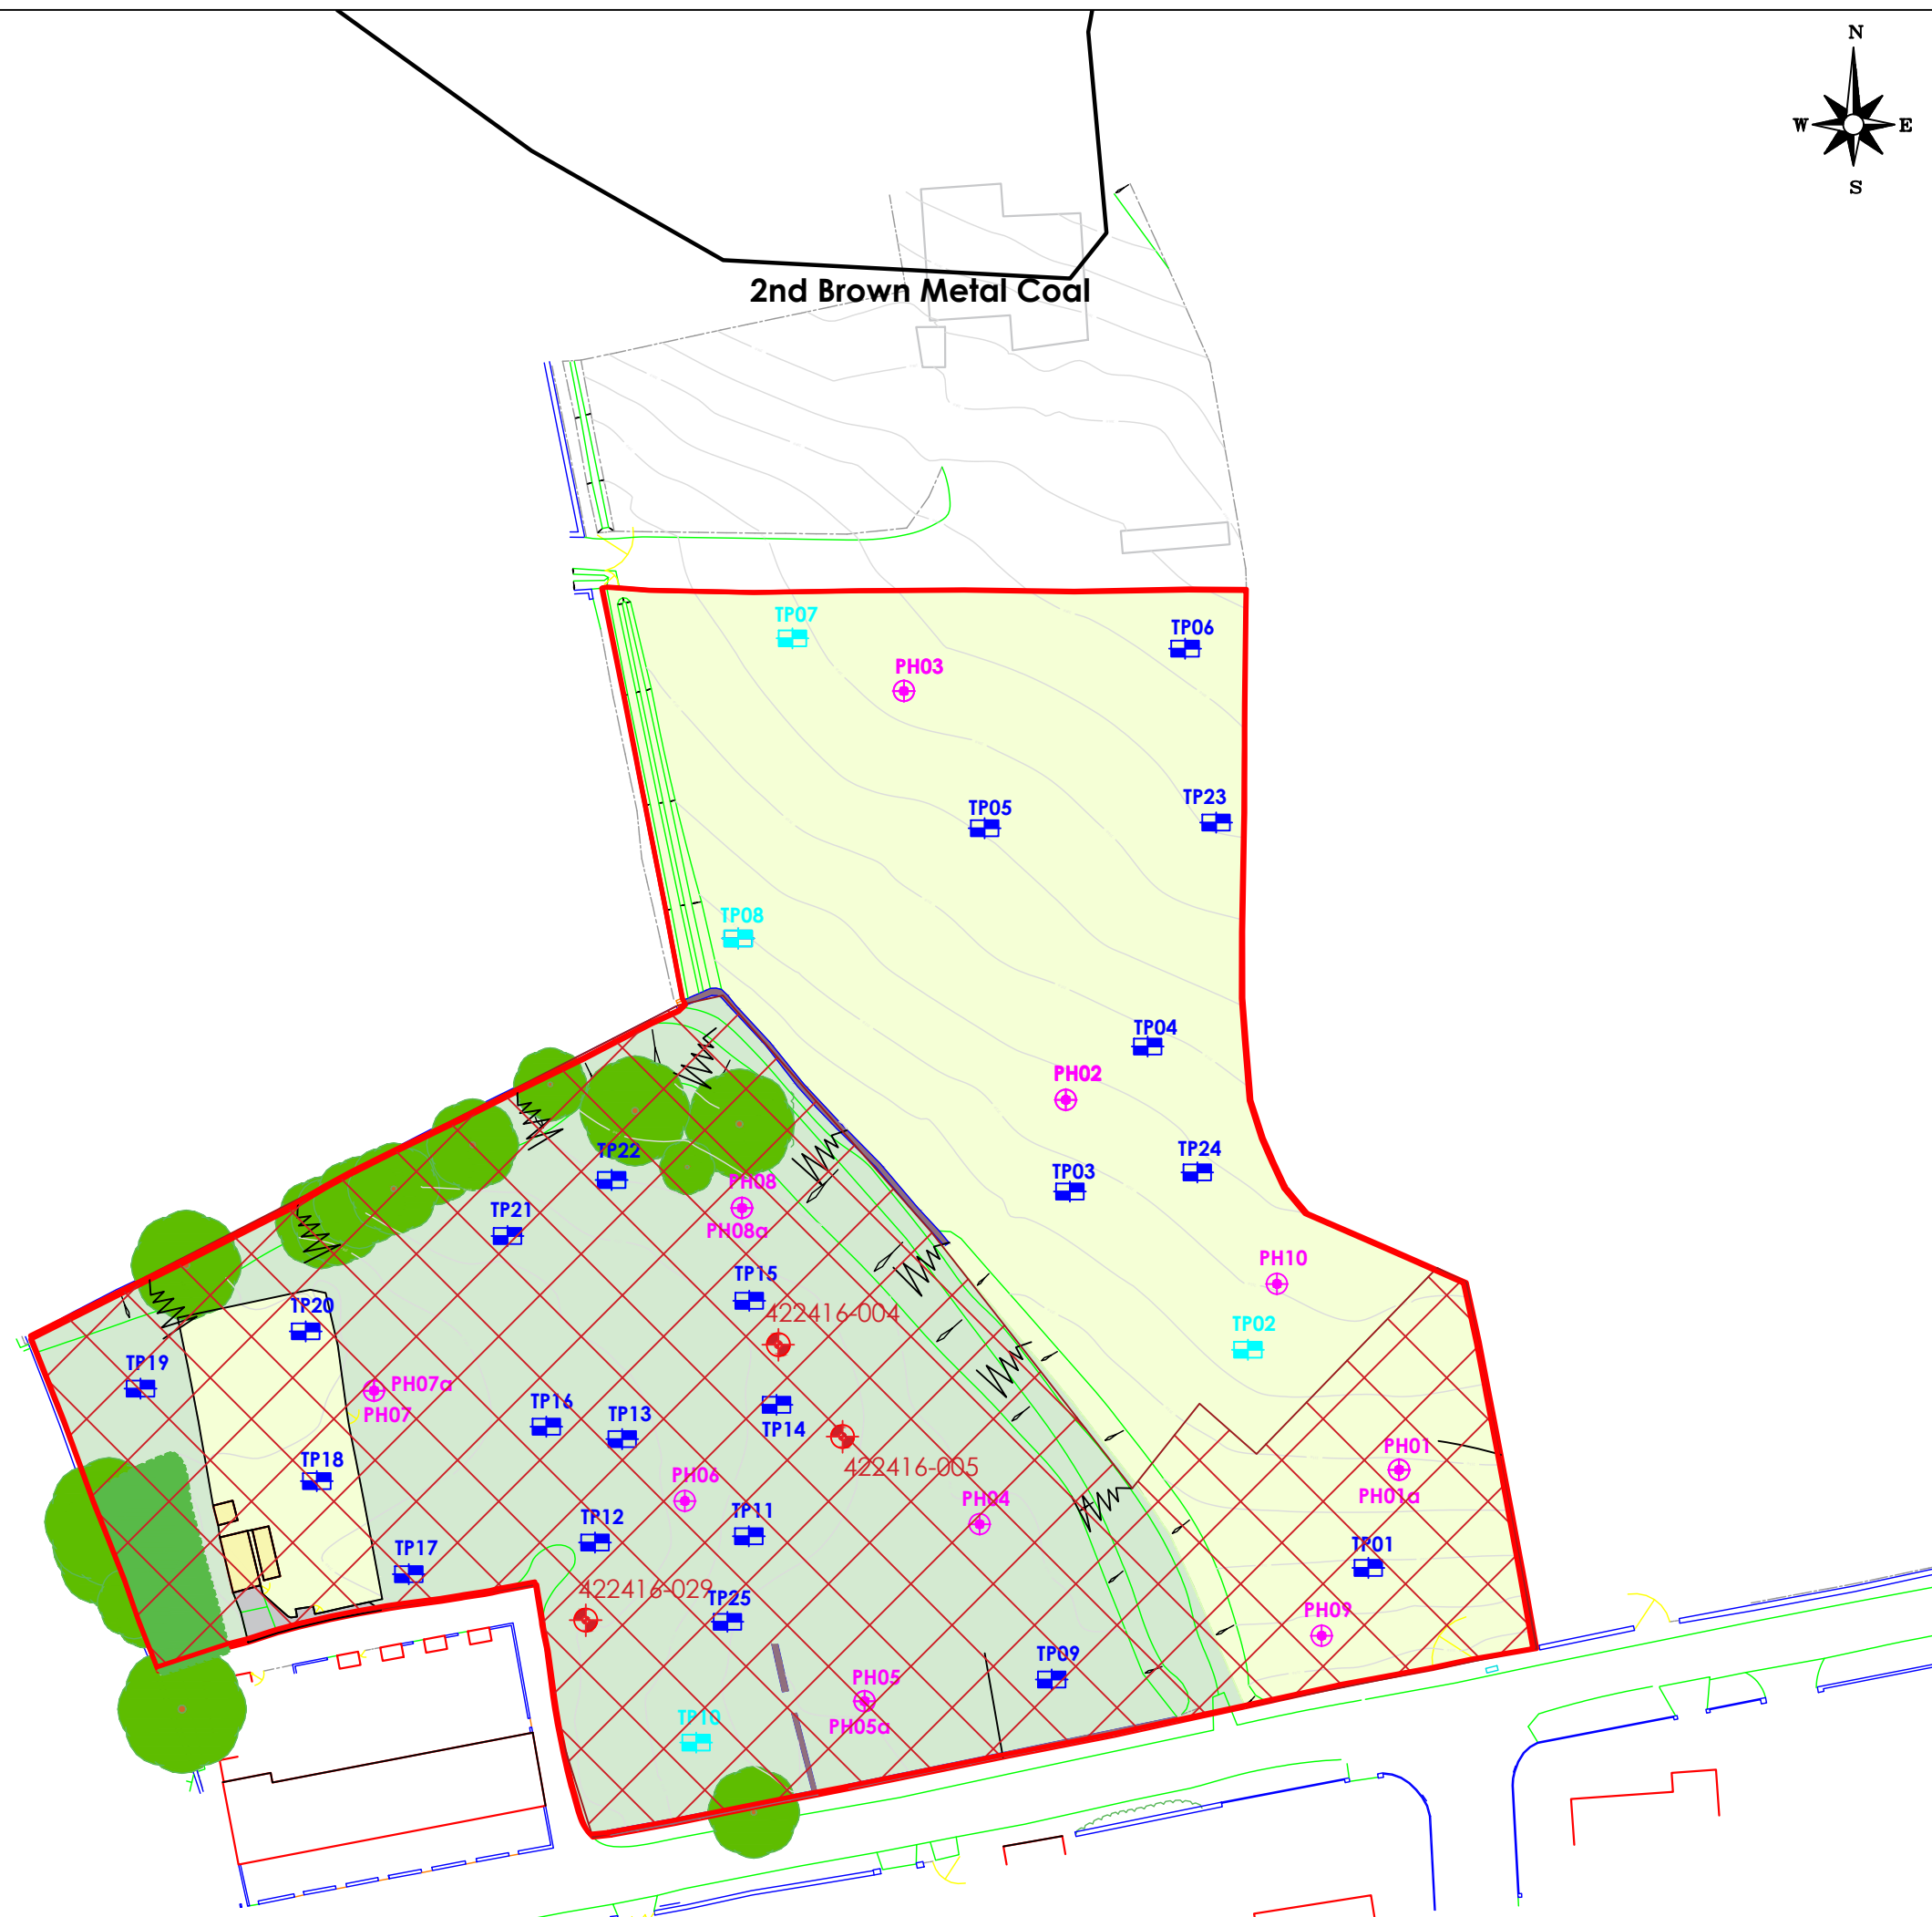
| SCALE | 1:750 | SHEET | A3 | DRAWING NO. | 4511/14 |

- NOTES
- TRIAL PIT LOCATION
  - SOAKAWAY PIT LOCATION
  - PROBEHOLE LOCATION
  - MINE ENTRY LOCATION
  - GRASS & OVERGROWN AREAS
  - CROPPED FIELD
  - AREA OF SHALLOW MINEWORKINGS
  - APPROXIMATE LOCATION OF COAL OUTCROP
  - APPROXIMATE SITE BOUNDARY
- EXPLORATORY HOLE LOCATIONS HAVE BEEN SURVEYED IN (COORDINATES & GROUND LEVEL) ON COMPLETION

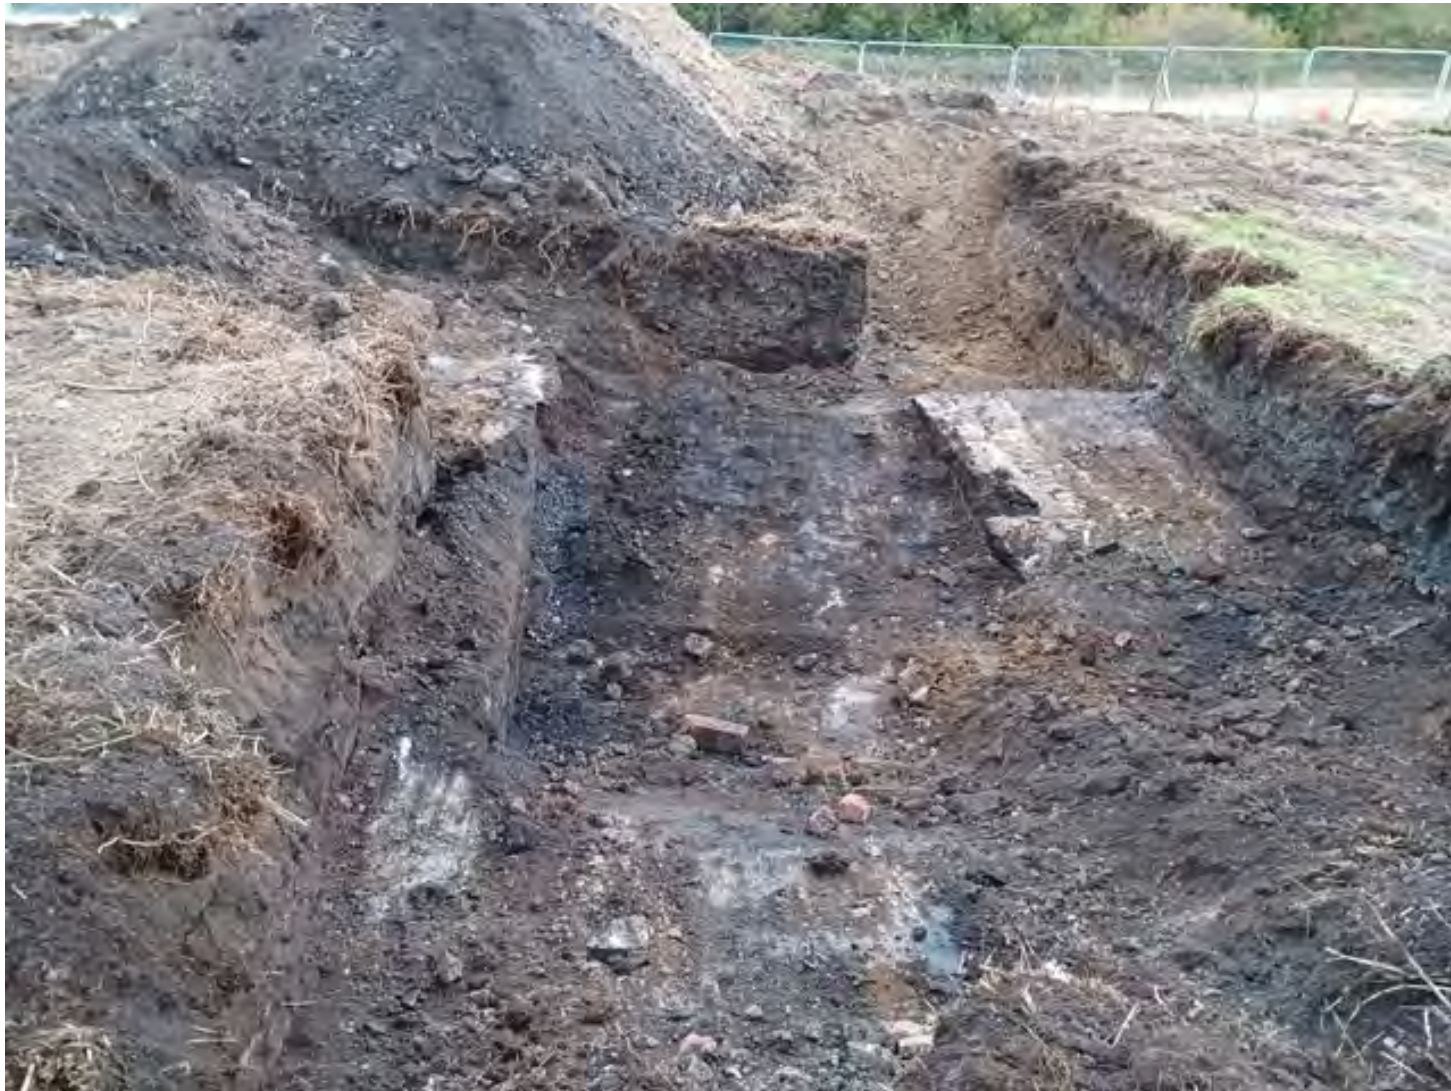
Shaft 422416-004. Located at coordinates 422335.99, 416216.01

| Entry type | Reference | Grid reference | Treatment description | Mineral | Conveyancing details |
|---|---|---|---|---|---|
| Shaft | 422416-004 | 422336 416216 | located by Lithos Consulting in 2022 and found to be a square sandstone brick lined mine entry 4.0m x 2.4m in size, backfilled with colliery spoil | Coal | |

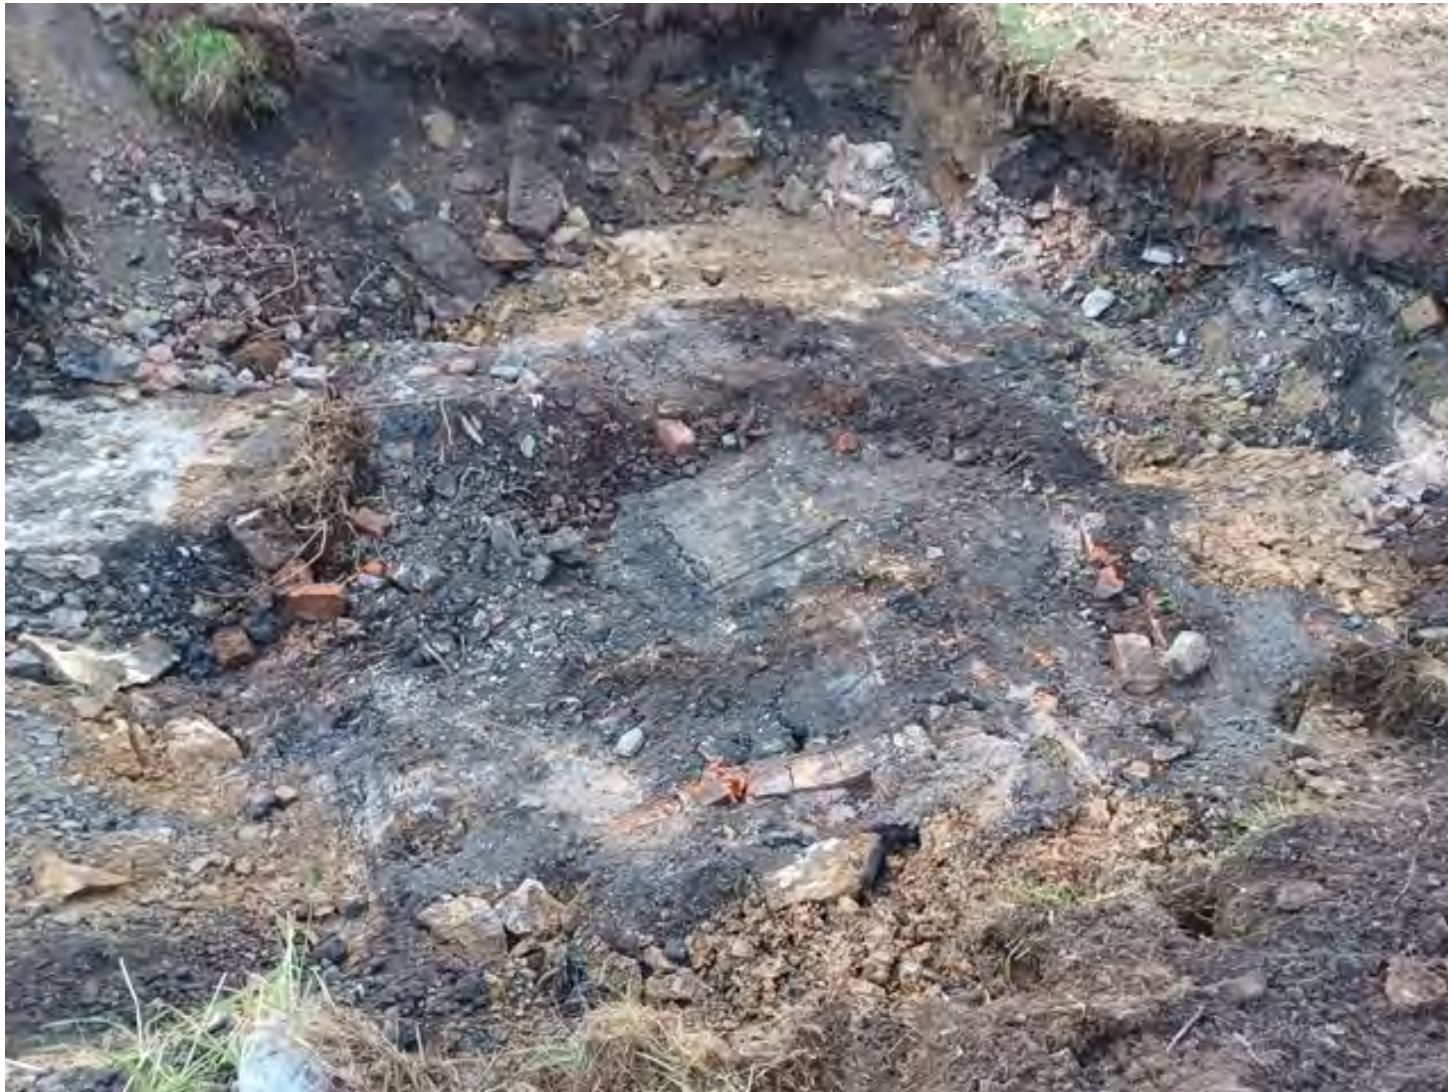
Shaft 422416-005. Located at coordinates 422342.00, 416206.01

| Entry type | Reference | Grid reference | Treatment description | Mineral | Conveyancing details |
|---|---|---|---|---|---|
| Shaft | 422416-005 | 422342 416206 | located by Lithos Consulting in 2022 and found to be a double brick lined circular mine entry, c.2.6m in diameter, backfilled with colliery spoil | Coal | |

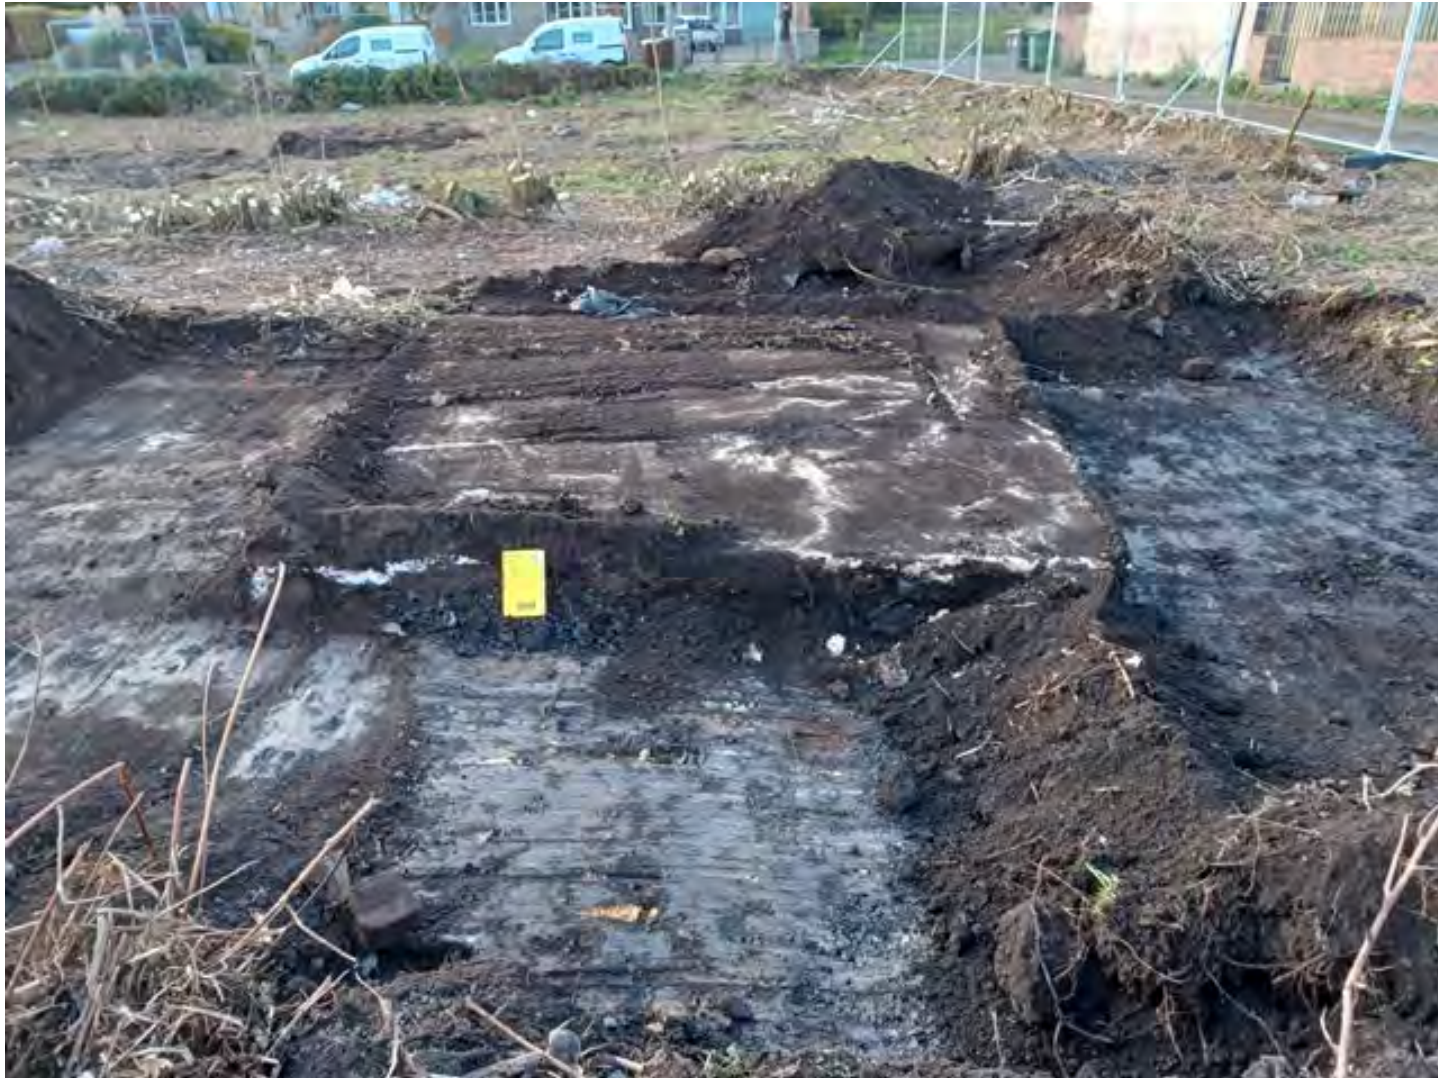
Shaft 422416-029. Located at coordinates 422315.01, 416186.03.

| Entry type | Reference | Grid reference | Treatment description | Mineral | Conveyancing details |
|---|---|---|---|---|---|
| Shaft | 422416-029 | 422315 416186 | has been capped to an unknown specification. There is some uncertainty as to whether this feature is in fact a well. Located by Lithos Consulting in 2022 and a concrete square pad 3m x 3m c 0.1m was observed. Suspected shaft/well cap | Coal | |

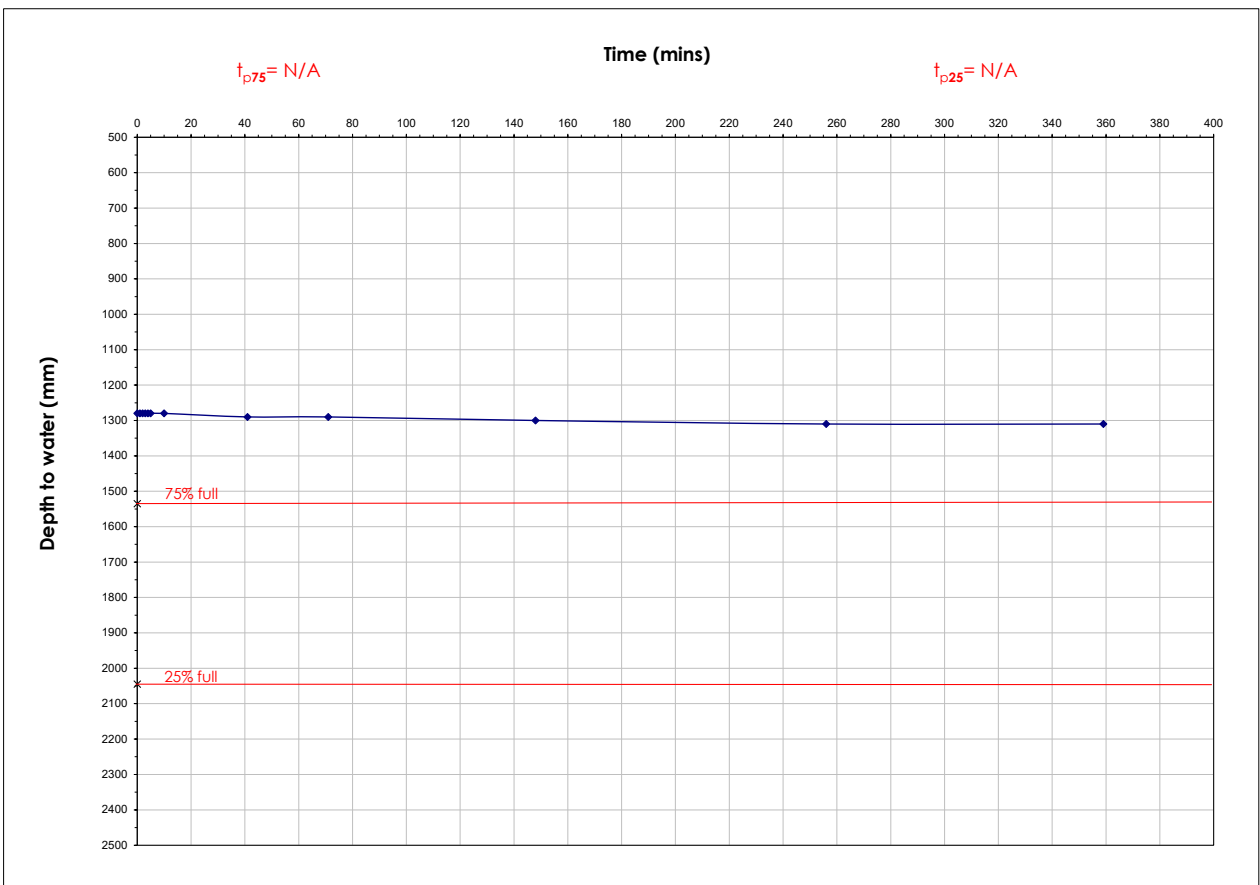
Test did not attain 25% Effective depth. Unable to calculate soil infiltration rate

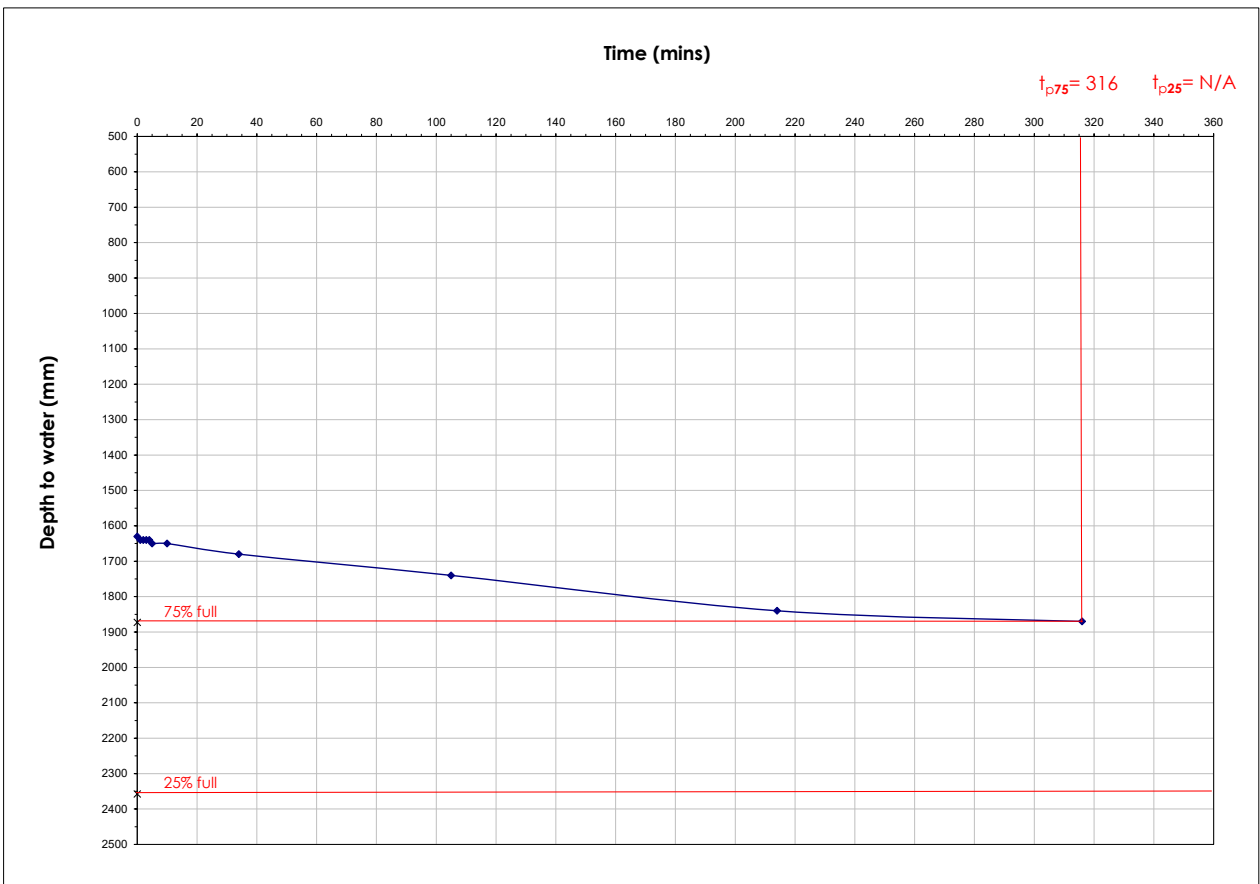
Test did not attain 25% Effective depth. Unable to calculate soil infiltration rate

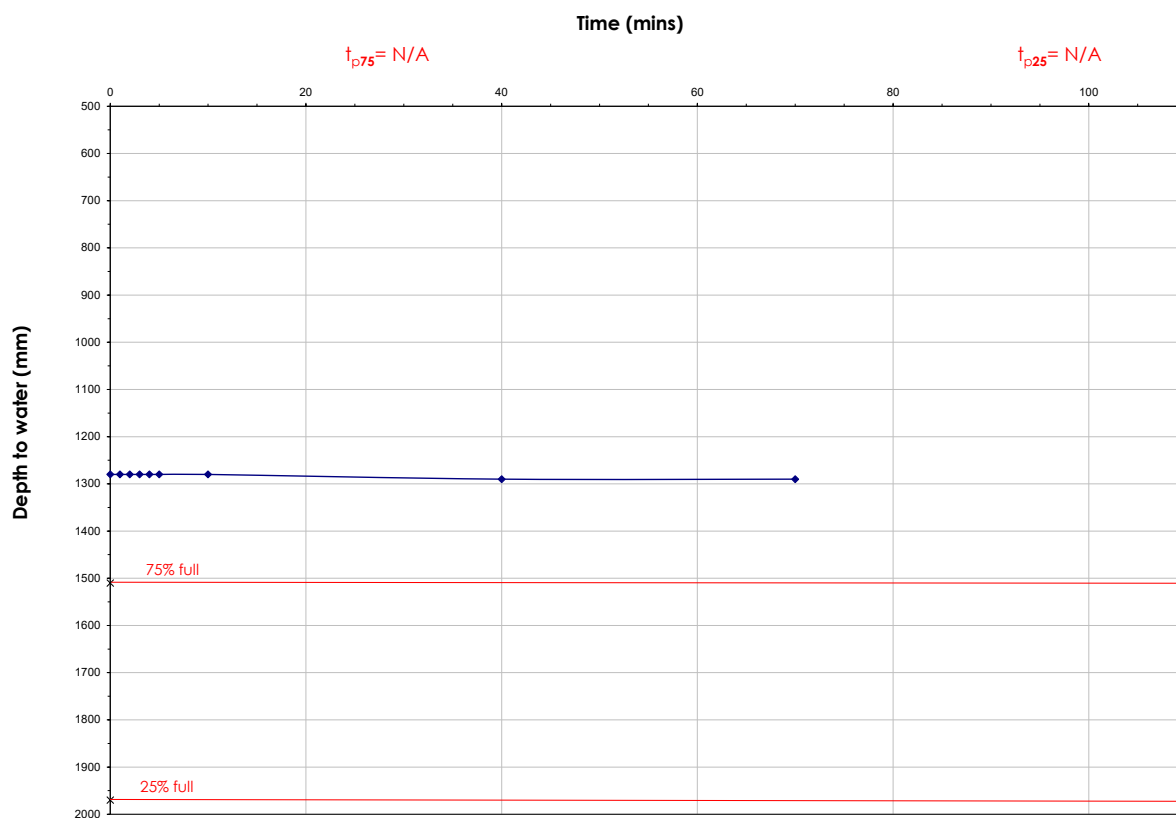
**Test did not attain 25% Effective depth. Unable to calculate soil infiltration rate**

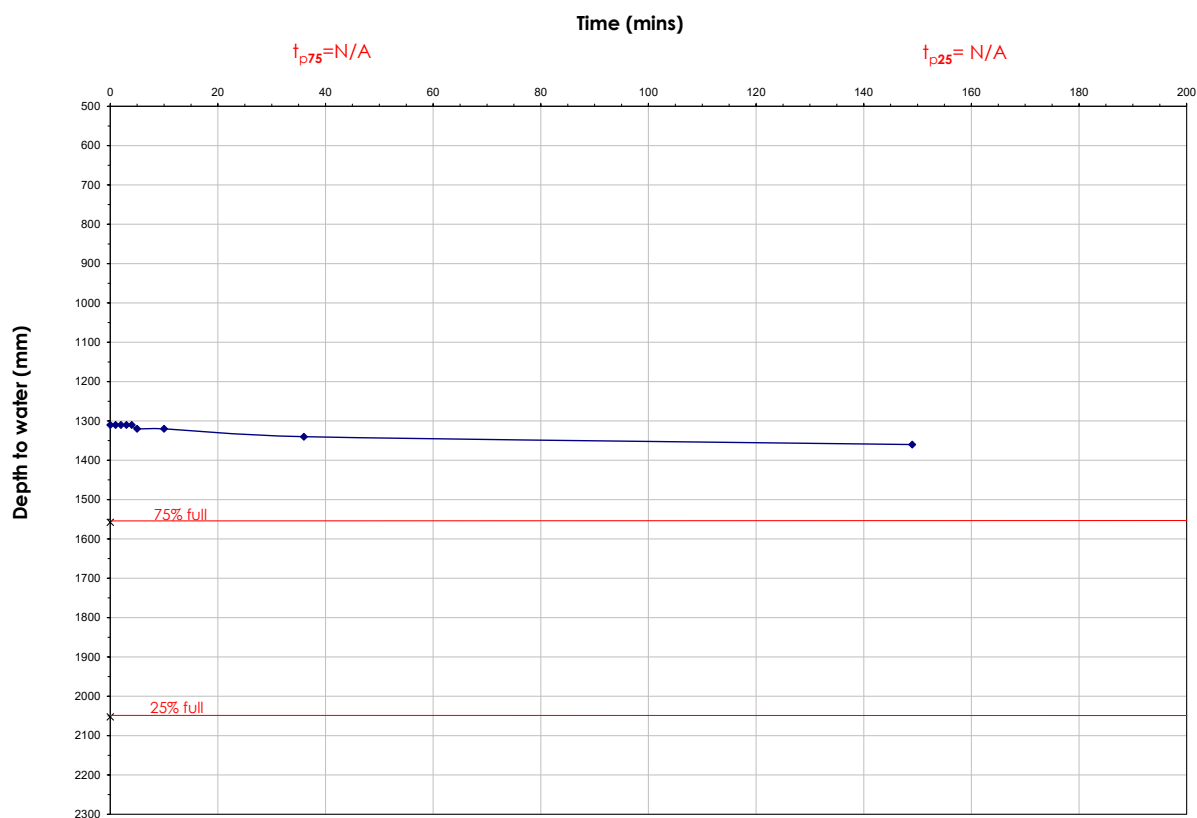
Test did not attain 25% Effective depth. Unable to calculate soil infiltration rate
