Bat Scoping Survey to

Waverley Church

Waverley Road

25th May 2024

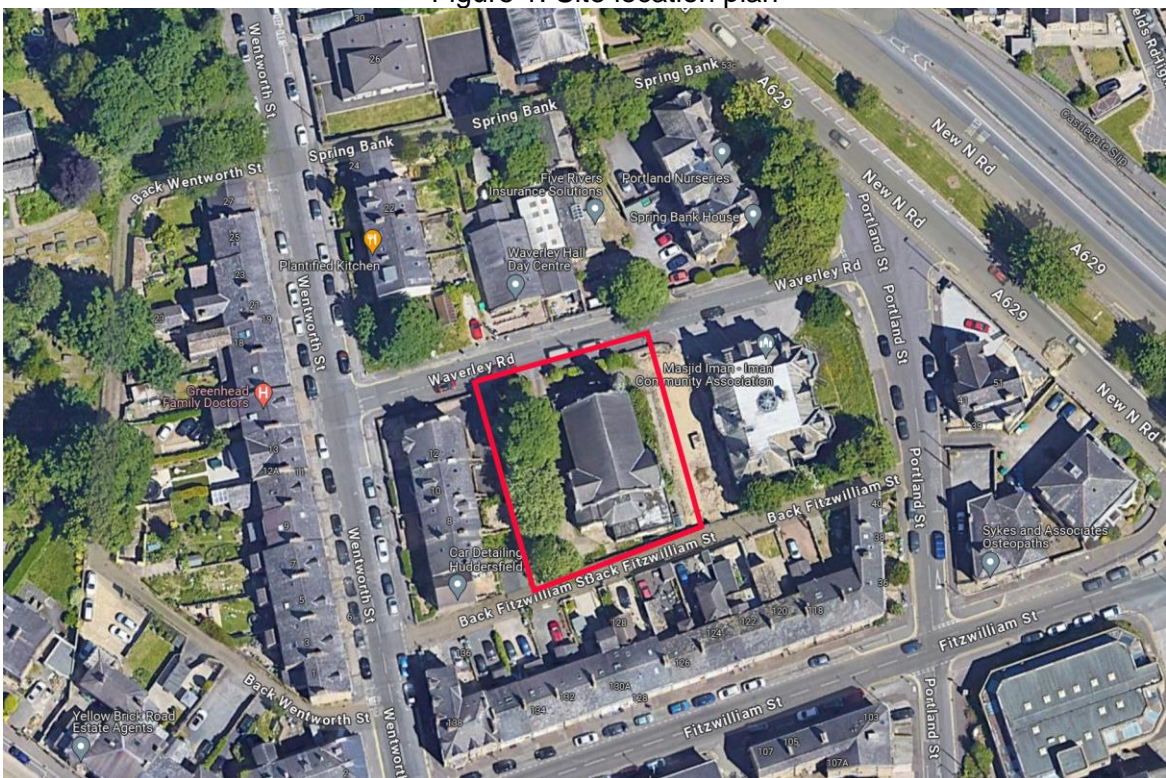
Figure 2 Aerial view of the site, surrounds and specific buildings surveyed.

5.1 The site consists of a large stone, former church and is double height but single storey with large blue slates to the roof. The site is located in an urban area with moderate foraging areas close by and the site is connected to the wider landscape by a series of linear features. There are residential dwellings close by all of which provide greater roosting opportunities..

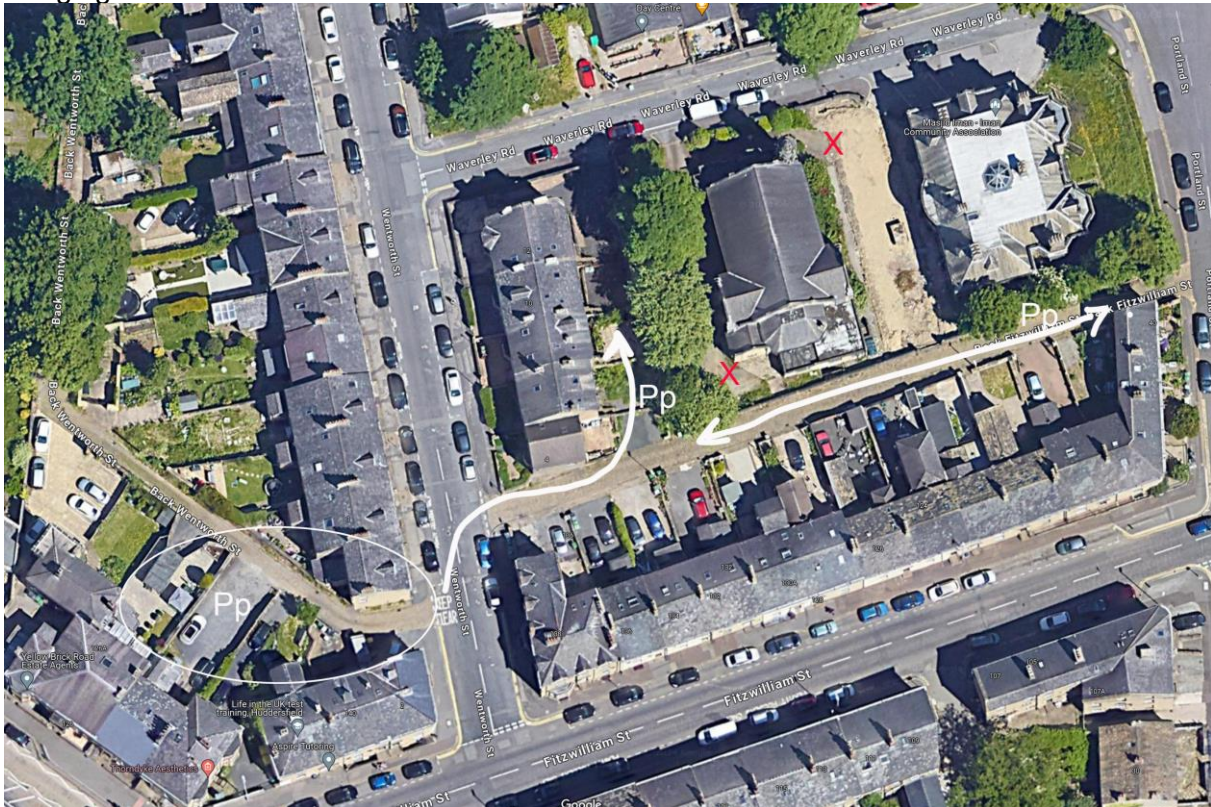
Figure 3. Flight pattern and main areas of bat activity

The first survey was undertaken on Wednesday 8th May 2024 and commenced 30 minutes prior to sunset until 90mins after sunset (recorded at 21:07). The weather was excellent with high cloud, a gentle breeze and a temperature of 17.5°C. Two surveyors were positioned at opposite corners of the building to cover the majority of the building clearly and having line of sight to the features identified as being of potential to roosting bats. The first bat was recorded at 21:25 and was detected flying into the site from the SW corner. Given the time the bat was on the wing, this bat had emerged from a very local roost. A second bat was detected foraging along the sycamore trees on the west boundary of the site and other bats were recorded foraging to the SW of the site. In all cases, the bats recorded were common pipistrelle. No bats were recorded emerging from the survey building and bat activity ceased around 45 minutes after sunset with only sporadic passes thereafter.

The second emergence survey was carried out on 19th May 2024 and again during warm conditions that had persisted since the previous survey. The emergence was quite consistent with the previous survey with the first bat on the wing at 21:30 and was recorded flying up and down along Back Fitzwilliam Street. At 21:35 a single common pipistrelle was clearly observed entering the SW of the site and hunted along the sycamores and around the west side of the site before leaving to the NW. Good numbers of common pipistrelle were observed against the sky to the west of Back Fitzwilliam Street along Back Wentworth Street. As before, no bats were seen to emerge from the survey site. Bat numbers around the site were much the same as

previously with singletons passing through the site and feeding briefly before moving on to other foraging sites.
