# Haich's Building, Firth Street, Huddersfield

## Bat Roost Suitability Assessment

Shound Properties Ltd

ER-7104-01

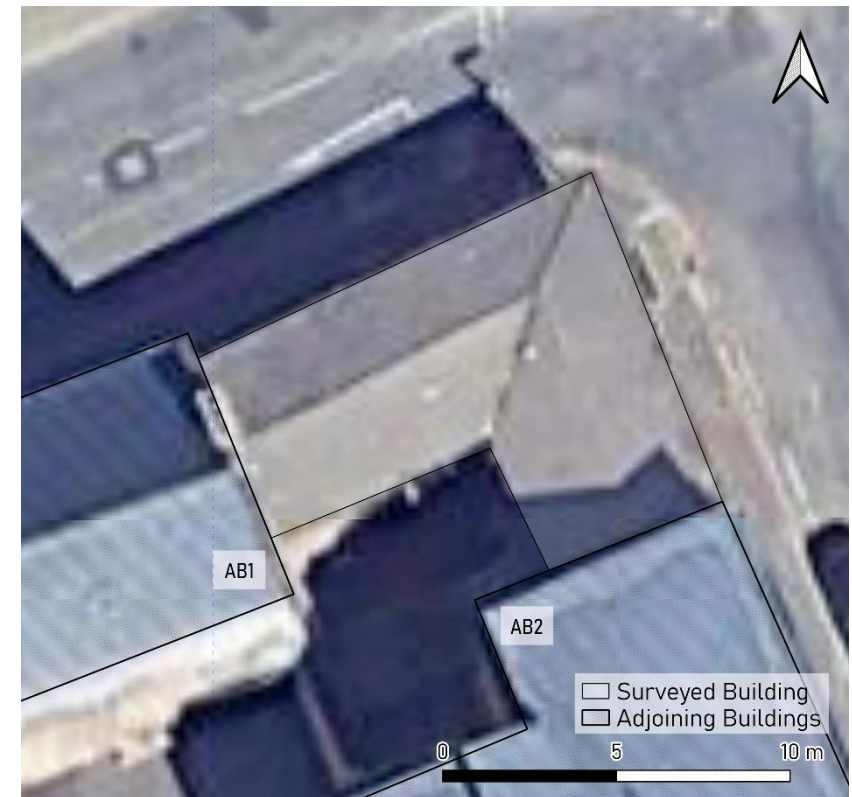
14. The Site comprises a two storey mortared sandstone brick building, with a mixture of wooden and uPVC window and door frames, dentilated eaves and a slate tiled hipped roof. A passageway connects Firth St. to the courtyard to the south of the building.
15. The surveyed building is bound to the west and south by adjacent buildings of a similar construction, both being an additional storey in height. As the proposed extension would join to these buildings, the affected elevations of these have also been considered.

**Figure 3** Surveyed and adjoining buildings

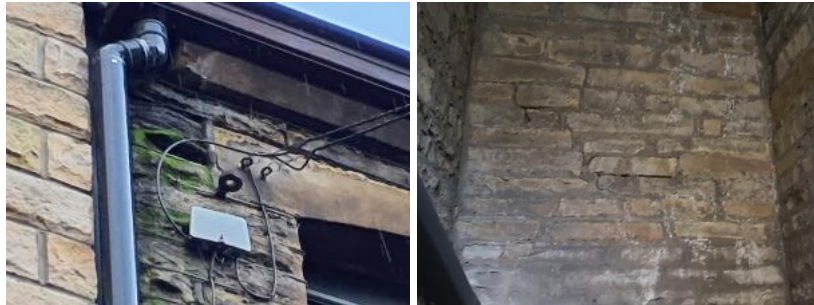
16. The exterior walls of the main building are in generally good condition and mostly well-sealed, with the exception of holes in brickwork on the western and southern elevations, and some damage to the mortar within the passageway.

**Figure 4** Showing hole on western elevation (l) and damaged passageway brickwork (r)

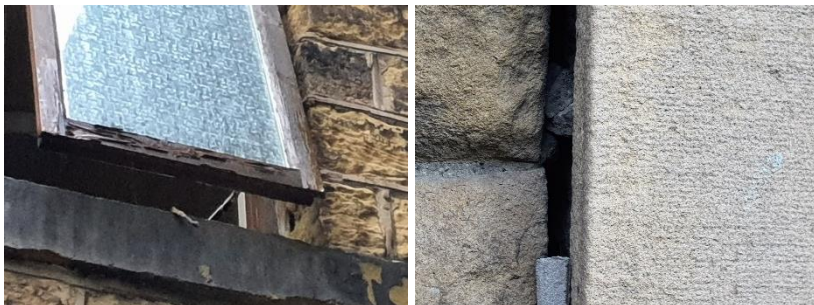
17. The windows are mostly uPVC framed, with some in wooden frames on the southern and western elevations. These are well sealed with the exception of a single hole in a first floor window frame on the southern elevation. The sills and lintels, constructed of sandstone all appear well sealed with no gaps present.

18. The doors, wooden framed to the northern and eastern elevations, and uPVC framed to the southern and western, were well sealed to the frames but with some weathering present to the sandstone surrounds and mortar.

**Figure 5** Showing hole to window frame (l) and door surrounding mortar (r)

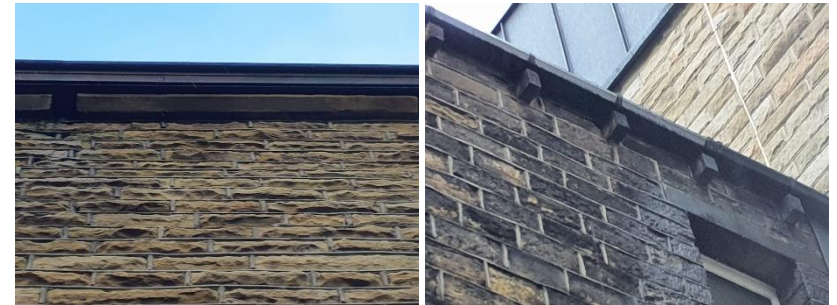
19. The eaves feature stone cornices to the front, and dentils to the courtyard, with wooden gutter casing. Some weathering to the casing is evident on the outer corner, but no roosting features were seen. Gaps are present between the cornice stones, however these appear to be from design and not weathering, and therefore are likely not to lead to any substantial space. Gaps to the eaves are present on the courtyard facing walls.

**Figure 6** Showing gaps to cornice (l) and location of gap at eaves (r)

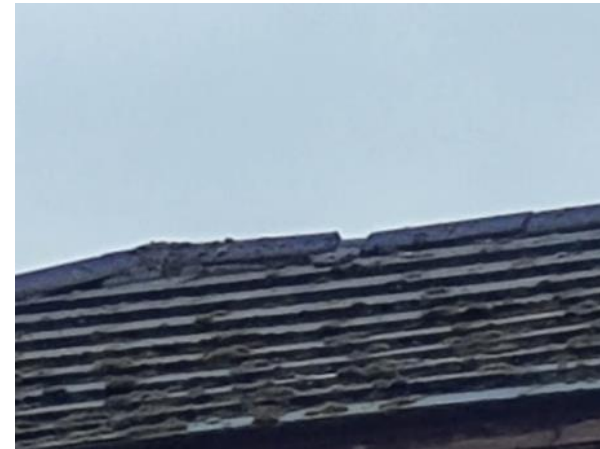
20. The roof appears in generally good condition, with the exception of some damage to ridge tiles and mortar.

**Figure 7** Showing gap to roof ridge

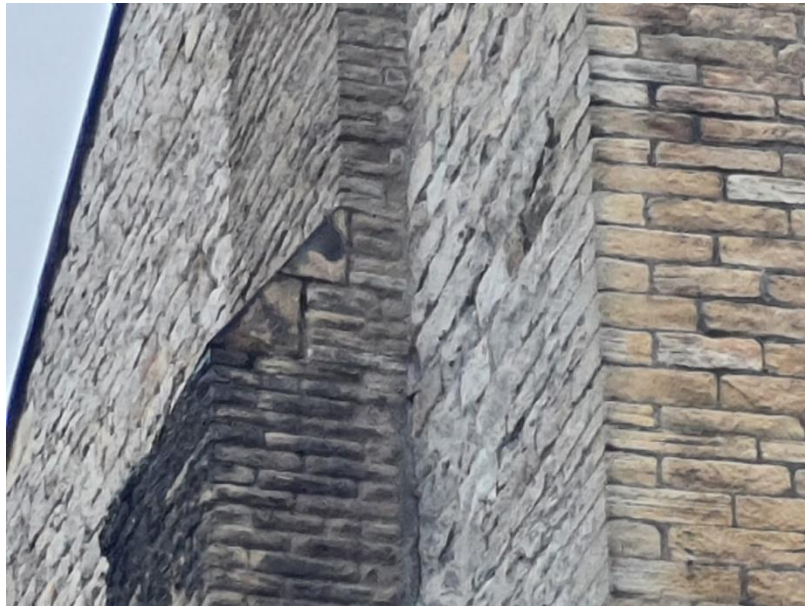
- 21. Adjoining building 1 (AB1) to the west has a similar mortared sandstone construction, and a slate tiled, gabled roof. A chimney stack is also present and protrudes from the eastern elevation of this building.
- 22. Some weathering is evident to the brick mortar of the wall and chimney of AB1's western elevation, providing possible access to a potential roost site.

**Figure 8** Showing weathering to mortar on AB1

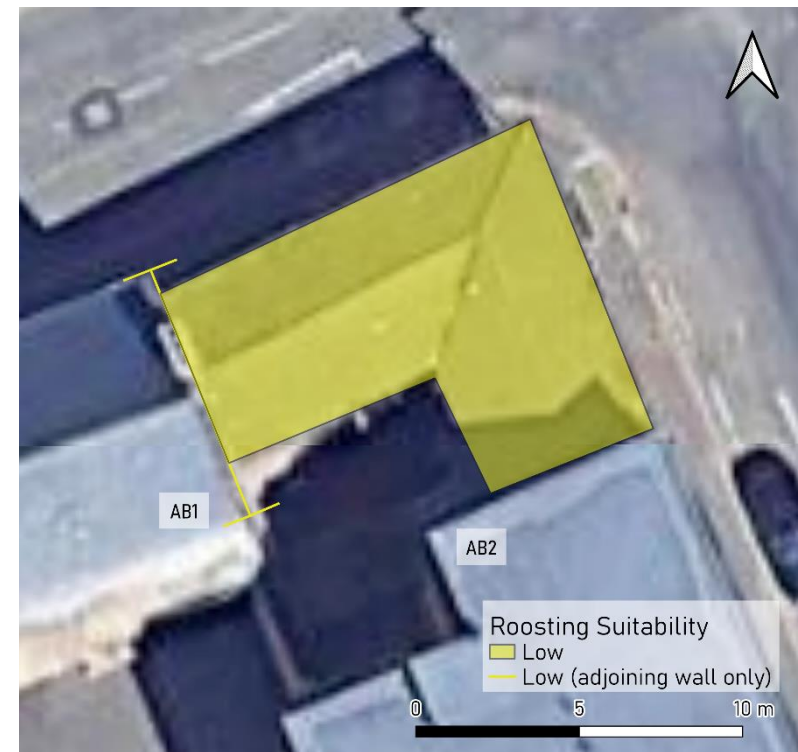
- 24. Based on the features present and the urban surroundings, the surveyed building has been assessed as having low suitability for supporting roosts.

**Figure 9** Showing bat roost suitability of on-site buildings.

25. In line with best practice guidelines (Bat Conservation Trust, 2023), further survey should be carried out to establish if potential roost features are being used by bats. This should take the form of a single dusk emergence survey, undertaken during the peak bat survey season, which runs from May to August inclusive, with September offering suboptimal conditions.
