THE GEORGE HOTEL

HERITAGE STATEMENT
DECEMBER 2022

Bowman Riley have been appointed by Kirklees Council to work with Queensbury Properties in order to develop the proposals for the re-development of the Grade II* listed George Hotel in Huddersfield.

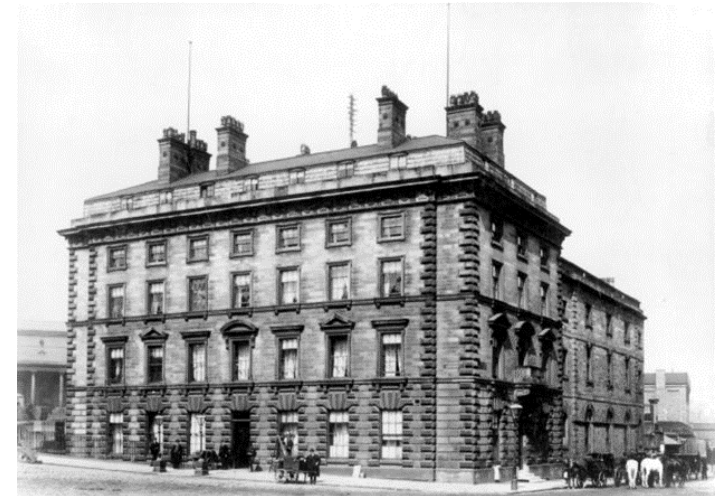
Photograph of The George Hotel in 1912 showing the former entrance from John William Street

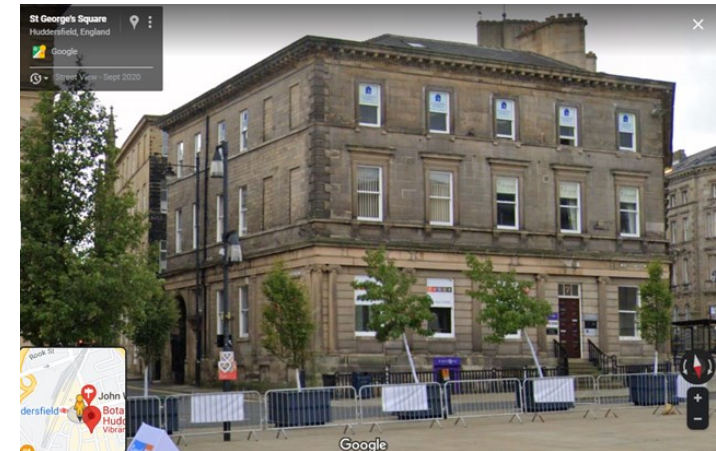
7 St George's Square / 19 Railway Street

This building is Grade II* listed. And also faces into St Georges Square There is a hierarchy to the elevations, with the most decorative facing Railway Street, then a simpler version facing the George Hotel, and the simplest facing Station Street. There is also a reducing hierarchy to its three floors. The building features include entablature, moulded sill bands, ionic columns and quoins.

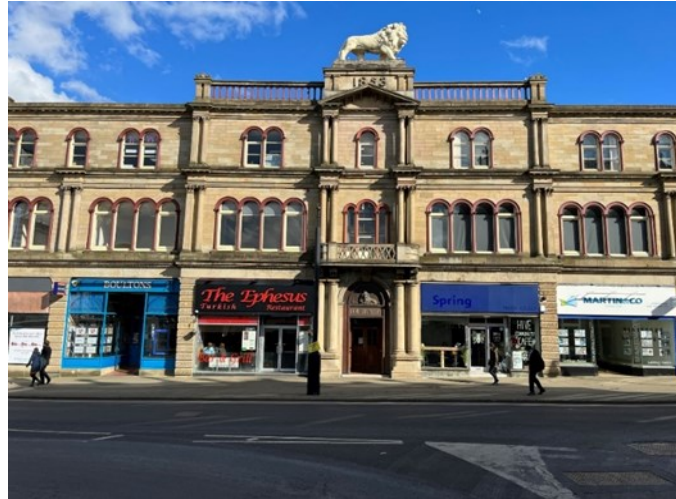
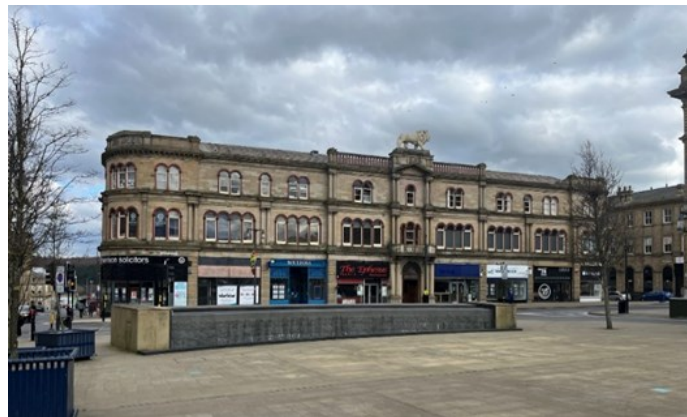
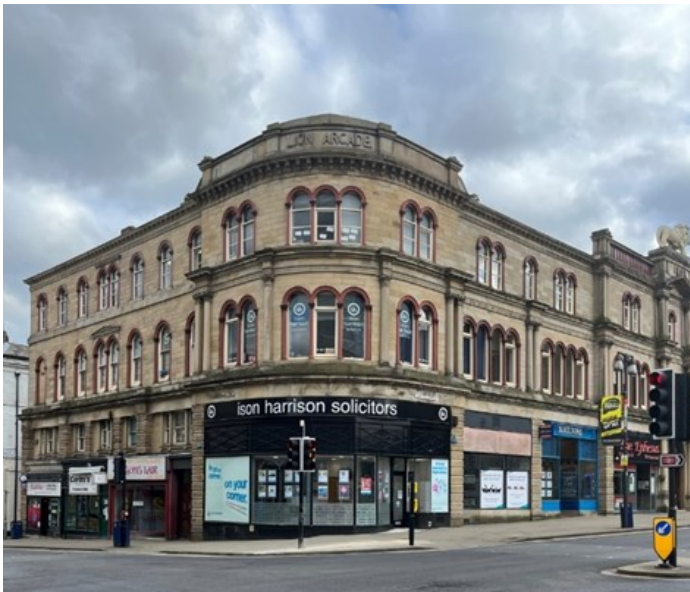
Lion Buildings on John William Street

This Grade II* building faces St. George's Square, The George Hotel and Huddersfield Train Station. This building is designed in a near symmetrical way, with a large curved façade to the primary road network. Its central entrance bay projects forward and features a large lion statue at the top. There is a hierarchy in the architecture, with a taller ground floor retail offering, and two further floors with reducing heights and window proportions. The double, triple and quadruple mullioned windows with projecting arches are a distinctive feature.

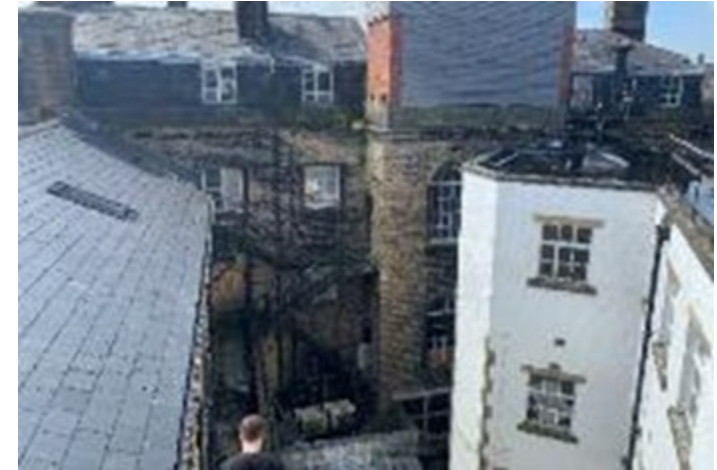
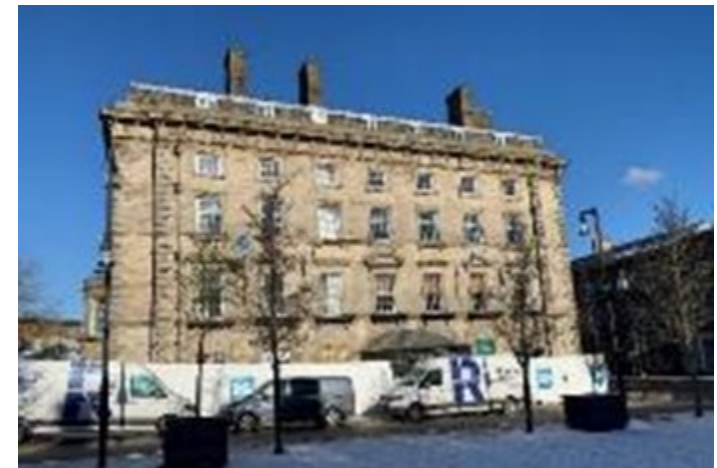
The Main Range of the hotel (c.1851), which overlooks St George's Square, is four-storeys in height and constructed of rusticated stonework with vermiculated detailing and quoins at ground floor.

The upper floors comprise of ashlar stonework from first to third floor with rusticated quoins (without vermiculation) and decorative stone surrounds to the windows. The stone has vertical batted tooling with borders of horizontal batted tooling at corner details. The elevation then steps back at fourth floor level to a slate mansard roof. The coursing of the ashlar blocks has a regular pattern with two courses per quoin.

The West Wing is also constructed from stonework, but this is a split faced coursed stone with plain stone surrounds to the metal casement windows.

The internal triangular courtyard is formed by the Main Range, East Wing, and the West Wing. The elevations overlooking this area are comprised of painted brickwork with stone sill and head details to the rear of the West Wing. The rear of the Main Range is coursed split faced sandstone as is the rear of the East Wing. The external corridor which was constructed in the 1930s along the rear elevation to the East Wing at first floor level is also constructed of painted brickwork similar to the West Wing.

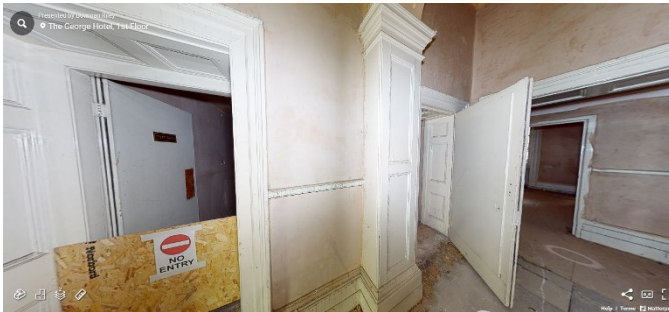
The second and some of the third phase of work, generally uses the same Victorian detailing, so for example, in room x (next to the Commercial Room), a new door from the corridor has the same panelled lining as the earlier doors .

The later Victorian doorset to the right has the same design as the original to the left.

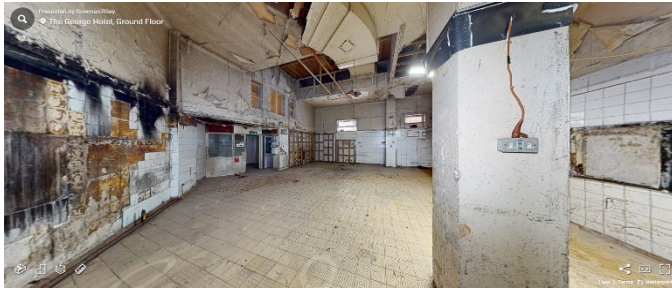
The main kitchen area.

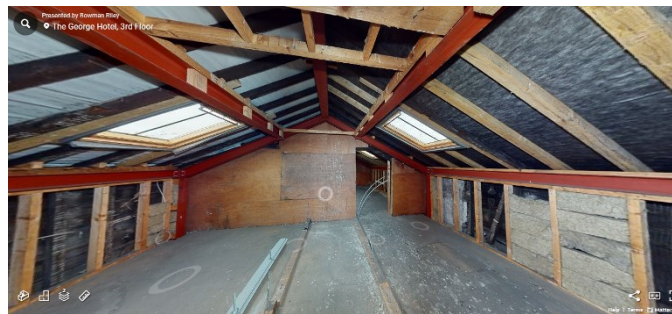
The upper floors of Block C have been the subject of structural works so there are large steel frames from which the first and second floors of the building are hung.

Steel frame to the third floor of Block C.

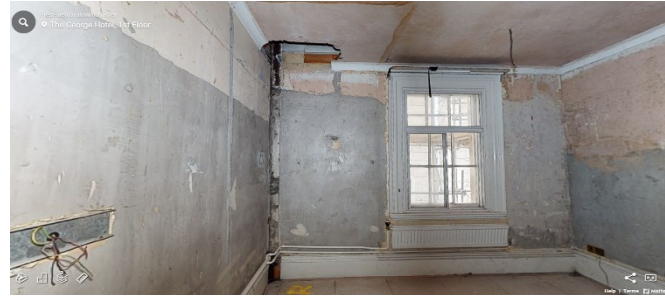
While many of the modifications have been particularly unsympathetic to some historic fabric, it has been retained in some areas, such as above or behind new insertions, and the form of some openings previous can still be seen. For example, on the ground and upper floors, there are numerous examples of false ceilings being inserted below the original. In some cases, it has been possible to see the original ceiling and cornice above.

False ceilings below the original.

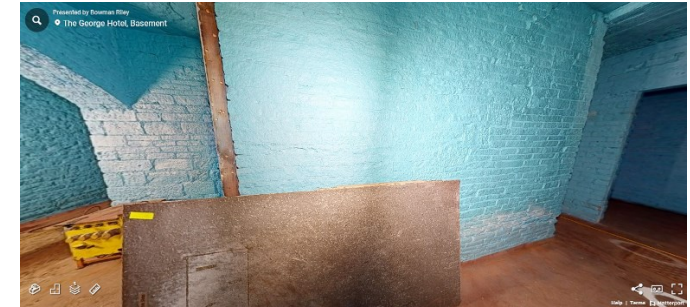
In the basement, where walls are painted brickwork, doors inserted into pointed arch openings (formed by vaulted ceilings) can be clearly identified, as can the edges of steps .

Evidence of former openings (top) and stairs (bottom).

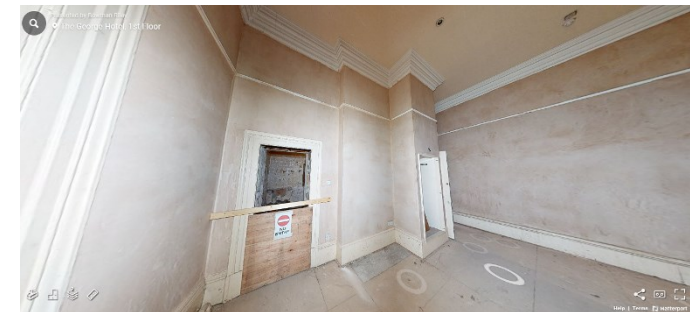
Unfortunately, previous adaptations involving new fabric have also tended to use a philosophy that does not align with current thinking in relation to being able to distinguish different phases of the building, so Victorian cornice details have been applied to new walls within existing rooms for example.

The Victorian cornice design has been recreated on new walls, such as the built-in cupboards.

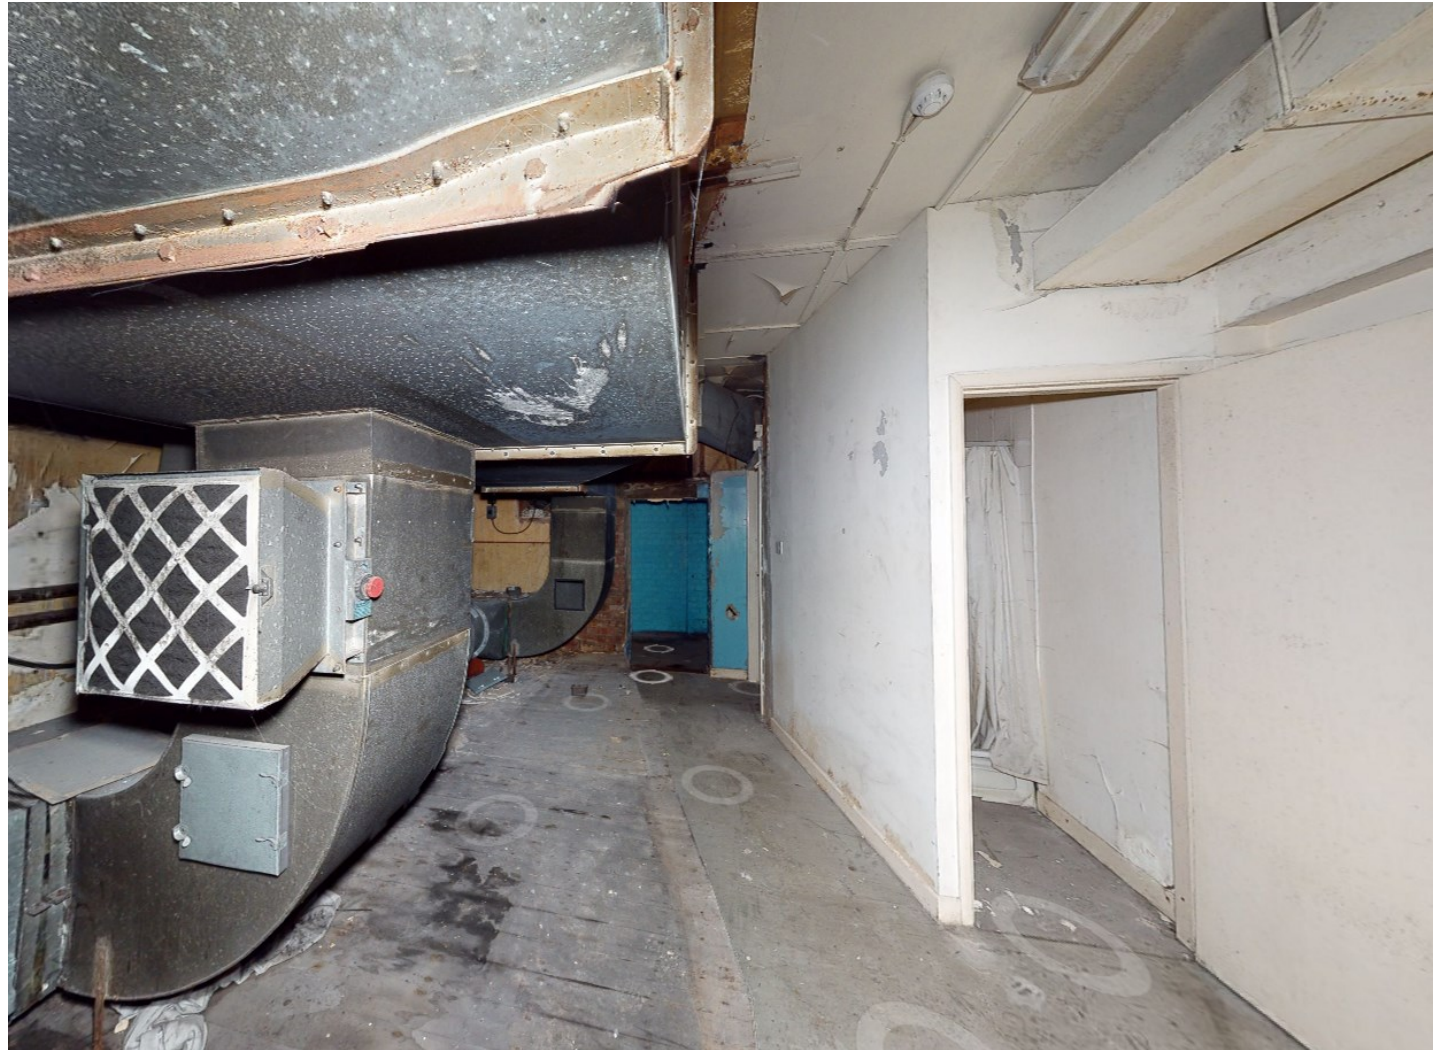
The room retains has been divided to create a small room in the corner. its original plan form, but a doorway has been blocked up and another has been created. No original features are retained.

The room has a high capacity for change.

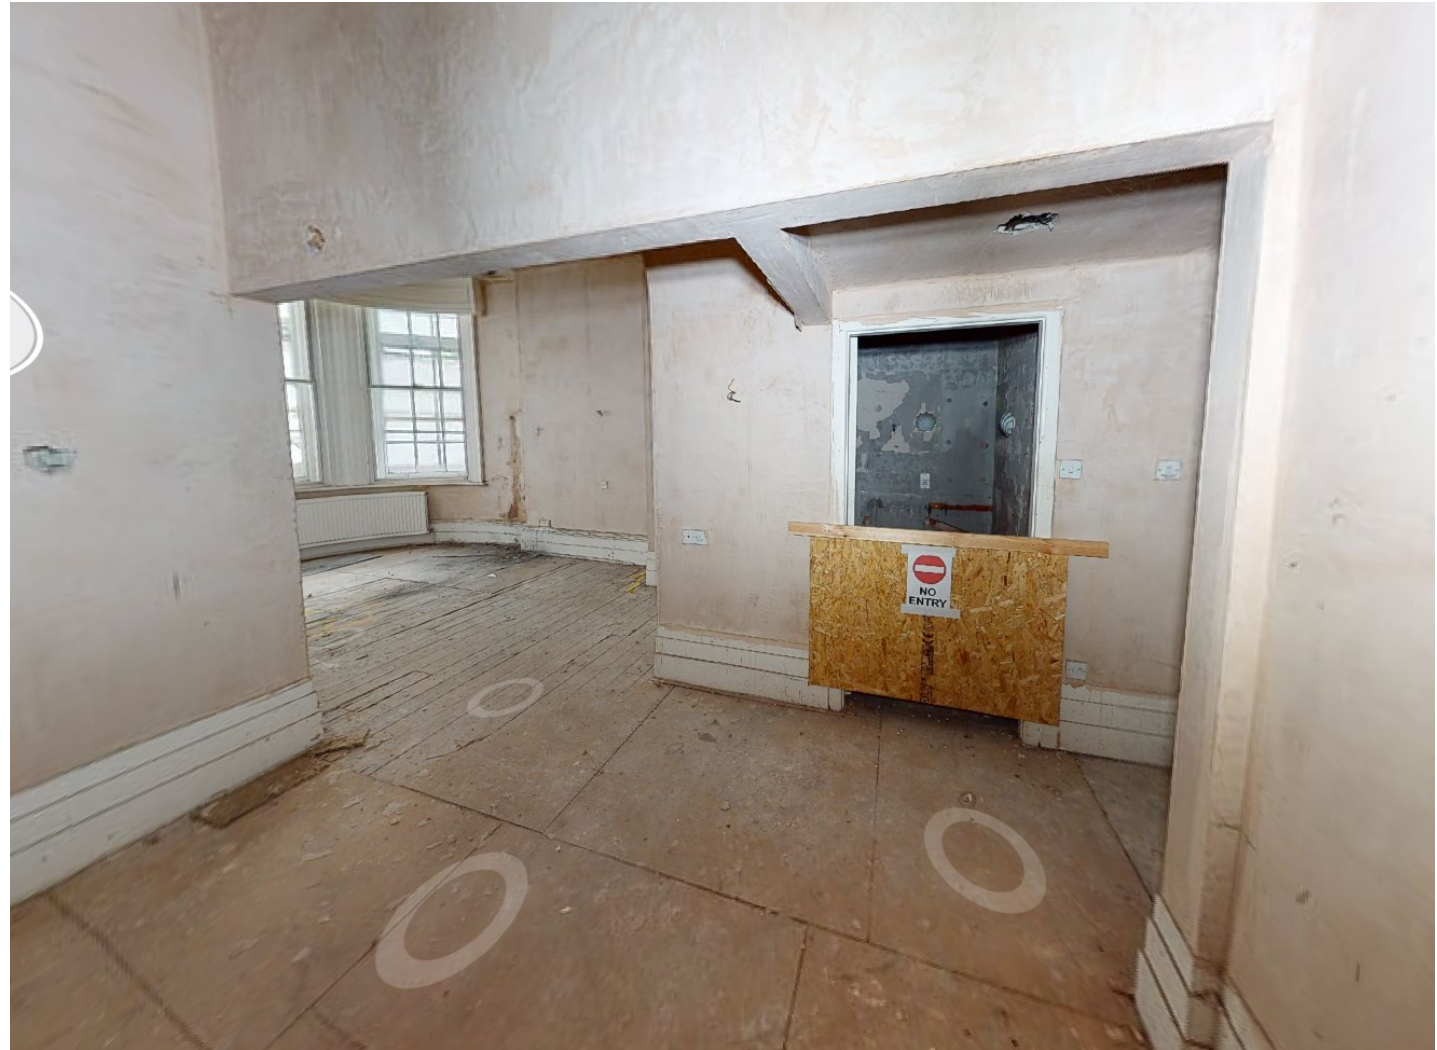
Example: Room 059

This part of the building was originally a single, large space, and has been subdivided into six smaller spaces. There are lowered ceilings and bulkheads and reproduction skirting boards, all of which make it difficult to understand the original design intent and use. Other than the windows, no original features remain.

The room has a very high capacity for change.

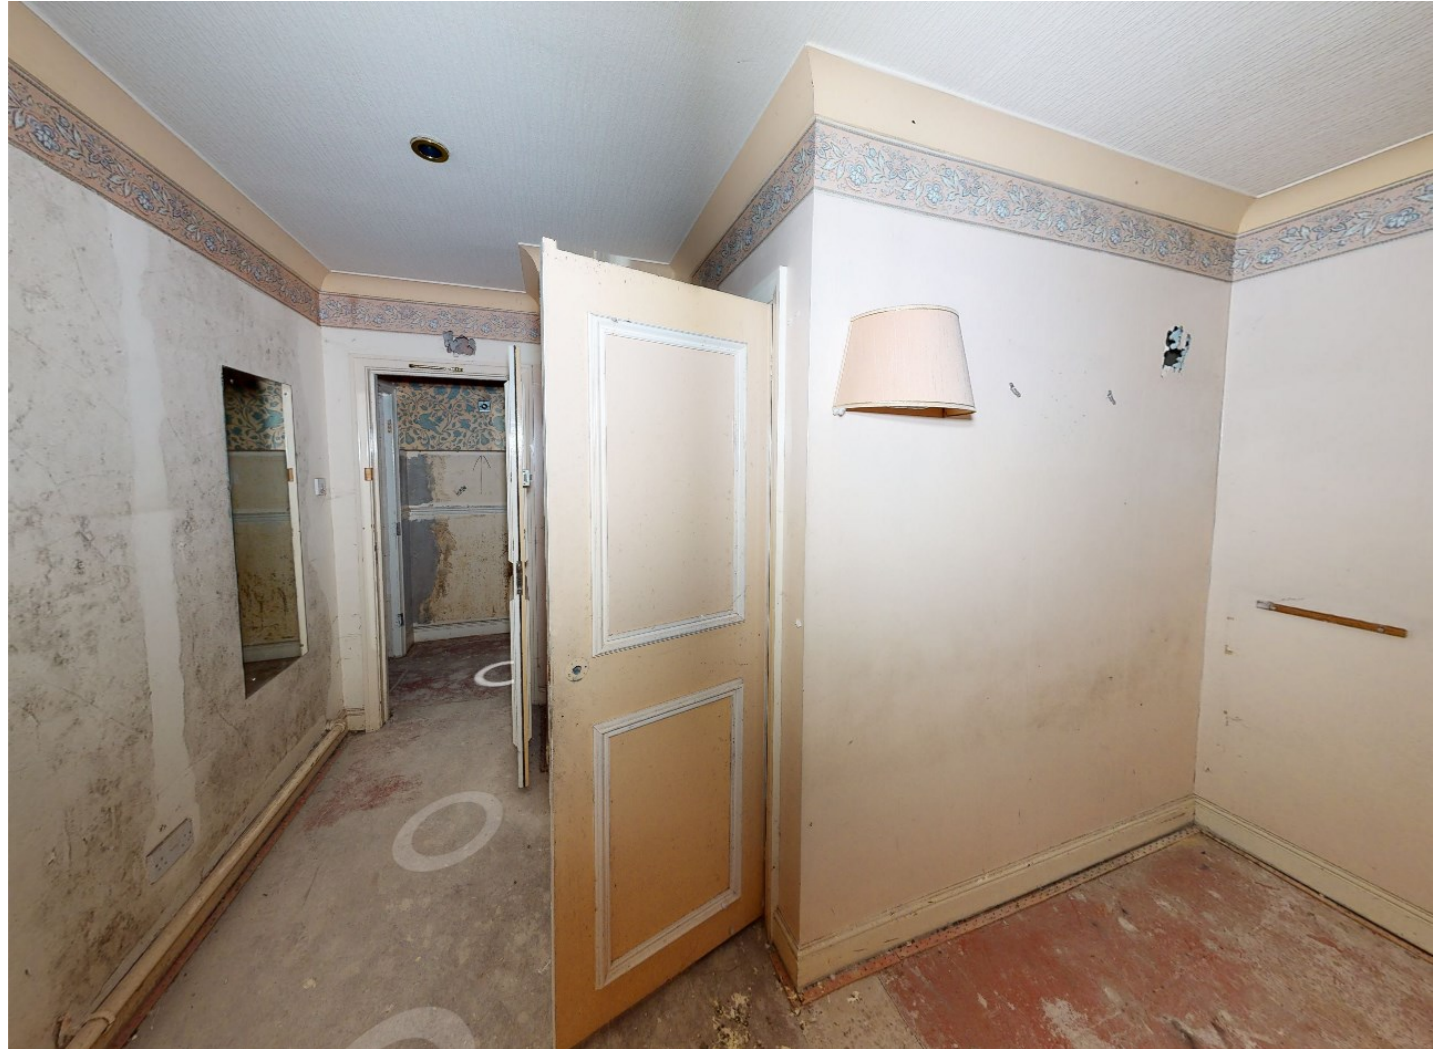
The 1930's floor plan is still readable, but an en-suite room has been inserted into the corner of the room, and there is a built-in wardrobe, both of which have a significantly negative impact on the original space. There are no architectural features worthy of note.

The room has a high capacity for change.

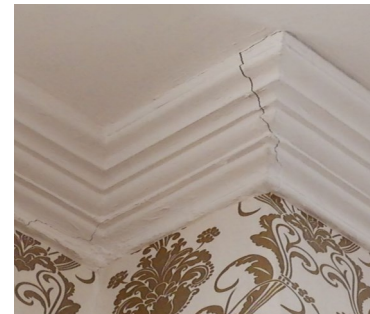
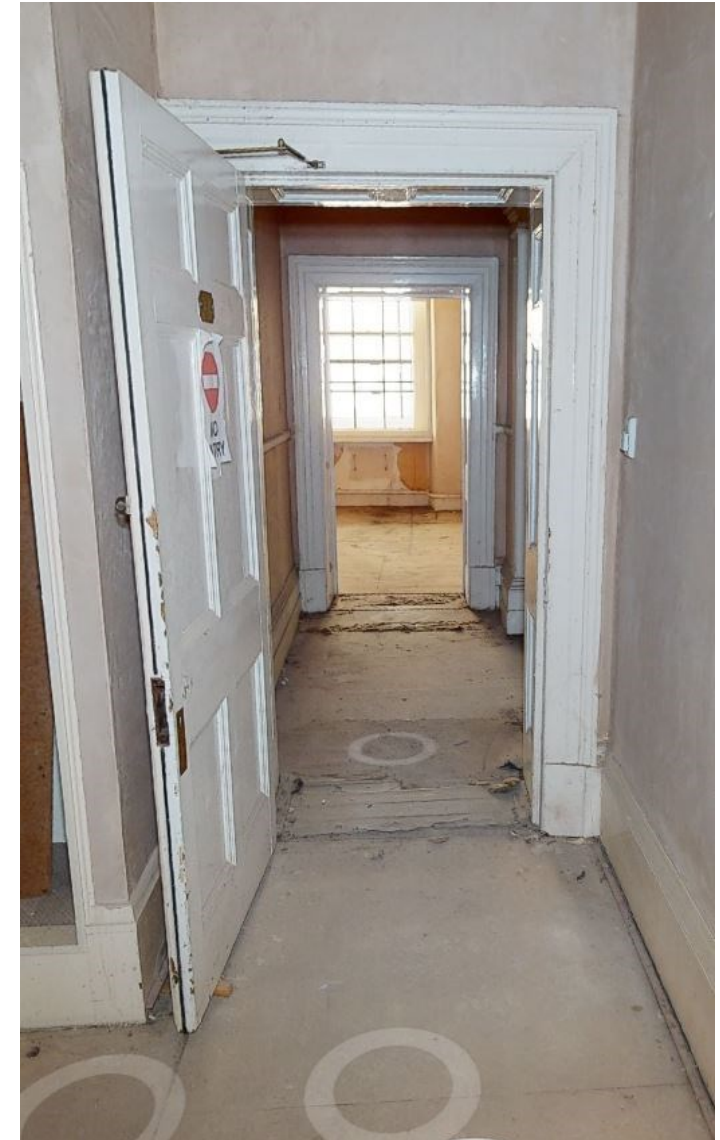
All areas of historic cornice will be replicated as part of the proposed works to match existing (two second floor examples shown below).

Example of historic door within existing opening

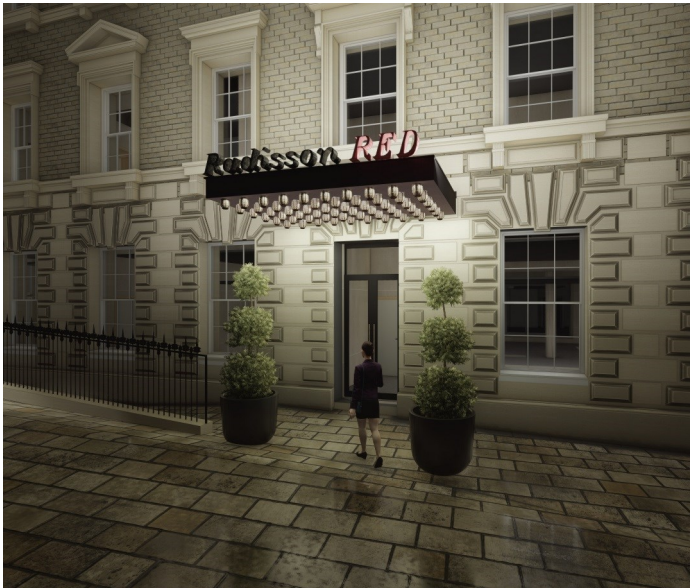
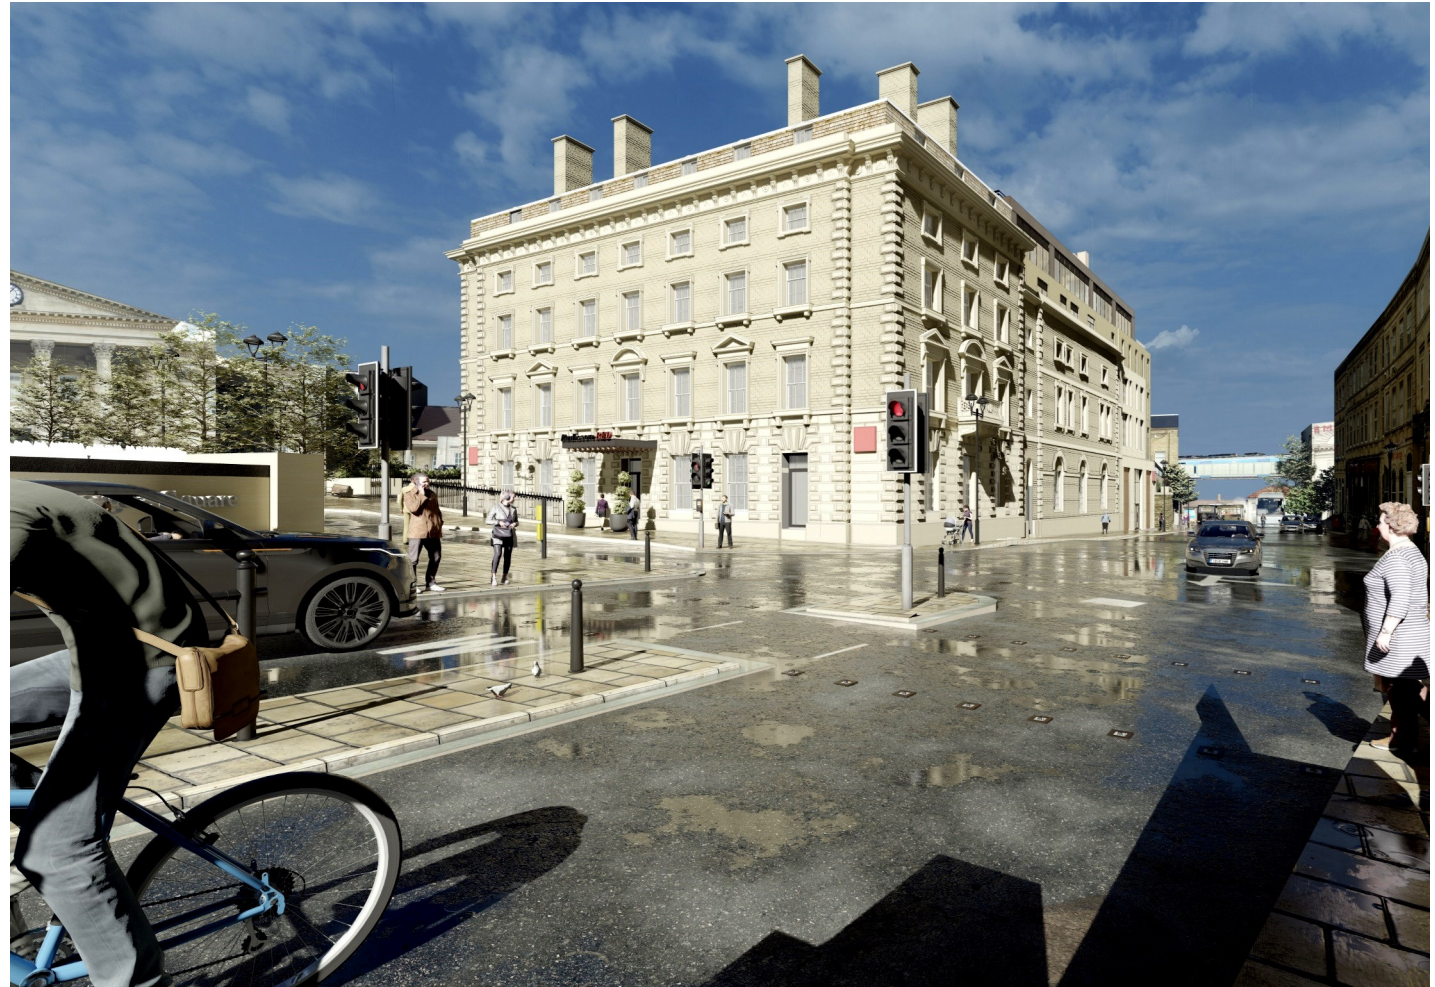
External fabric of the building has been retained and repaired as part of the previous Phase 2 works. The only intervention we are proposing to the principle elevation is to provide additional signage (details of which are subject to a separate application) and the provision of a new entrance canopy.

Proposed CGI's above and adjacent showing the principle elevation and the new canopy

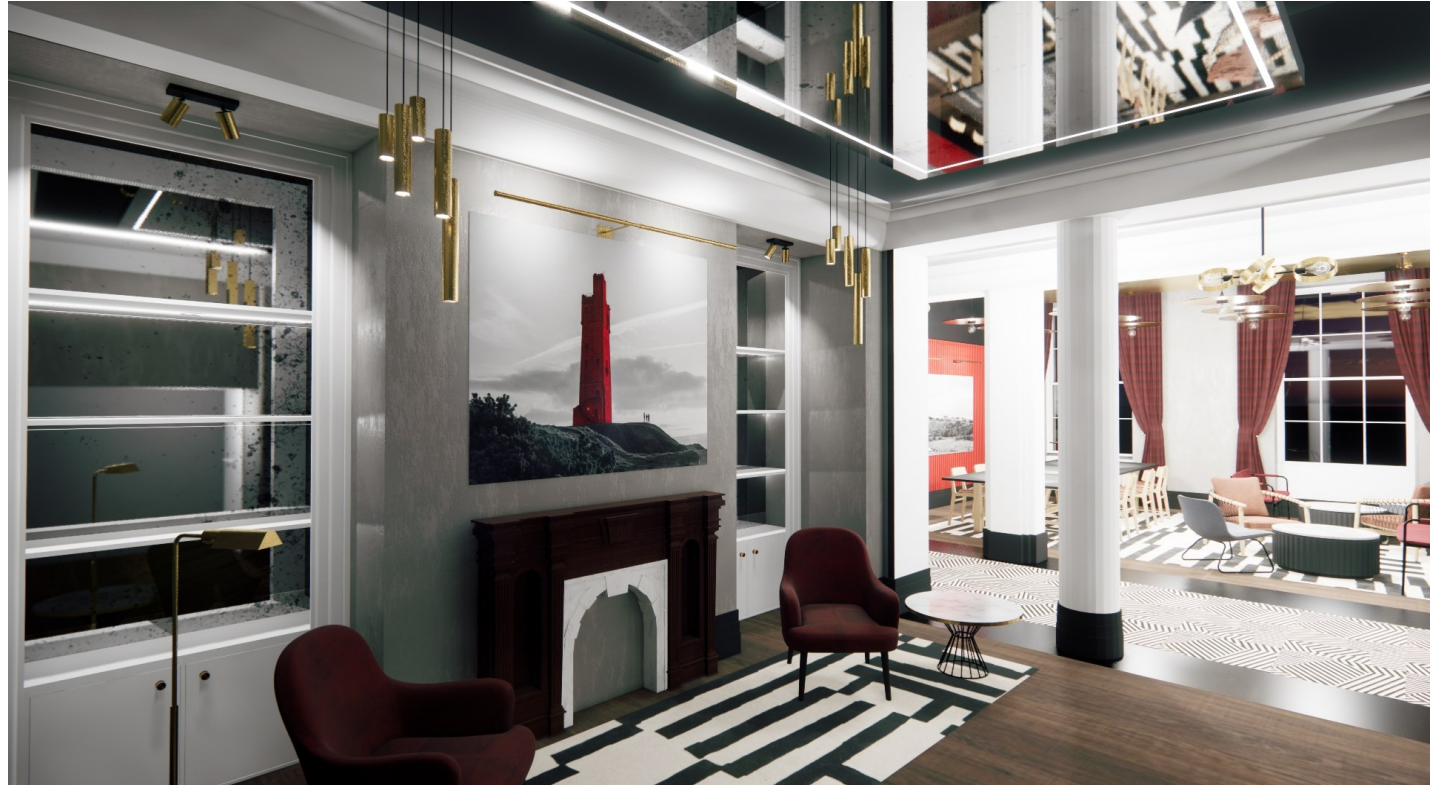
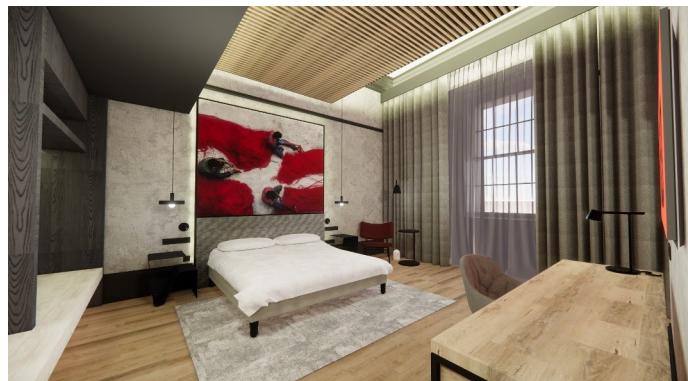
The location of the original walls (historically removed) have been identified using changes, or banding in floor material. The majority of the existing, historic finishes and features are to be retained, particularly at ground floor level with the retention of the decorative columns and pillars.

Indicative CGI's adjacent showing the proposed alterations to the internal entrance spaces and bedrooms.

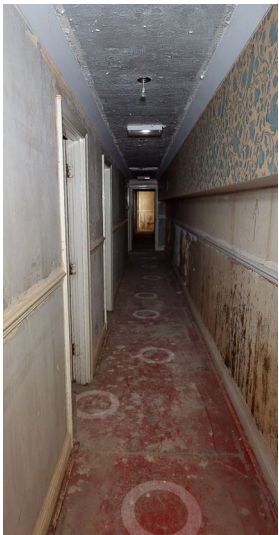
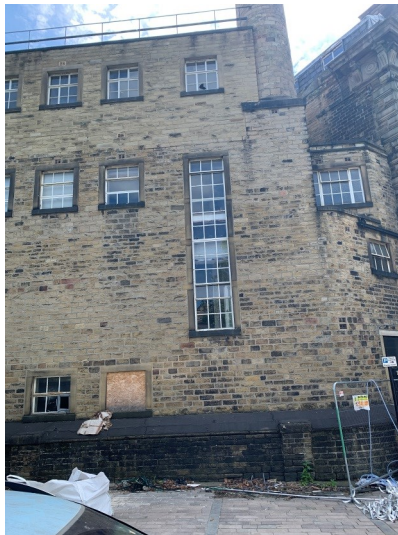
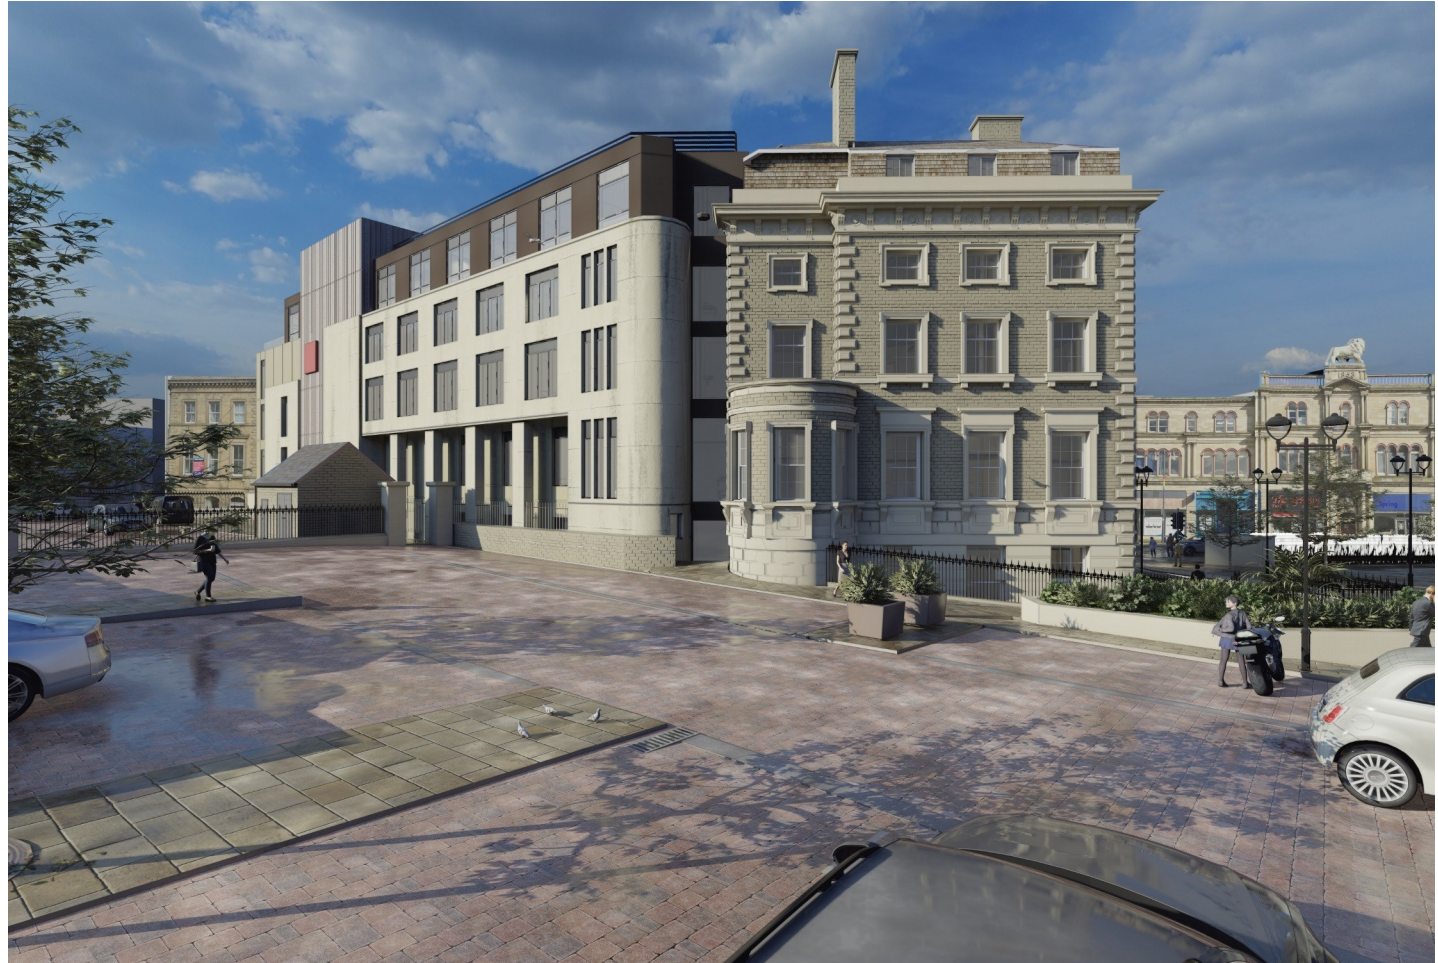
This would allow the provision of hotel rooms from ground floor upwards (with natural light achieved at ground floor via a proposed lightwell, evident to rear of columns in CGI opposite) with ancillary accommodation at ground and basement levels.

Proposed CGI's above showing the new-build and adjacent photographs showing existing building externally and internally.

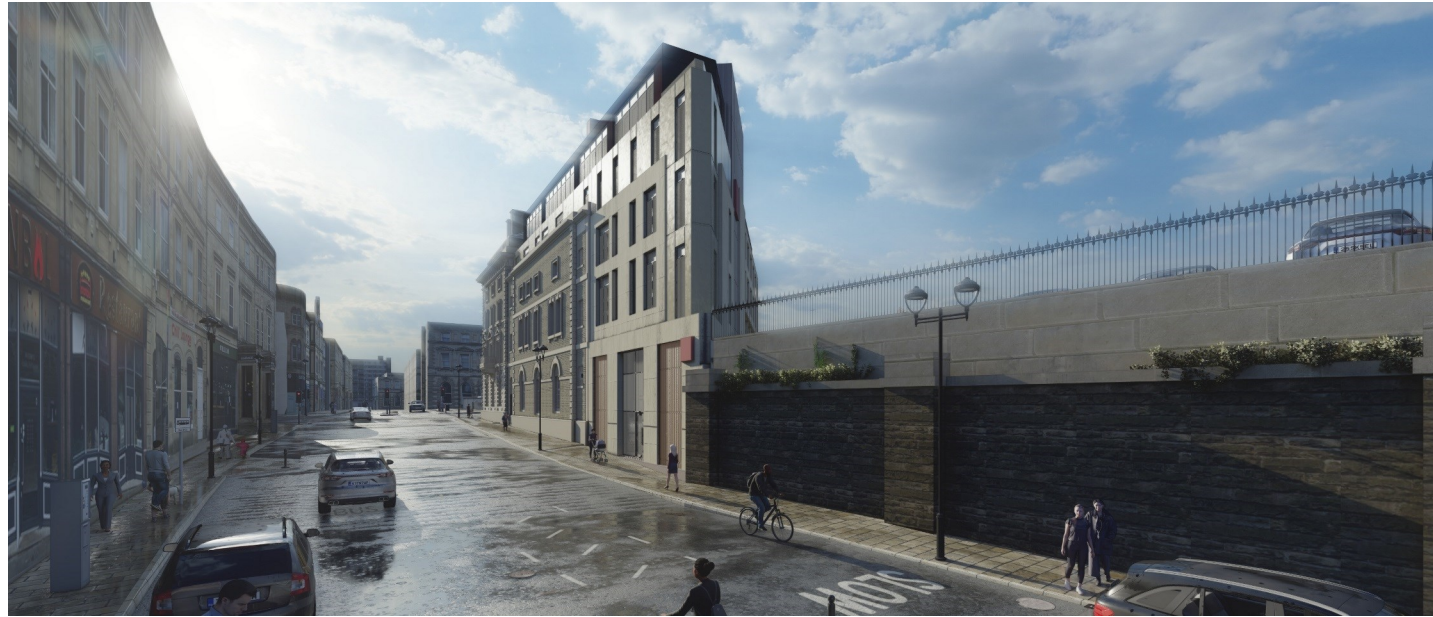
Proposed CGI

The majority of the courtyard facing and North facing walls had been lost at Basement & Ground floor and the remaining wall over supported on steelwork inserted at first floor level. 50% of the wall had also been lost at First Floor and the full extent of the mansard wall at Third Floor had been replaced with blockwork. (historic walls identified in red on 3d sketch below)

It became apparent that the structure supporting the second floor had failed and the solution that had been implemented was to install a new steel frame from which to hang the second floor. As a result of intrusive surveys it became apparent that this solution also extended down to the first floor. (See excerpt from structural report adjacent)

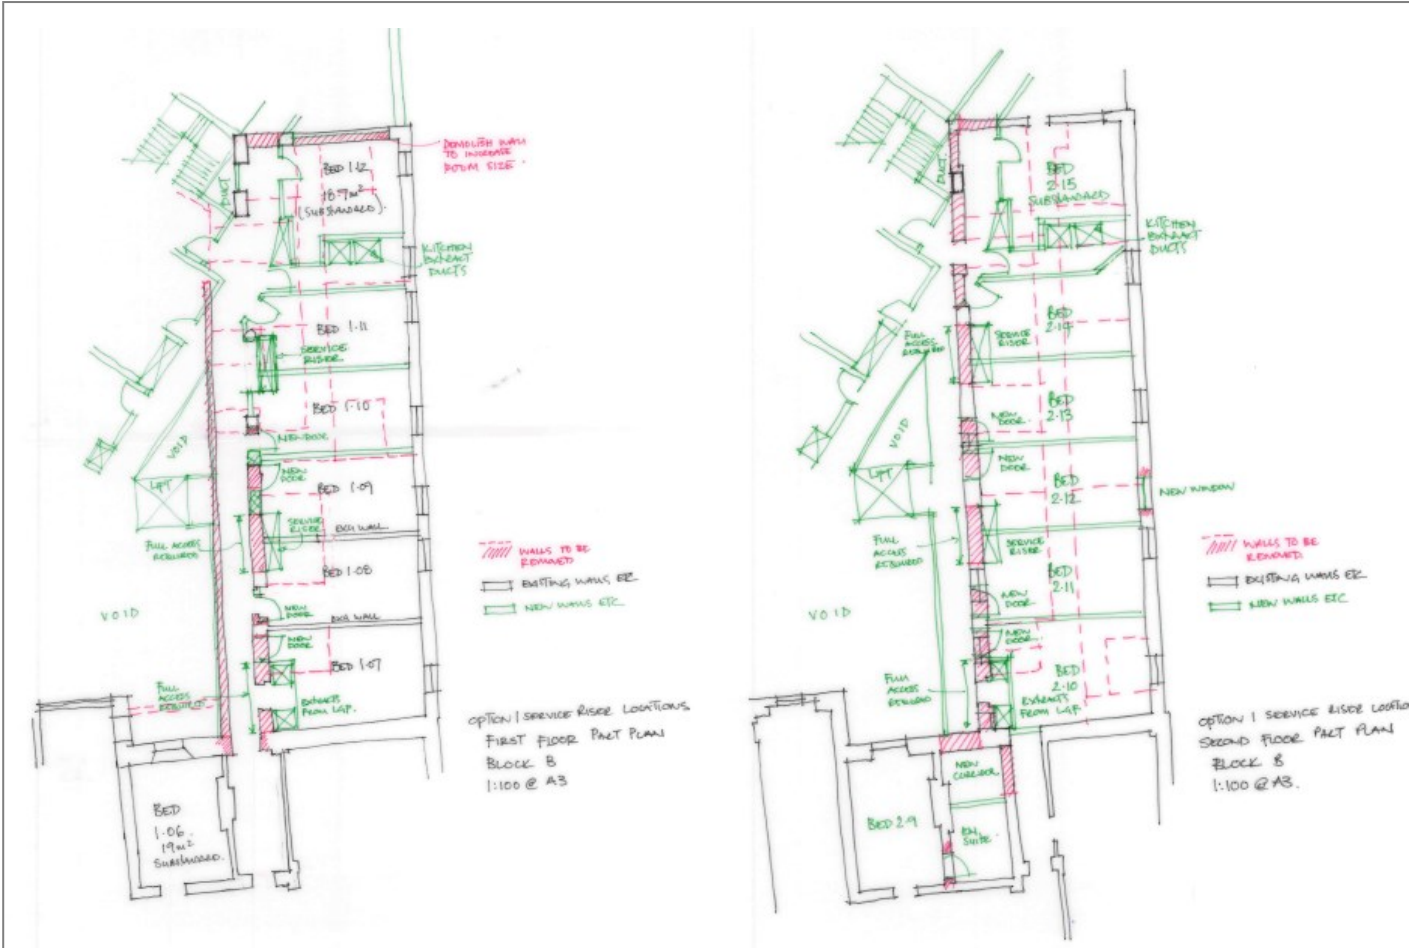
Option 1 for redevelopment with service risers shown and the impact on First and Second Floors

The internal walls needed to be removed to achieve the correct size and number of rooms, the internal courtyard wall prohibited the provision of adequate riser positions (see options appraisal on following page). Restrictive head heights at basement level and changes in floor levels resulted in a substantial redesign of Block C.
