Transpennine Route Upgrade West, Huddersfield Station: Roofs A, B & C

**Historic Building Investigation and Recording Interim
Report**

January 2024

**Client: BAM Nuttall on behalf
of TRU Alliance**

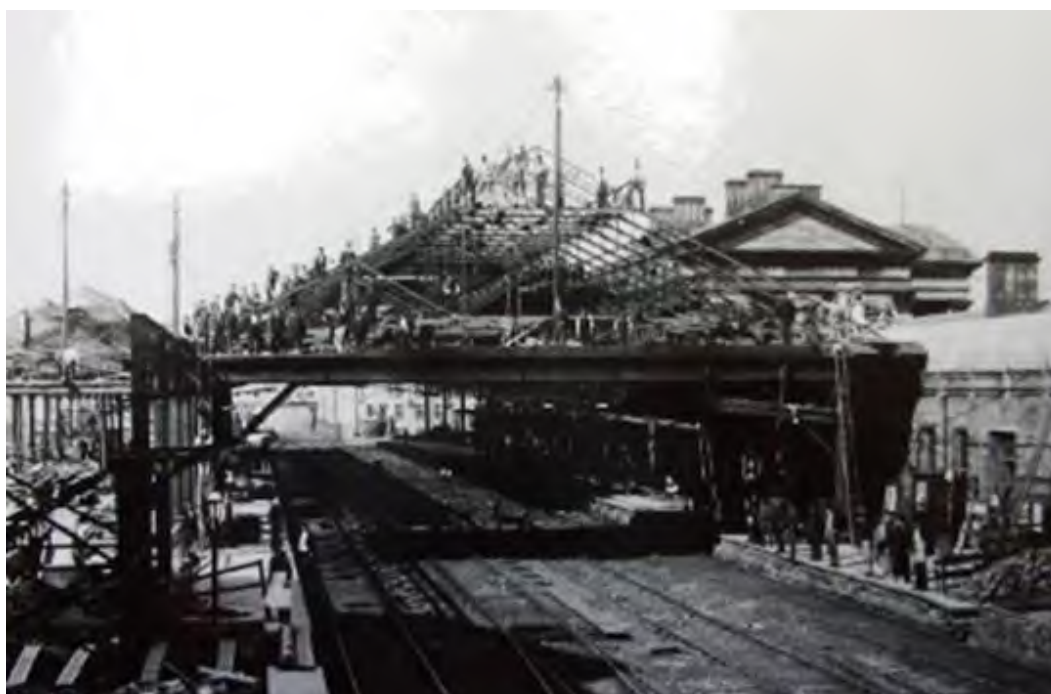
Plate 2: Trainshed roofs under construction, 1886 (Network Rail 2021)

- 2.3.3 By the 1860s, station facilities became less fit for purpose with the increase in usage and limited capacity of the single platform causing considerable problems (Network Rail 2021). By the 1870s, the arrival of bigger locomotives and longer carriages made the old track obsolete, and it became necessary to enlarge the station platforms (*ibid*). A programme of station enlargement conducted during the 1880s was completed by 1886, extending the station with the addition of an island platform connected via a subway link (*ibid*). The station now comprised three through-platforms and five bays for local and terminating services (*ibid*). A new, wider roof covered the new and extended platforms and consisted of two spans, comprising a series of wrought iron pitched trusses, supported on longitudinal beams and columns, originally with a raised roof lantern along the top of both pitches (*ibid*) (Plate 2). The roof represented an example of an iron-trussed pitched roof trainshed, an approach which had been pioneered by the London & Birmingham Railway at Euston in 1837 and is consequently referred to as the 'Euston Roof' (*ibid*) (Plate 3 & 4). This approach was common to several stations during the nineteenth century, particularly those of the LNWR (*ibid*). Defects in the roof's design, centred around its structural instability, contributed to its collapse during construction in 1885, killing four men (*ibid*). An improved structural design by Joseph Butler & Co. of the Stanningley Ironworks saw the roof finally completed in 1886 (*ibid*).

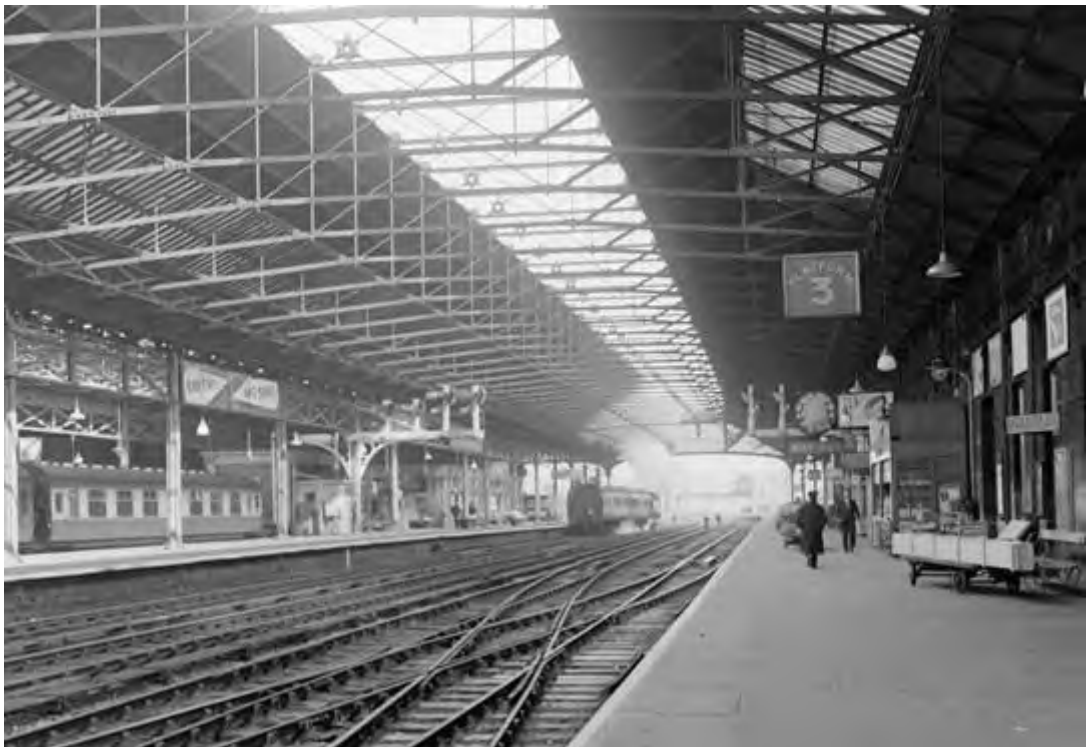
Plate 4: Huddersfield Station, 1954, facing north (source Yorkshire Live 2023)

the period of expansion in the 1880s (*ibid*). The most notable changes include the removal of Roof A's lantern prior to 1954 (Plate 4), and the shortening of the roofs at the northern end sometime during the late twentieth century.

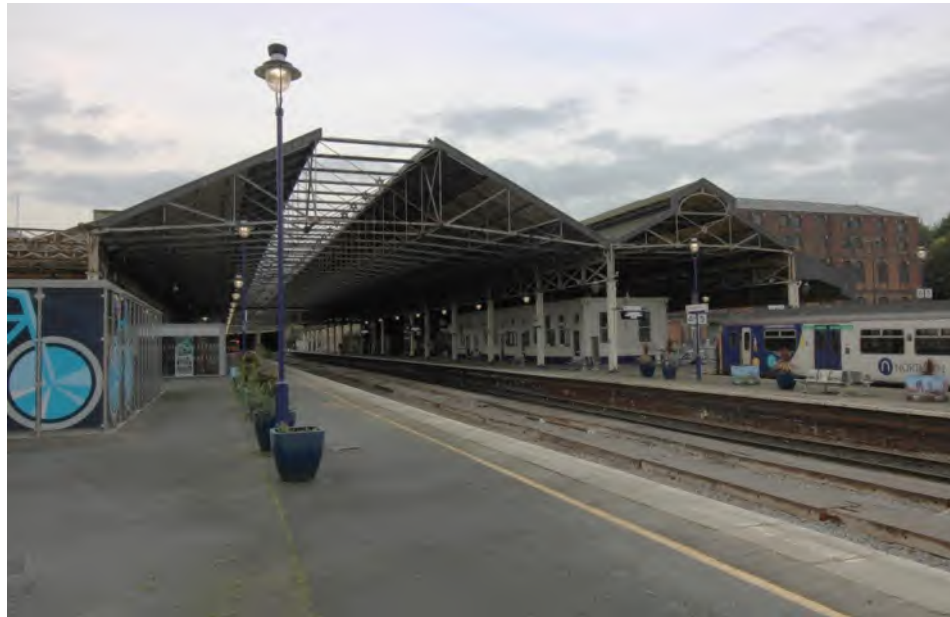
Plate 10: Northern gable end of Roof A (left) with attached Roof B (right), Roof C cantilevered off the edge of Roof B (far right) and the Large Brick Warehouse NHLE 1228533 (background far right), facing south-west

3.2.2 The northern elevation showed the open northern gable end of Roof A with its double pitched truss roof spanning Platform 1 of the main station on the eastern side, and Platform 4 of the Island Platform on the western side, where it connected to the eastern side of Roof B (Plate 10 & 11). On the upper section beneath the canopy, the wrought iron truss and its components of joists, struts and tie rods were interlocked with joint plates, rivets and bolts which spanned the roofs width (Plate 12 & 13). In the centre, a decorated moulded roundel (also known as a 'rose' connection) with fleur-de-lis decoration was present at the intersection of cross-bracing members (Plate 14 & 15). This structural form and decoration was repeated throughout the length of the roof. Attached at either corner of the central cross brace were two, possibly later, iron join plates over the original connection plate with two wrought iron supporting brackets connected to the second internal truss (Plate 13), these may have been installed following the removal of the northern section of the roof in the later twentieth century (*Section 4.4.3*). Above this, a central gap with a top cross beam highlighted the former location of the roof lantern which, based upon historic photography (Plate 2 & 3), would have been of a similar design to the adjacent extant lantern of Roof B.

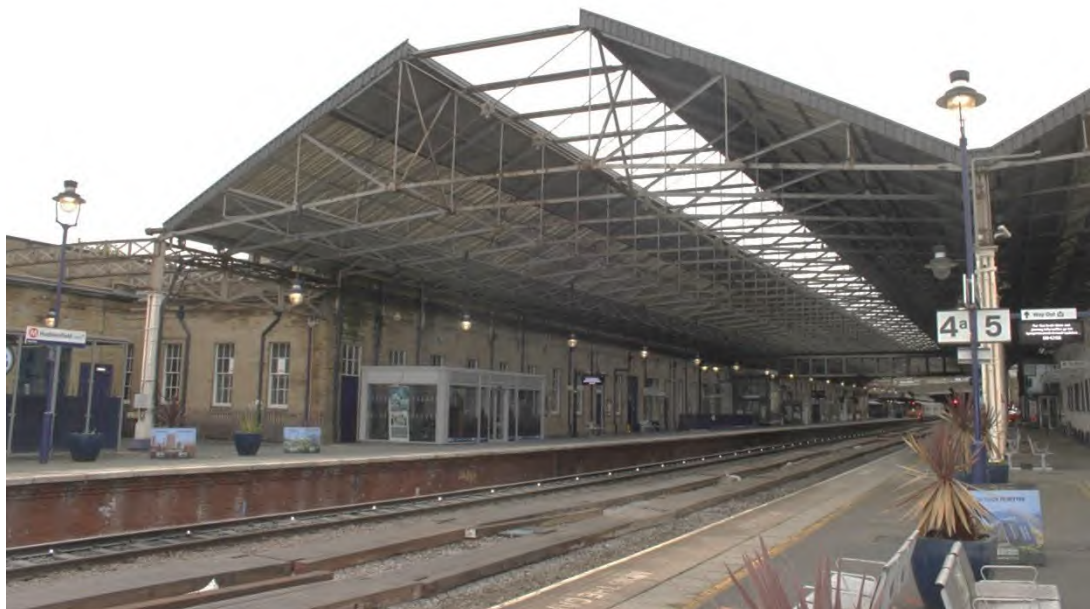
Plate 11: Northern gable end of Roof A, facing south-east

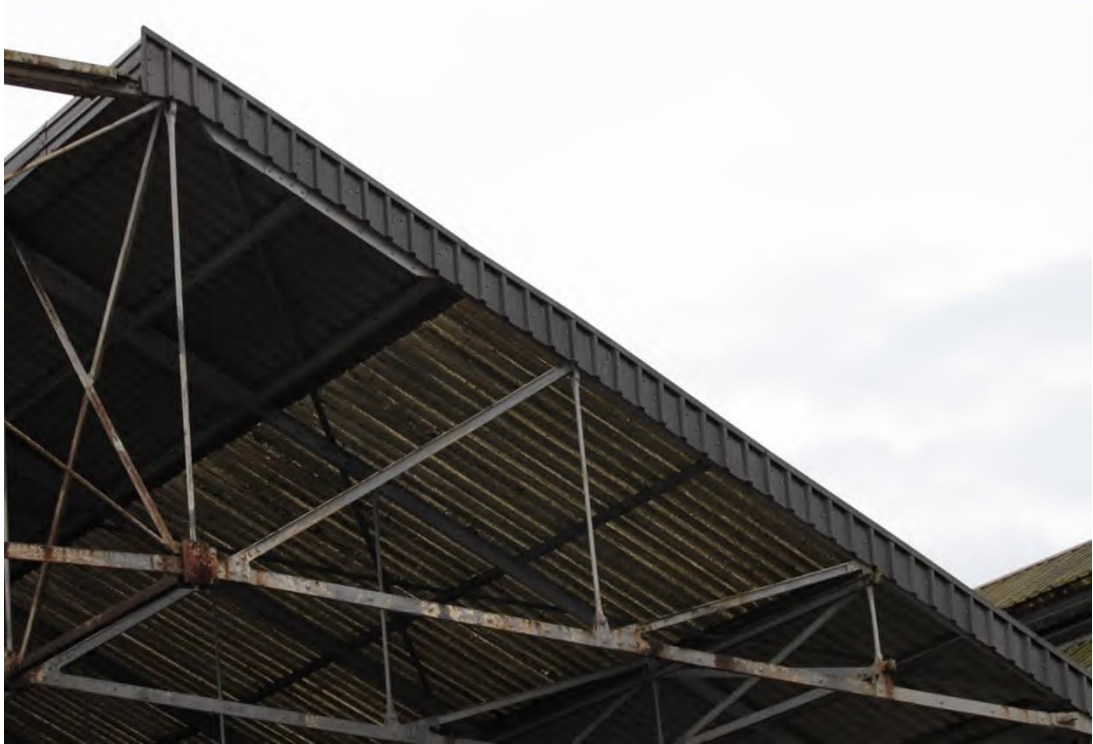
Plate 12: Western end of Roof A showing joist, struts and tie rod interlocked with joint plates and rivets

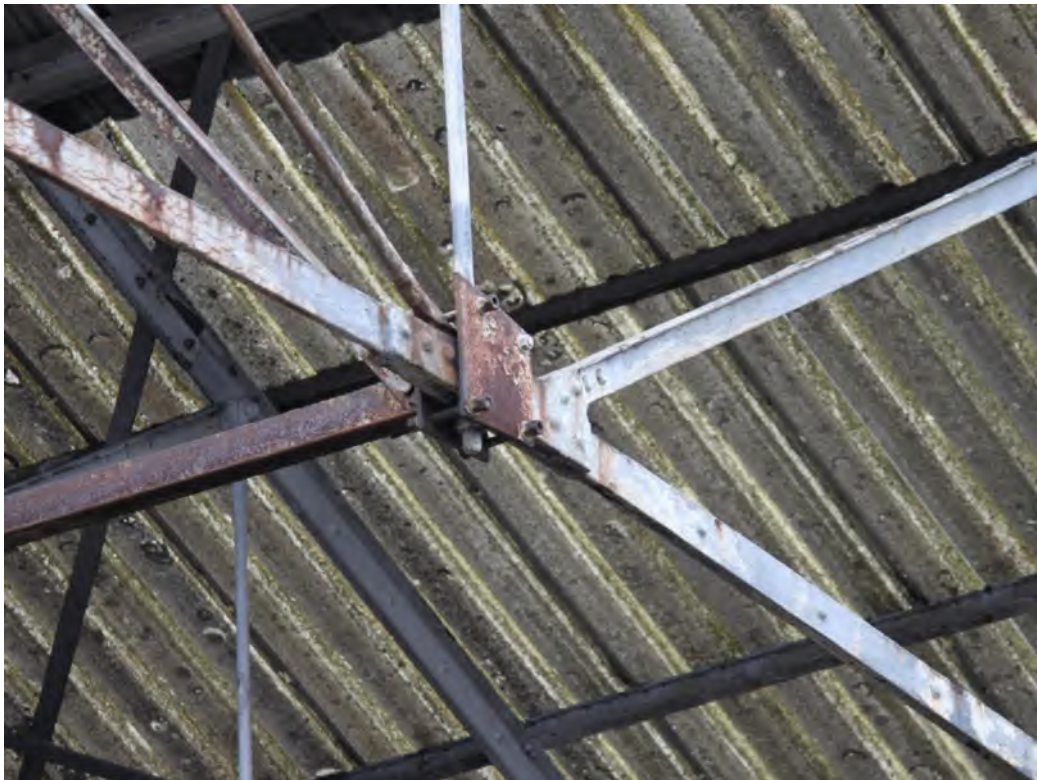
Plate 13: Example of a later join plate attached over an original connection plate at the western end of the northern truss

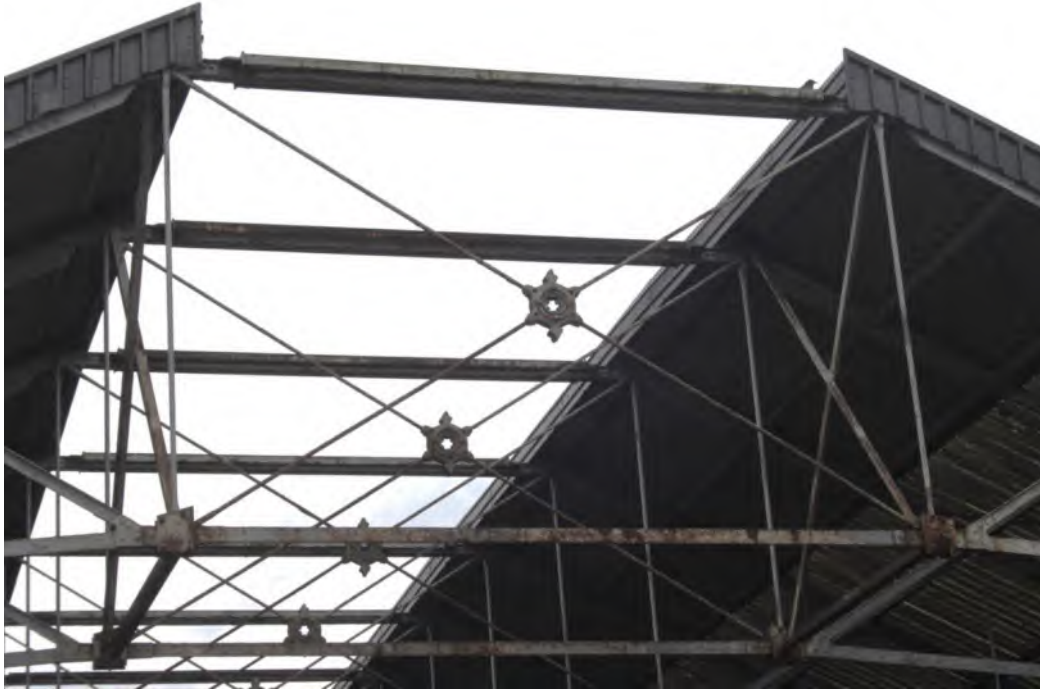
Plate 14: Central cross brace with moulded roundel (or 'rose' connection) and space above marking the location of the former roof lantern

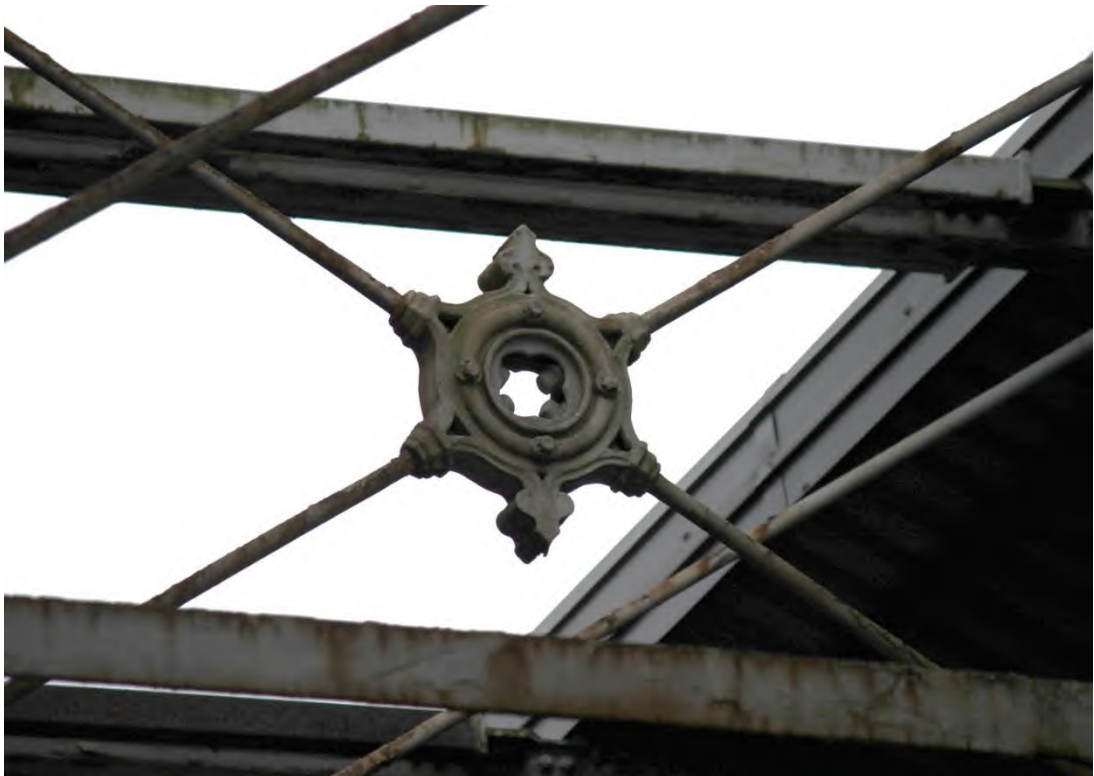
Plate 15: Close up of moulded roundel with fleur-de-lis decoration

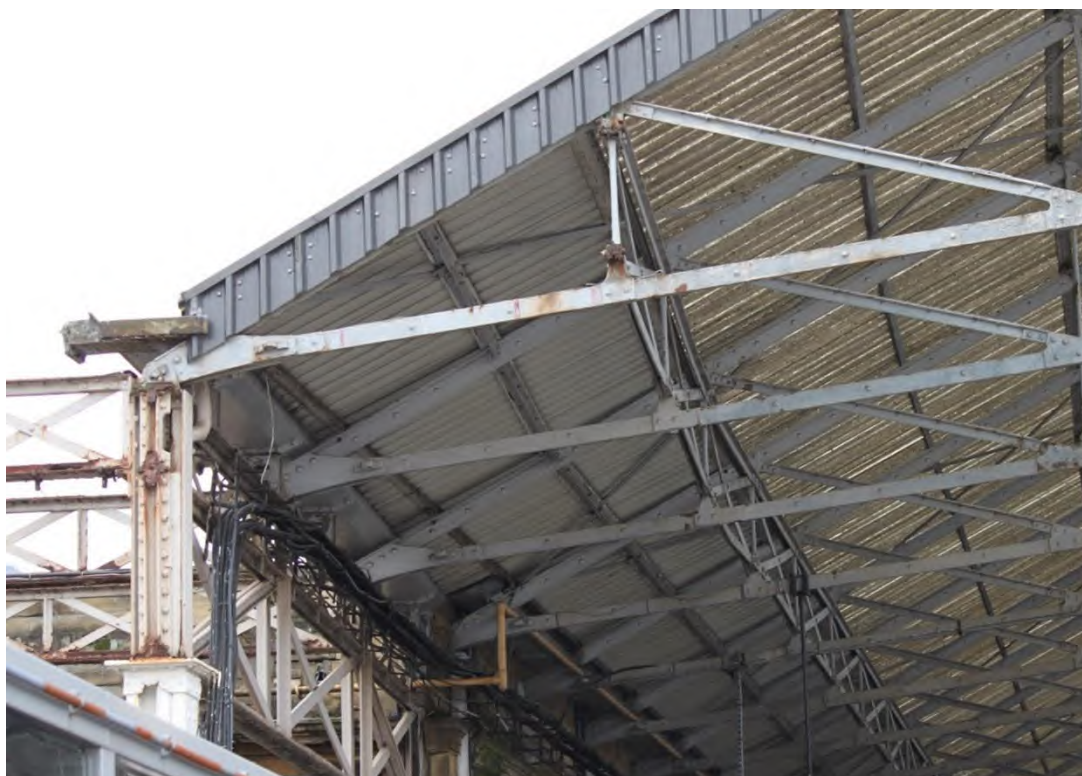
- 3.2.3 Surface corrosion was visible on all of the iron elements as its open sides and top were exposed to the weather. Attached to the northern face of both rafters were two strips of the corrugated metal cladding. Beneath the truss at both the eastern and western corners of the canopy the roof was supported by two compound-riveted wrought iron columns with incorporated down-pipes, bell-shaped foot detailing and a horizontal cap plate beneath the longitudinal truss, with the upper section contained within the depth of the truss (Plate 11). Attached to the upper section of the eastern column, lattice girders connected to the upper western elevation of an ashlar sandstone wall of a structure attached to a row of former offices (Plate 16).

Plate 16: Eastern corner of Roof A on top of a cast iron support

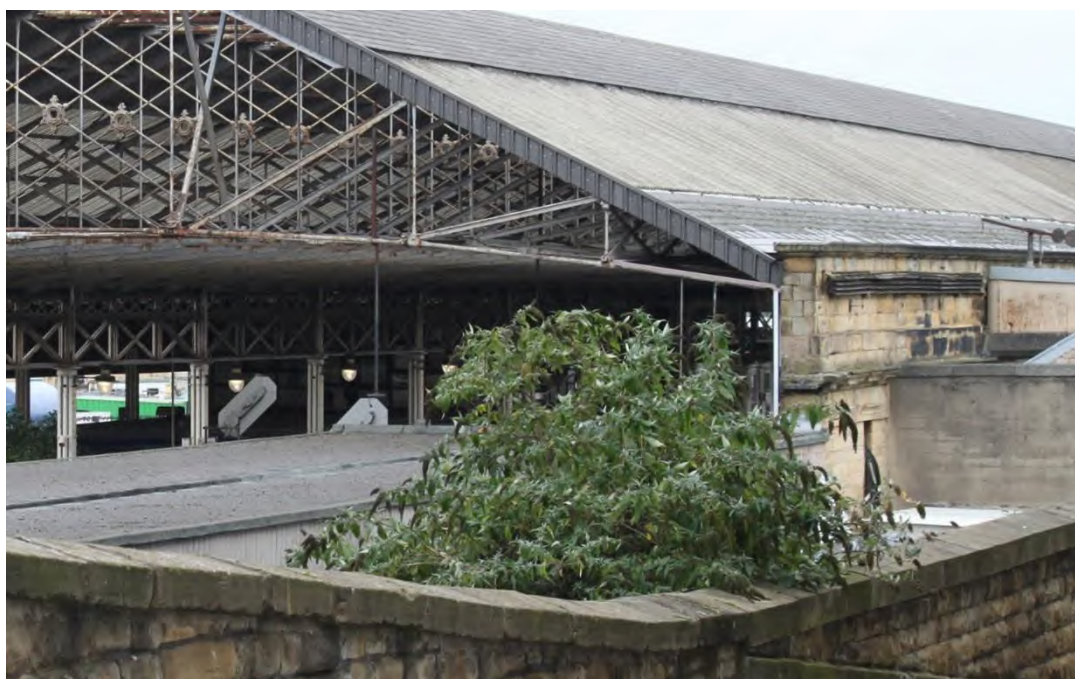
Plate 17: Sandstone wall visible at southern end of eastern elevation (right), facing north-west

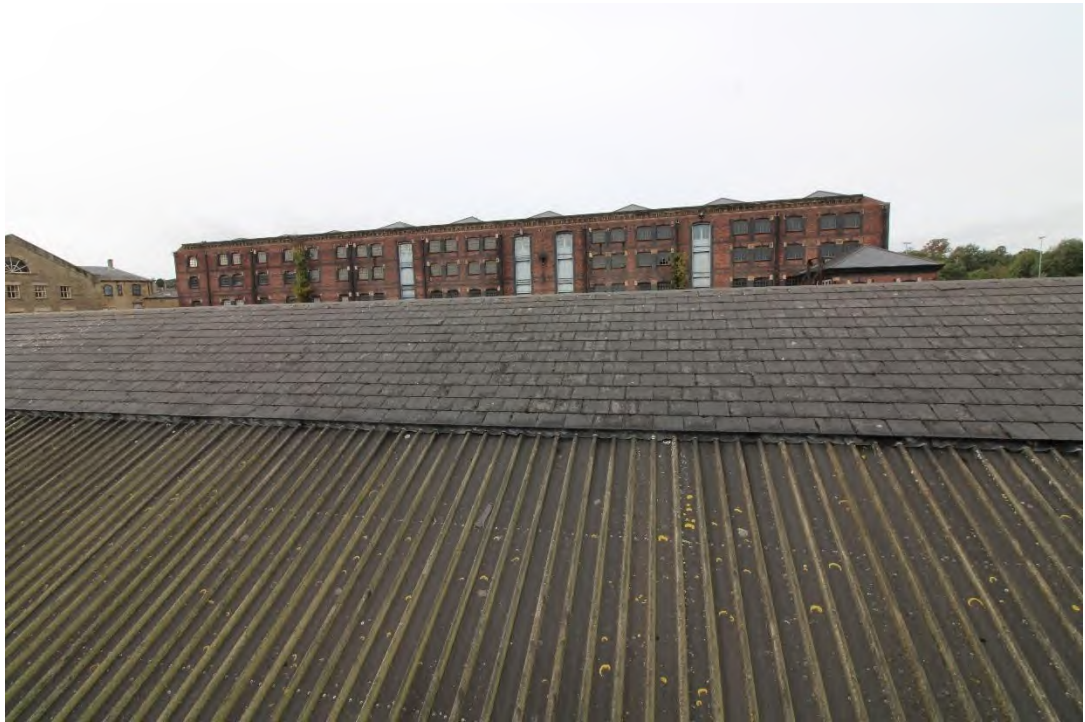
Plate 18: Central section of Roof A with eastern elevation of the Large Brick Warehouse (NHLE 1228533) behind, facing west

- 3.2.6 Access to the top floor of the principal station building enabled observations from a central position of the eastern pitched roof (Plates 18, 19 & 20). Facing both north and south, the appearance of the roof's exterior showed it to be attached to the length of the station building (and raised wall at the southern end) and have grey slate running the length of its lower and upper sections with translucent corrugated fibre sheeting running through the centre. The current ridge line marked the top of the roof but historic photography showed the eastern elevation of the former central lantern was once raised above this line, having lattice girders running the length of the roof with a double-pitched translucent structure above (Plate 3).

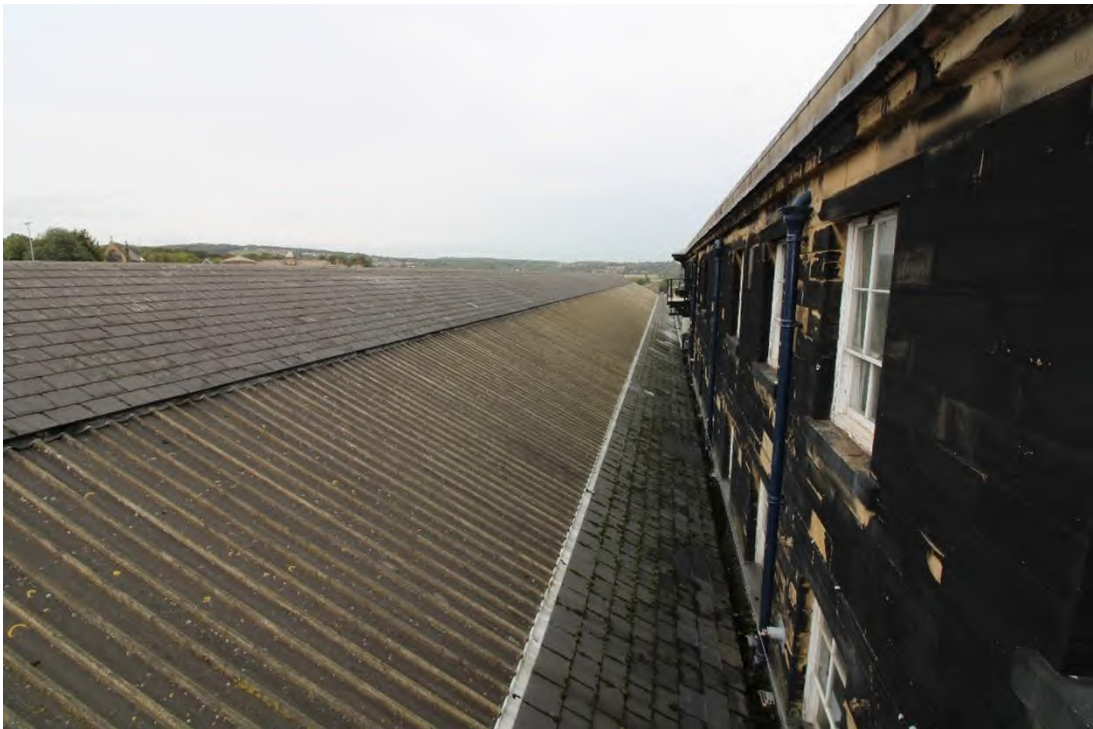
Plate 19: Roof A attached to the rear (western) elevation of the principal Huddersfield Station building (NHLE 1277385) (right), facing north

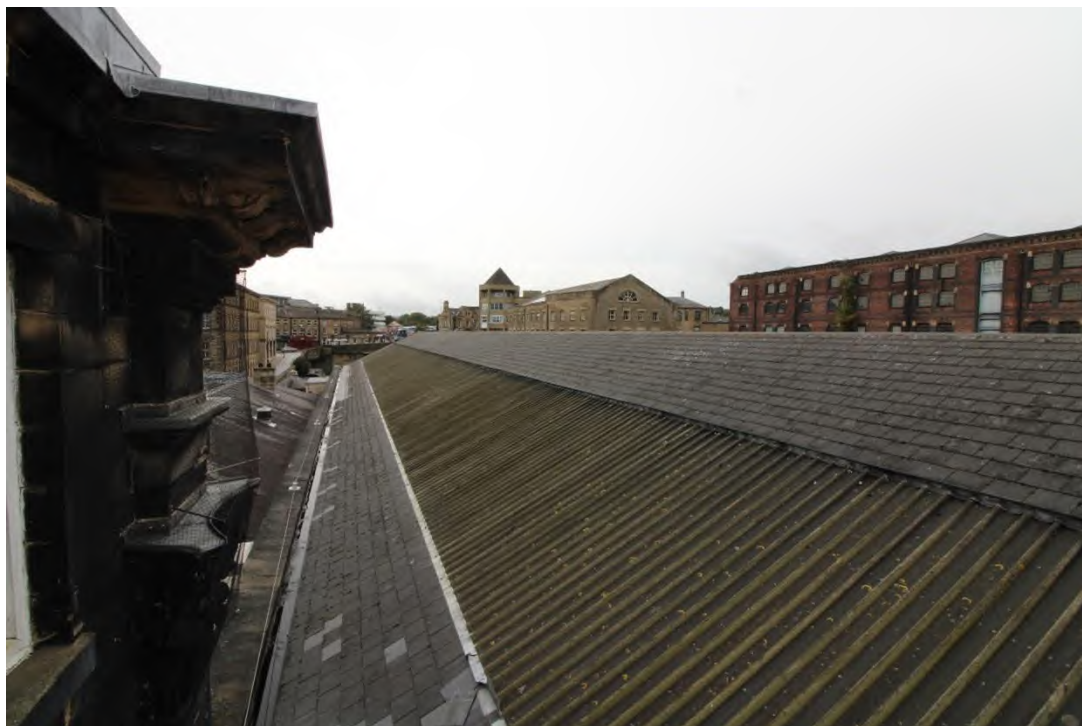
Plate 20: Roof A attached to the rear (western) elevation of the Huddersfield Station and southern wing (NHLE 1277385) (left) with the Large Brick Warehouse (NHLE 1228533) (right) and the Stone Warehouse (NHLE 1287149) (centre)

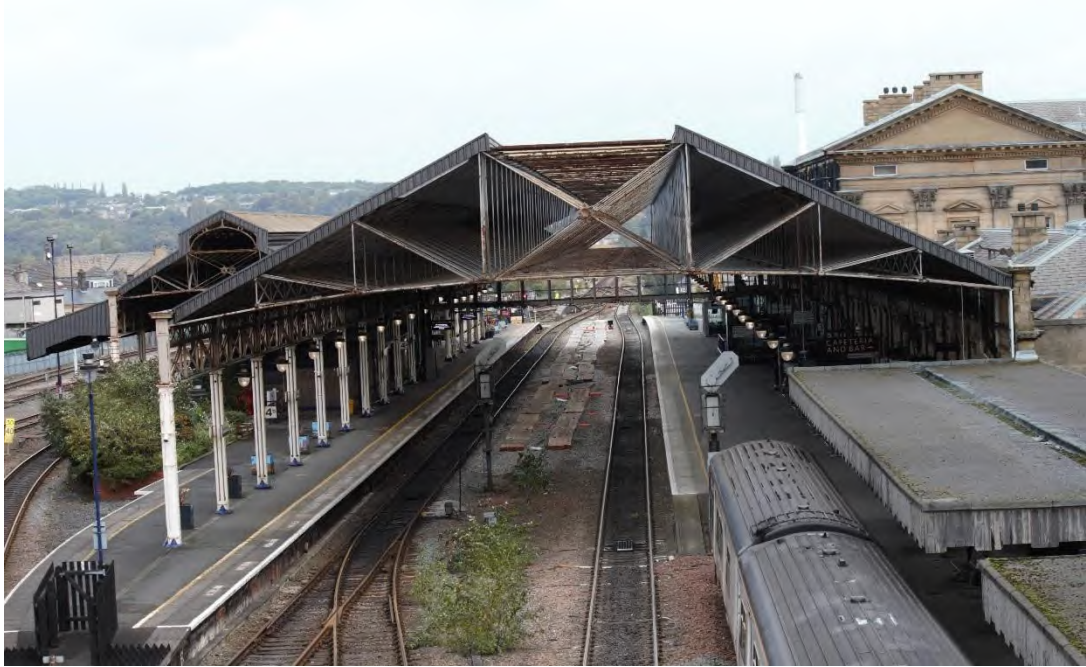
Plate 21: Southern end of Roof A with Roof B and Roof C (far left), Huddersfield Station (NHLE 1277385) (right) and Penistone Line canopy (bottom-right), facing north

- 3.2.7 The southern gable end of Roof A was subject to Level 3 Historic Building Recording due to it being scheduled for demolition (bays 1 & 2) (Plate 21). Its form was almost identical to that of the northern gable end, except its rafter tie components appeared to be tubular and curve upwards in the centre. Its width spanned Platform 1 of the main station on the eastern side and Platform 4 of the Island Platform on the western side. Beneath the canopy the components of the wrought iron truss were visible with a moulded roundel, again with a fleur-de-lis decoration, located in the centre at the intersection of cross-bracing members (Plate 22). Above this was another cross beam and a gap where the former roof lantern would have been located. The condition of the truss was slightly worse than at the northern gable end with a greater amount of surface corrosion present on the iron components. Attached to the southern face of both rafters were two strips of corrugated metal cladding.

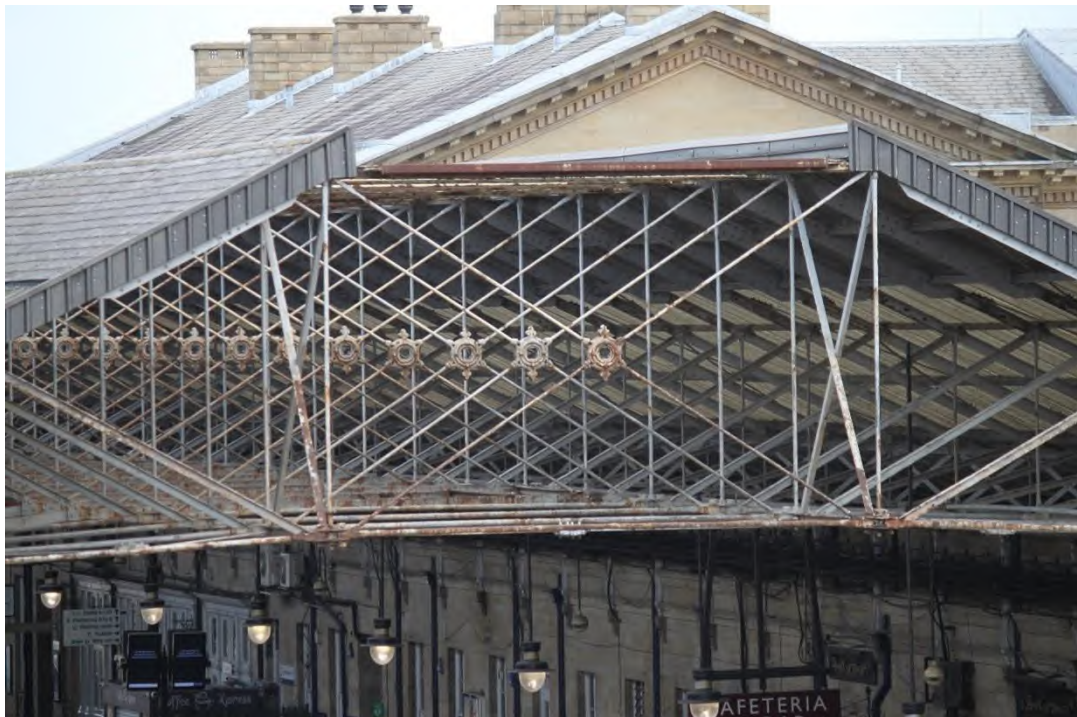
Plate 22: Central cross brace with elaborate central moulded roundel with the space above marking the location of the former roof lantern, facing north-east

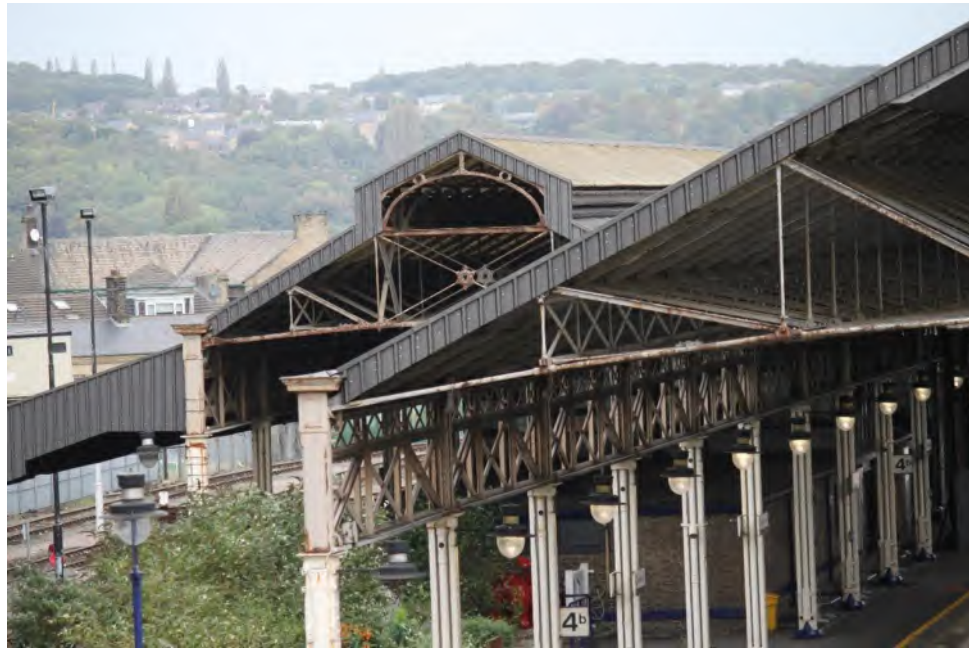
panelling beneath a wrought iron eaves trough. (Plate 23). At the eastern end, the roof was attached to the western elevation of the ashlar sandstone wall with coping stone top that extended beyond a southern structure to the south of the southern pavilion (Plate 24). Attached to its southern elevation was the Penistone Line canopy which protruded to the south.

Plate 23: Western column with eaves trough above (centre-left) with the same present on the western side of Roof B (left)

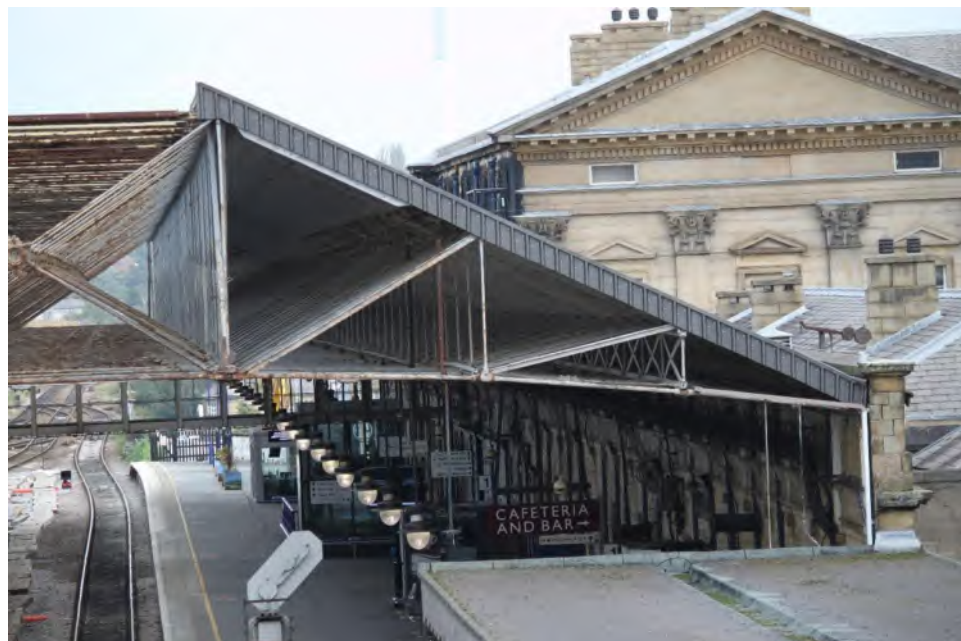
Plate 24: Eastern end of truss attached to the western elevation of the sandstone wall (far right) with the Penistone Line canopy attached (bottom right) and Huddersfield Station (NHLE 1277385), facing north-east

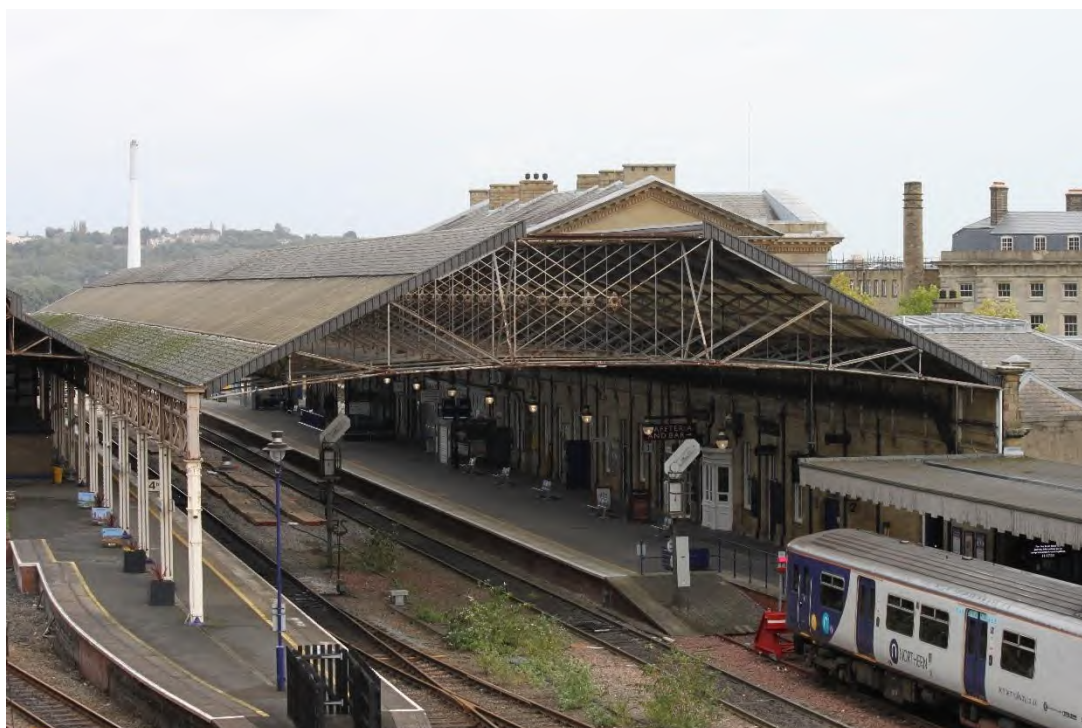
Plate 25: Lower external western elevation (far left) with western pitched roof above, facing north-east

- 3.2.10 The majority of the western elevation was contained within the interior of the attached Roof B, with the only exposed external section located at the southern end of the Island Platform (Plate 25). This exposed section contained five compound-riveted wrought iron columns, each with incorporated down-pipes and the bell bottom bases. The two most southerly bays at this end of the roof were to be removed as part of the TRU programme of works. Between each column and spanning the length of the roof were a series of lattice beams consisting of a deep Howe-truss with a smaller truss above (Network Rail Heritage Statement 2023, 23).

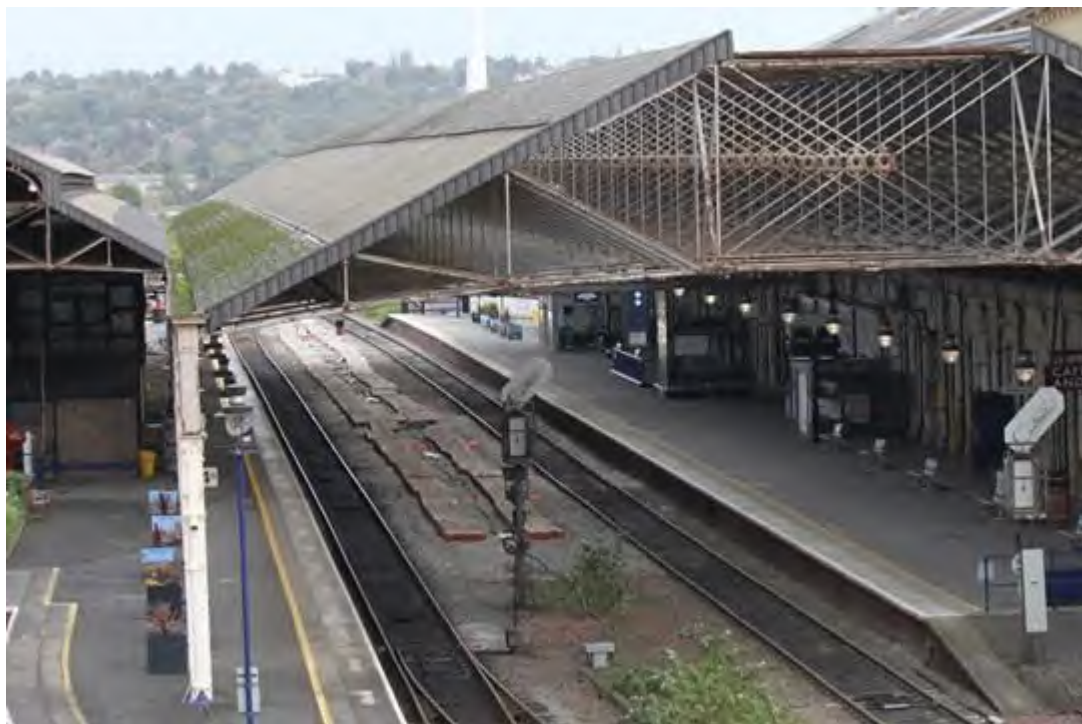
Plate 26: Western pitched roof of Roof A with Roof B attached (left), facing north

- 3.2.11 The western elevation of the pitched roof showed it to be the same as the eastern pitch with grey slate running the length of its lower and upper section with translucent corrugated fibre sheeting running through the centre (Plate 26). Above, the current ridgeline marked the base of the former roof lantern. At the base of the canopy was the eaves trough shared with Roof B, which sat on top of an iron girder above the small Howe-truss running across its length. Attached at the centre/southern end and the northern end was the eastern edge of Roof B.

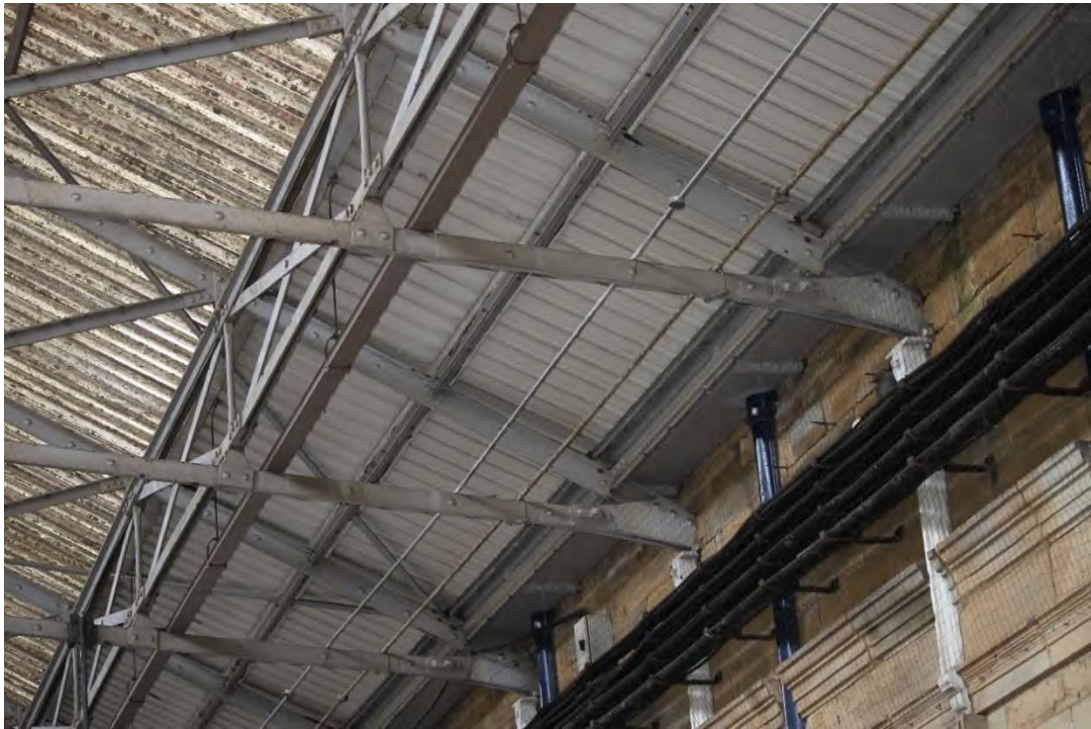
Plate 30: Structural supports with trusses attached above

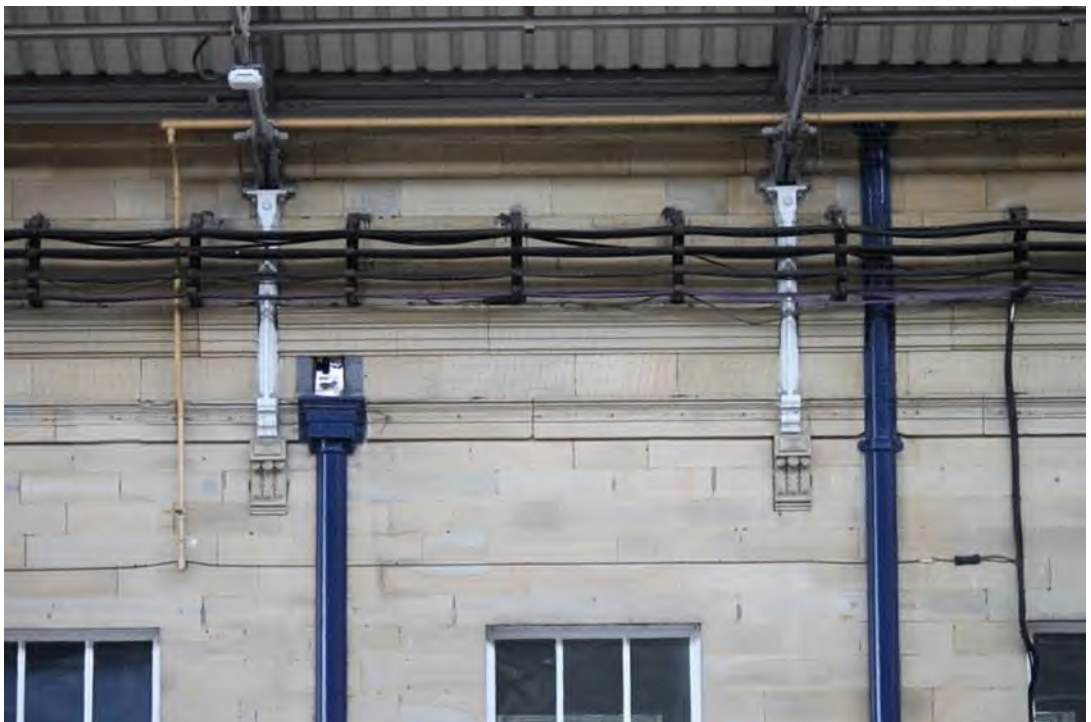
Plate 31: Example of two structural supports attached to the eastern elevation

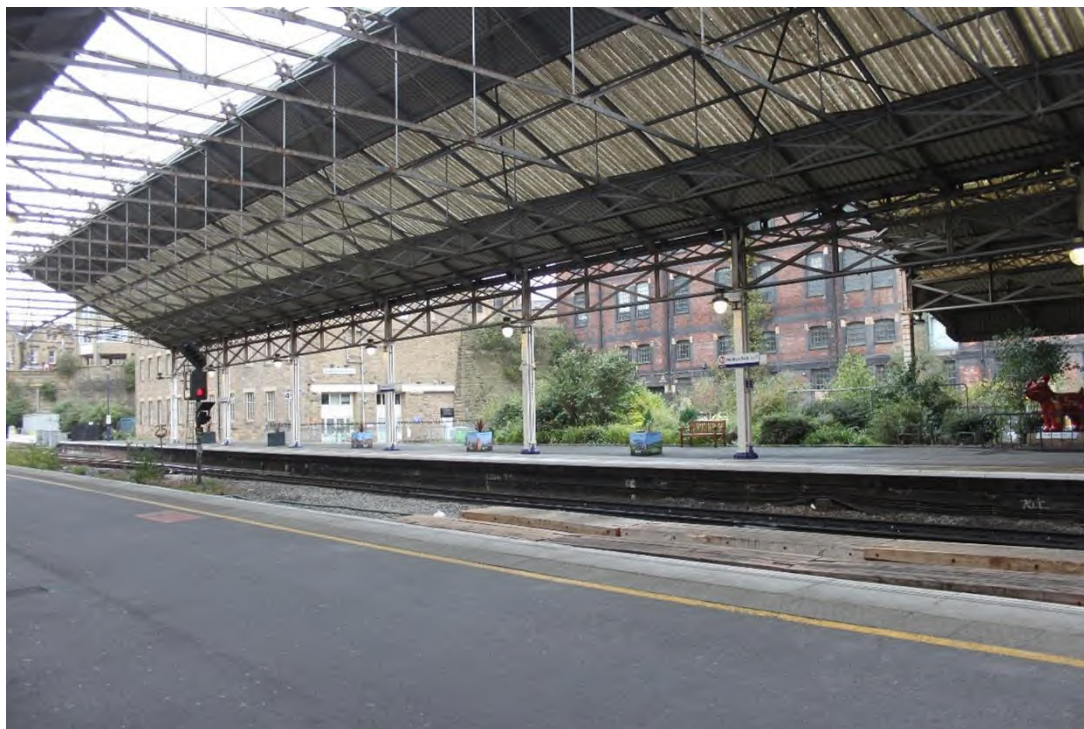
Plate 35: Southern end of western elevation

- 3.2.17 The western elevation comprised a row of 18 columns along the length of the Island Platform that supported the western pitched roof of Roof A (interior) and the eastern pitched roof of Roof B (exterior) (Plate 33, 34 & 35). Sixteen of the columns were of compound-riveted wrought iron construction with five at the southern end forming part of the roof's open structure (the two most southerly bays 1 & 2 were to be removed as part of the TRU programme of works) (Plate 35).

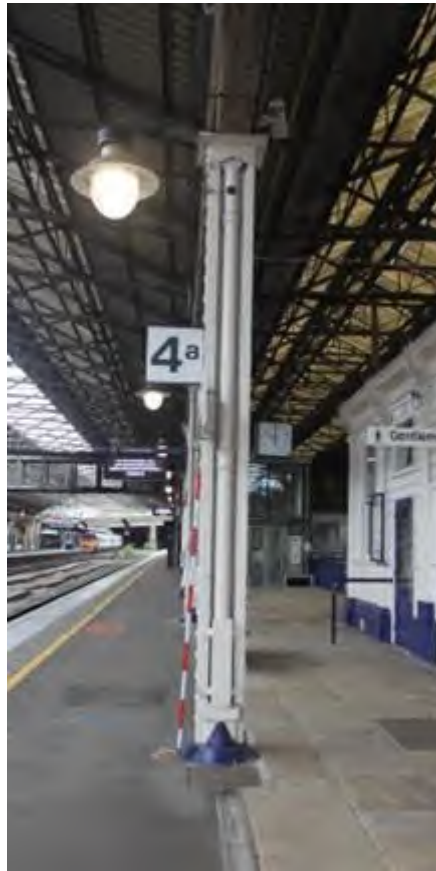
Plate 36: Example of a compound-riveted wrought iron column with 2m scale, facing south

- 3.2.18 Each of the wrought iron columns had incorporated down-pipes, bell-shaped foot detailing and a horizontal plate beneath the longitudinal truss, with the upper section contained within the depth of the truss (Plate 36 & 37). Located at the centre-northern end were two cast iron Corinthian columns with decorated capitals and bases, the base having decorative fleur-de-lis emblems, supporting the structure of Roofs A and B (Plates 38, 39 & 40). Both were distinct in comparison to the wrought iron columns, but it was not clear whether they were constructed as part of the same phase of development or whether they were architectural features that survived the collapse of the initial roof in 1885 (Network Rail Heritage Statement 2023, 23). Unlike the compound-riveted columns, which were evenly spaced apart, the two cast iron columns had a wider gap between them, possibly a design decision so as to avoid placing a column directly over the buried subway beneath (*ibid*).

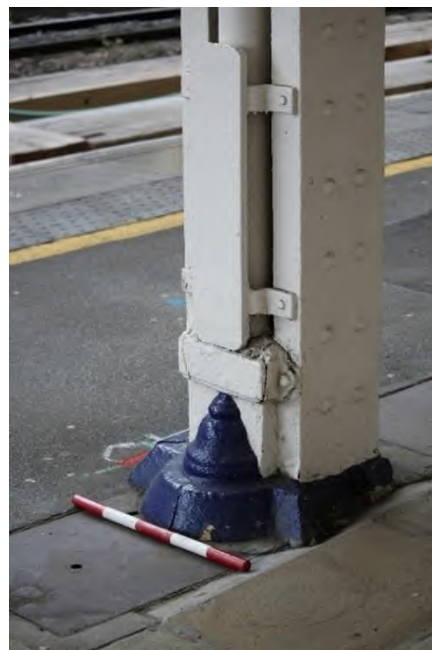
Plate 37: Bell-shaped foot detailing at the base of a compound-riveted wrought iron column with 0.5m scale

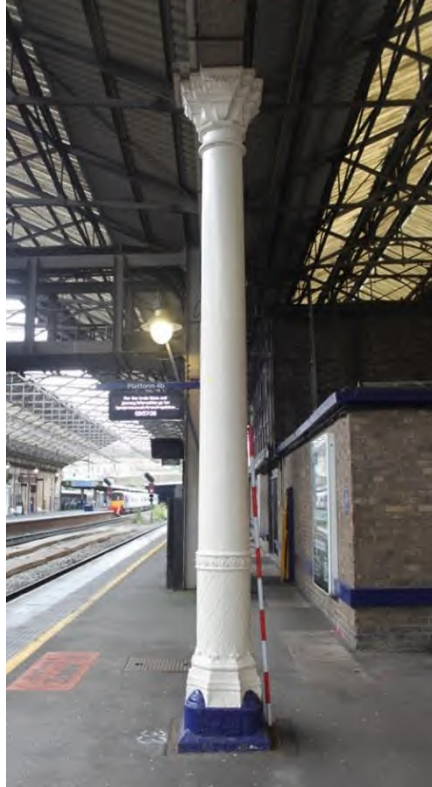
Plate 38: One of the two decorative cast iron columns with 2m scale, facing south

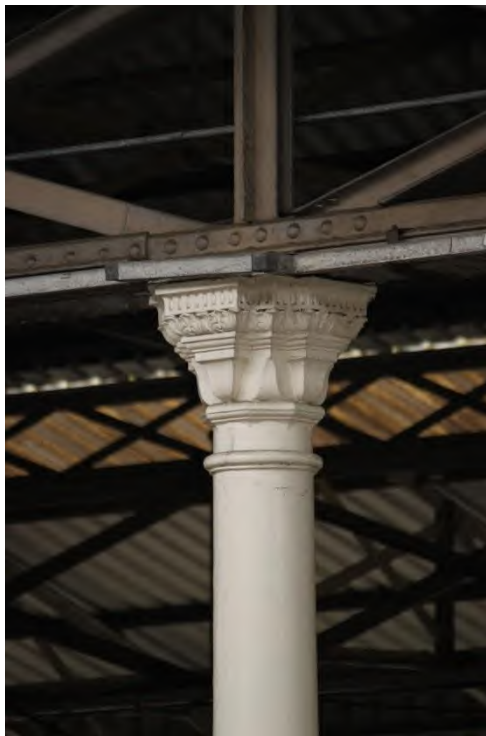
Plate 39: Decorative capital of cast iron capital

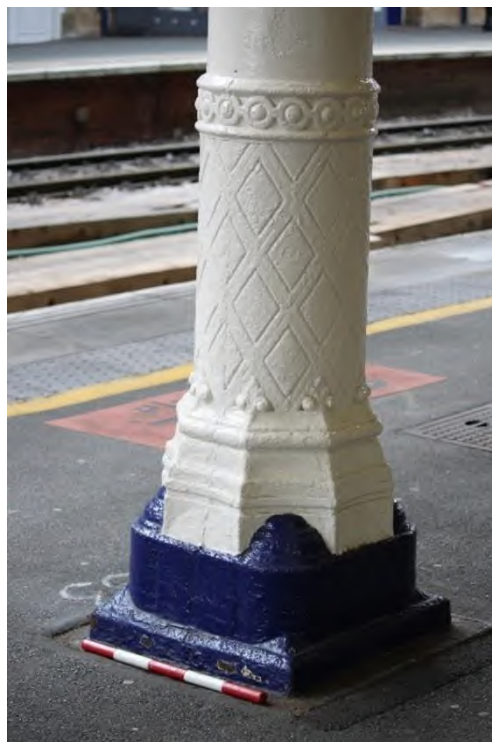
Plate 40: Decorative base of cast iron column with 0.5m scale

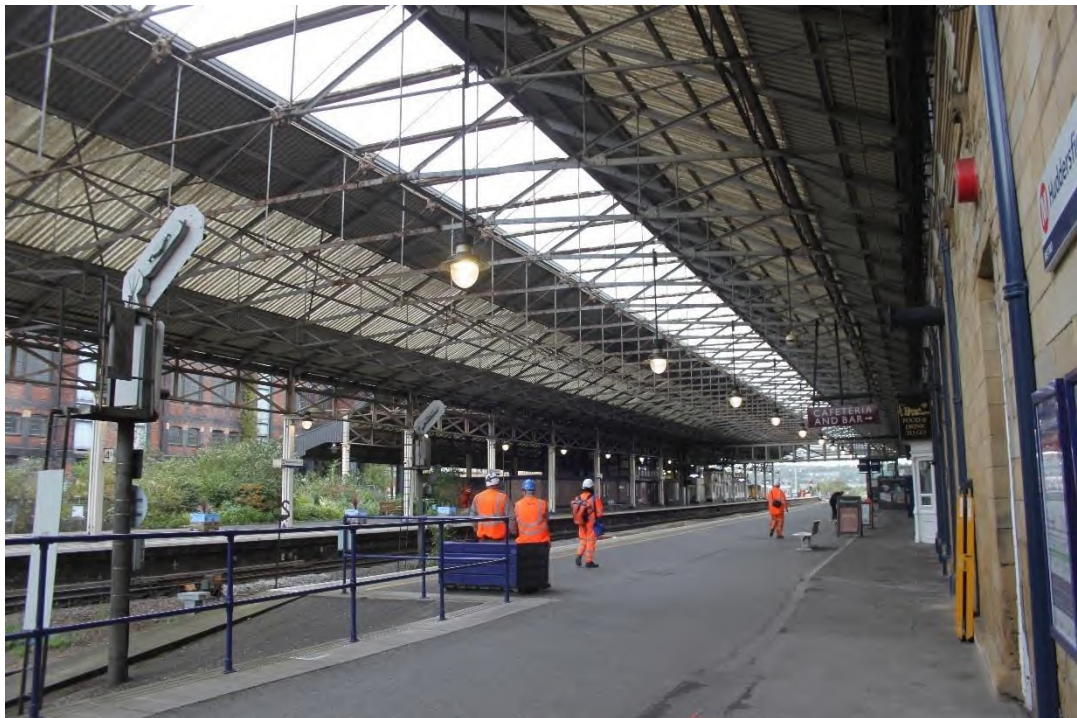
Plate 41: View of underside of Roof A, facing north

- 3.2.21 The central roof structure of Roof A was dominated by the wrought iron trusses which spanned its width and ran along its length. The open gap above, spanned by cross beams connecting the eastern and western pitched roofs, marked the location of the former lantern light (Plate 41). The wrought iron trusses were uniform in design, with central cross-bracing and decorative roundels. They were almost identical in appearance except for four trusses at the southern end (Manchester end), which had tubular rafter tie components
