Transpennine Route Upgrade West, Huddersfield Station: Roofs A, B & C

**Historic Building Investigation and Recording Interim
Report**

January 2024

**Client: BAM Nuttall on behalf
of TRU Alliance**

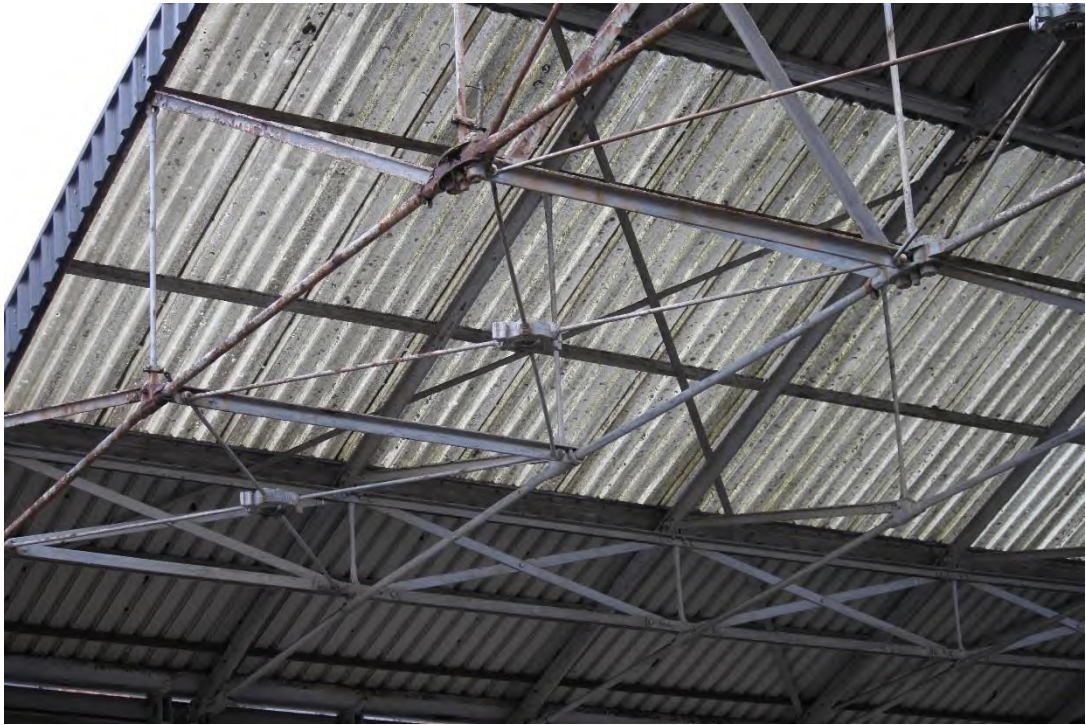
Plate 42: Manchester end of Roof A with tubular rafter ties and decorative moulded fleur-de-lis roundels laid perpendicular to the upright central cross braces

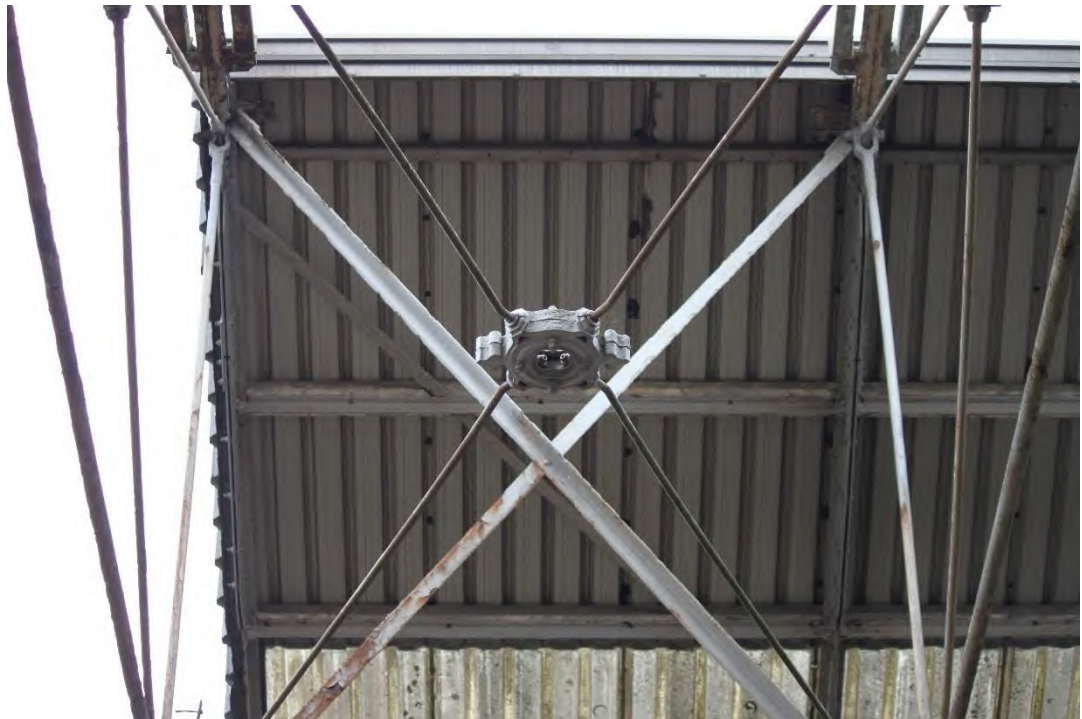
Plate 43: Close up of decorative moulded fleur-de-lis roundel and cross brace

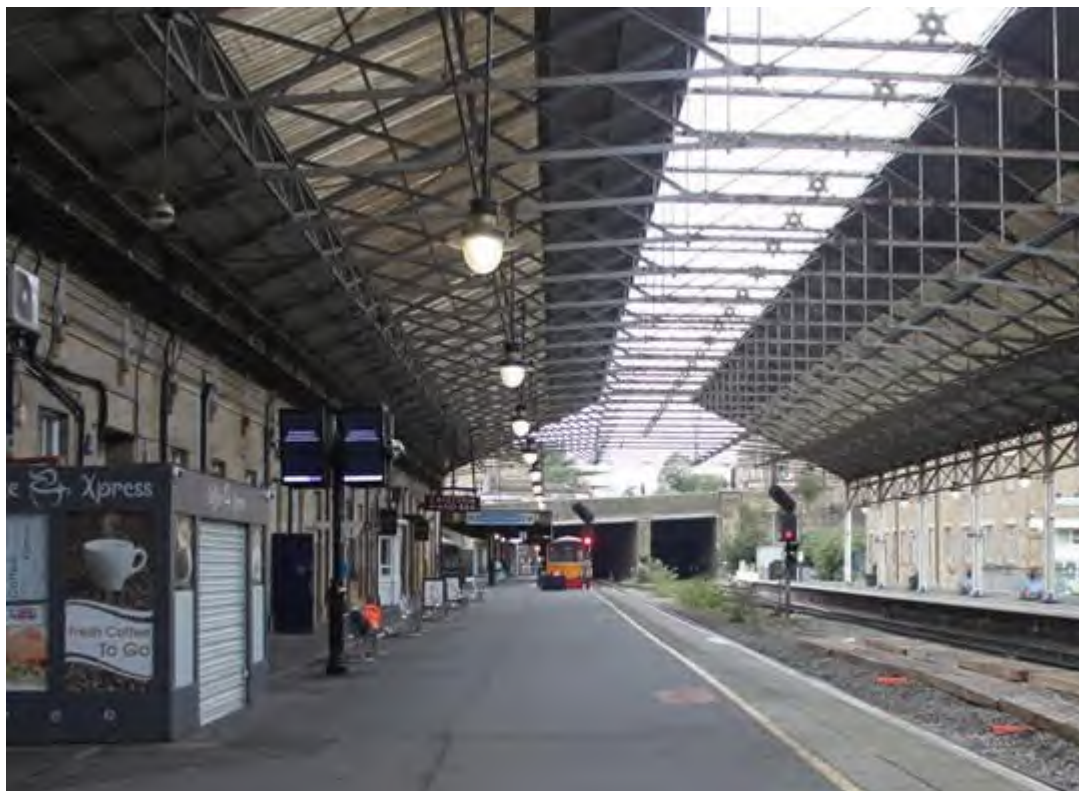
Plate 44: Pendant industrial lighting attached to the western side of the roof trusses

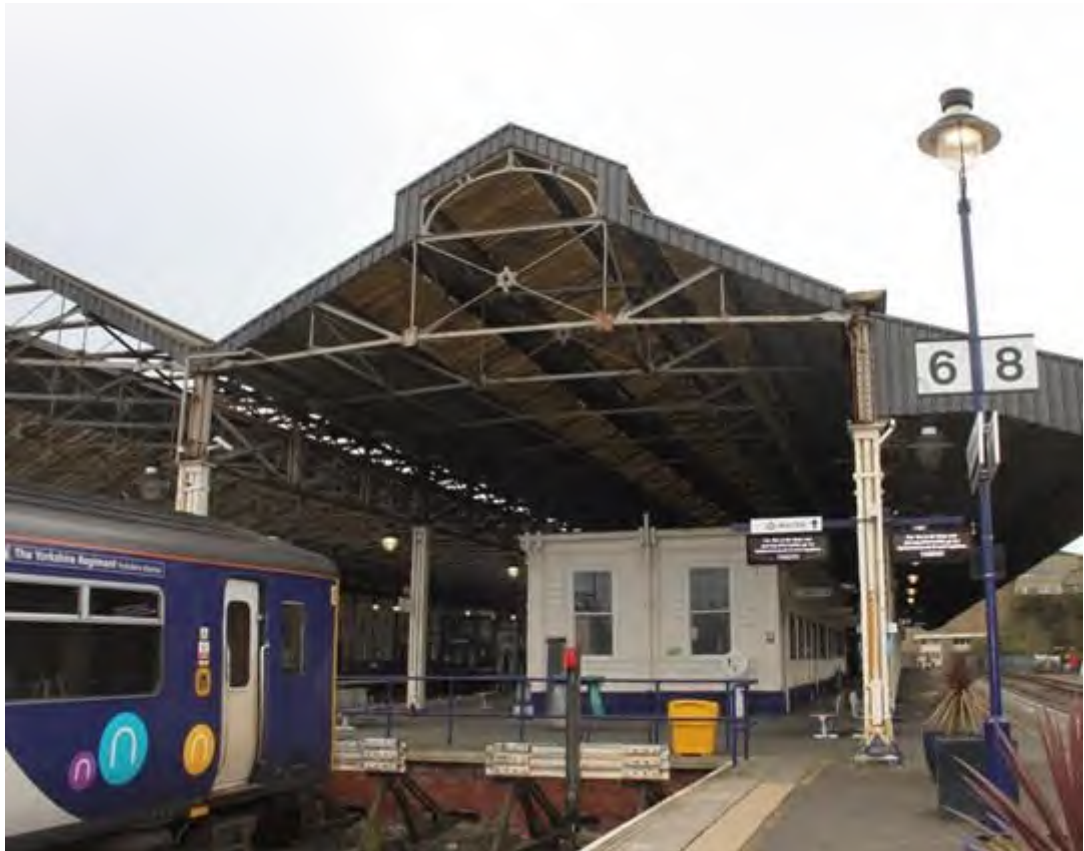
3.3.2 The northern elevation showed the northern gable end of Roof B with its wrought iron truss spanning Platform 4 on the eastern side and Platform 8 on the western side (Plate 45). Its construction was identical to that of the northern gable of Roof A with the same interlocking joists, struts, tie rods and a central moulded roundel, with fleur-de-lis decoration at the intersection of cross-bracing members (Plate 46). Attached at either corner of the central cross brace were two, possibly later, iron plates covering the original connecting plate, with two wrought iron supporting brackets connected to the second truss (Plate 47). Above the central cross brace was a rounded wrought iron arch with two small circular elements and a pointed arch above,

Plate 45: Northern gable end of Roof B with attached Roof A (left) and Roof C (right) and Tea Rooms (centre-right), facing south-east

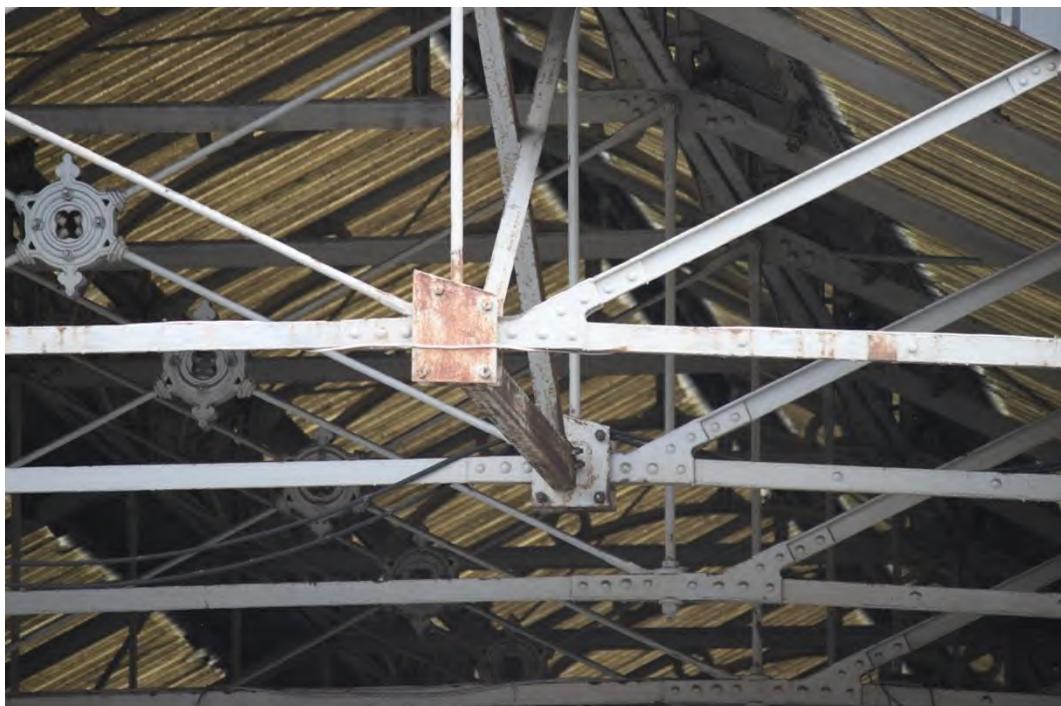
Plate 47: A later supporting bracket located at the western corner of the central cross brace

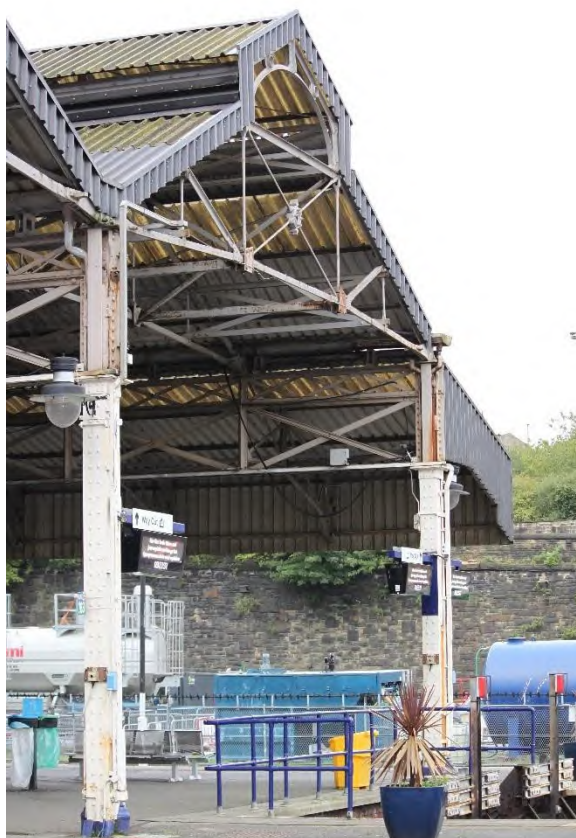
interlocked with joint plates and rivets that formed the northern gable end of the raised roof lantern (Plate 46). Above this and along the roofline of the pitched roof, the face of the rafters were covered by strips of corrugated metal cladding. At the eastern end was the attached Roof A and on the western side was the attached cantilevered Roof C. Beneath these, at both the eastern and western ends, the roof was supported on compound-riveted wrought iron columns with incorporated downpipes and bell-shaped foot detailing (Plate 48).

Plate 48: Northern gable end of Roof B with wrought iron column supports, facing west

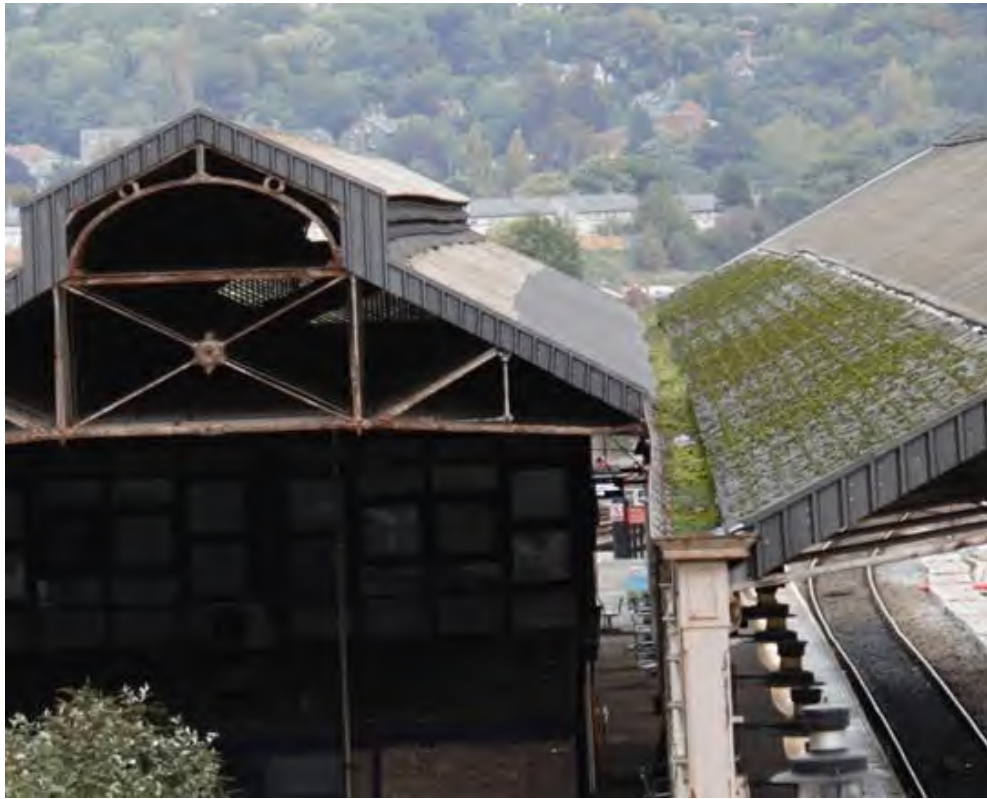
- 3.3.4 Beneath the bottom edge of the roof canopy was the eaves trough shared by Roof A and Roof B. Above this, the pitched roof was topped with grey corrugated metal sheeting across the lower and upper section with translucent corrugated fibre sheeting across the centre (Plate 49). Where the upper section of the pitched roof met the raised roof lantern, two rows of sheet metal created longitudinal ventilation slats, with the eastern-pitched roof of the lantern covered by translucent corrugated fibre sheeting (Plate 50).

Plate 49: Eastern pitched roof of Roof B (centre) with eastern pitch of roof lantern above (centre-left) and Roof A attached (right), facing north

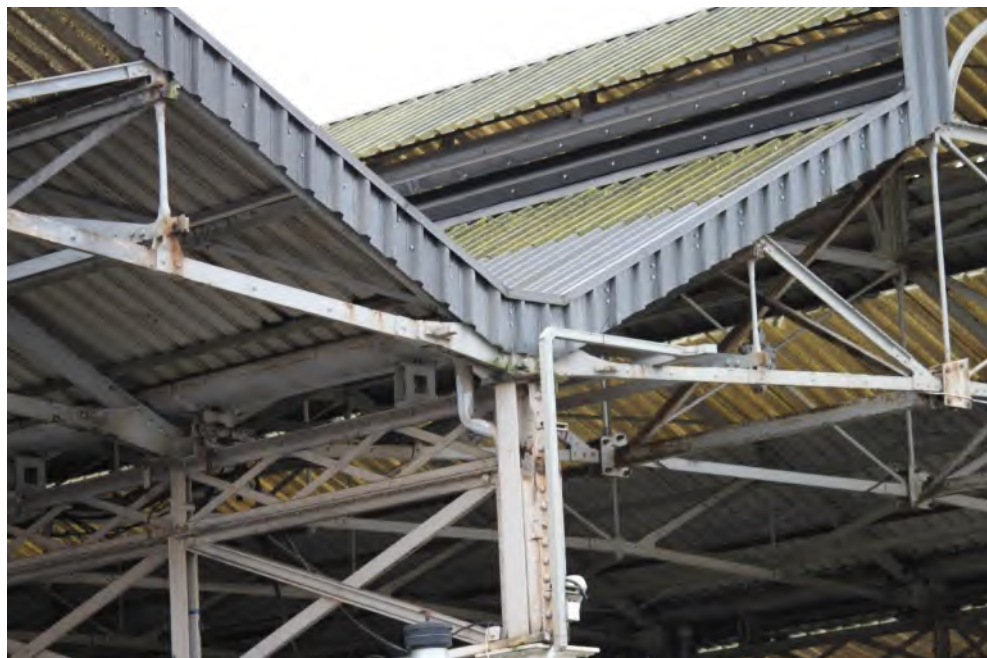
Plate 50: Northern corner of eastern elevation showing longitudinal slats and translucent corrugated fibre pitched roof of lantern with attached western corner of Roof A (centre-left), facing south-west

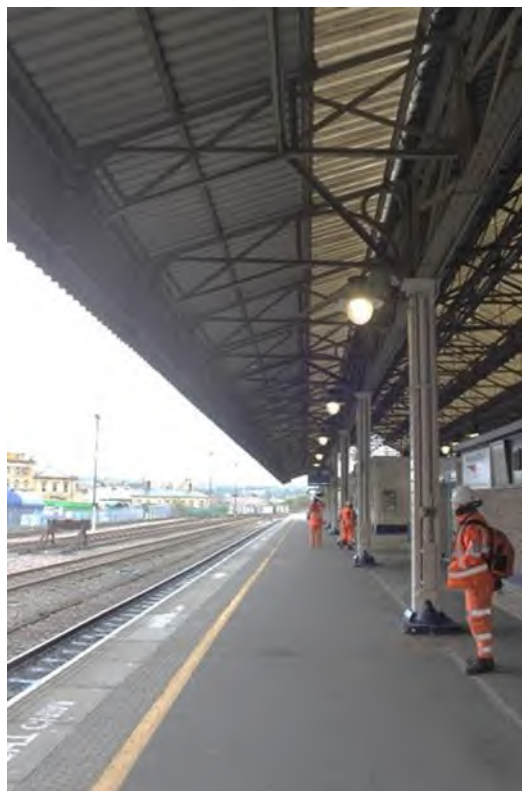
- 3.3.5 The lower external western elevation comprised 14 supporting compound-riveted wrought iron columns, each with incorporated down-pipes, that were evenly spaced along the roof's length (Plate 51 & 52). Attached to the majority of the columns were station fixtures and fittings including signage, platform numbers and on the upper section industrial lighting. The girders which spanned the columns were composite lattice beams with exposed rivets consisting, in places, of a deep Howe-truss, some appearing to be of a slightly different construction displaying thin lattice beams, with small trusses above. Attached to the vertical beams of the larger lattice trusses were the supporting roof brackets of the cantilevered Roof C protruding to the west (Plate 53).

Plate 51: Lower western elevation of Roof B, facing north

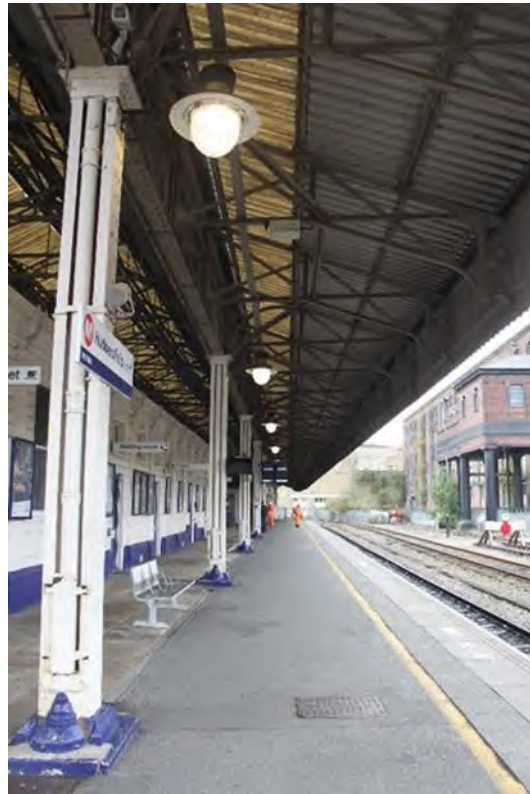
Plate 52: Lower western elevation of Roof B with Large Brick Warehouse (NHLE 1228533) (far-right) facing south

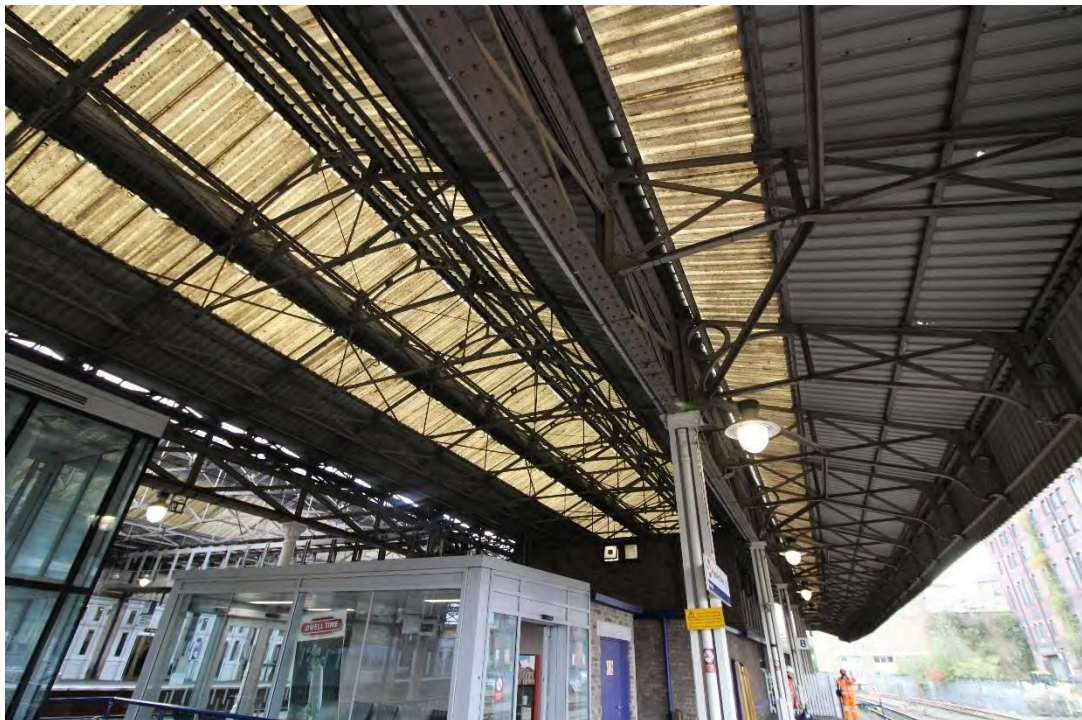
Plate 53: Narrow lattice beams (upper centre) and attached cantilevered Roof C

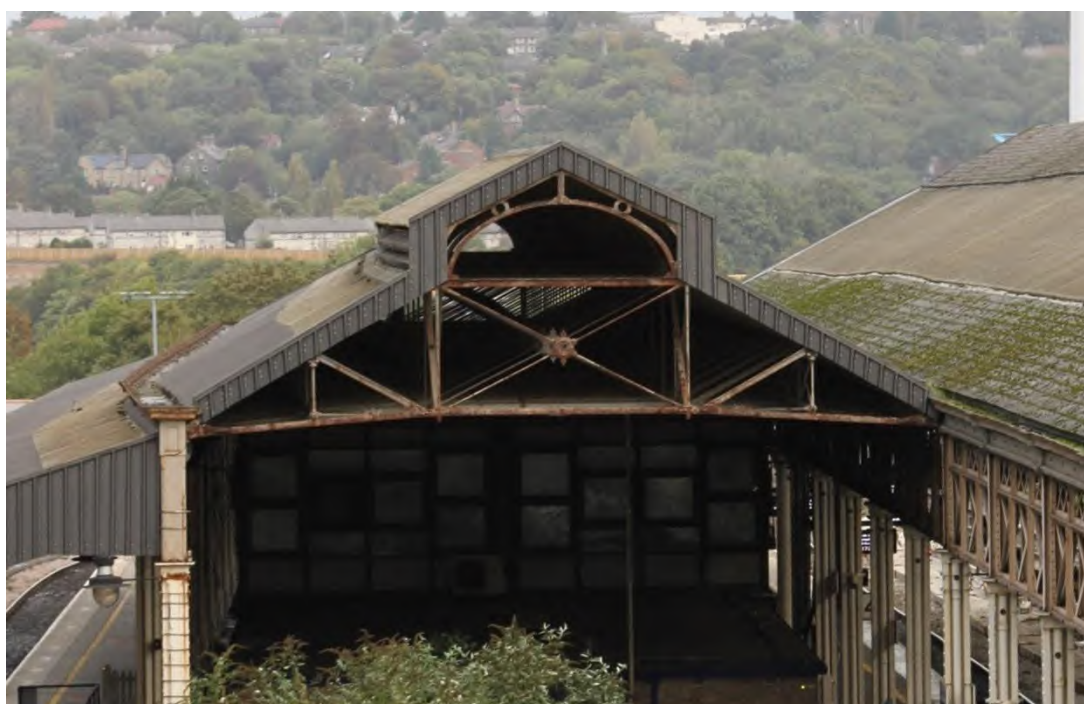
- 3.3.6 As with the eastern elevation, beneath the bottom edge of the canopy was an eaves trough above the western column (Plate 54), which ran the length of canopy and above the top edge of the cantilevered Roof C. Above this, the western pitched roof was of the same construction as the eastern elevation with a lower section of corrugated metal sheeting, a central section of translucent corrugated fibre sheeting and a narrow strip of corrugated metal sheeting above that. Again, where the upper section of the pitched roof met the raised roof lantern, two rows of metal sheeting created longitudinal ventilation slats, with its eastern pitched roof constructed of translucent corrugated fibre sheeting.

Plate 54: Partially visible western pitched roof of Roof B (left) with western pitch of roof lantern above (centre-left), facing south

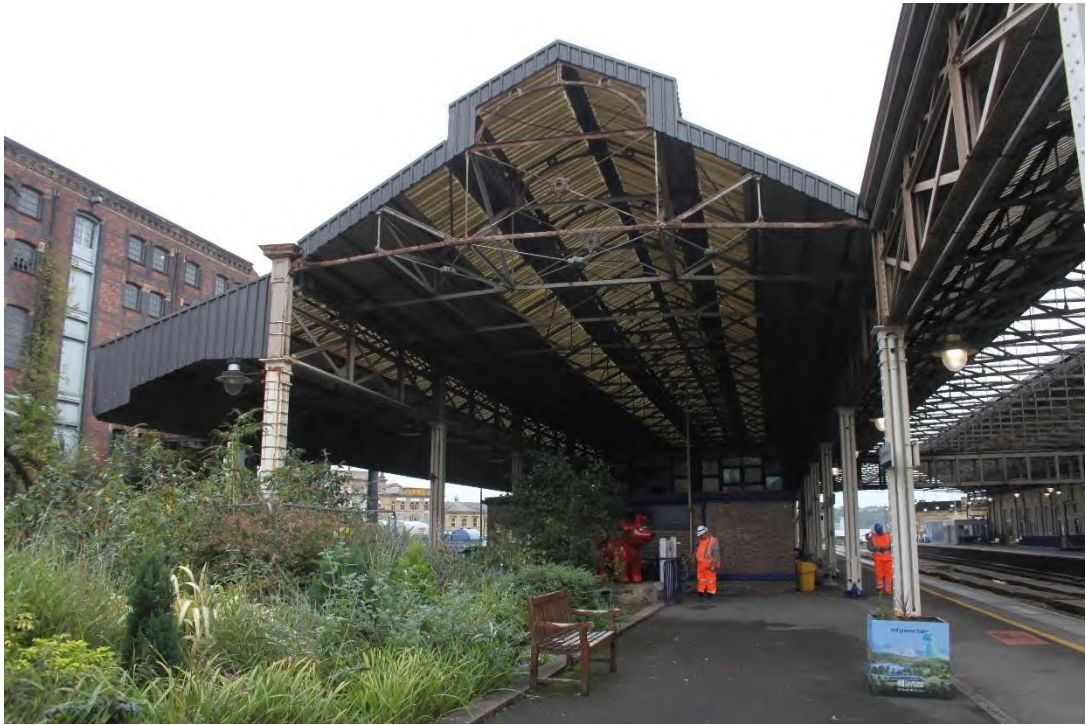
- 3.3.7 The southern gable end was identical in construction and appearance to the northern gable end with a wrought iron truss containing a central moulded roundel with fleur-de-lis decoration at the intersection of cross-bracing members (Plate 55 & 57). The truss was held together by joint plates, rivets and bolts and spanned Platform 4 on its eastern side and Platform 8 on its western side. Above, was another wrought iron curved arch with two small circular elements and a pointed arch above, forming the southern gable end of the raised roof light (Plate 56). Along the edge of the roof line, the south-facing rafters were covered by sheets of corrugated metal cladding. The southern gables condition was, however, notably worse than the northern gable end as there was greater evidence of surface corrosion to the iron components.

Plate 55: Southern elevation of Roof B with Roof A attached (right), cantilevered Roof C attached (left) and Large Brick Warehouse (1228533), facing north

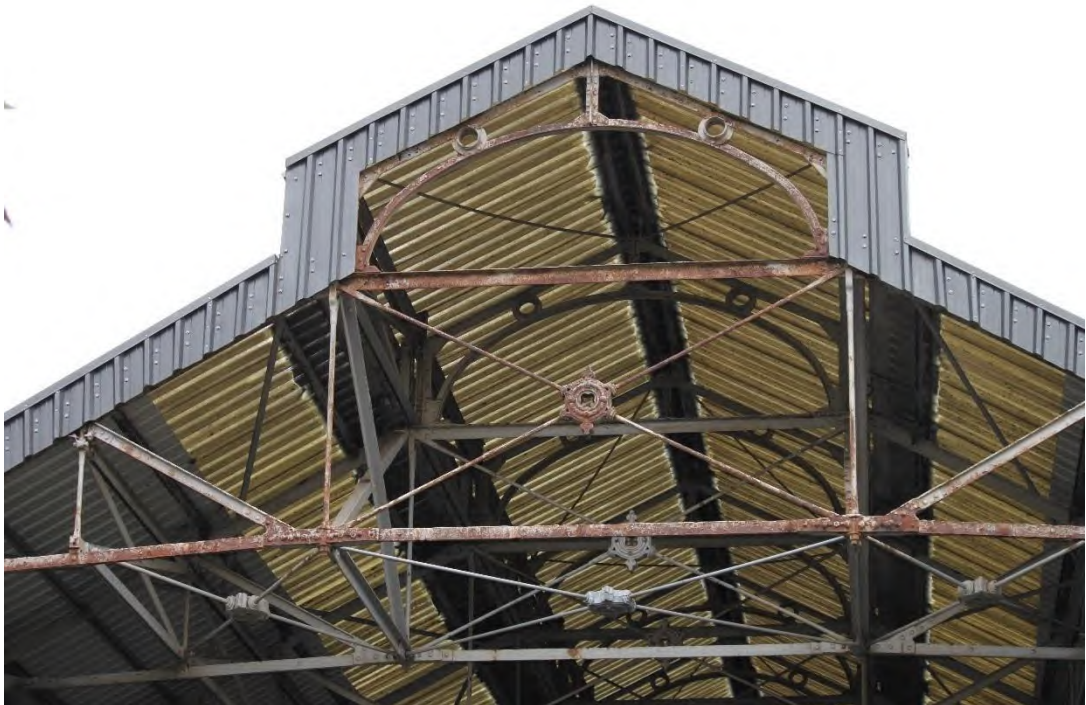
Plate 56: Southern gable end of raised roof lantern with central cross brace and moulded roundel beneath

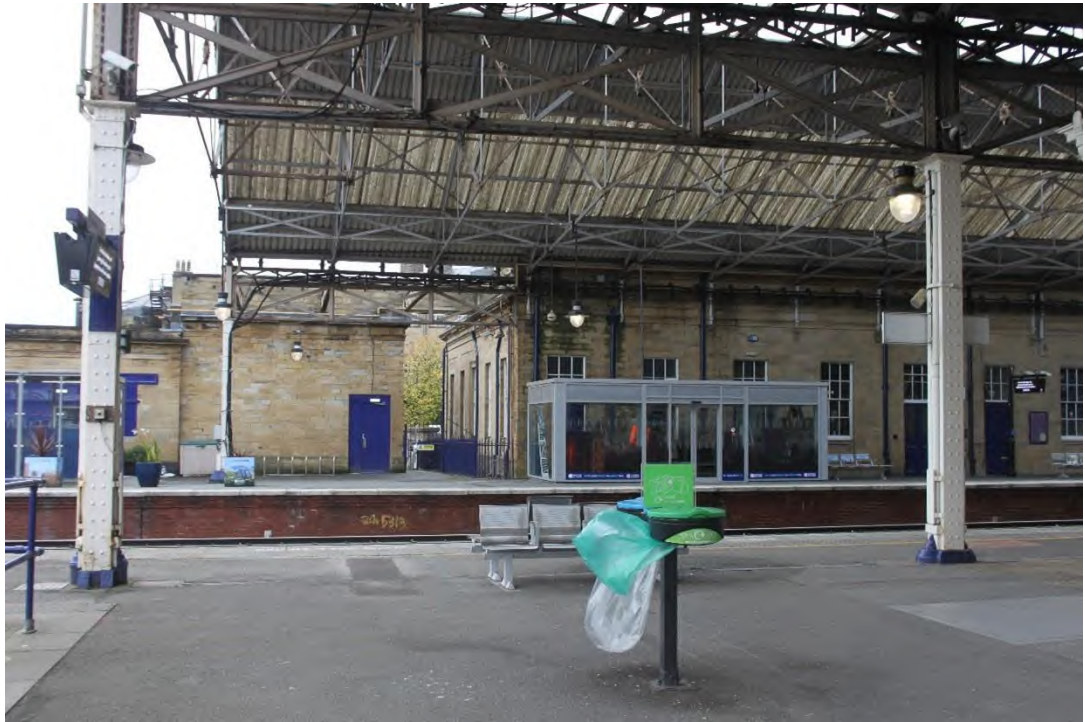
Plate 58: Eastern elevation of two wrought iron columns with lattice beams located at the northern end of Roof B, facing east

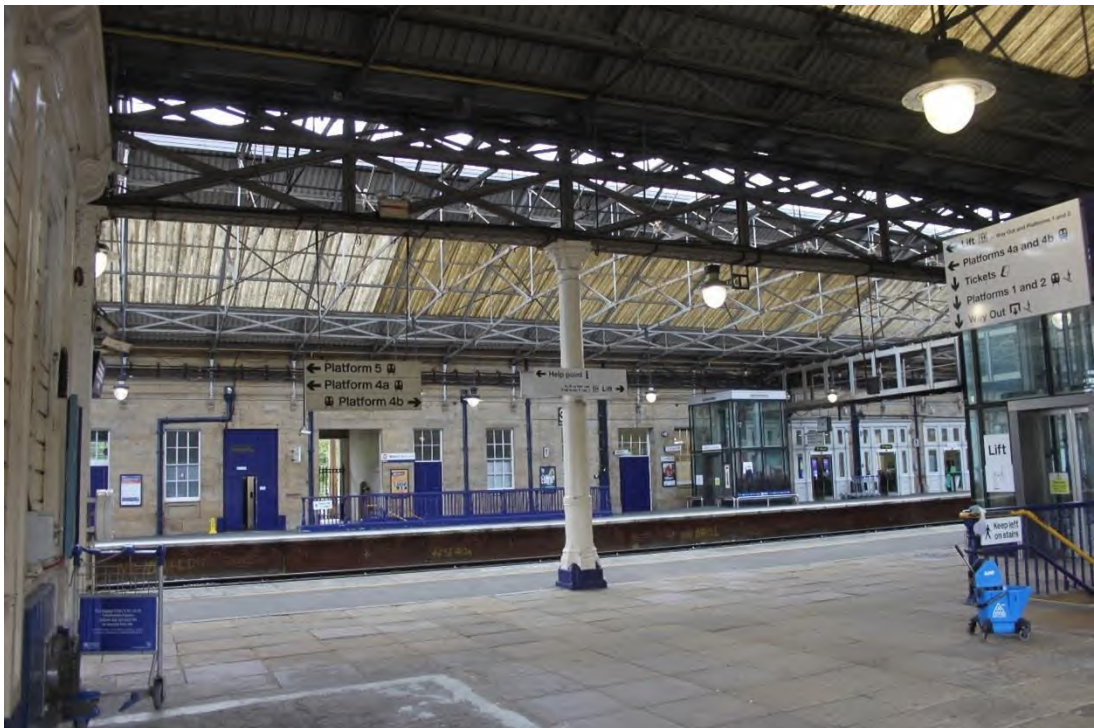
Plate 59: Eastern elevation showing centre-north located cast iron column with lattice beams above, facing east

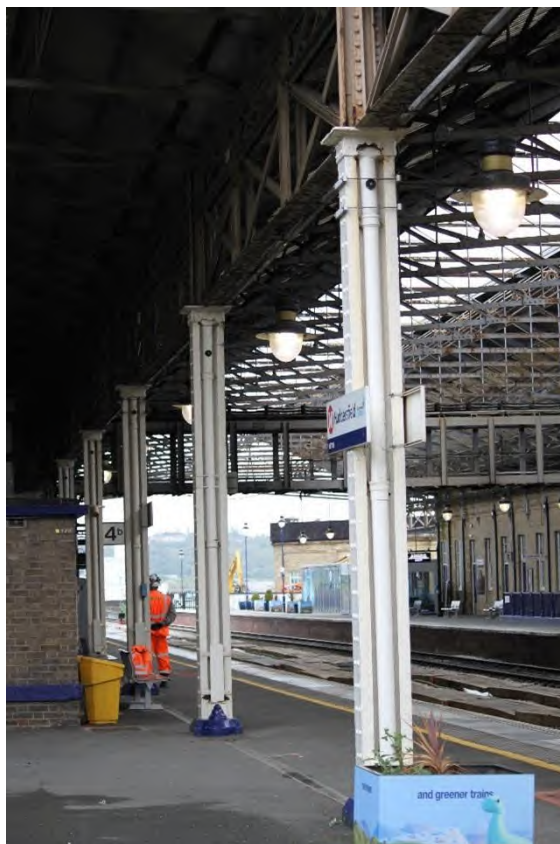
Plate 60: Southern end of eastern elevation

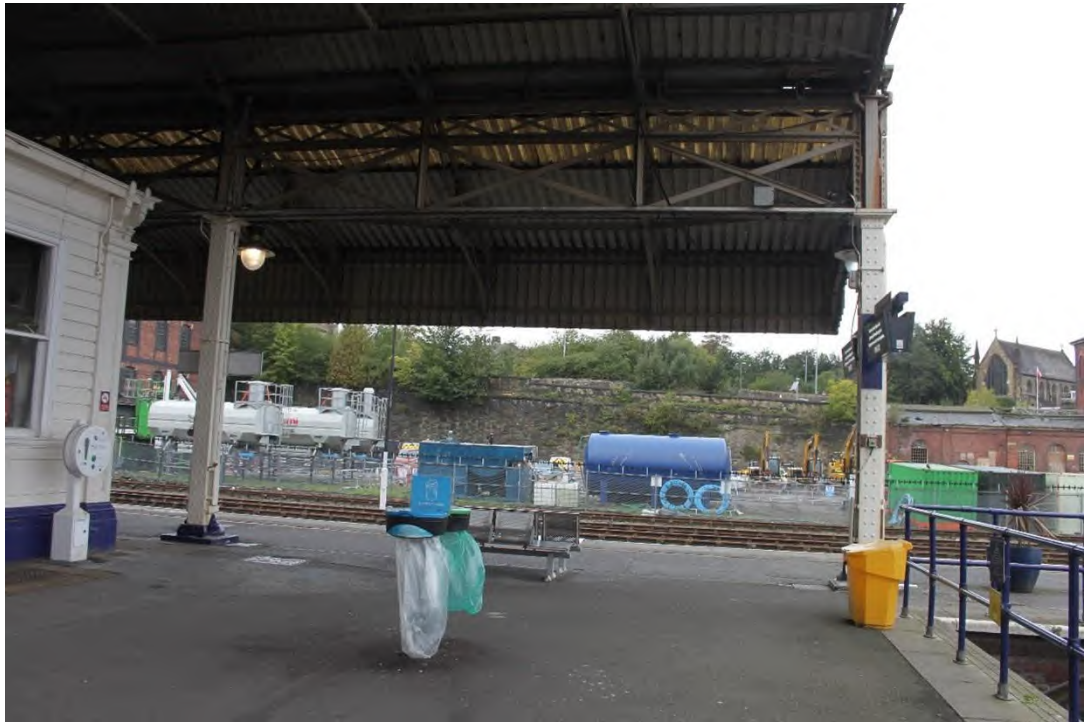
Plate 61: Western elevation of two wrought iron columns with lattice beams located at the northern end of Roof B with the goods yards visible behind, facing west

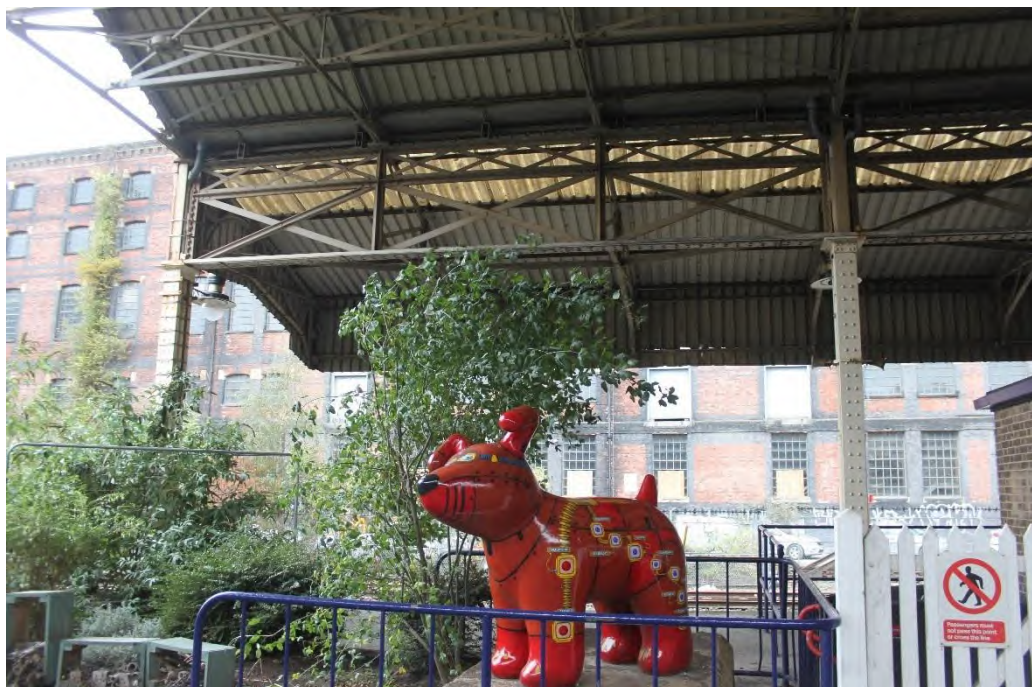
- 3.3.12 The western elevation comprised the internal face of 14 compound-riveted wrought iron columns with incorporated down-pipes and longitudinal lattice beams consisting of a deep Howe-truss and smaller truss above spanning between them (Plate 61 & 62). Level with the height of the smaller truss, modern piping could be seen connecting the underside of the eaves trough to the down-pipes (Plate 62). Above the smaller truss, the large pitched trusses which spanned the width of the roof were connected above (Plate 63).

Plate 62: Southern end of western elevation with Large Brick Warehouse (NHLE 1228533) behind, facing west

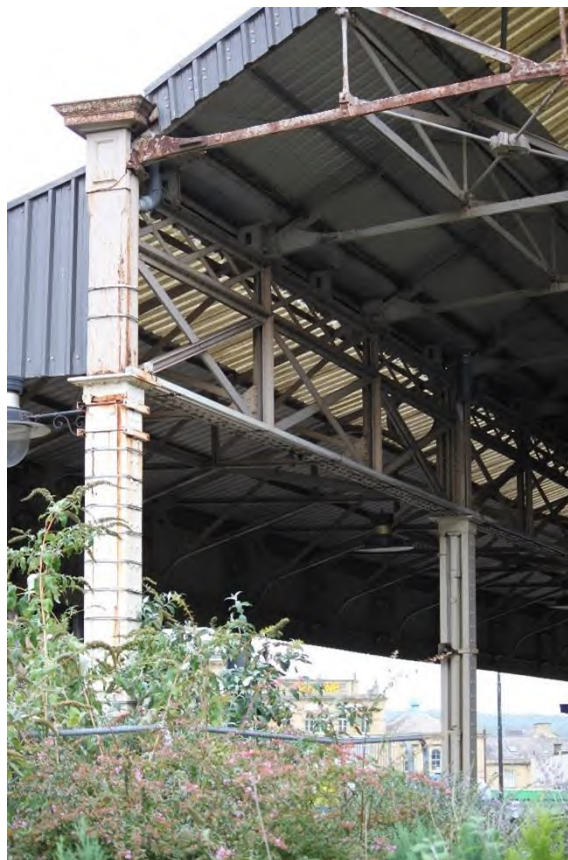
Plate 63: Southern corner of western elevation showing the western ends of the principal trusses connected above the small Howe truss, facing north-west

- 3.3.13 Above the top girder of the small truss was the underside of the canopy roof with the underside of the lower corrugated metal sheeting and the translucent corrugated fibre sheeting present through the centre providing a dim light (Plate 63). Beneath the line of the fibre sheeting, lattice bracing was suspended from the roof's underside and extended its length, passing through the eastern corner of the principal trusses.

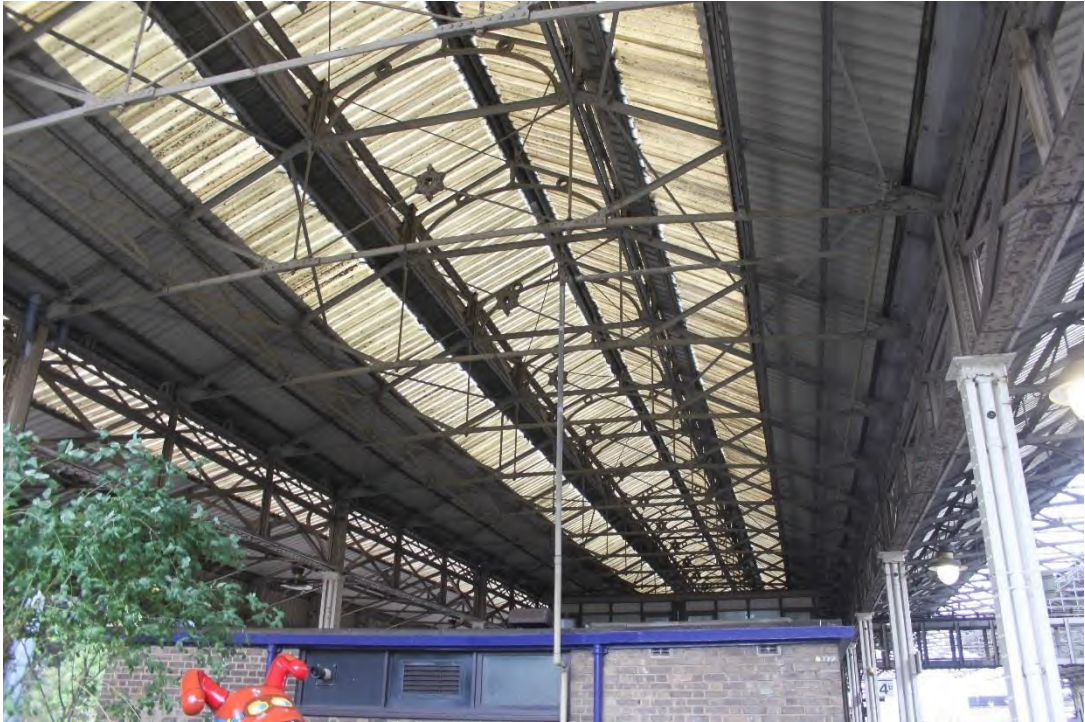
- 3.3.14 The central underside of Roof B was dominated by the principal wrought iron trusses comprised of joists, struts and tie rods, interlocked with joint plates, rivets and bolts, which spanned its length and were identical in design to the one present at the northern and southern gable ends, with fleur-de-lis moulded roundels and central cross-bracing members (Plate 64). The positioning of the trusses lined up with those trusses of Roof A and the half trusses of Roof C. Above, the extant roof lantern was supported by a curved and pointed arch separated by two small circular elements, located on top of each of the principal trusses that connected to the central ridge of the lantern by joint plates and bolts (Plate 65). V-shaped brackets and tie-rods were also connected to the trusses and longitudinal lattice bracing ran the length of the roof, between the lower edge of the lantern and top edge of the pitched roof on both the eastern and western sides. Along the lower section of the

Plate 64: Underside of Roof B and lantern, north-west

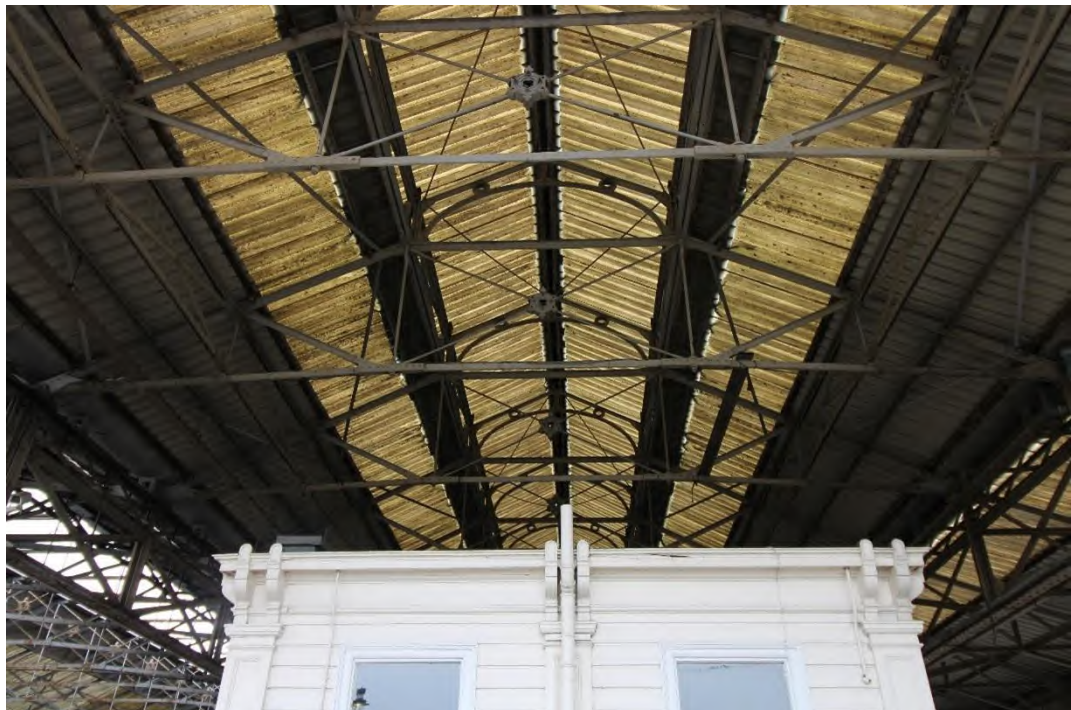
Plate 65: Northern end of underside of Roof B and lantern with northern elevation of 'Tea Rooms' (bottom)

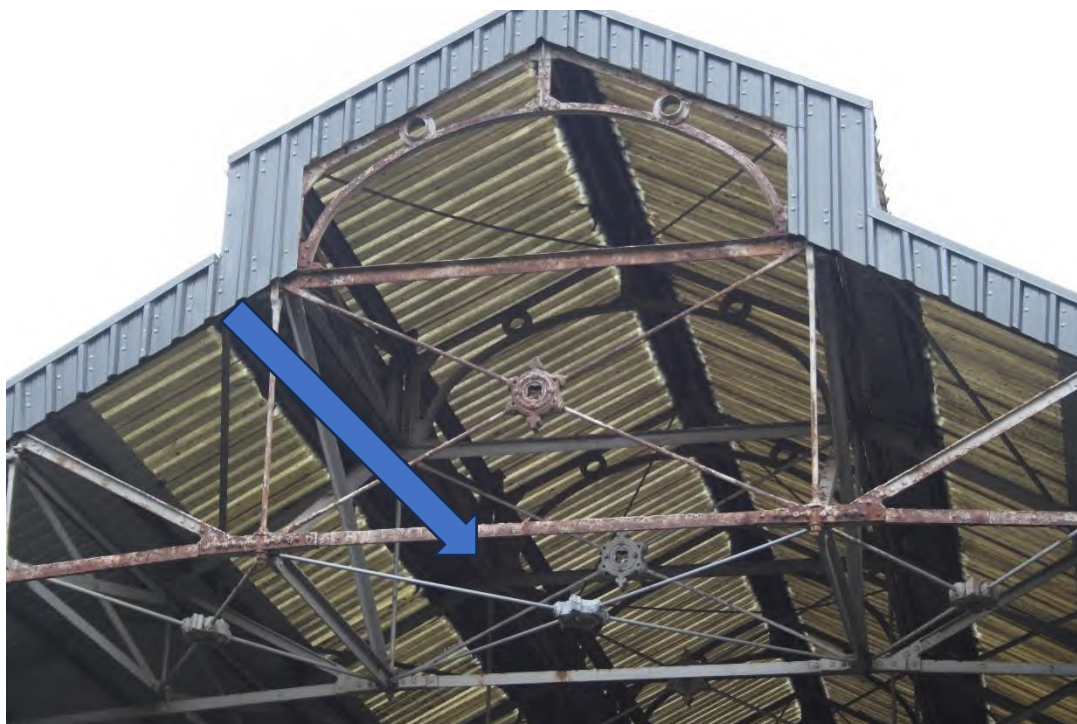
Plate 66: Decorative moulded fleur-de-lis roundels (bottom) laid perpendicular to the upright central cross bracing members at the southern end of Roof B, marked by arrow

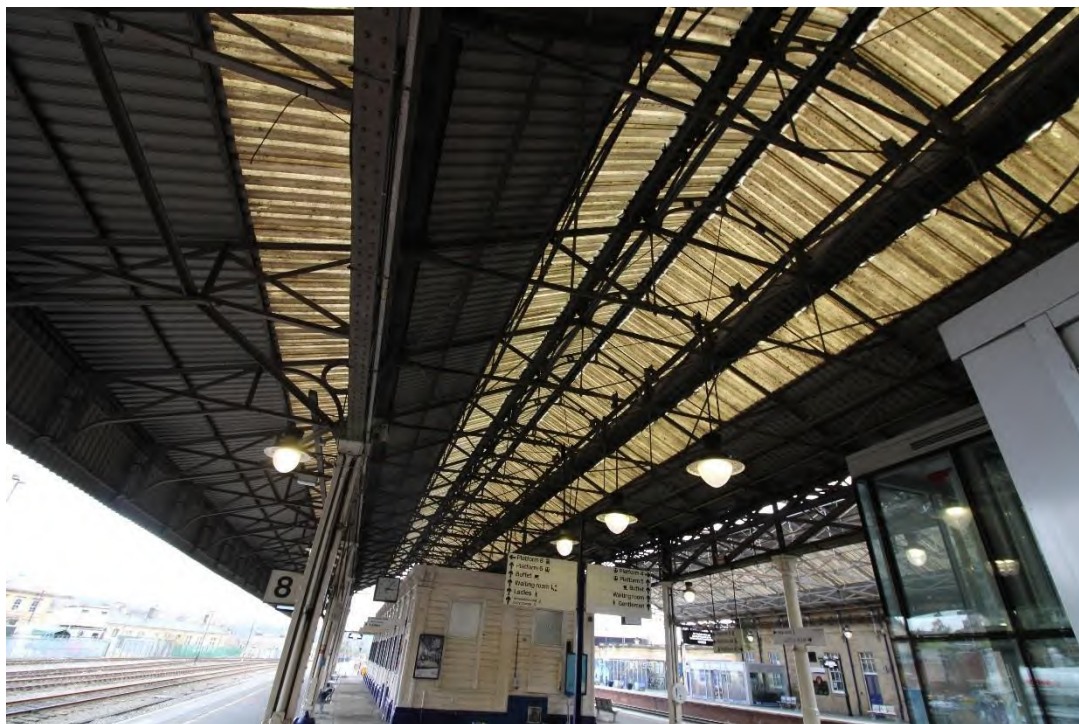
- 3.3.16 Attached to a principal truss at the northern-end were two squared clocks, likely dating to the second half of the twentieth century which hung over the eastern and western platforms (Plate 67). Located centrally attached to three principal trusses were three industrial pendant lights (Plate 67). Beyond this at the central-southern end, the roof of the twentieth century signal box was located just beneath the principal trusses.

Plate 67: Northern end of Roof B with two station clocks hung either side of the 'Tea Rooms' and three central pendant industrial lights, facing north-east

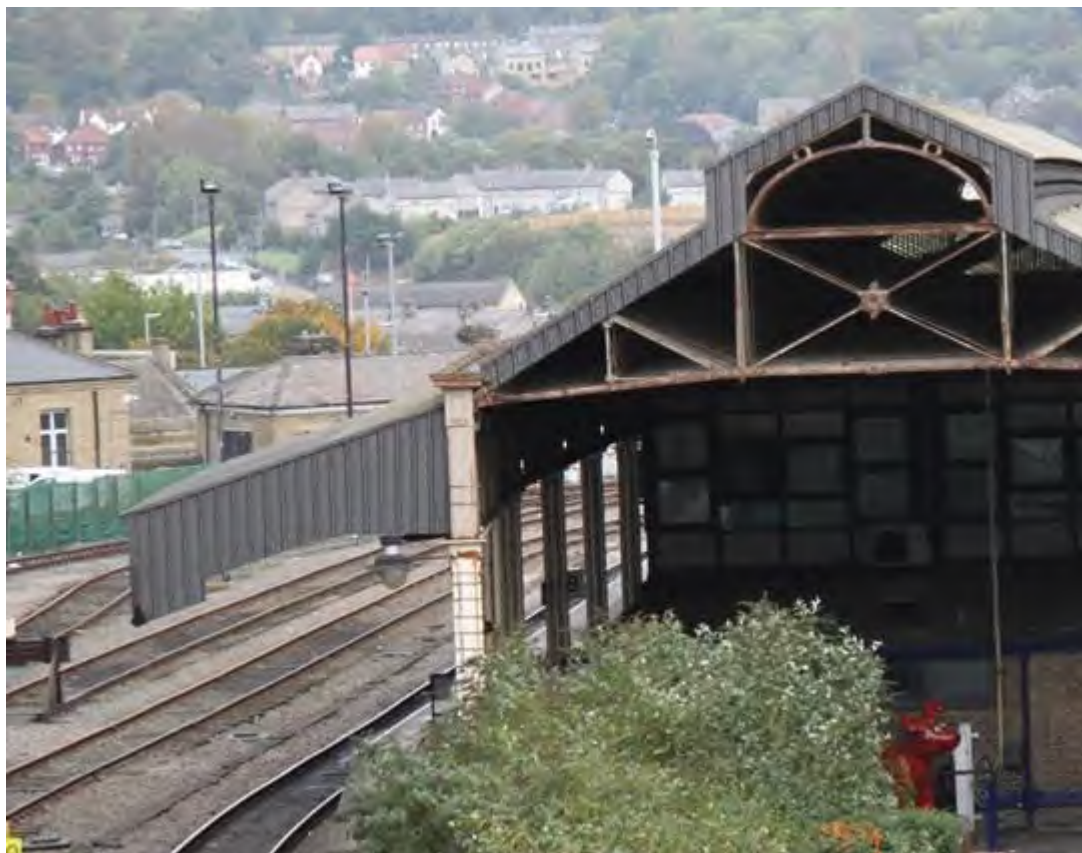
- 3.4.1 Roof C was a cantilevered canopy measuring a width of approximately 5m and attached on its eastern edge to the western edge of Roof B, extending over the edge of Platform 8 (Plate 68). Its external appearance showed it to be constructed of corrugated metal sheeting topped across its upper section by translucent corrugated fibre sheeting. Its northern, southern and western elevations were formed of dropdown corrugated metal sheeting which hung from its edges with the northern and southern ends having a slight arch shape to enable train traffic to pass beneath (Plate 68).

Plate 68: Southern elevation of Roof C (left) attached to western edge of Roof B (centre), with the Former Good Storage Yard and former Office Building visible in the goods yard (background left), facing north

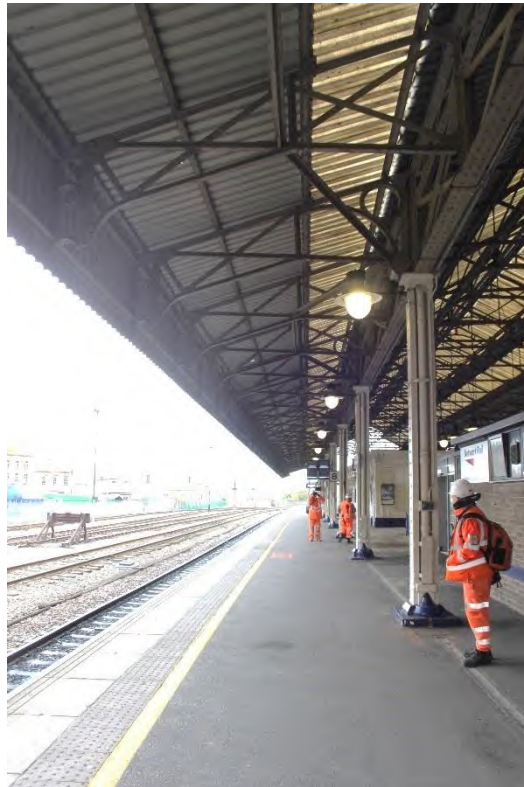
Plate 69: Northern end of Roof C, facing north

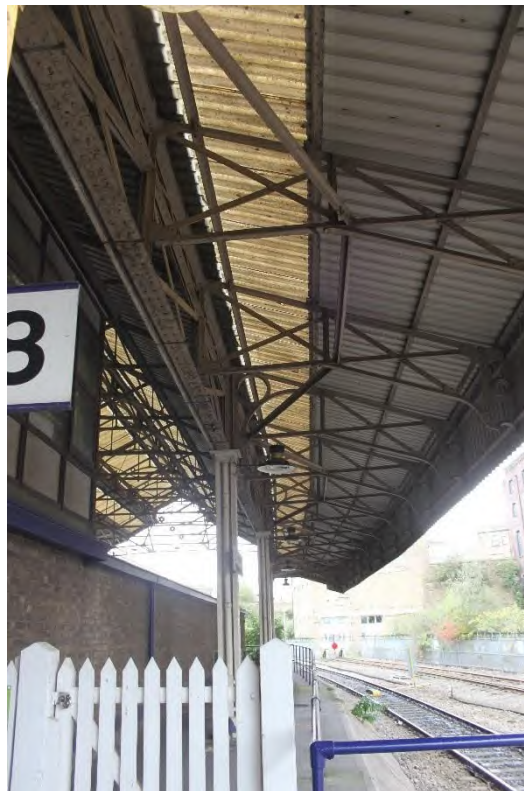
Plate 70: Southern end of Roof C with partial eastern elevation of the Large Brick Warehouse (NHLE 1228533) (right), facing south

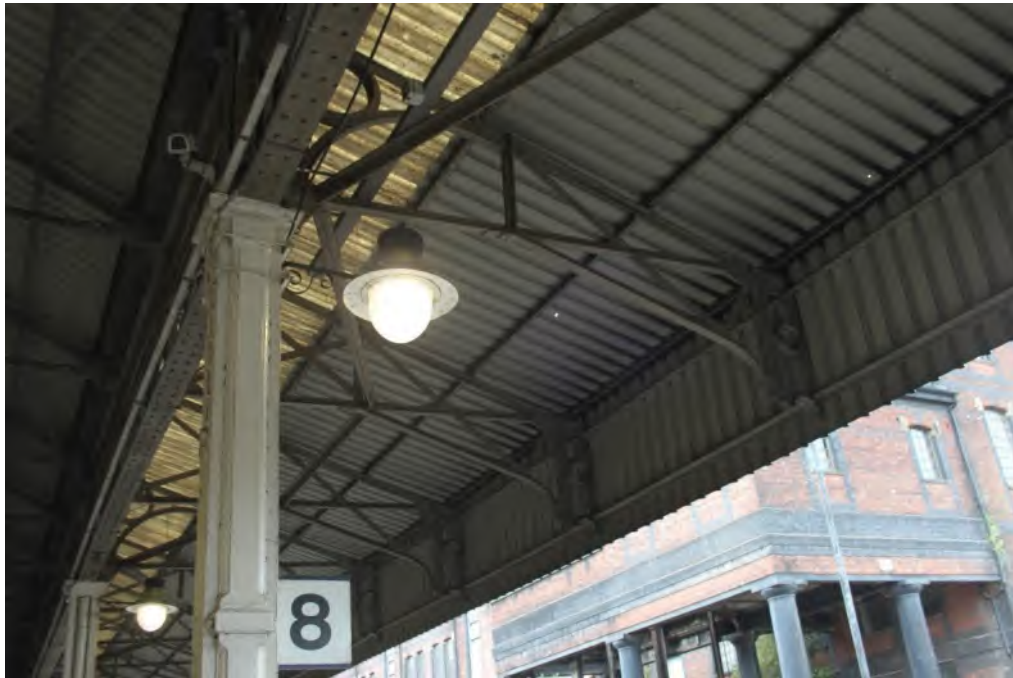
Plate 71: Example of riveted lattice wrought iron brackets within Roof C With the Large Brick Warehouse (NHLE1228533) (background left), facing south-west

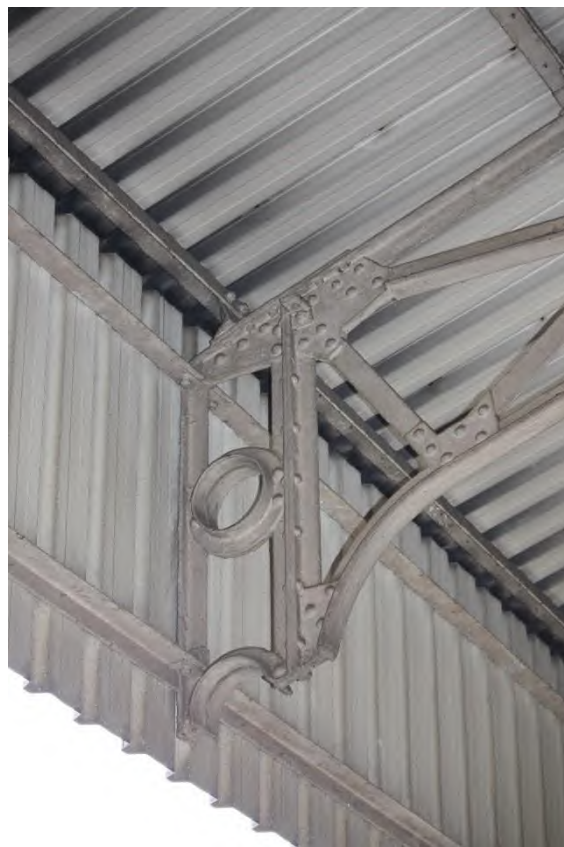
Plate 72: Example of the western end of a riveted lattice wrought iron bracket attached to the western dropdown corrugated metal sheeting
