Transpennine Route Upgrade West, Huddersfield Station: Roofs A, B & C

**Historic Building Investigation and Recording Interim
Report**

January 2024

**Client: BAM Nuttall on behalf
of TRU Alliance**

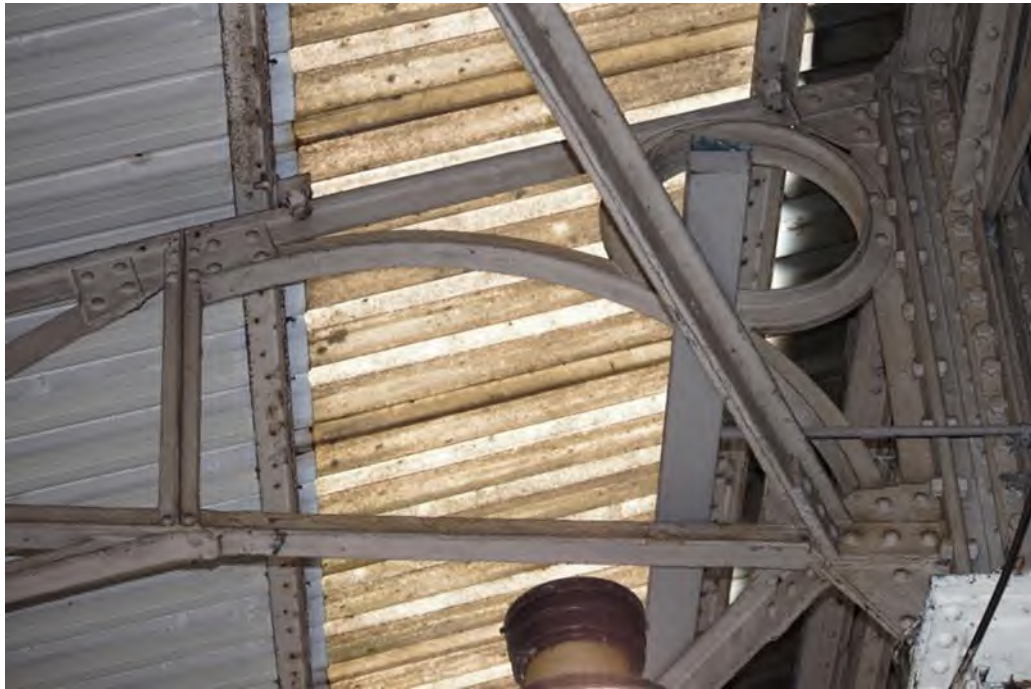
Plate 73: Example of eastern end of a riveted lattice wrought iron bracket attached to the western composite lattice beam of Roof B (right)

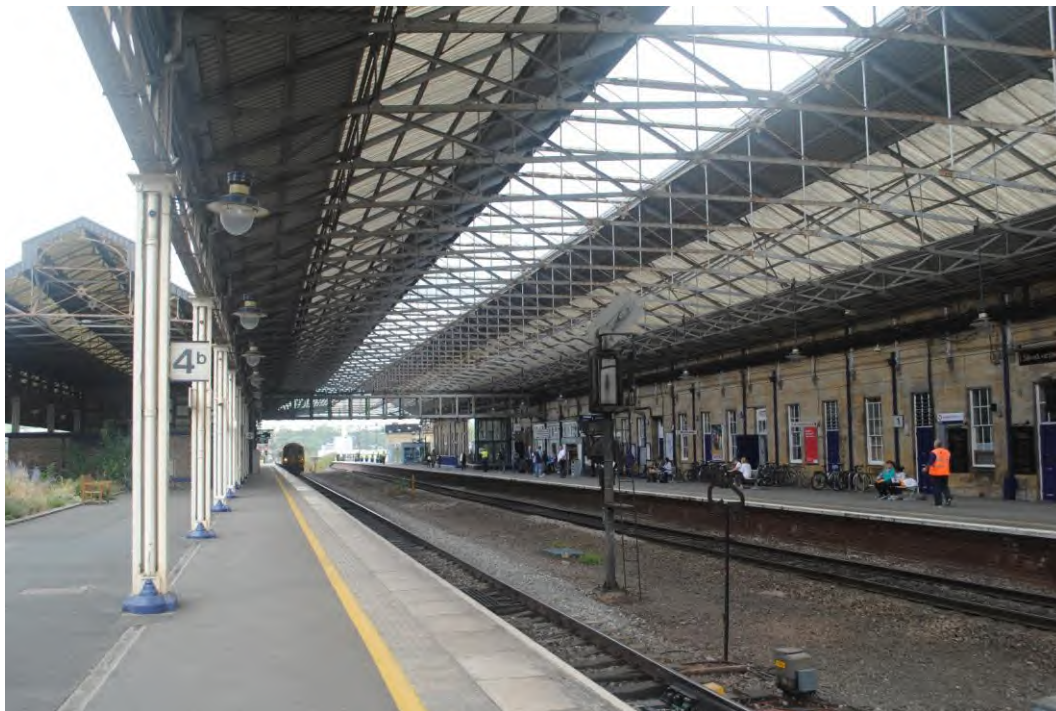
Insert 4-4 Trainshed roof at Huddersfield Station, viewed from southern end of island platform; the main span of ‘Roof A’ is in the foreground while the smaller secondary ‘Roof B’ span can be seen on the left.

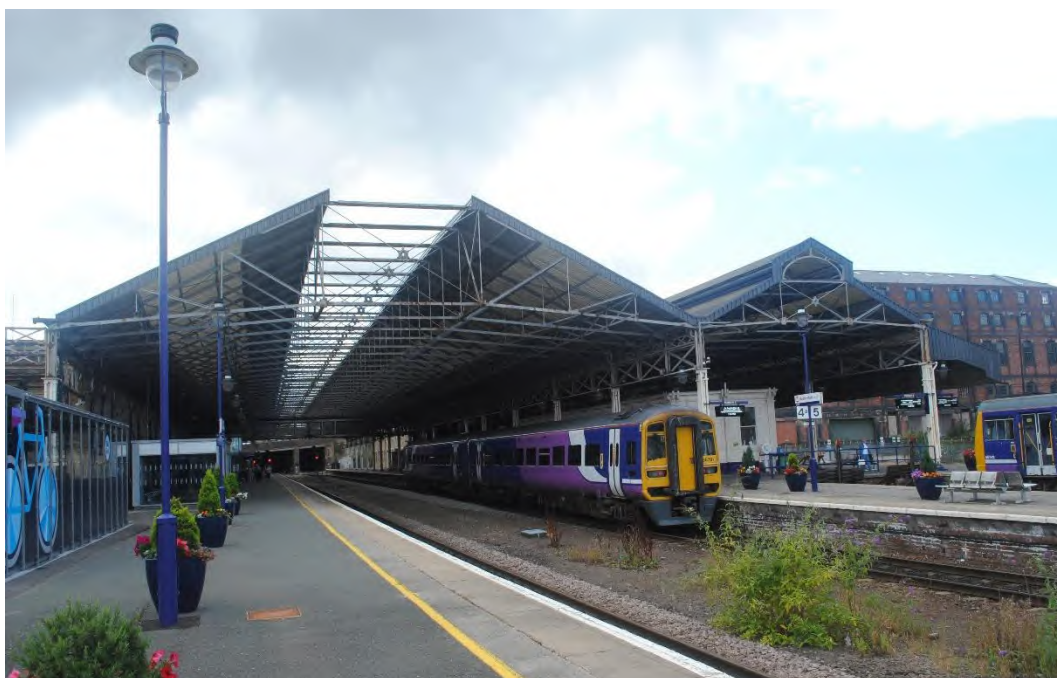
Insert 4-5 Trainshed roofs viewed from the northern end of the platforms, showing gable ends of principal ‘Roof A’ (left) and ‘Roof B’ (right). ‘Roof C’ is visible cantilevered off the edge of ‘Roof B’ on the far right.
