**ARBORICULTURAL IMPACT ASSESSMENT  
to BS 5837:2012  
at  
Land East of Penistone Road  
Fenay Bridge  
Huddersfield  
West Yorkshire  
HD8 0JS**

**Client:**  
Homes By Honey

**JCA Ref:**  
21115-A/AJB

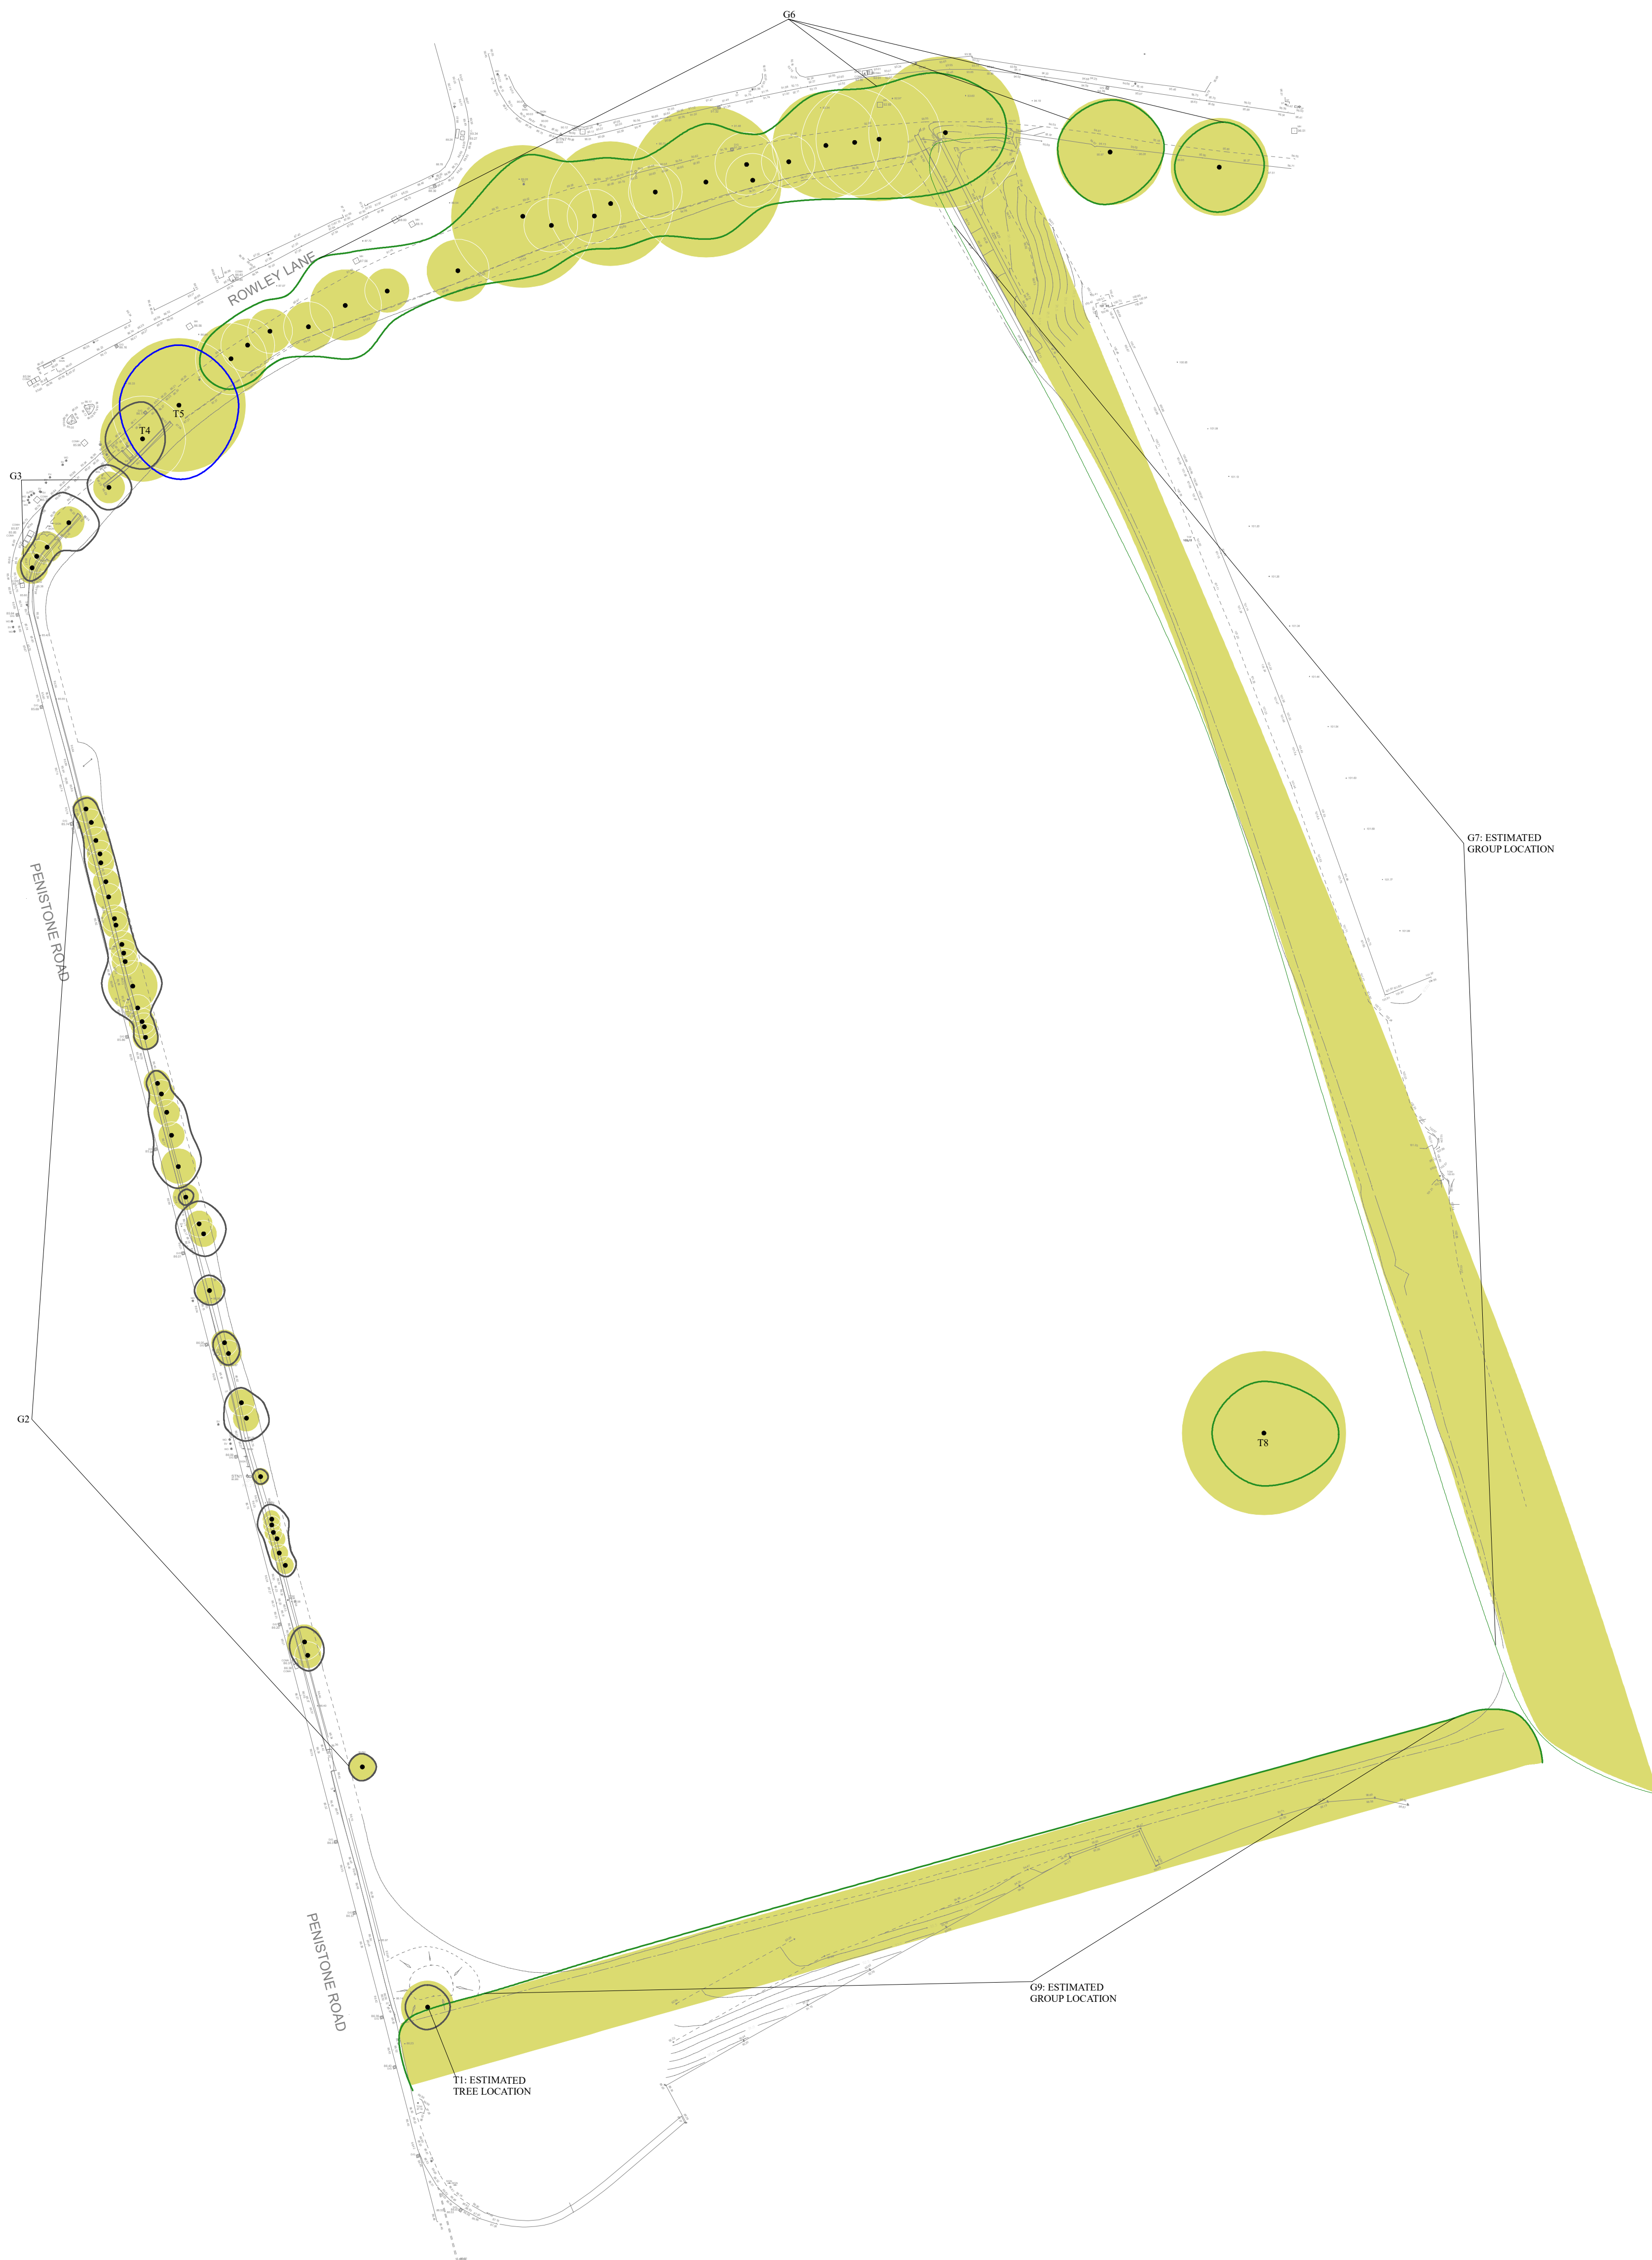
**Appendix 5:  
Tree Constraints Plan**

- 2.1 The tree information recorded during the original survey is detailed in the tables at **Appendix 1**. A full explanation of the tables can be found at **Appendix 2**. Please refer also to the Tree Constraints Plan at **Appendix 5** for tree locations.

- 4.6 The protection of retained trees can be achieved by the creation of a Construction Exclusion Zone based on the Root Protection Area of a tree. The Root Protection Area of each tree or group is marked on the Tree Constraints Plan at **Appendix 5**.

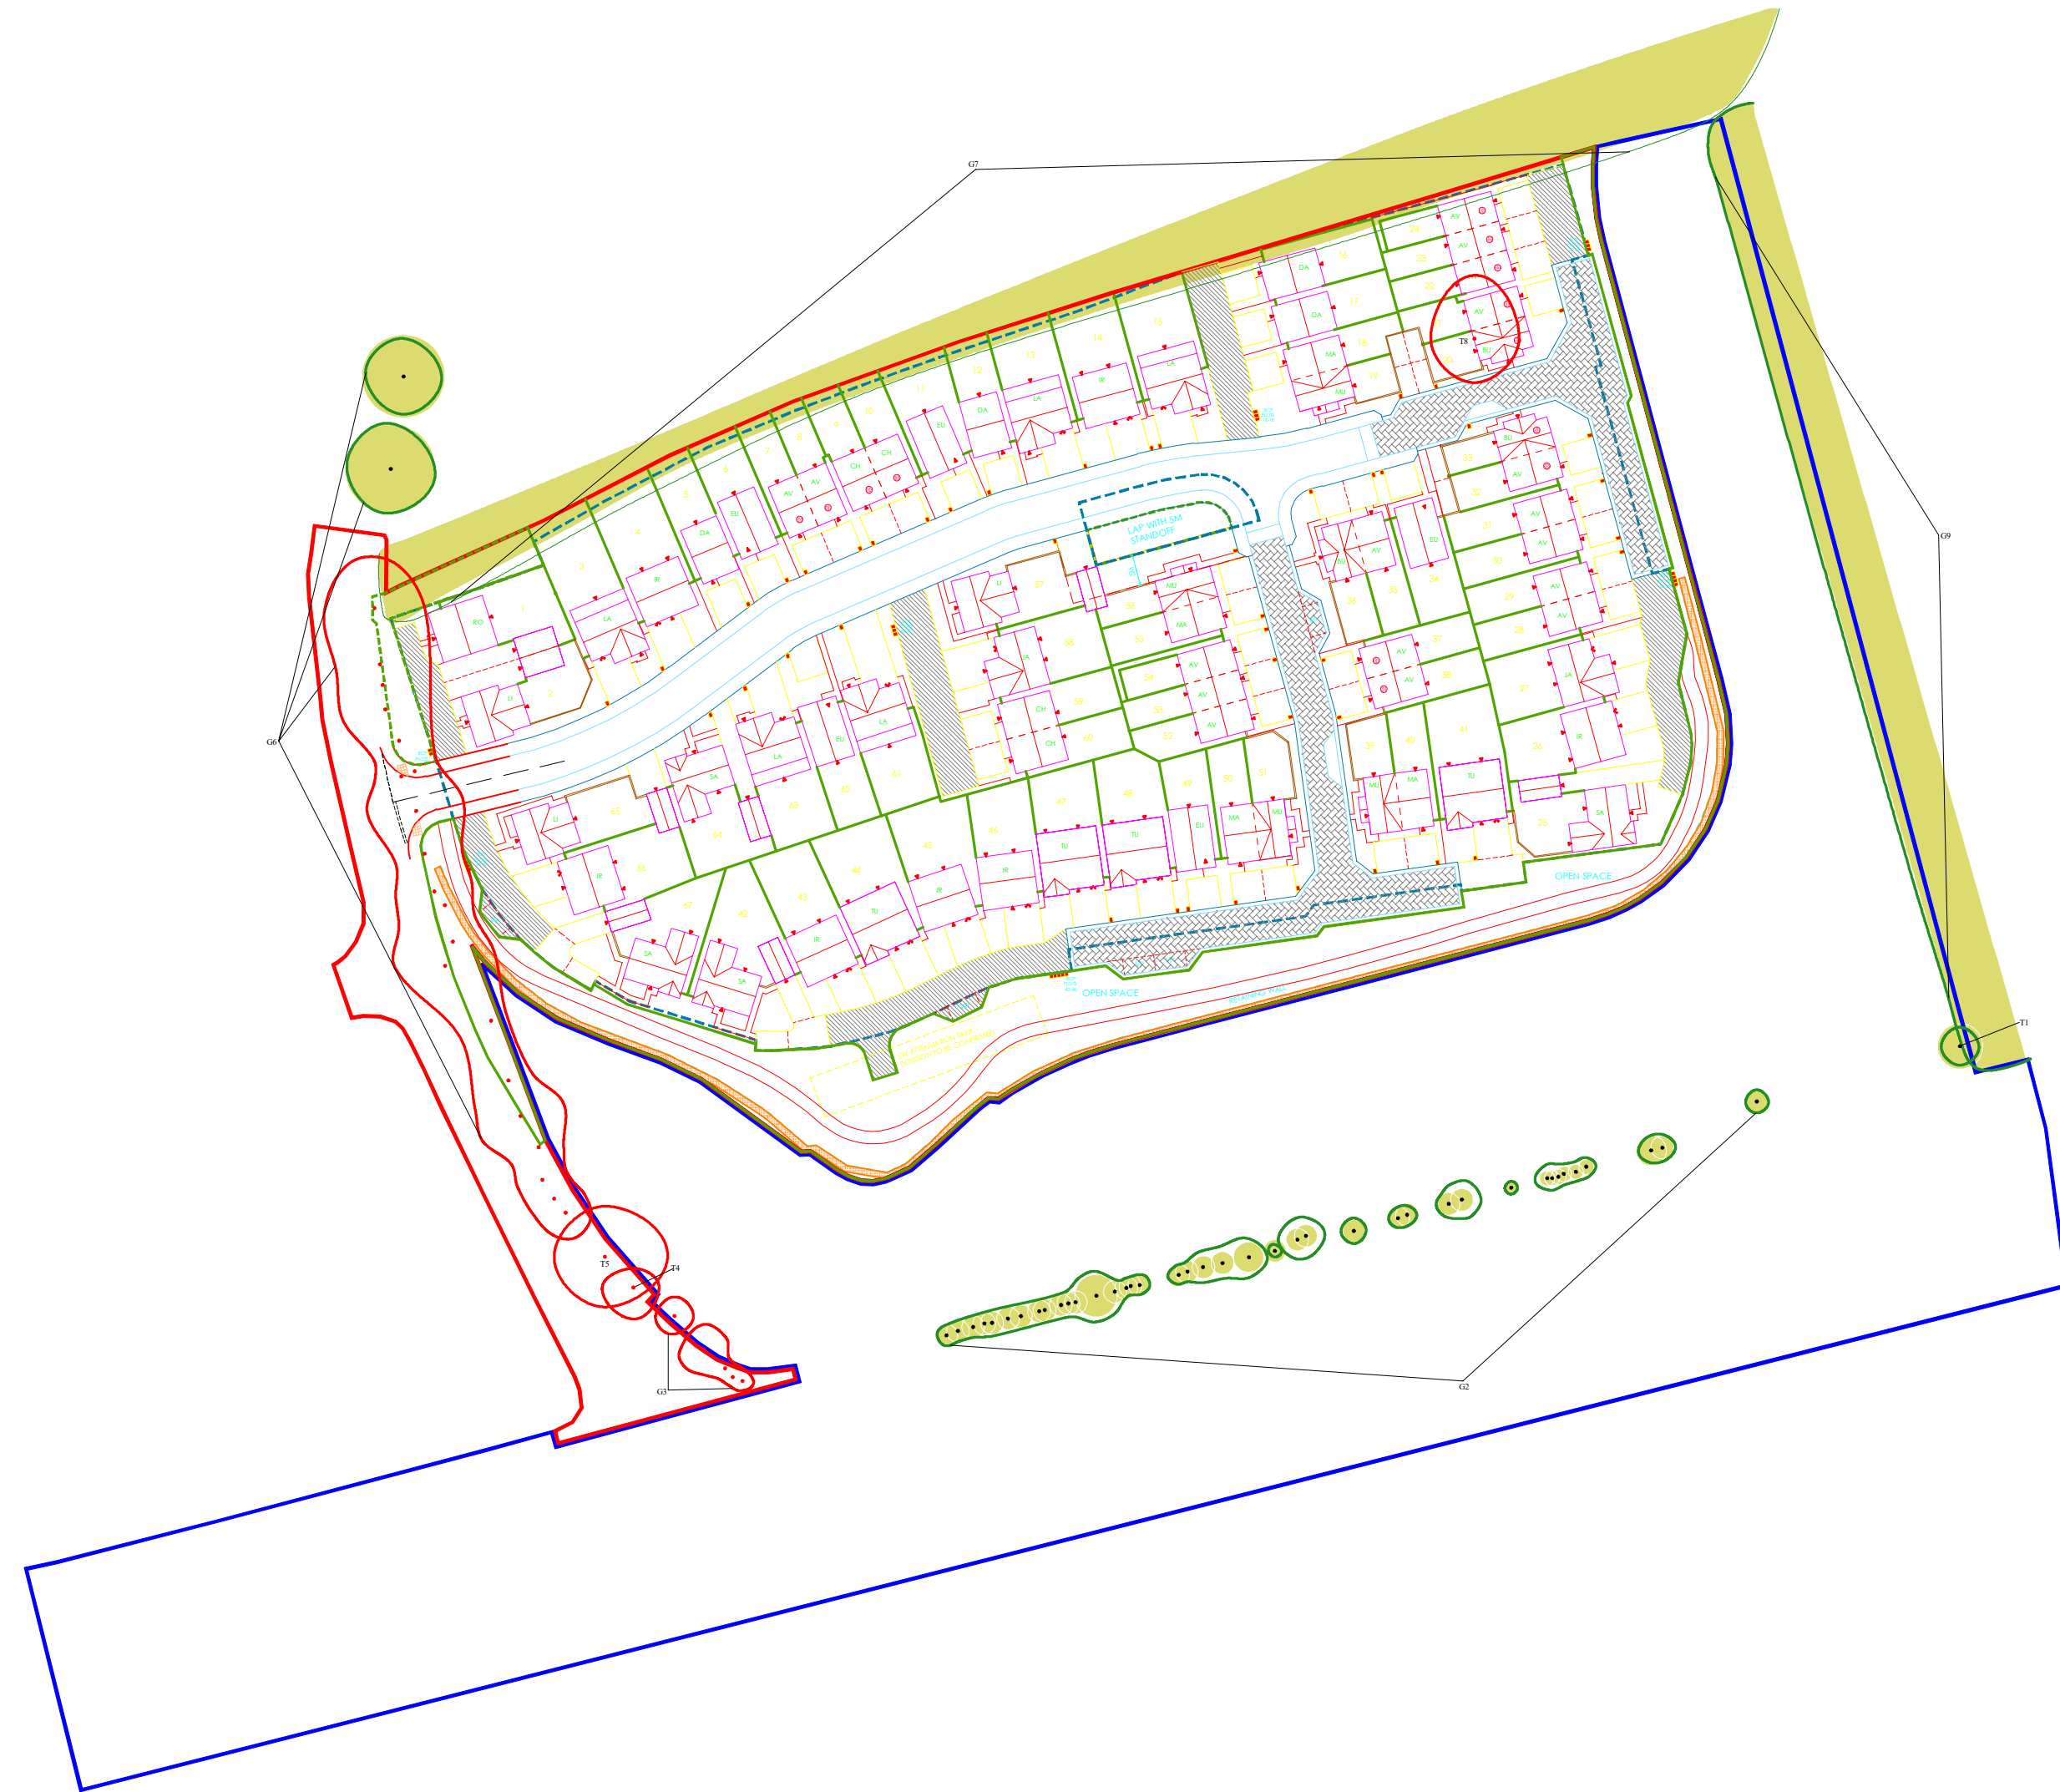
### Appendix 6: Arboricultural Implications Plan

- 3.2.1 In order to facilitate the proposed development, it will be necessary to remove **G3, T4, T5**, circa nineteen trees within **G6** (as shown in red on the plan at **Appendix 6**) and **T8**. Of these, **G6** and **T8** fall into retention category 'A', **T5** falls into retention category 'B' and **G3** and **T4** fall into retention category 'C'.
- 3.2.2 Whilst the development will require the removal of some trees within the site, it should be noted that a planting scheme is included within the proposals. This will act to mitigate tree losses, improve the visual benefits of the site and the surrounding area, and will improve the localised tree stock.

- 4.4 **G3, T4, T5**, circa nineteen trees within **G6** and **T8** require removal in order to facilitate the proposed development. Tree works required to accommodate the proposals are detailed in *italics* in the tables at **Appendix 1**. Those trees requiring removal are shown in red on the Arboricultural Implications Plan at **Appendix 6**, where the proposals can also be viewed.

- 1.3.1 This report is compiled in accordance with *BS 5837:2012 'Trees in relation to design, demolition and construction – Recommendations'* and is based on an objective assessment of the existing vegetation.
- 1.3.2 The specific design of the proposed development has been considered within the Arboricultural Implication Assessment in **Section 3** and is detailed on the Arboricultural Implications Plan at **Appendix 6**.
