# Bat Scoping Survey to

Raypal Business Park

Dewsbury Road

6<sup>th</sup> March 2024

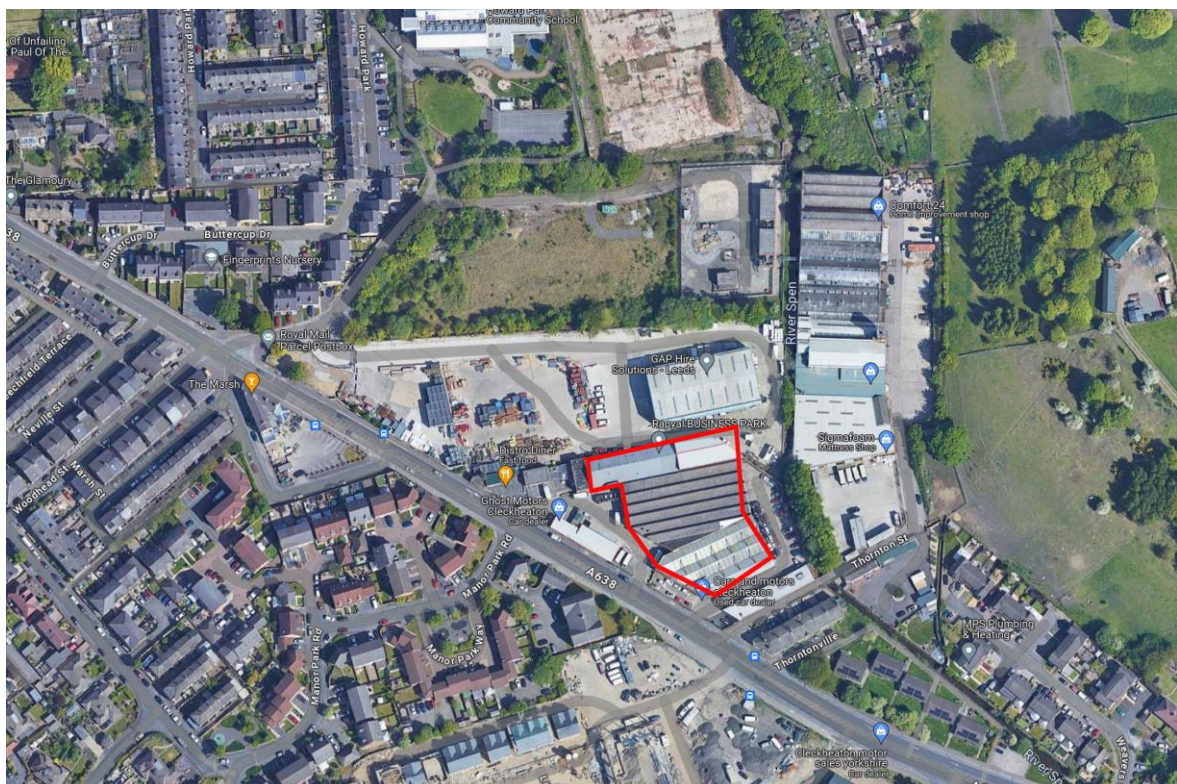
Figure 2 Aerial view of the site, surrounds and specific buildings surveyed.

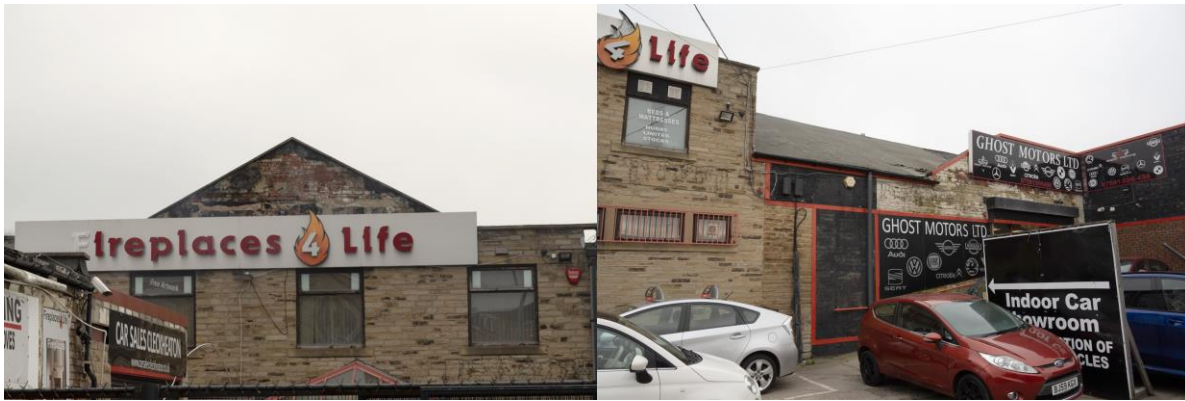
This is a brick building with a slate roof which is most likely unlined. There was no access inside the loft space due to a suspended internal ceiling. However, much of the roof has been covered with a felt or bitumastic layer over the slates and the remaining, exposed slates appear sound and without missing or slipped tiles. Ridge tiles are present and with no failed mortar. The gable walls are only partially rendered due to frost damage, but the render remains at the dry verges. The gable wall has a raised parapet and has stone caps and no obvious access. Bats are considered unlikely to use this building and it has been assessed as being of negligible interest to bats. Building 1a is an extension of this roof, slightly raised above that of building 1 and has a covering of pressed steel sheeting and is considered to be of negligible value to bats.

Photo 1: Showing gable and roof of building 1

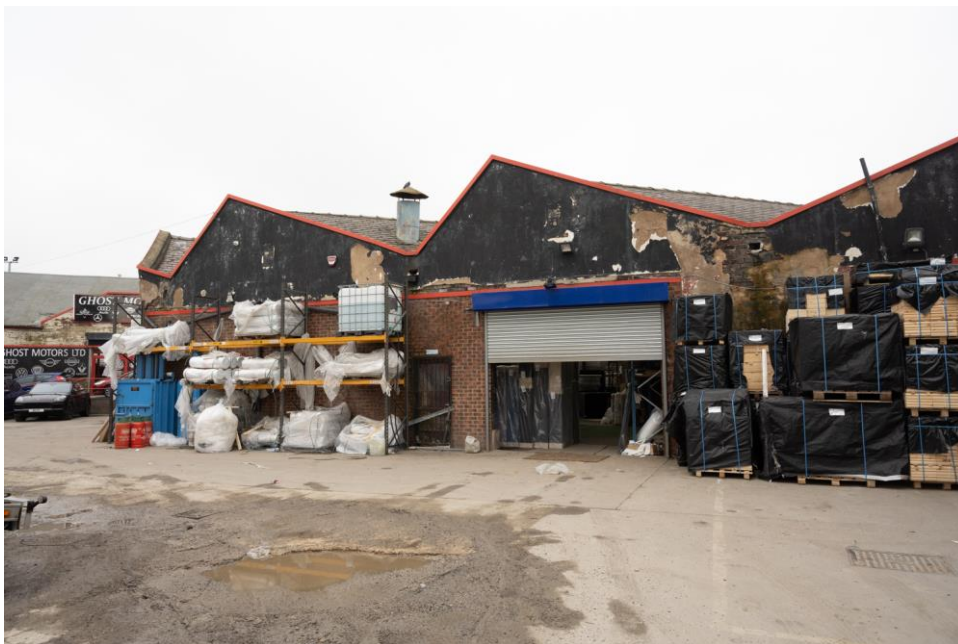
A large brick workshop with multiple north light roofing. The south slopes to the roofs are slate while the north slope is entirely glass. This style of roof tends not to support ridge dwelling species and the roof is subject to constant light ingress. Internally, the roof is open and without any roof void and the unit is in constant use throughout the day with industrial processes and associated noise and dust which would prevent bats from using the roof. The brickwork walls do not have gaps or structural cracks and the gable walls are all completely rendered making access to the dry verges unlikely for bats.

Photo 2: Showing building 2
